**Narrative: 64 Dane St, Somerville, MA 02143 (Littlefield-James House)****Replacement/ Demolition of Front Porch (updated)**

September 3, 2025

Project: 64 Dane Street, Somerville, MA  
Re: Structural analysis of historic porch posts  
Project Number: 25003

# HANGER GRODD FRONT PORCH RECONSTRUCTION

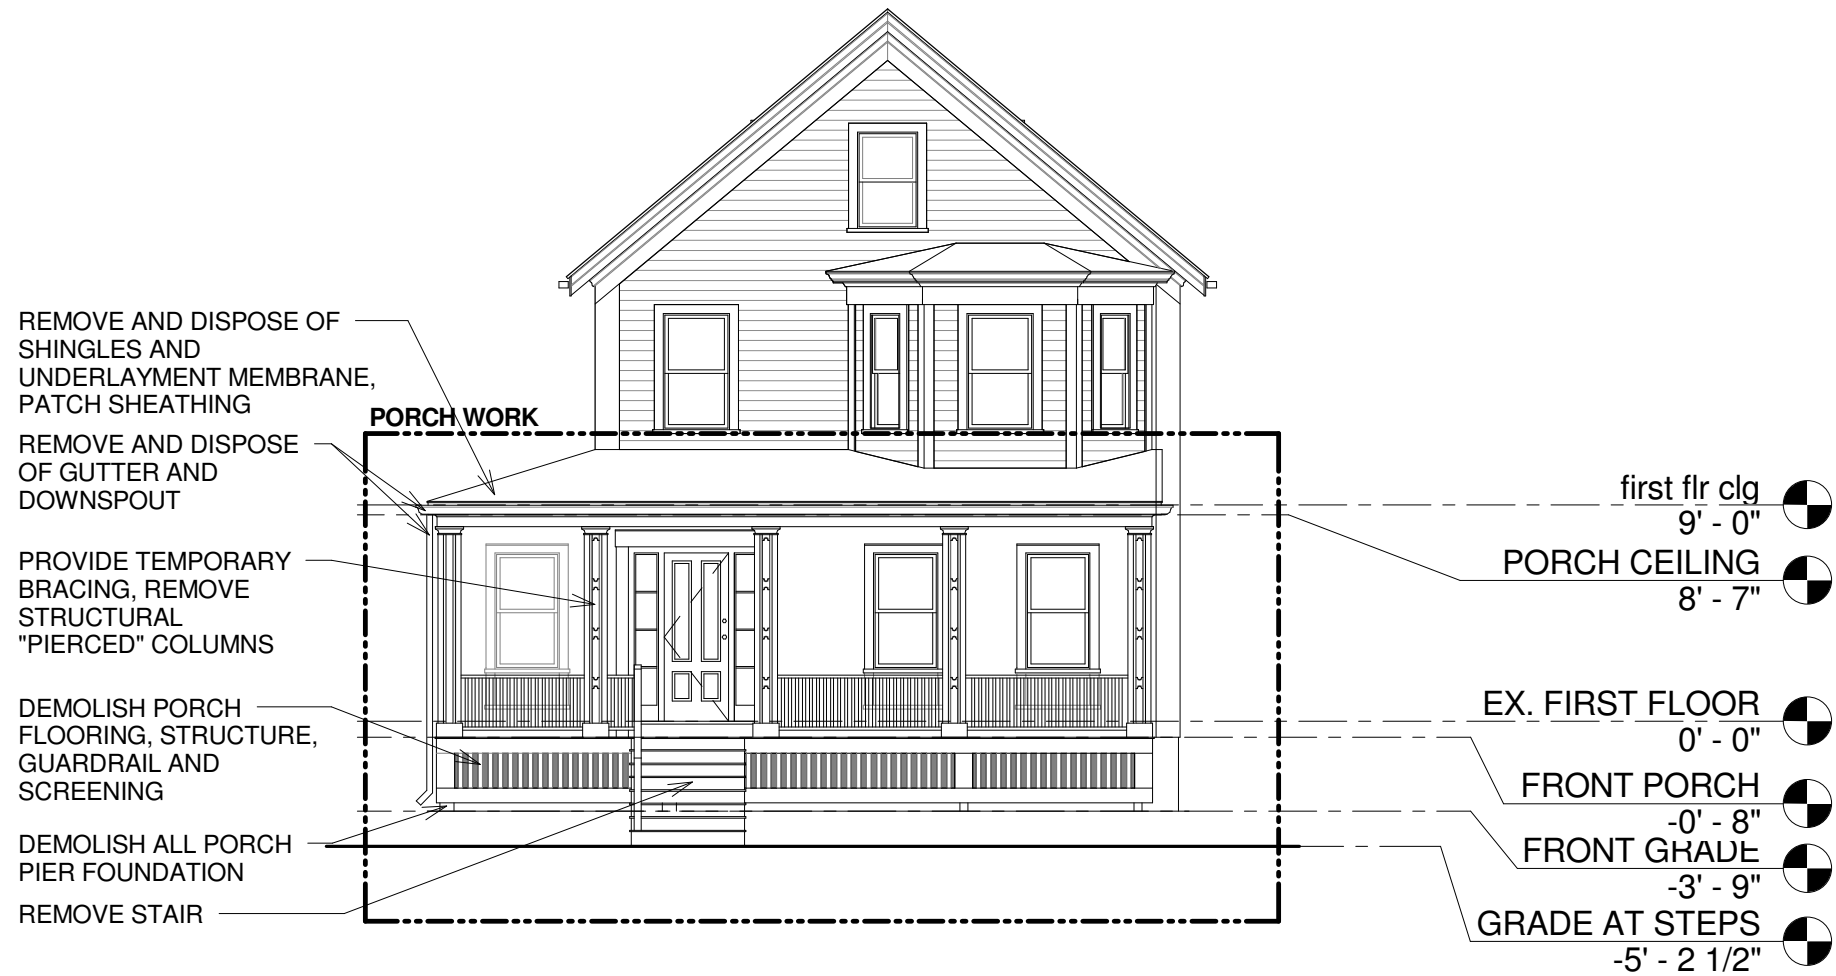
DEMOLITION – FRONT ELEVATION

The pierced **columns** are in various stages of decline. Refer to included letter from structural engineer. They have rot at the base and the corner column had the webbing removed completely to accommodate downspout. ~~A structural engineer has reviewed the existing columns and stated that while the columns could be replaced with replicas they would have to be with larger members that would alter the scale and width of the new replica columns. The homeowner would like to replace the pierced columns with simple square ones of similar proportion to the front facing width of the existing columns, 10". The capital would replicate the cove crown and the flat base at the bottom proportionally. The column will be cast fiberglass w/ wood crown and fly ash (TruExterior) base, painted.~~

**Deck structure** is unsound. The three concealed 8x8 brick piers and two 4" steel pipe set into concrete are degraded and need to be replaced and repositioned to better support the loads. The framing needs to be replaced due to rot and degradation.

*A structural engineer has reviewed the existing columns and stated that the columns could be replaced with replicas. The replacement columns will be made of wood, replacing what was original with duplicates to be painted.*

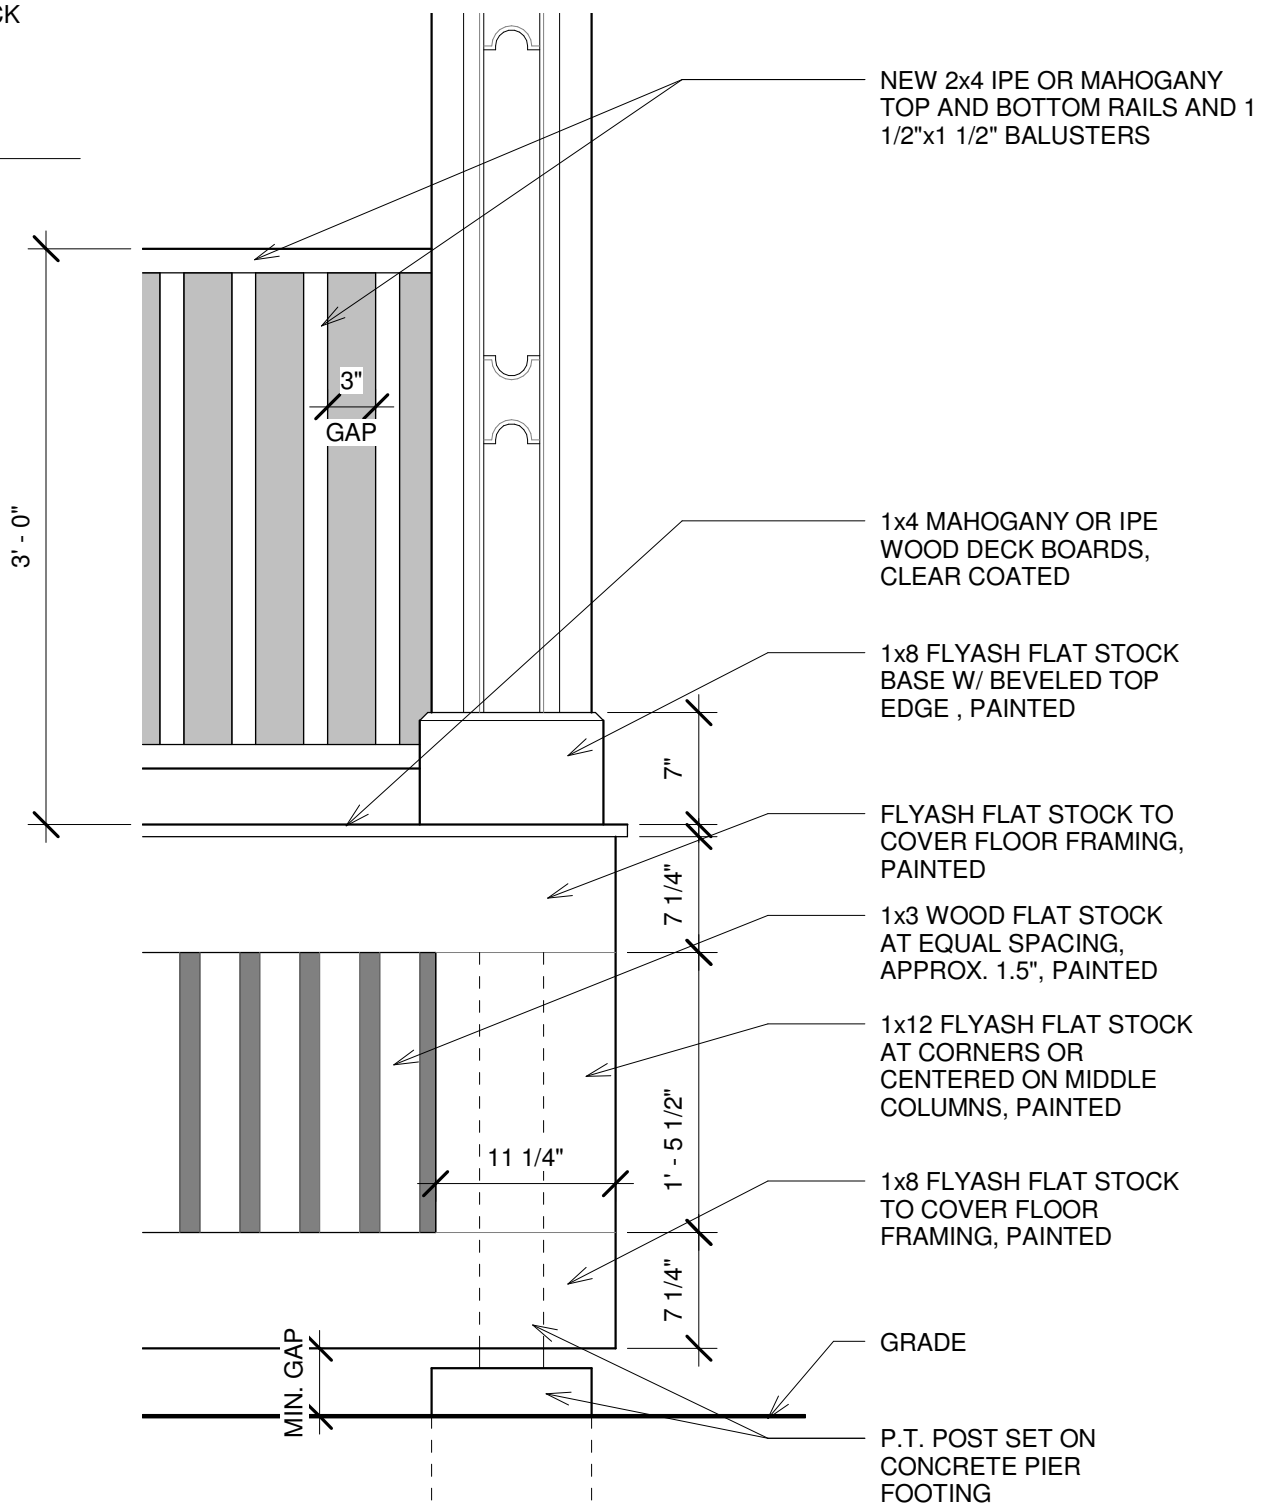
1 COLUMN DETAIL  
1" = 1'-0"

BE analyzed the posts to determine if they can be repaired or rebuilt with the same narrow profile and still support the code required loading. **Based on the analysis, the existing posts are too narrow and are inadequate to support the required snow drift loading on the porch roof. BE recommends that the posts be replaced with a larger profile during the renovation project.**
