Case #: HPC 2019.062
Date: October 15, 2019

PRESERVATION STAFF REPORT
for
Determination of Preferably Preserved

Site: 59 Linden Avenue Barn

Regarding: Existing Barn Structural Assessment
59 Linden Ave., Somerville, MA
TLHC Project# 1909281

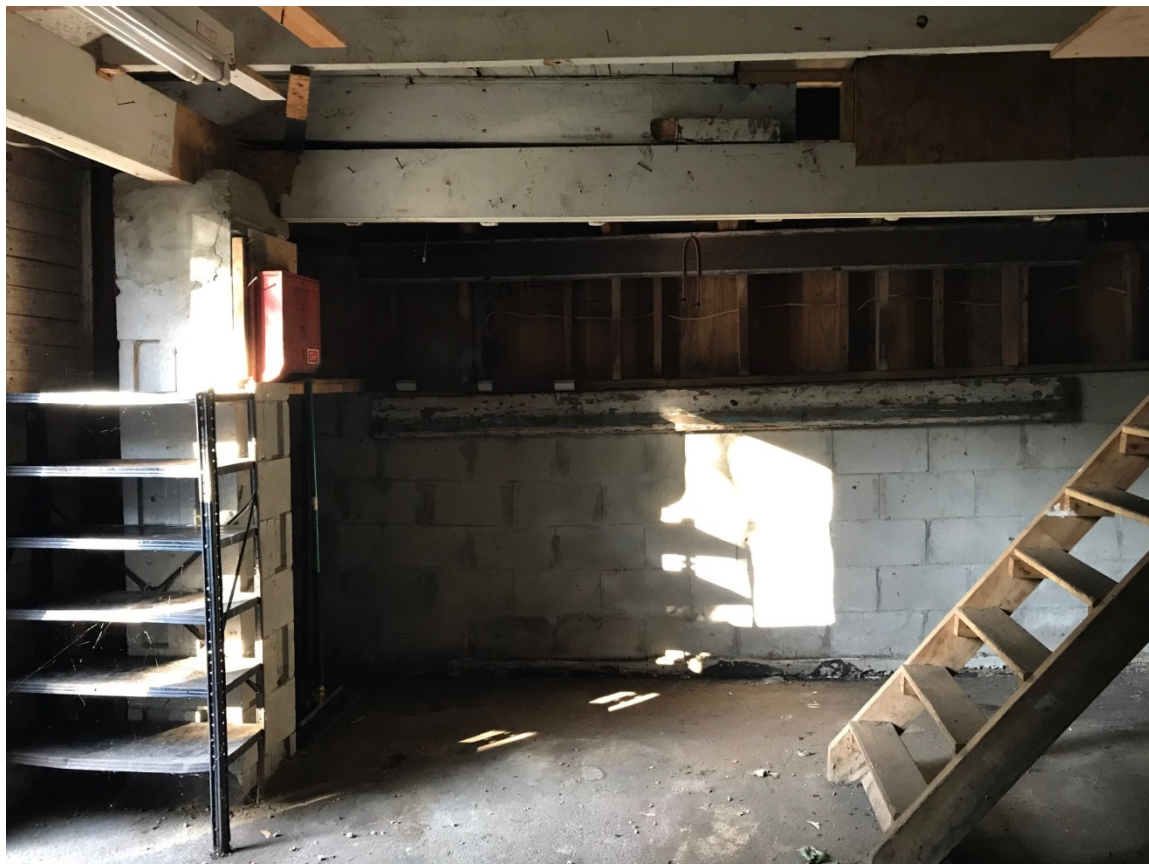
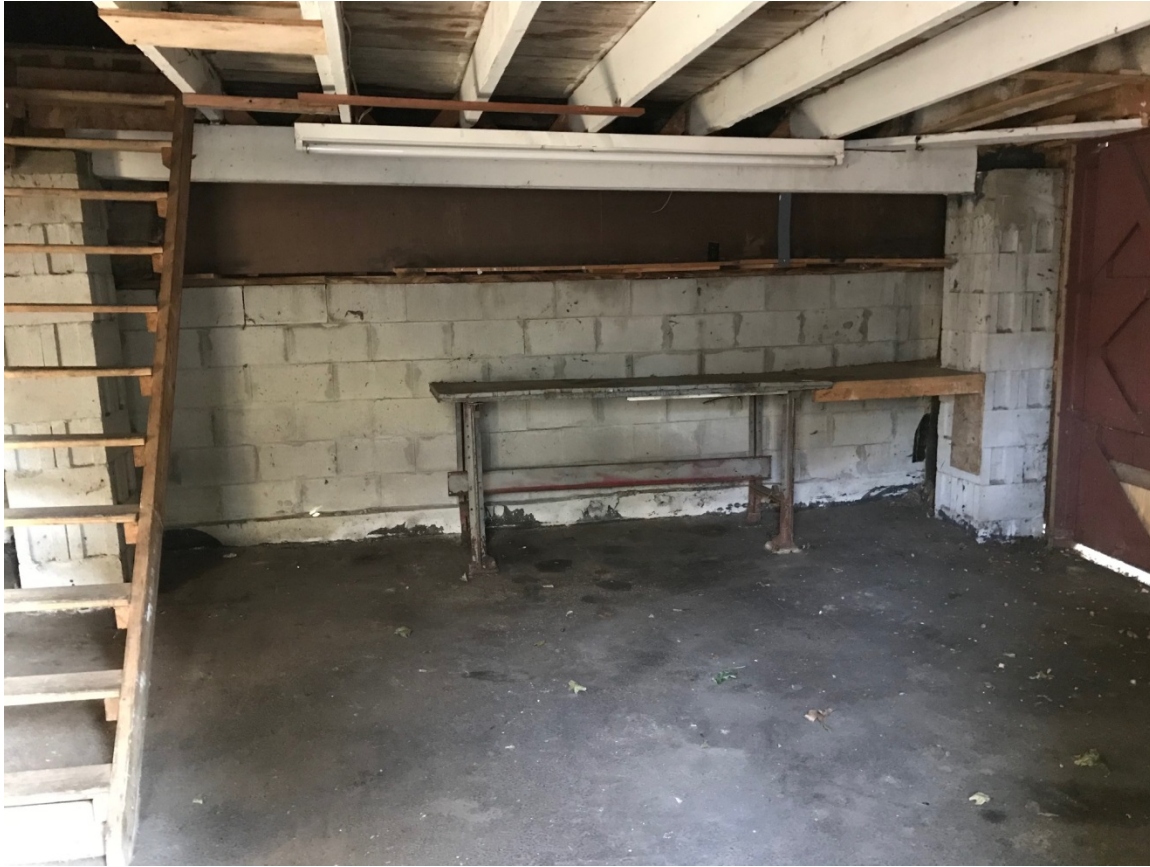
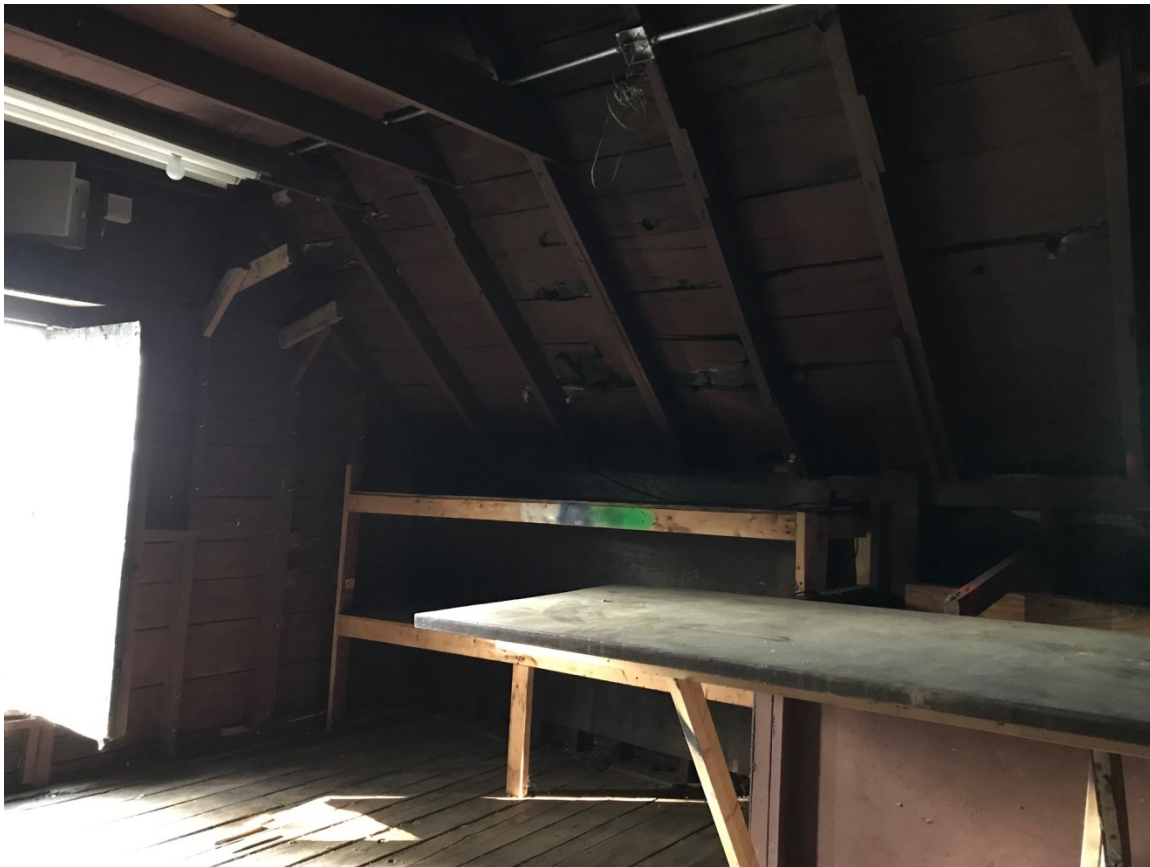
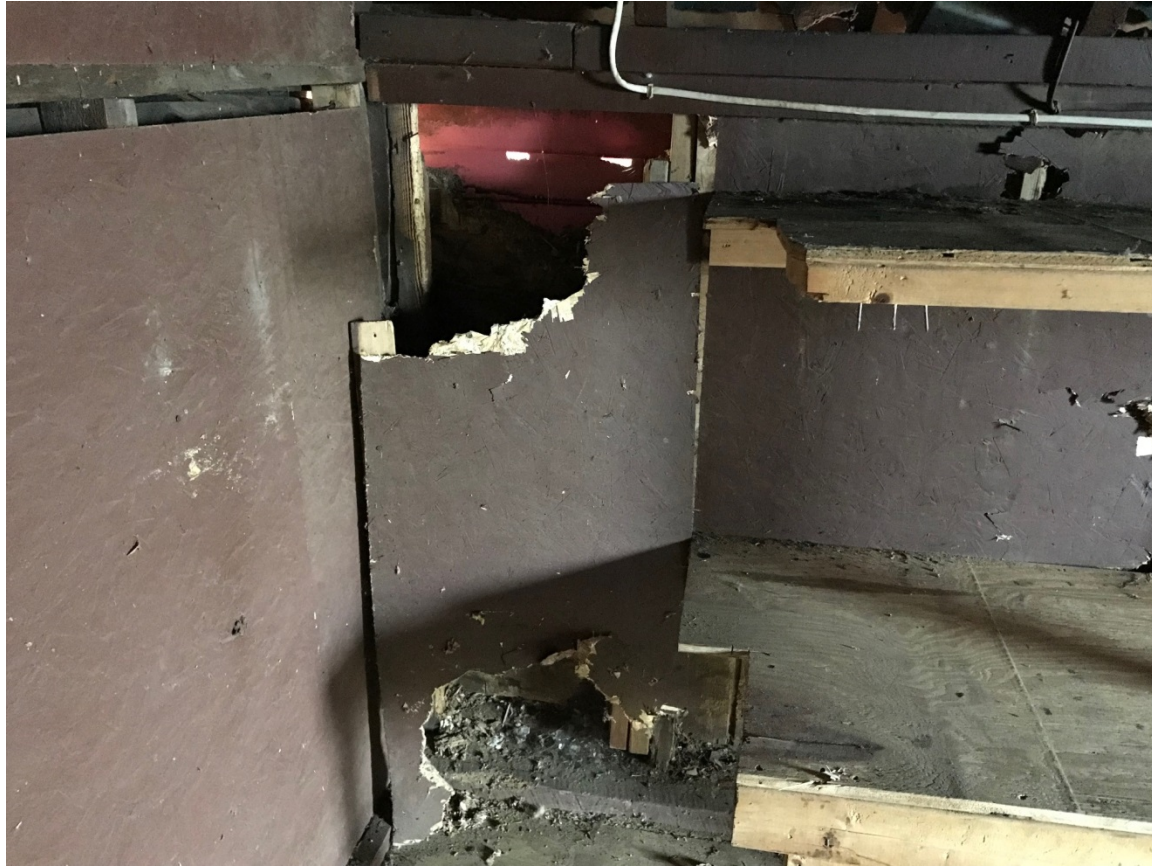
The barn framing is in very poor condition. The roof sheathing is deteriorating and rotted in several places. The roof rafters are undersized when compared to current residential framing standards. The wood framed walls supporting the rafters are bowing outward which is an indication the rafters are not properly tied together.

The attic floor framing of the barn is out of level and the floor joists seem slightly undersized. The attic floor joists are supported by triple 2x10 beams at each end of the joists. The triple 2x10 beams are undersized. The beams bear on built up concrete masonry unit (CMU) piers. One of the piers has a significant lean to it.

The front and rear gable walls are approximately 5 to 10 degrees out of plumb. The rear gable wall is poorly framed; the portion of the front gable wall above the attic space is framed in an acceptable manner, however, the lower portion of the wall is unacceptable. The wall studs face the wrong direction and the bottom wall plate appeared to be “floating”, i.e. there was no sill plate.

The walls running parallel with the ridge are in very poor condition. The door headers at the wall closest to the driveway are notched at each end, and the wall framing along this wall is poorly constructed. The two walls on the opposite side of the ridge are not in much better condition than the driveway side wall.

In summary, it is our opinion the barn should be demolished. The condition of the barn is poor at best; the CMU foundation seems to be the only structurally sound element associated with the barn. If you have any questions or require additional information feel free to contact TLH Consulting at (978) 362-1804.
