STEP 1: DETERMINATION OF SIGNIFICANCE
STAFF REPORT

Site: 11 Benedict Avenue

Case: HPC.DMO 2022.03

Legal Ad: *Demolish principal structure.*

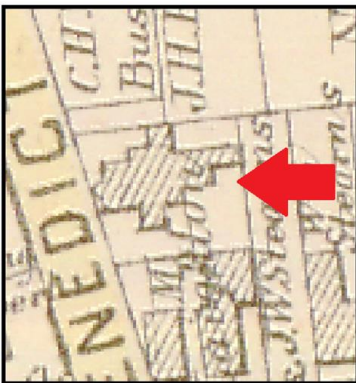
Above: Fig 1

Fig 1: 1874 Hopkins Map, close-up of 11 Benedict Ave.

- The structure in 1874 had a front bay, an ell on both sides and the rear. The sketch shows further details on the side ells. On the left ell there is a portion of the structure that projects in front of the

ell. On the right elevation this detail appears to the rear of the ell. In both cases it is that may have been a porch or a lean to.

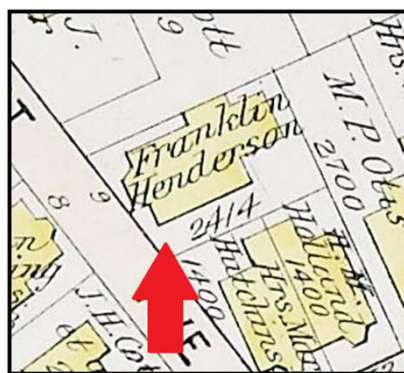
Above: Fig 2

Fig 2: 1895 Bromley Map, close up of 11 Benedict Ave

- By 1895 the left elevation is now flat with an ell. The ell on the right elevation appears to have been removed. There also appears to have been an addition added to the rear increasing the massing of the rear.

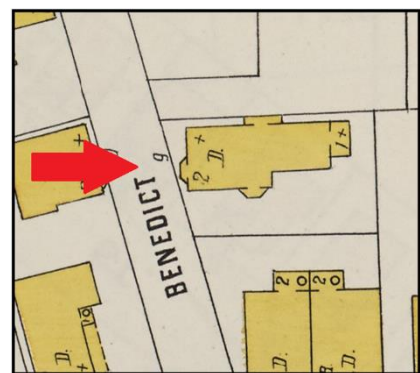
Above: Fig 3

Fig 3: 1900 Sanborn Map, close up of 11 Benedict Ave

- The only change by 1900 is that a bay has been added to the right elevation.

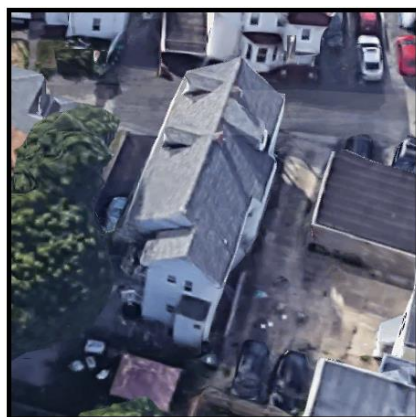
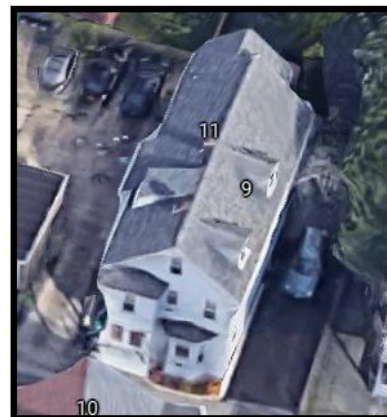
Fig 4 & 5: Satellite images of the rear and front of 11 Benedict Ave

- By 2022, an addition to the second floor of the front elevation has been added. The addition acts as a roof to a porch below. On the rear a lean-to has been added.
