**Tree Health Assessment Report**  
**Corbett-McKenna Playground**

Somerville Parks Tree Health Program

IFB 25-26

Jan 21, 2025

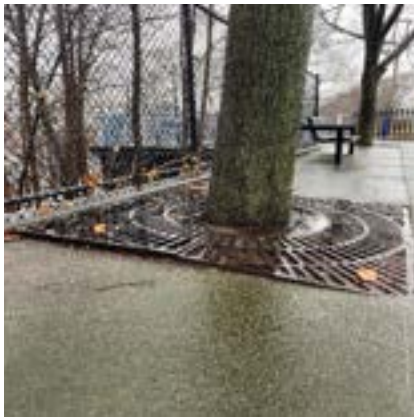
All trees in the park were issued a “low” risk rating based on a Level 1 TRAQ assessment. It should be noted that the roots of Linden #42622 located near the southern border have started to raise the metal grate creating a potential tripping hazard. We recommend removing these grates for access to the root zone so soil health can be addressed through root crown examination, mulching and soil amendments.

*Linden #42622 raising grate*

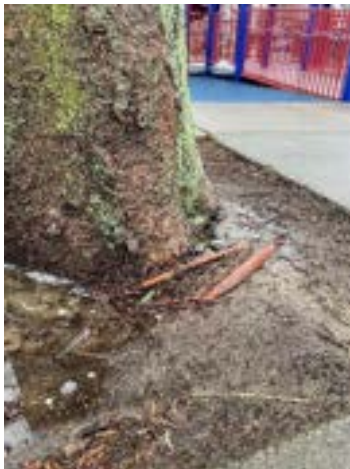
We recommend pruning all trees to raise 8-10' off ground, 4-6' off play structures, lights, fences. Prune to remove dead, diseased, broken branches greater than 1.5" in diameter, crossing and rubbing branches in all trees. The Zelcova # 42632 located near the southeastern border has an exposed girdling root that we recommend pruning out. See photo below.

*Zelcova #42632 with exposed girdling root*

- 18" Zelcova on left side of park (#42632):  
Prune to Sever/remove section of girdling surface root
