HISTORIC PRESERVATION COMMISSION

#### DETERMINATION OF SIGNIFICANCE STAFF REPORT

Site: 56 Line Street Case: HPC 2014.088

Re: No 56 Line Street, Somerville, Massachusetts.

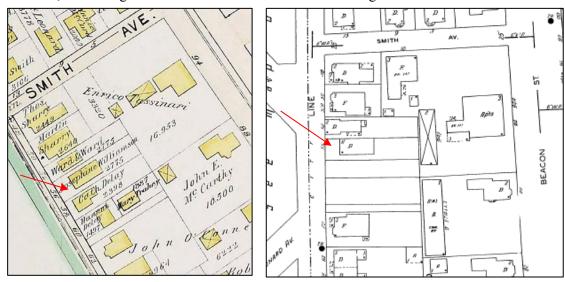
This research indicates that there were three buildings at this approximate location in 1852. By 1895, a majority of the surrounding buildings are in existence and these three noted buildings seem more clearly identified. By 1950, the adjacent gable-end dwelling has the existing front addition, and the right side lot has been razed of three buildings.

Left: 1895 Bromley Atlas

Right: 1950 Sanborn map
