REPORT DETAILS

| Report No. | PRI-SAMPLE-001 | Date | June 22, 2026 | Inspector | Sample Inspector |
| Property Address | Fictional demo property - Charlottetown area, PE | | | Postal Code | N/A |

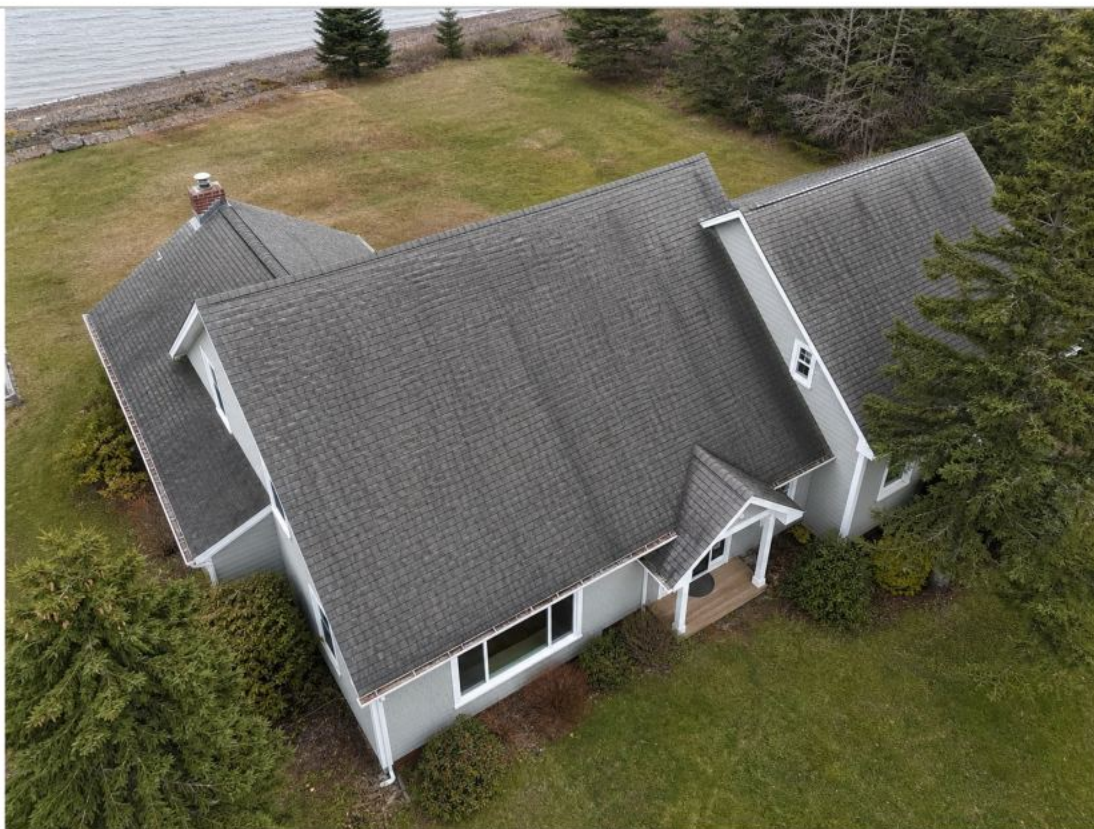
| Location | Full roof overview | Roof Area | A/B | Direction | Drone | Defect ID | CTX | Date | 2026-06-22 |

Drone overview shows the main gable roof, rear slopes, valleys and gutters. Overall condition appears fair with aging visible on shaded slopes.

Drone capture helps identify drainage paths, valley debris zones and exposure patterns that are harder to see from ground level.

Use overview for roof-area reference and compare after maintenance or future inspections.

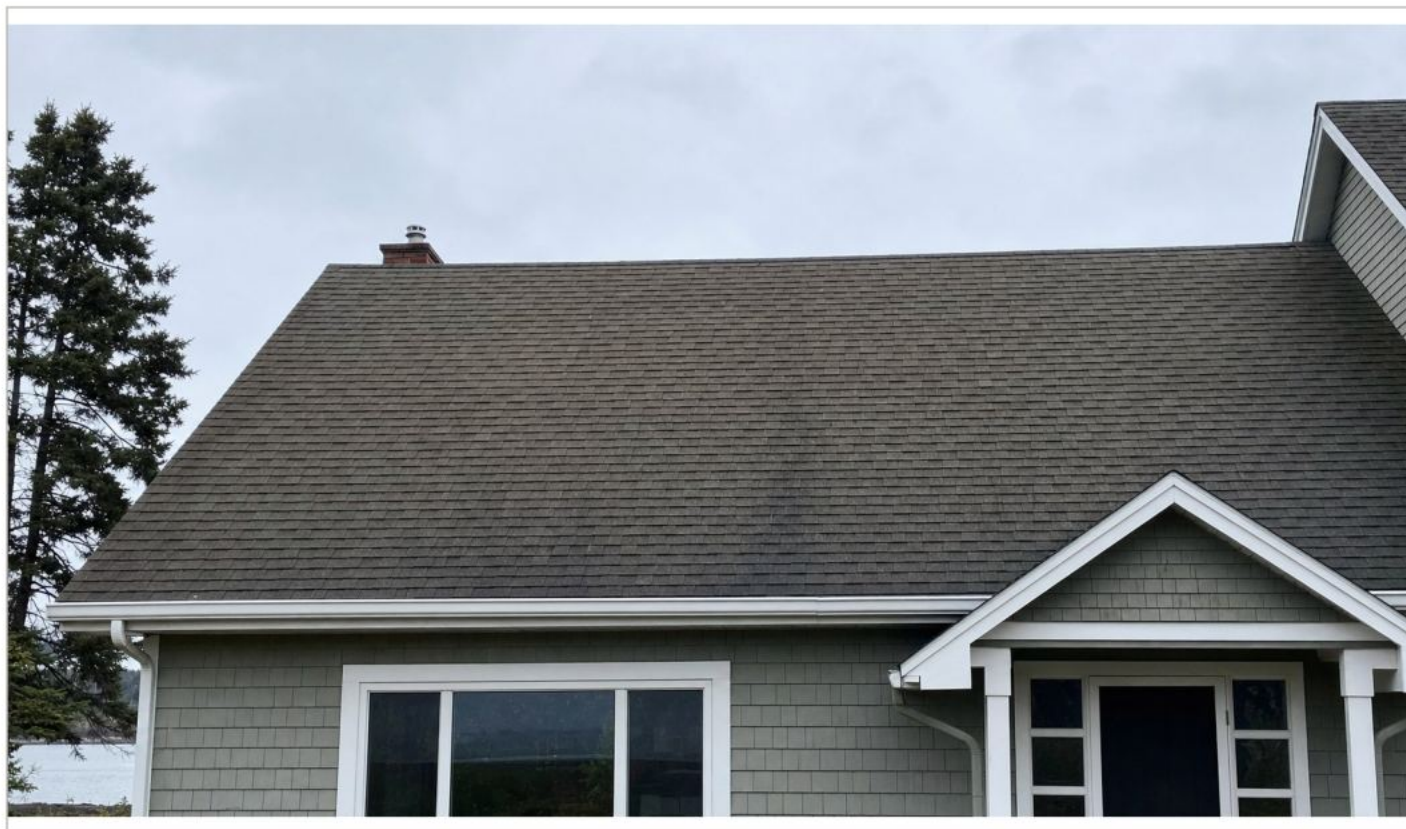
| Location | Front slope | Roof Area | A | Direction | Ground | Defect ID | CTX | Date | 2026-06-22 |

Front slope is generally serviceable with visible age-related staining and weathering.

No immediate failure is visible from this overview, but roof age and exposure support continued monitoring.

Maintain annual review and use close-up photos for repair planning.

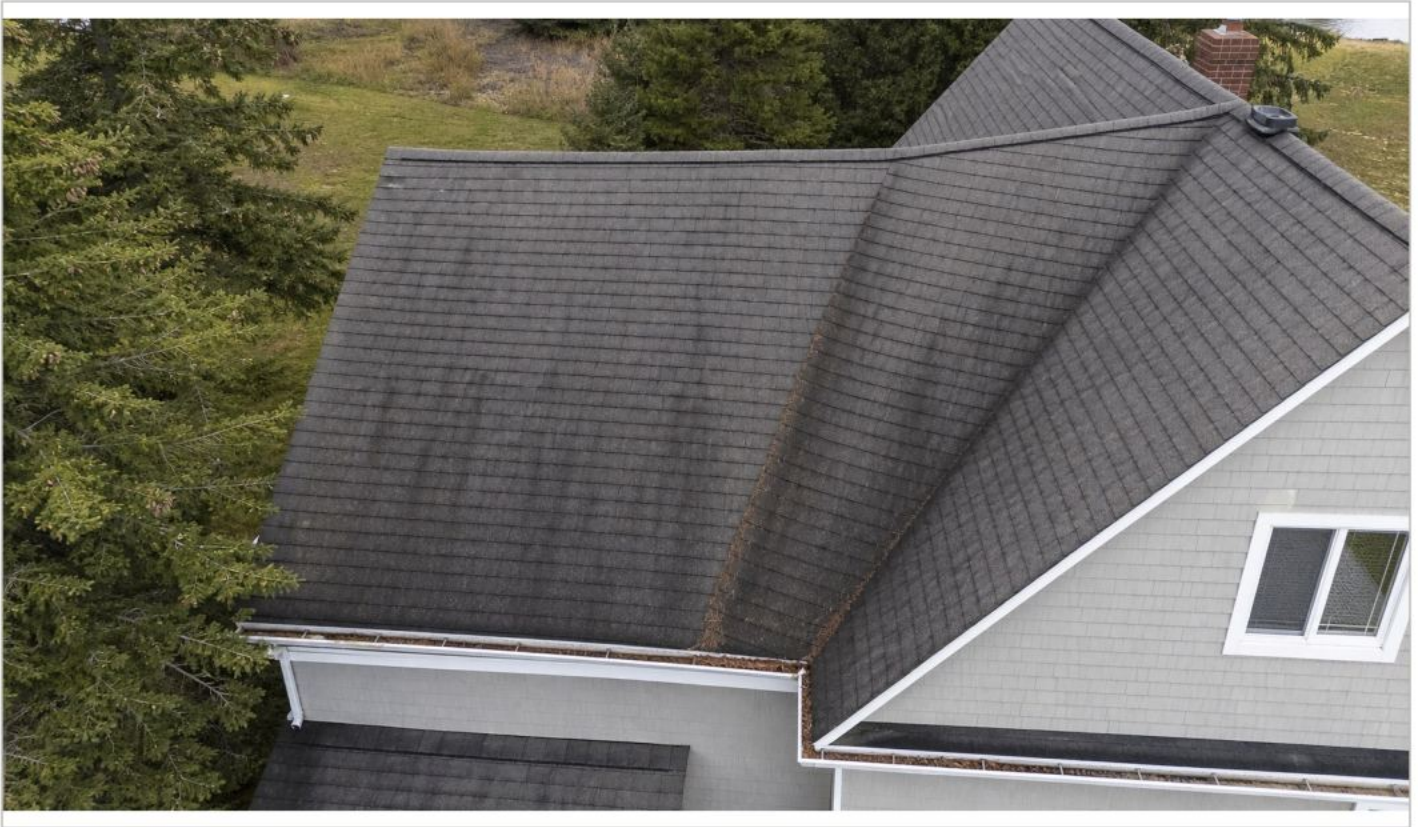
| Location | Rear roof / valleys | Roof Area | B | Direction | Drone | Defect ID | D2 | Date | 2026-06-22 |

Drone view shows rear valley configuration, shaded slope staining and tree influence near drainage paths.

Debris collection and slower drying increase leak risk at valleys and transitions.

Clear valleys and trim overhanging branches where practical.

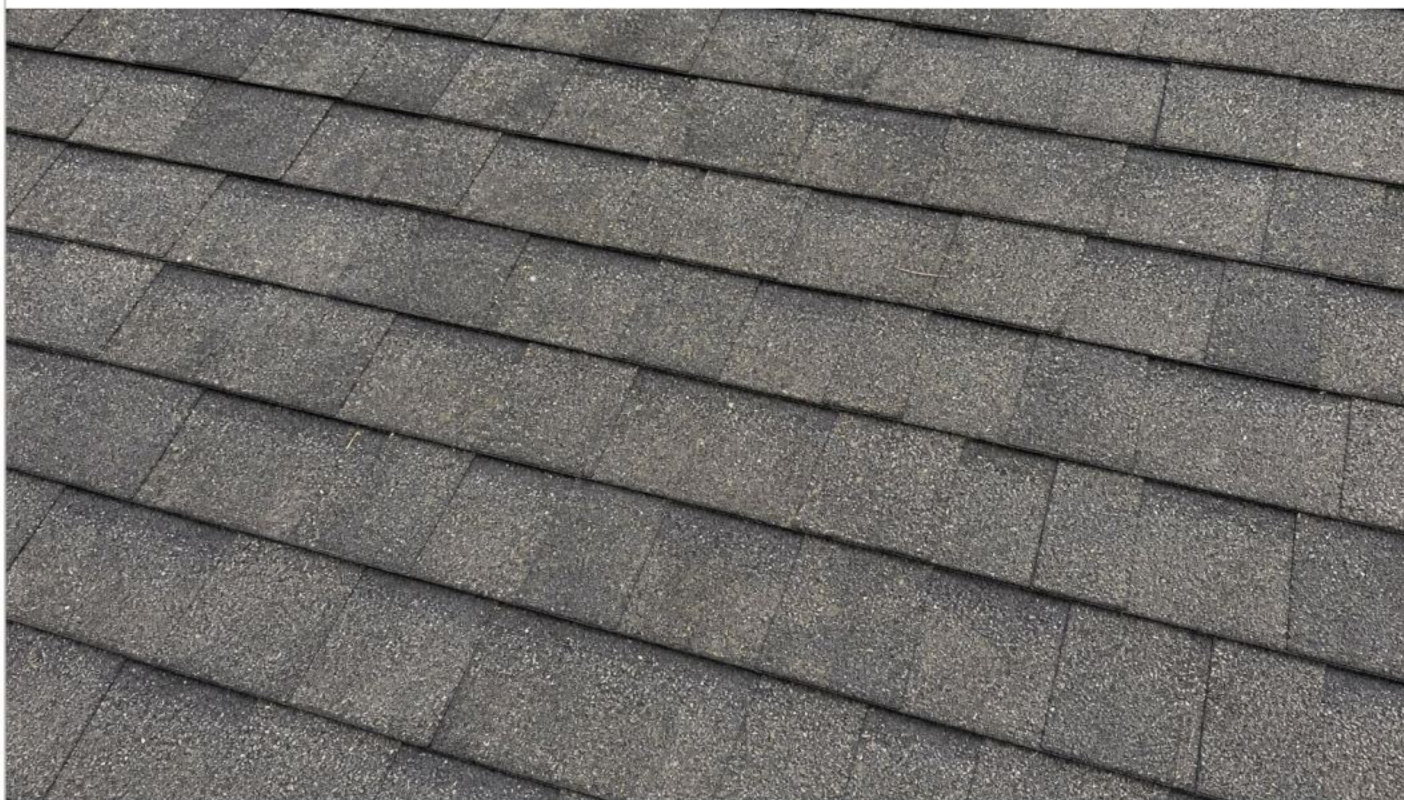
| Location | Main roof field | Roof Area | A | Direction | Drone | Defect ID | D1 | Date | 2026-06-22 |

Field shingles show moderate granule loss and weathering consistent with mid-to-late service life.

Wear is not yet widespread failure, but protective granules are reduced.

Monitor annually and include roof replacement in medium-term budgeting.

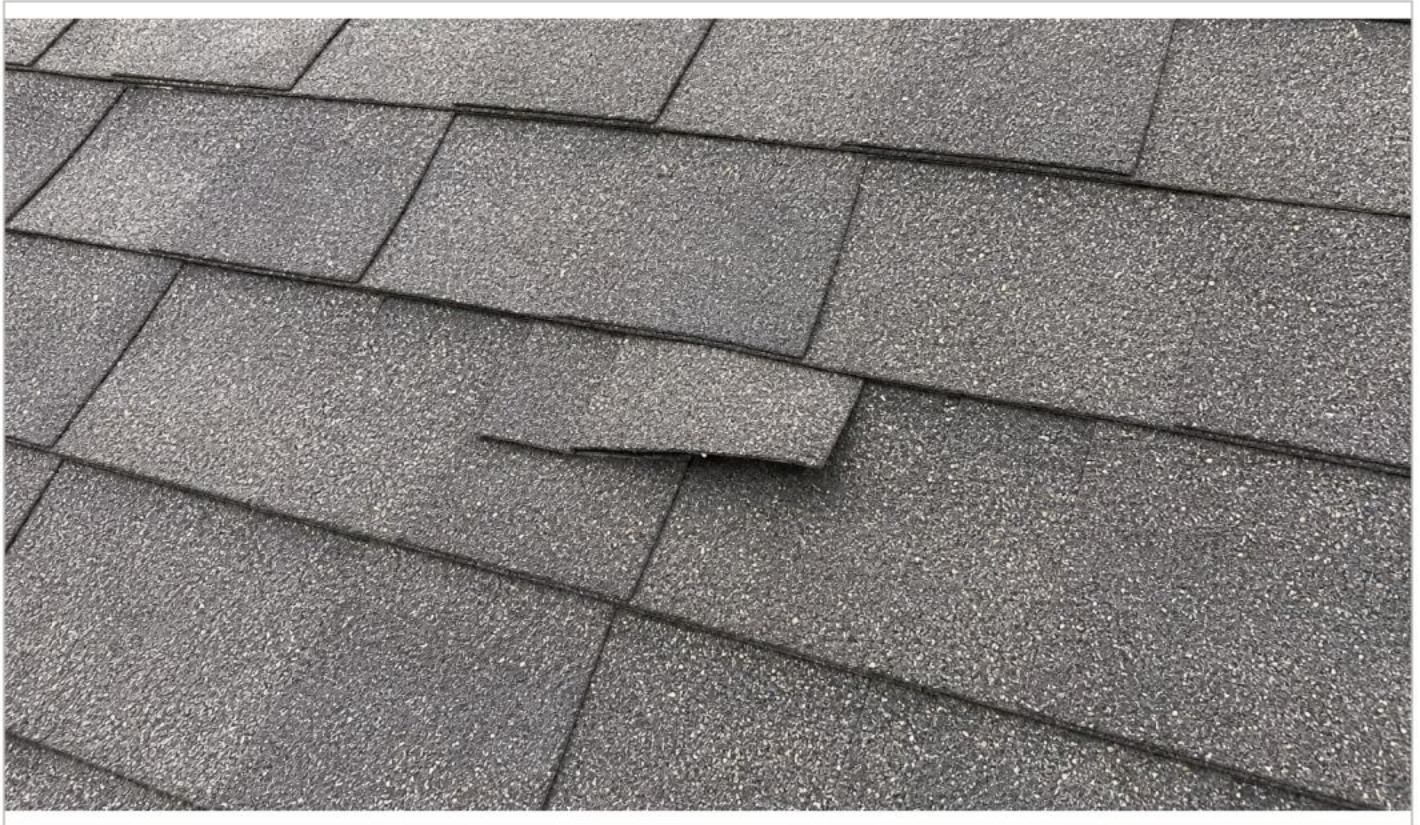
| Location | Main slope | Roof Area | A | Direction | Drone | Defect ID | D1 | Date | 2026-06-22 |

One shingle tab is lifted/creased while adjacent shingles remain mostly intact.

Lifted tabs are more vulnerable to wind-driven rain and further wind damage.

Secure or replace affected shingle tab during targeted repair visit.

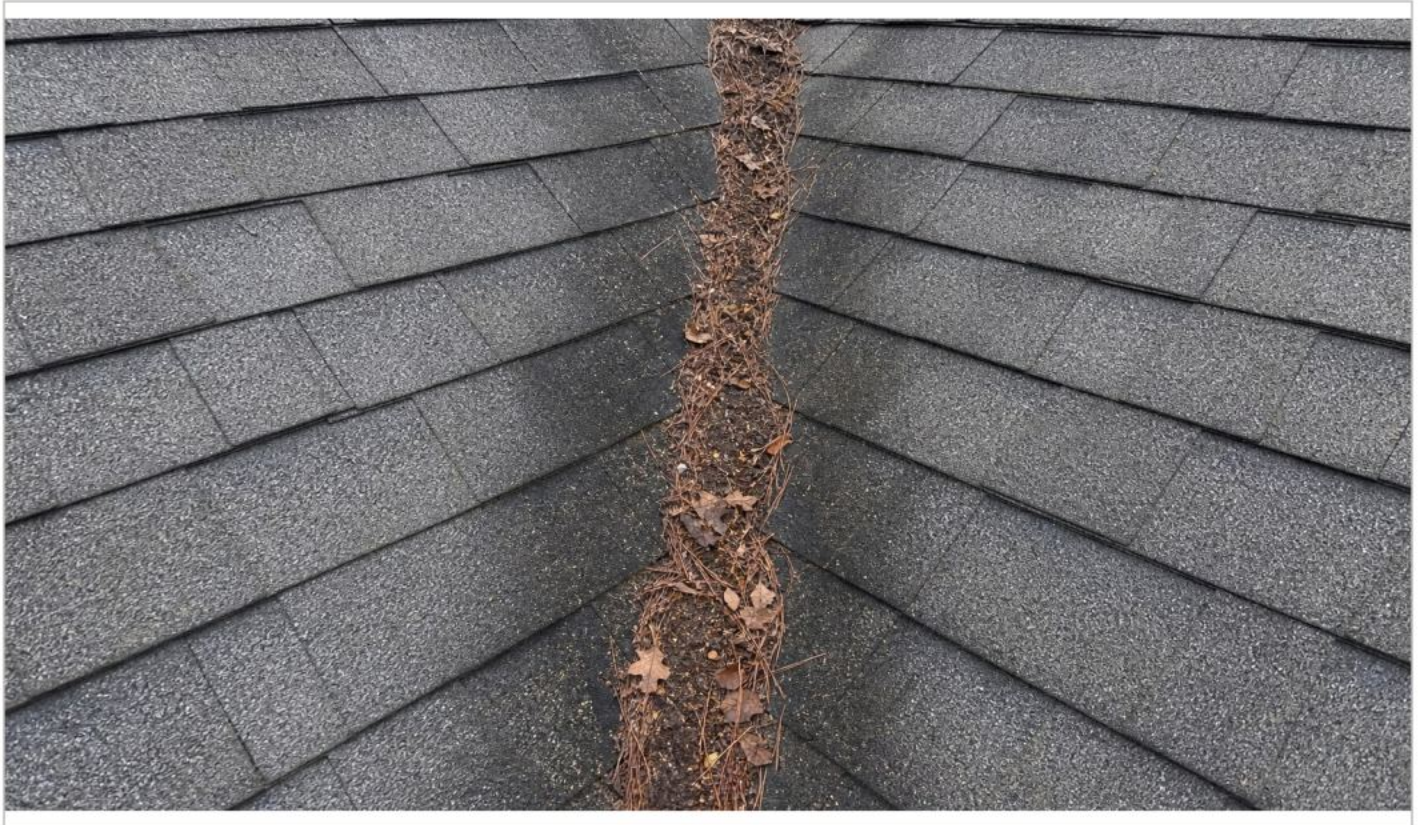
| Location | Rear valley | Roof Area | B | Direction | Drone | Defect ID | D2 | Date | 2026-06-22 |

| ID | LOCATION | COMPONENT | PHOTO | PRIORITY | OBSERVATION / RECOMMENDED ACTION |
|---|---|---|---|---|---|
| D2 | Rear valley | Drainage | 3,6 | P2 | Leaf/pine debris in valley. Clean valley and confirm unobstructed runoff. |

Leaves and pine needles are collected in the valley with staining along the drainage path.

Debris holds moisture and can divert water under shingle edges.

Clean valley promptly and review for damaged shingles after debris removal.

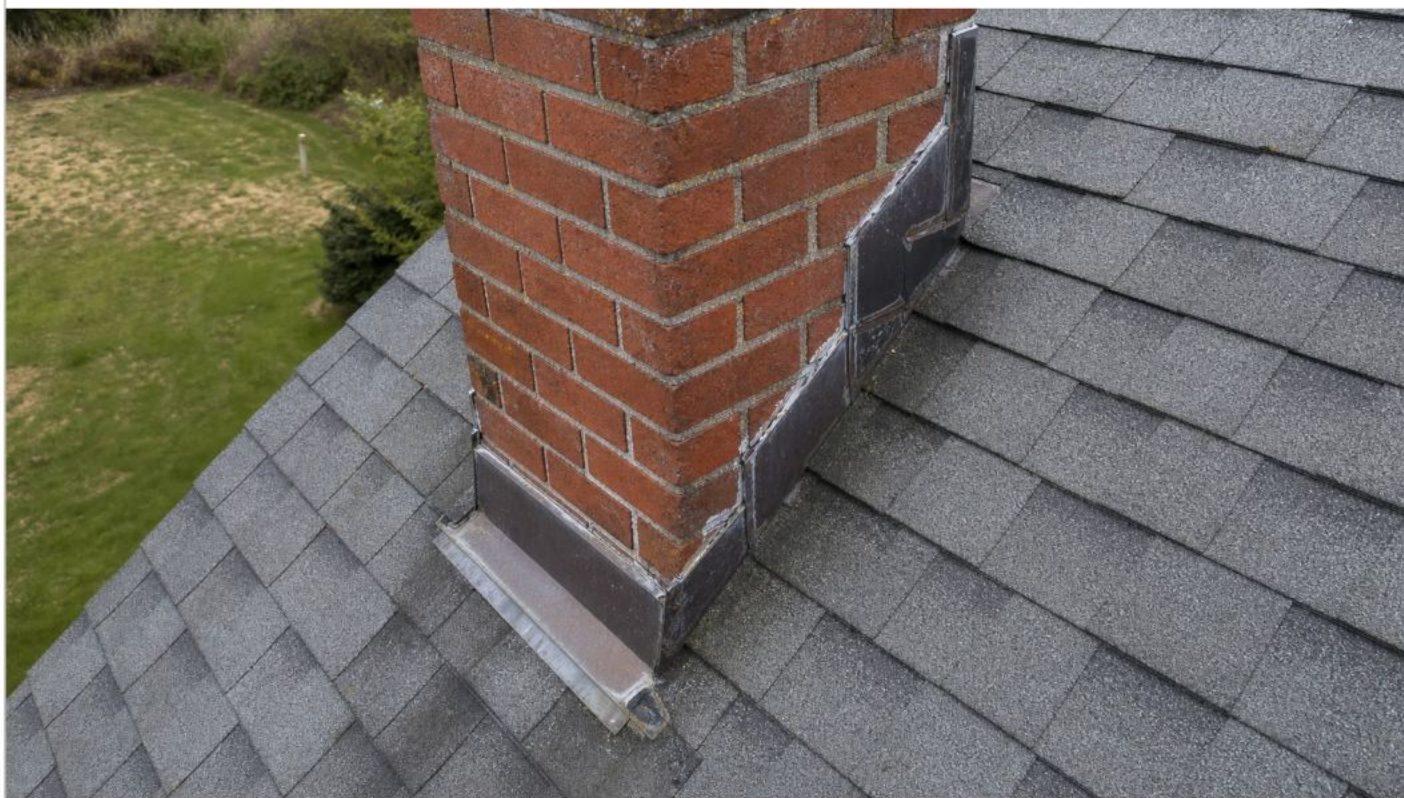
| Location | Chimney | Roof Area | A | Direction | Drone | Defect ID | D3 | Date | 2026-06-22 |

| ID | LOCATION | COMPONENT | PHOTO | PRIORITY | OBSERVATION / RECOMMENDED ACTION |
|---|---|---|---|---|---|
| D3 | Chimney | Flashing | 7 | P2 | Aged flashing sealant and staining. Repair sealant/counterflashing detail. |

Chimney flashing shows aged sealant and staining at the roof/chimney interface.

Aged sealant at masonry transitions is a common leak source under wind-driven rain.

Have a roofer repair flashing sealant/counterflashing detail.

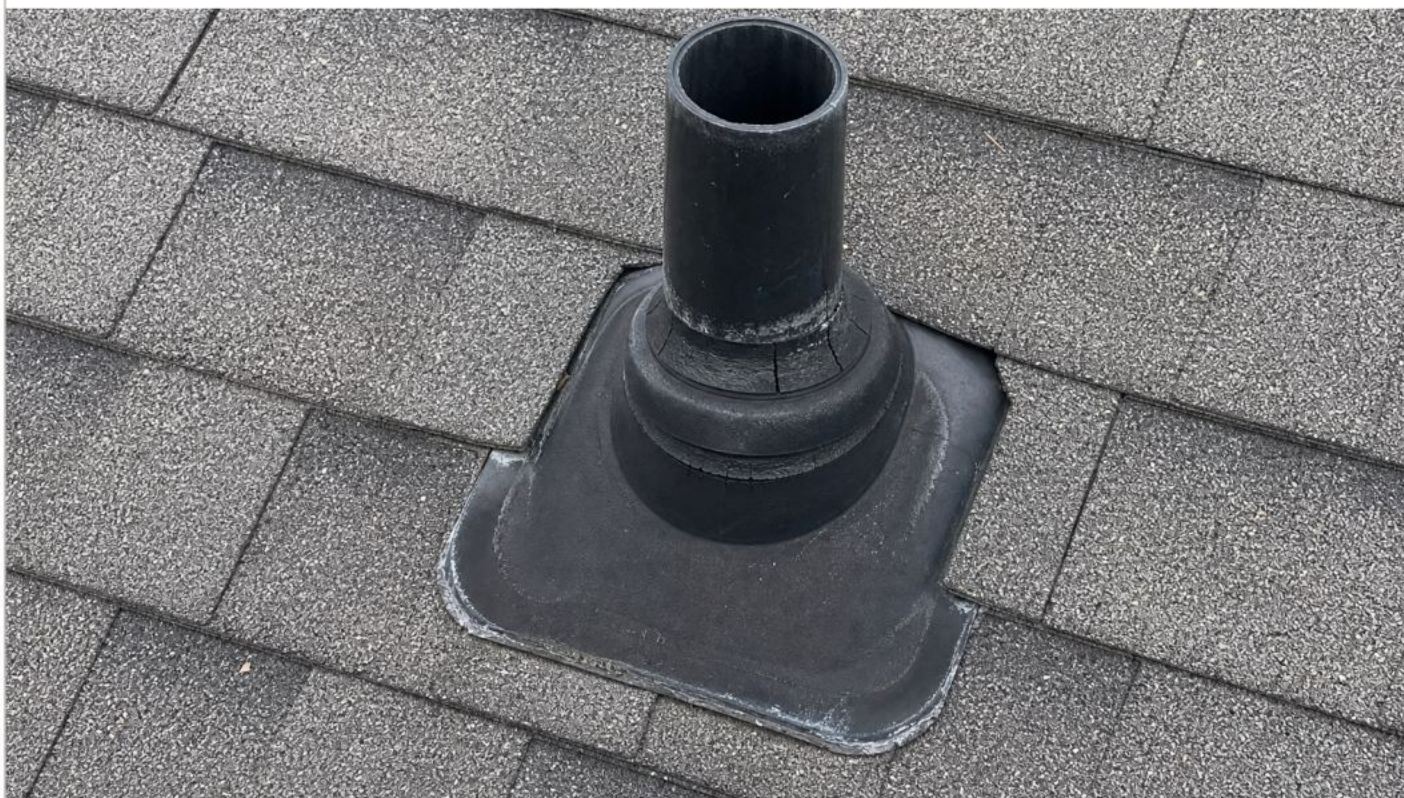
| Location | Plumbing vent | Roof Area | A | Direction | Drone | Defect ID | D4 | Date | 2026-06-22 |

| ID | LOCATION | COMPONENT | PHOTO | PRIORITY | OBSERVATION / RECOMMENDED ACTION |
|---|---|---|---|---|---|
| D4 | Vent boot | Penetration | 8 | P2 | Rubber boot cracking. Replace boot before water entry develops. |

Rubber vent boot is weathered and cracking near the pipe collar.

Cracked boots can admit water directly at the penetration.

| ID | RECOMMENDED WORK | PRIORITY | TRADE | BUDGET | TARGET |
|---|---|---|---|---|---|
| R1 | Replace cracked plumbing vent boot | P2 | Rofer | \$ | 90 days |

Replace vent boot before the next winter cycle.

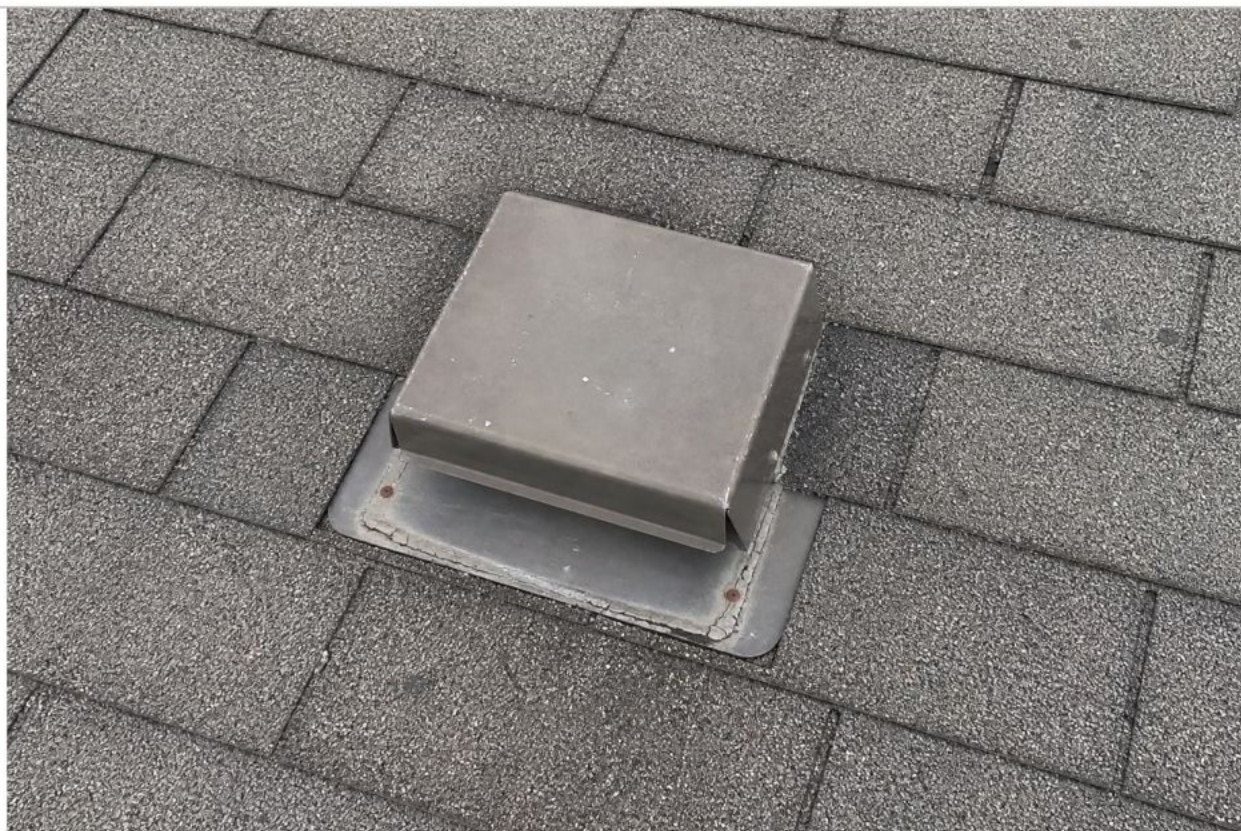
| Location | Roof exhaust vent | Roof Area | A | Direction | Drone | Defect ID | D4 | Date | 2026-06-22 |

Low-profile vent has aged sealant and exposed fastener heads.

Sealant-only maintenance points need periodic renewal to prevent minor leaks.

Reseal fasteners and confirm vent flashing is seated properly.

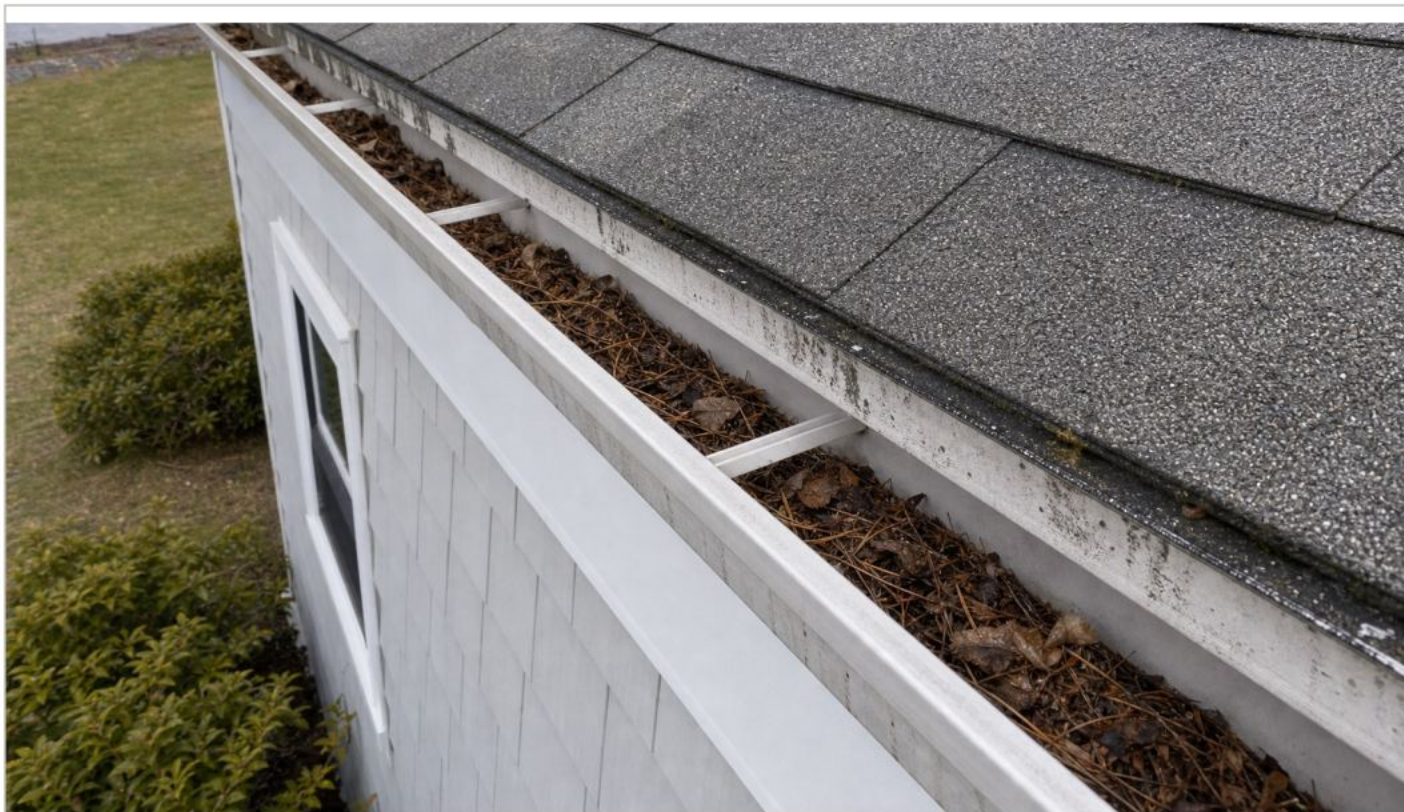
| Location | Front eave / gutter | Roof Area | C | Direction | Drone | Defect ID | D5 | Date | 2026-06-22 |

| ID | LOCATION | COMPONENT | PHOTO | PRIORITY | OBSERVATION / RECOMMENDED ACTION |
|---|---|---|---|---|---|
| D5 | Eaves | Drainage | 10,11 | P3 | Gutter debris and overflow staining. Clean gutters and review slope/discharge. |

Gutter contains leaves and roof grit with staining at the drip edge.

Restricted drainage can cause overflow, fascia staining and ice buildup.

Clean gutters and confirm downspouts discharge away from the building.

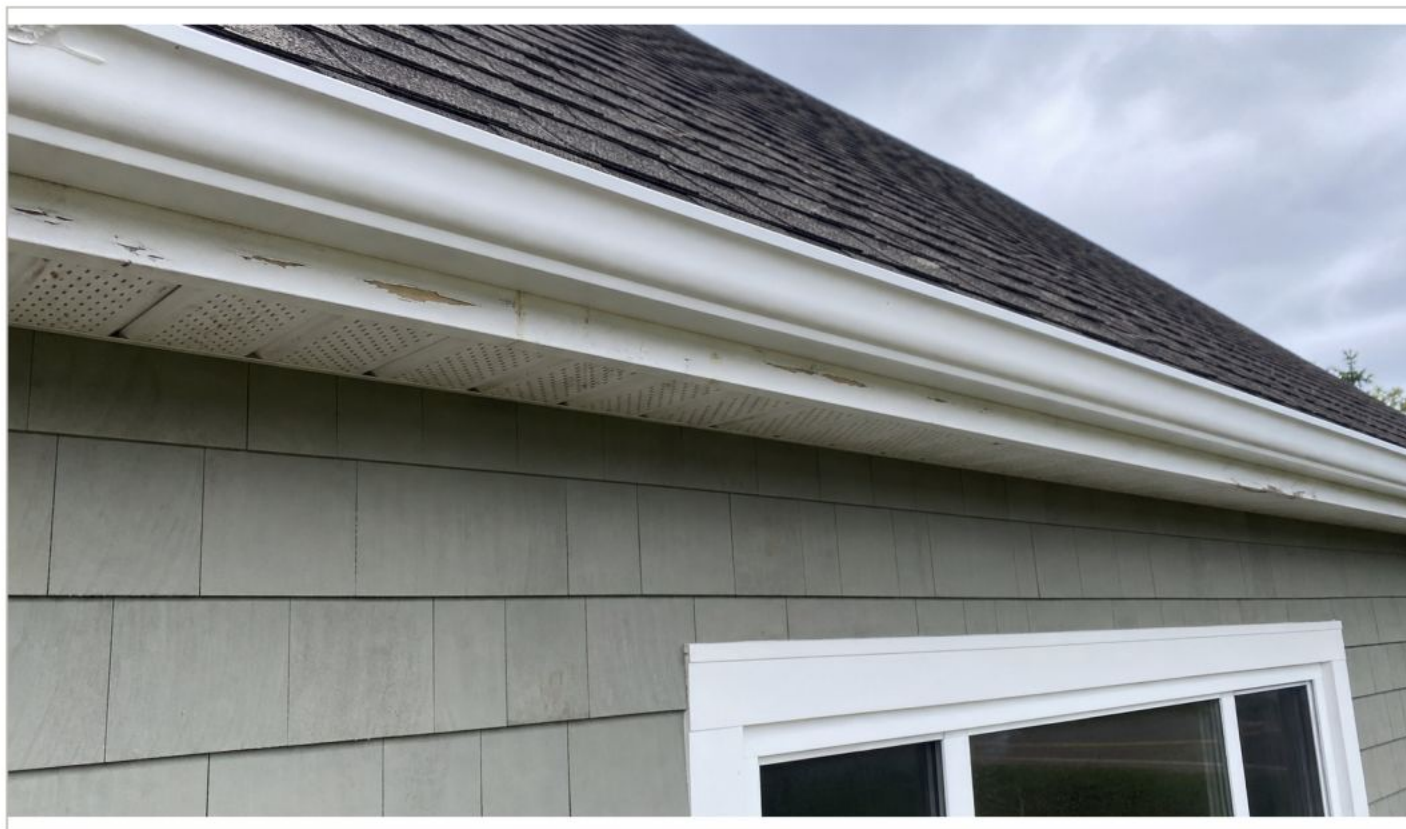
| Location | Eave / fascia | Roof Area | C | Direction | Ladder | Defect ID | D5 | Date | 2026-06-22 |

Minor staining is visible at fascia/soffit near the gutter line.

Pattern is consistent with intermittent overflow or slow drying at the eave.

Clean drainage system and repaint/monitor stained areas after flow is corrected.

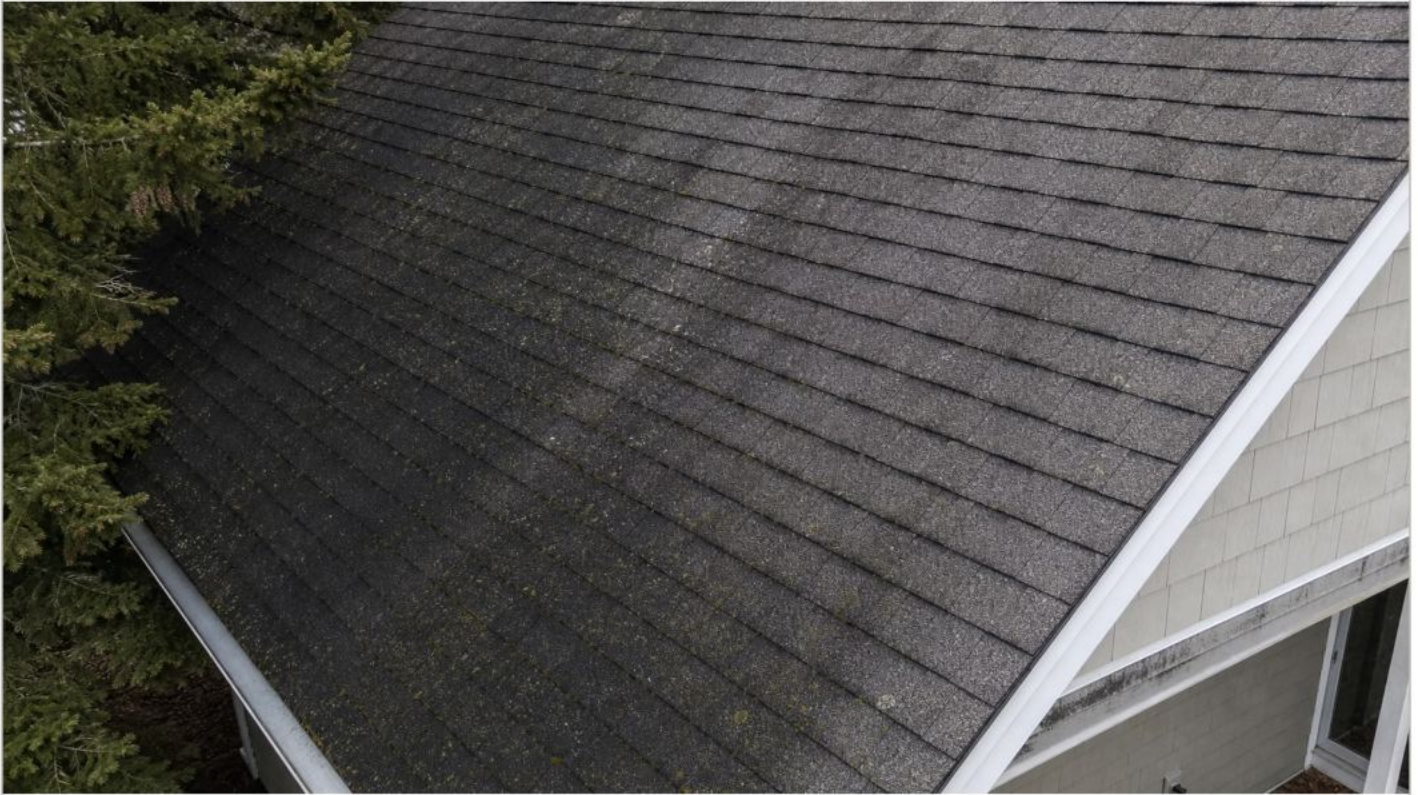
| Location | North/shaded slope | Roof Area | A | Direction | Drone | Defect ID | D6 | Date | 2026-06-22 |

| ID | LOCATION | COMPONENT | PHOTO | PRIORITY | OBSERVATION / RECOMMENDED ACTION |
|---|---|---|---|---|---|
| D6 | North slope | Covering | 12 | P4 | Algae/lichen staining in shaded area. Clean gently and monitor progression. |

Shaded roof surface has algae/lichen staining and slower drying conditions.

Biological growth can retain moisture and accelerate shingle wear over time.

Use roof-safe cleaning methods and improve sun/air exposure where practical.

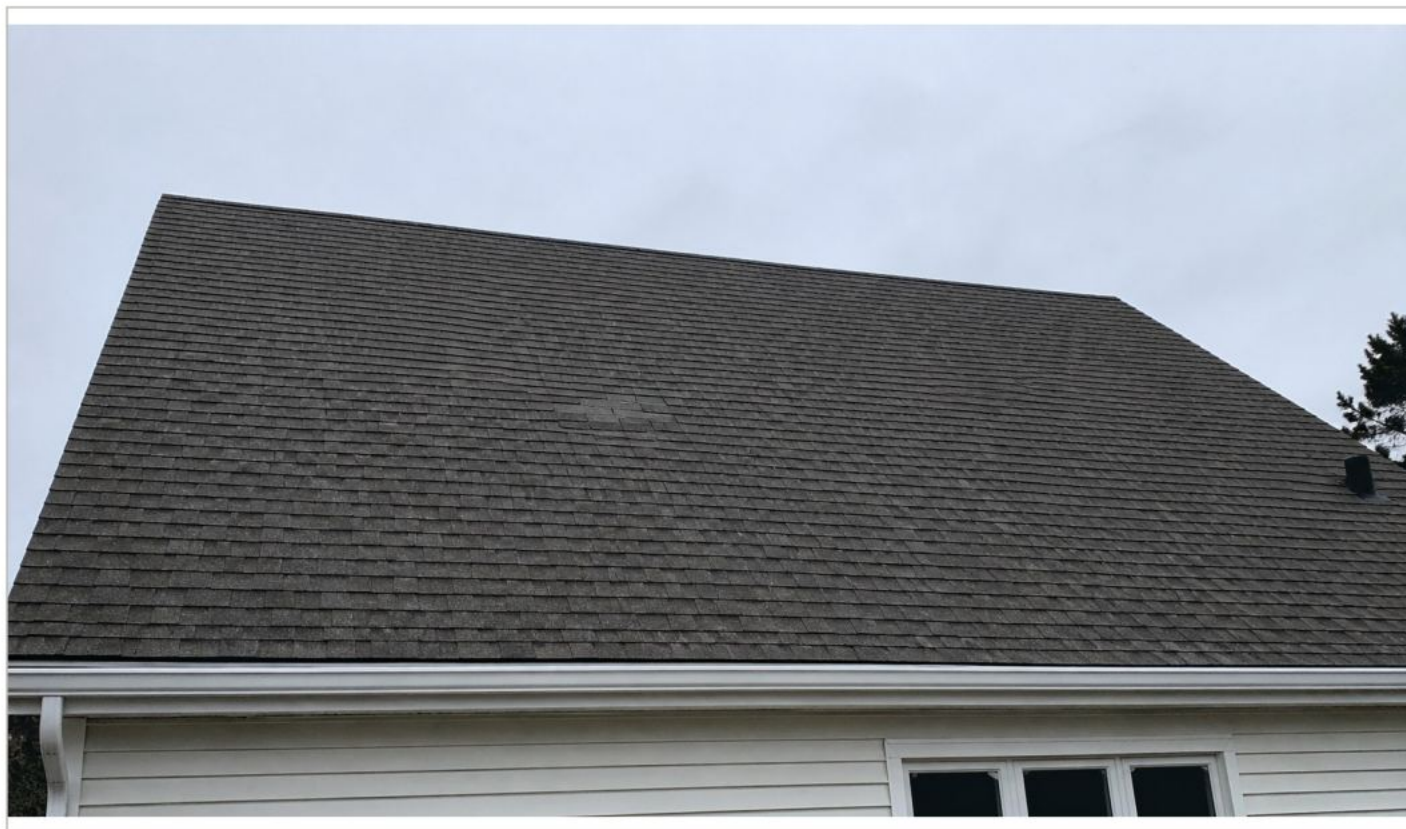
| Location | Rear slope | Roof Area | B | Direction | Ground | Defect ID | D1 | Date | 2026-06-22 |

A small area of mismatched or prior replacement shingles is visible on the rear slope.

Prior repair appears localized, but should be monitored for recurring distress.

Review repair area during annual inspection and after severe weather.

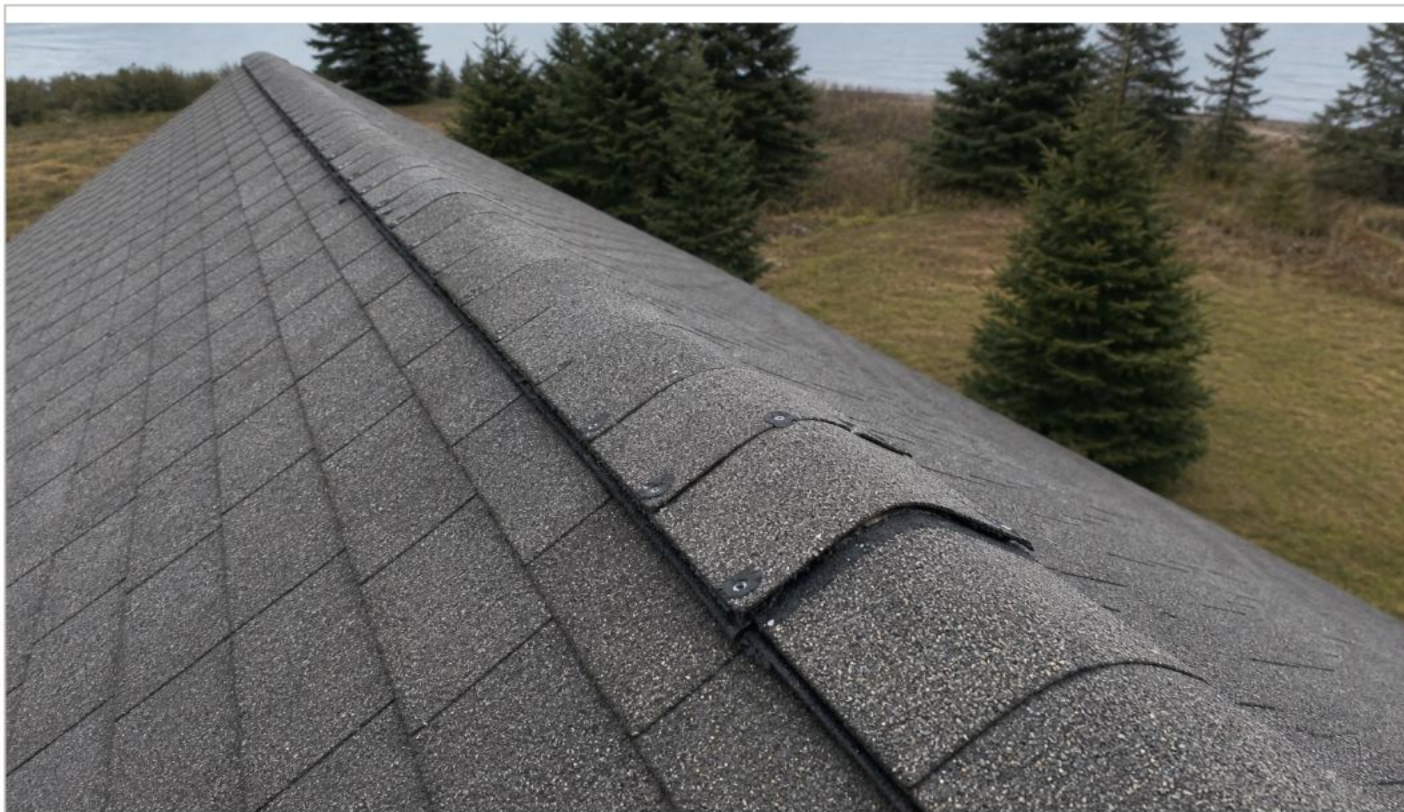
| Location | Main ridge | Roof Area | A | Direction | Drone | Defect ID | D7 | Date | 2026-06-22 |

| ID | LOCATION | COMPONENT | PHOTO | PRIORITY | OBSERVATION / RECOMMENDED ACTION |
|---|---|---|---|---|---|
| D7 | Ridge | Covering | 14 | P3 | Weathered ridge caps and minor lift. Secure/replace affected caps. |

Ridge caps show weathering with minor edge lift and sealant spots.

Ridge caps receive high wind exposure and may fail before field shingles.

Secure or replace affected ridge caps during targeted repair visit.

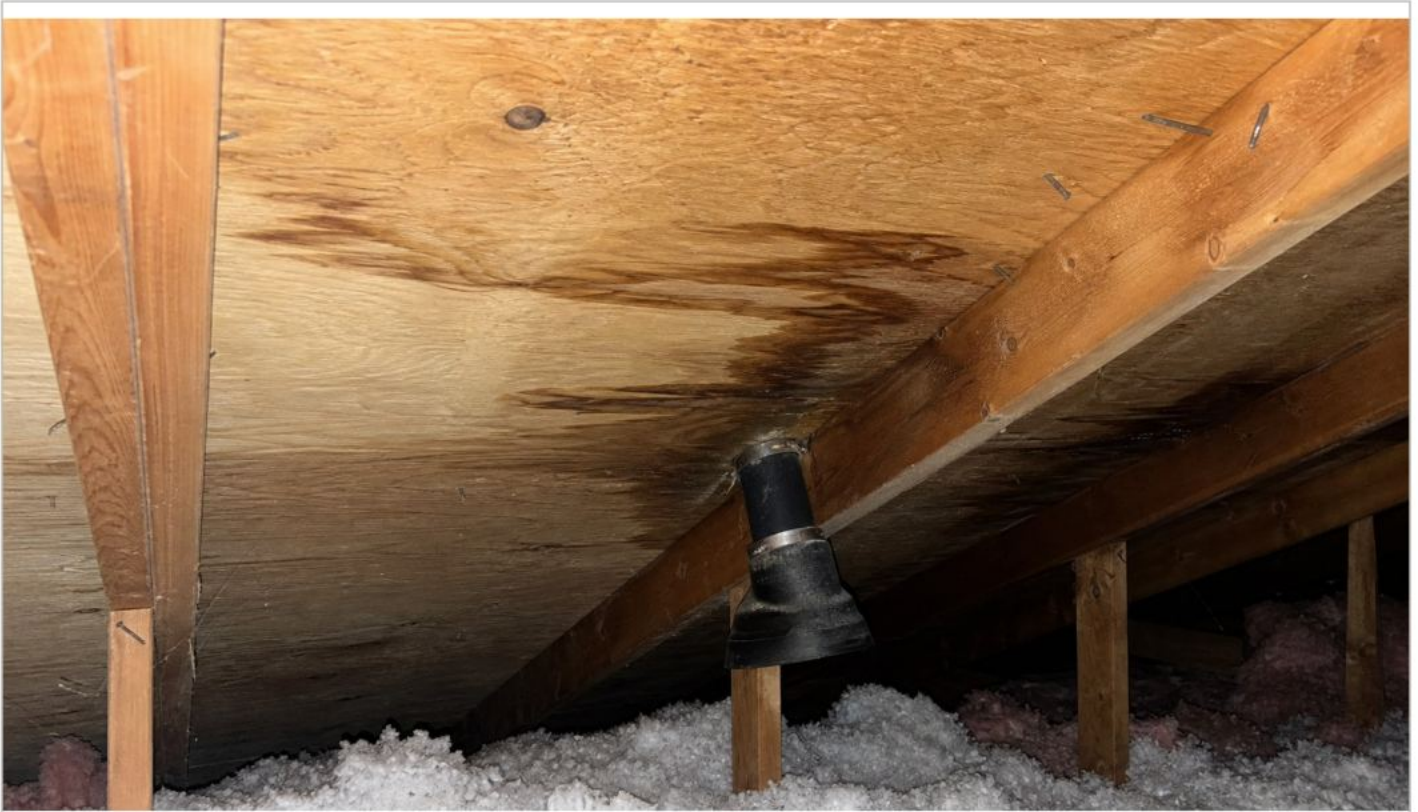
| Location | Accessible attic | Roof Area | A | Direction | Attic | Defect ID | D8 | Date | 2026-06-22 |

| ID | LOCATION | COMPONENT | PHOTO | PRIORITY | OBSERVATION / RECOMMENDED ACTION |
|---|---|---|---|---|---|
| D8 | Attic | Moisture | 15 | P4 | Historic staining observed dry. Monitor after heavy rain and after exterior repairs. |

Light historic staining is visible on roof sheathing near a penetration area; area was dry at inspection.

Staining indicates prior moisture but not confirmed active leakage in this sample scenario.

Monitor after exterior repairs and recheck following heavy rainfall.

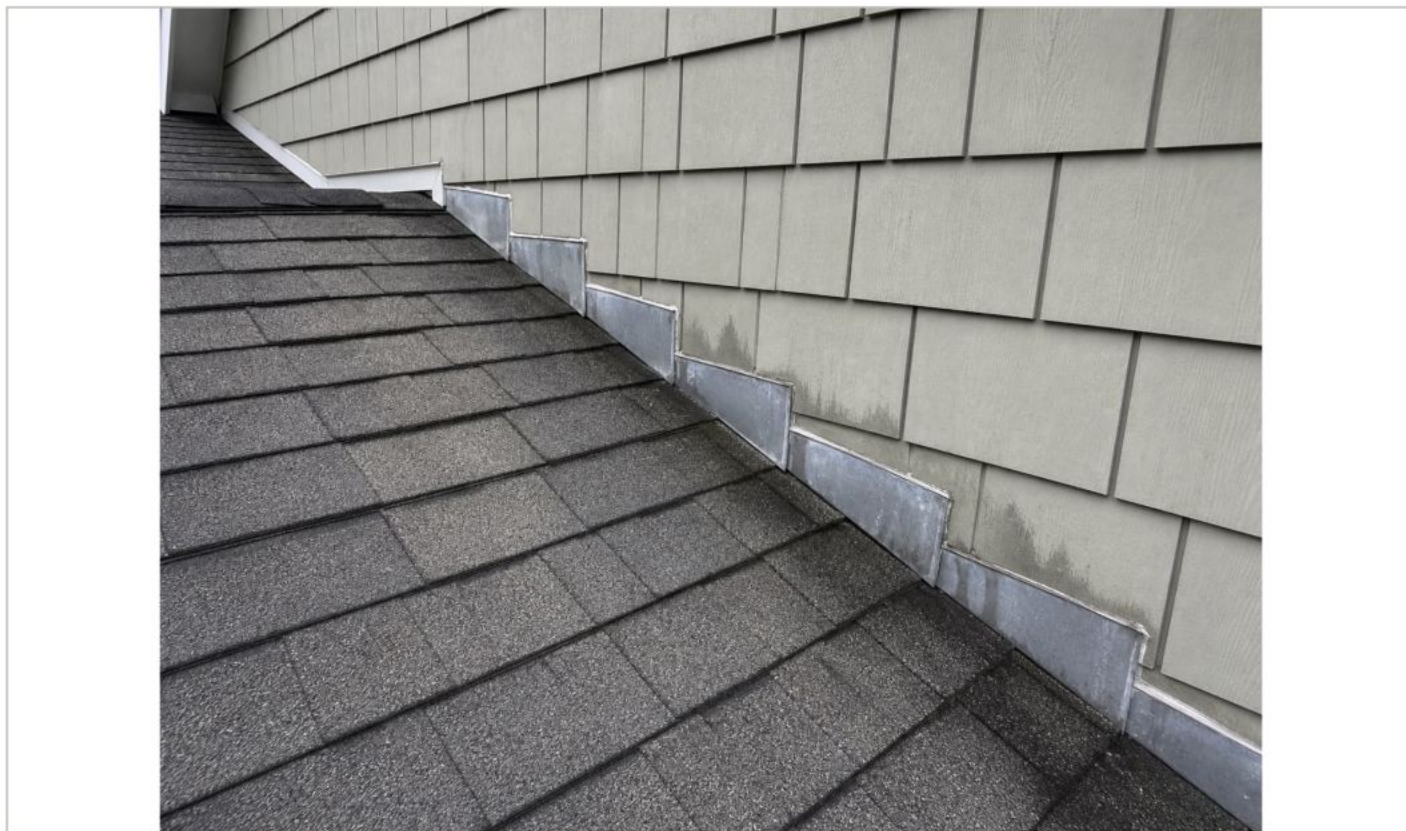
| Location | Wall/roof transition | Roof Area | D | Direction | Drone | Defect ID | D3 | Date | 2026-06-22 |

Wall transition flashing has aged sealant and staining below the siding intersection.

Transitions are vulnerable to wind-driven rain when sealants age or siding clearances are tight.

Renew sealant/flashing detail and confirm water can drain freely.
