1.0 INTRODUCTION

The locally landmarked Stoughton Main Street Historic District is significant for its role in regional commerce, trade, and transportation, and locally for architecture, government, and education. The district is also listed on the National Register of Historic Places and has fourteen properties individually designated as local landmarks. These designations have helped to preserve the character of Stoughton's Main Street through the conservation of the historic building stock and the encouragement of maintenance, repair, and restoration.

The developed guidelines provide information on the architectural and historical significance of the district, available financial incentives, and preservation recommendations and best practices for the repair, restoration, and maintenance of contributing buildings located within the district. The district's history, pattern of development, and rich architectural character provide a basis to help guide compatible infill redevelopment on vacant lots and alterations to non-contributing buildings in the district.

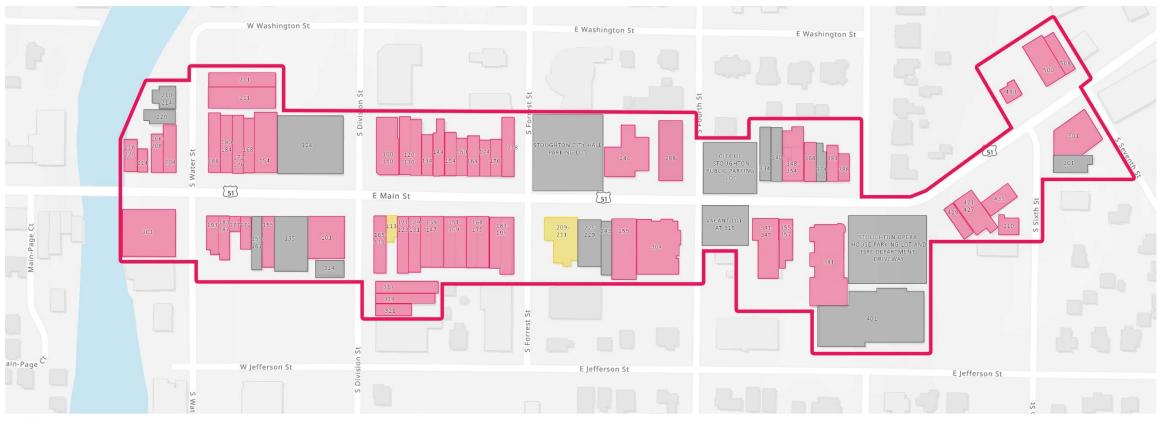
A map of the district is provided below. This map identifies the boundary of the landmark district, contributing and noncontributing buildings, potentially contributing building, and noncontributing vacant and parking lots.

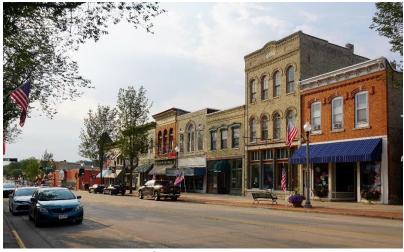
Figure 15: Photograph of the historic streetwall along the north side of E. Main Street between Division and Forrest Streets, 2021.

The individual buildings of the Stoughton Main Street Historic District retain a high degree of architectural integrity and character. Building alterations have been minimal and are mainly localized to the first-floor storefronts and second floor windows. At the first floor, original windows, doors, and most signs have been removed or altered and many original storefronts have been replaced with new glazing and an aluminum frame. At upper floors, many windows have been replaced, while architectural details including the cornices, brick pattern or relief work, window trim, bay windows, and stringcourses remain intact and with excellent integrity.

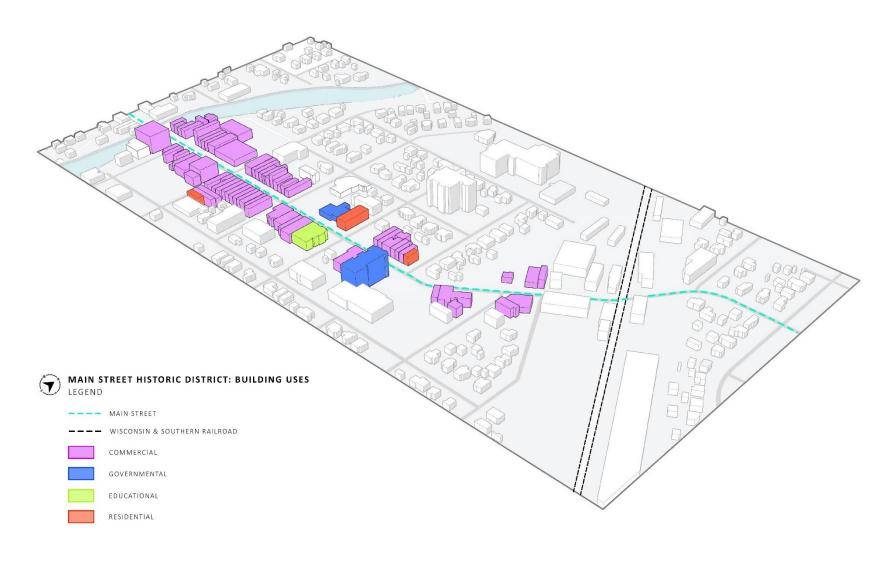
Figure 16: This massing model presents a bird's eye view of the Main Street Historic District to illustrate the pedestrian-oriented scale of the district and identify the broad use of each building. The historic commercial built environment of the district remains well intact, with ninety-one-and-a-half percent of buildings serving a commercial use. The few remaining buildings are governmental (three percent), educational (one-and-a-half percent), and residential (four percent) which have enhanced the historic and present-day built environment along Main Street.

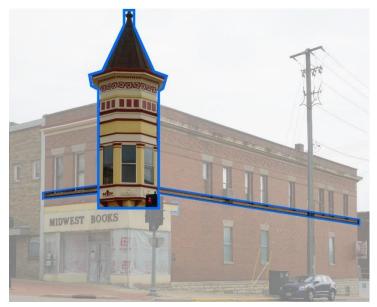
Figure 19: Corner turret and a belt course.

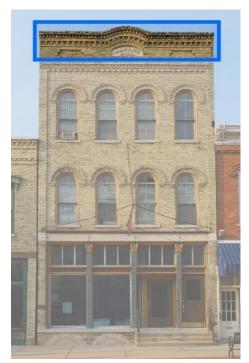
Figure 25: Shaped parapet, brick relief work and corbeling, and inset name plaque.

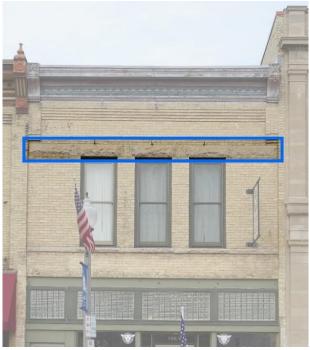
Figure 27: Rough-hewn limestone window headers with bas relief scrollwork carvings.

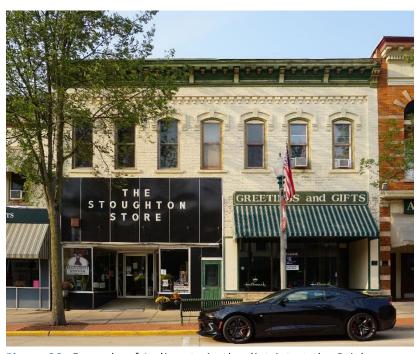
Figure 28: Example of Italianate in the district at the Brickson Block, 120-130 E. Main Street.

A popular mid-nineteenth century style, Italianate was derived from the architecture of Italian villas and originated in England at the start of the Picturesque Movement. This style with its wide overhanging bracketed eaves was typically found on two and three-story commercial and residential buildings.

The style is typically defined by vertical proportions, tall, arched window and door openings; brick or stone window and door hoods with incised foliated carvings, and intricate wood or pressed metal cornice.

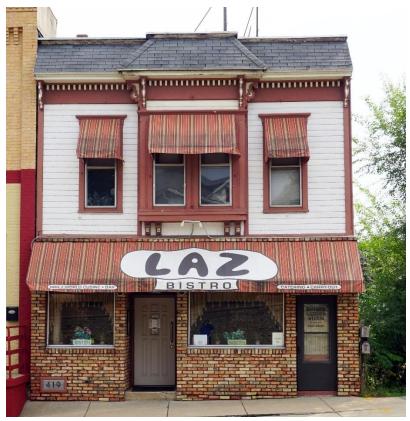
Figure 29: Example of Second Empire in the district at the Carl Ellingson Saloon building, 419 E. Main Street.

The Second Empire style was popular throughout the United States in the 1860s and 1870s, and used extensively in the northeastern and midwestern parts of the country. The style had its beginnings in France where it was the style during the reign of Napoleon III (1852-70), known as France's Second Empire. Prominent exhibitions in Paris in 1855 and 1867 helped to spread Second Empire style to England and then the United States. The Second Empire style is recognized by the Mansard roof form with dormers that allow for the maximum use of an attic area. Unlike earlier Italianate or Greek Revival styles that were based on historic precedent, the Second Empire Style reflected the latest French fashion of the day. The style is commonly defined by the use of intricate stone ornament surrounding doors and windows; Mansard roofs, often with multi-colored patterned shingles and elaborate dormers with arched or pedimented tops; prominent cornices; decorative eave brackets; and masonry quoins.

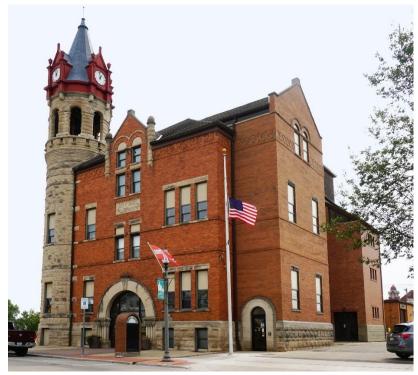
Figure 30: Example of Romanesque Revival in the district at the Stoughton Opera House, formerly City Hall and the public library, 381 F. Main Street.

with early versions during the 1840s-1850s. The second phase came in the late nineteenth century when the style was popularized by Henry Hobson Richardson. Buildings in the Romanesque Revival style are always heavy, massive masonry construction, usually with some rough-faced stonework. Wide, rounded arches in Roman or Romanesque architecture is an important identifying feature, often resting on squat columns. Frequently, decorative foliated or arabesque detailing appears in the stonework, and sometimes on column capitals.

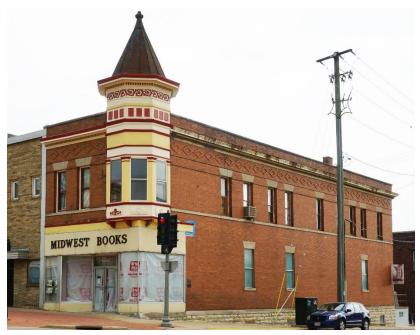
Figure 31: Example of Queen Anne in the district at the former Hausmann Brewing Company Saloon building, 105-111 E. Main Street.

Common characteristics of the style when applied to commercial architecture include: rich but simple ornament; variety of materials, including wood, brick, stone, and pressed metal; patterned masonry, shingles, or textured wall surfaces; pressed metal bays and turrets; and decorative stained glass windows.

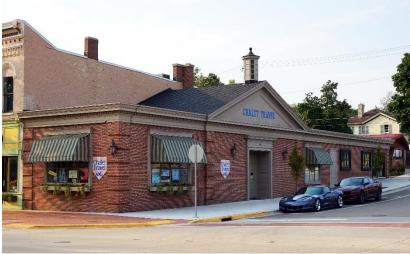
Figure 32: Example of Colonial Revival in the district at Chalet Travel, 218 S. Forrest Street.

Many front facades have simplified classical, temple-like entrances with projecting porticos topped by pediments. Paneled doors flanked by sidelights and topped by rectangular transoms or fanlights are common, as are multi-pane double-hung windows with wood shutters. Additional architectural characteristics include: symmetrical facades, often with side porches; red brick or wood clapboard walls; accentuated entrances with classical detailing and decorated with fanlights, sidelights, transoms, columns, and pediments; hipped or gable roofs, often with dormers; columned porch or portico; pedimented door, windows or dormers; bay windows; and cornice with dentils or modillions.

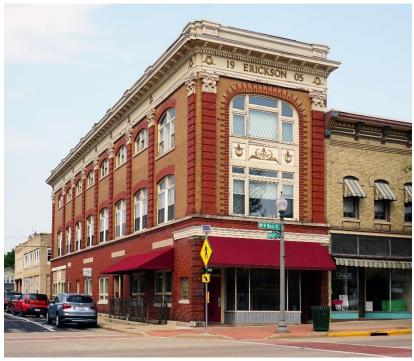
Figure 33: Example of Beaux Arts in the district at the Erickson Block, 188 W. Main Street.

Typical architectural features can include: masonry construction, usually of a smooth, light-colored, ashlar-cut stone; symmetrical façade; first floors may be rusticated; flat or low-pitched roofs; wall surfaces ornamented with decorative garlands, floral patterns, or cartouches dripping with sculptural ornament; colossal columns or pilasters with Ionic or Corinthian capitals; an exuberance of detail and variety of stone finishes; enriched moldings; windows framed by columns or pilasters, sometimes with a balustraded sill and/or pedimented entablature; and pronounced cornices and entablatures.

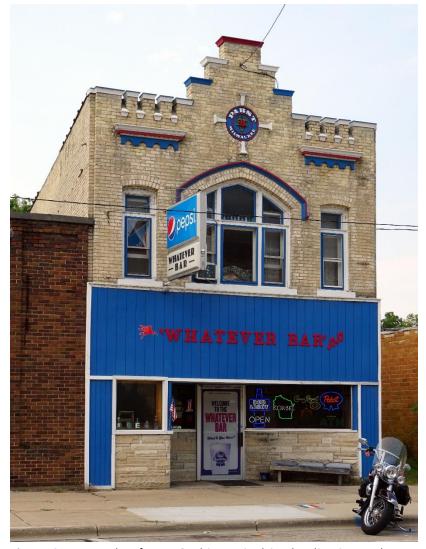
Figure 34: Example of Late Gothic Revival in the district at the Pabst Brewing Co. Saloon Building, 508 E. Main Street.

In the district, the style is characterized by simpler and smoother features than those of the preceding High Victorian Gothic. Typical architectural characteristics can include: windows commonly extend into the gable, frequently having a pointed-arch shape (Gothic arch); other window shapes include the clover-like foil with three, four or five lobes; doors often have pointed-arch and/or heavy hood ornament; roof peaks are often topped with pinnacles (typically found on churches); and decorative crowns (gable or drip mold).

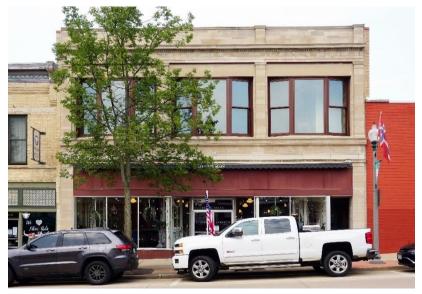
Figure 35: Example of Late Classical Revival style in the district, 154 W. Main Street.

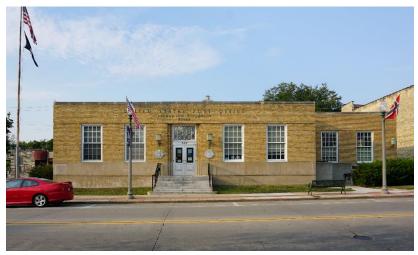
Figure 37: Example of Art Deco in the district at the Stoughton Post Office, 246 E. Main Street.

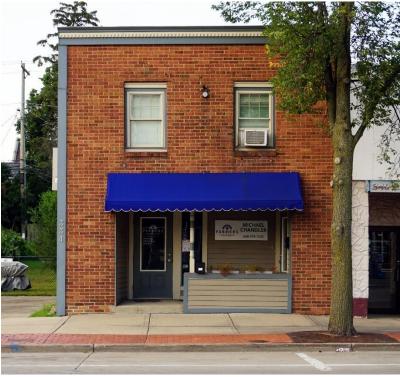
Figure 38: Example of New Traditional applied to a façade of a historic building in the district, 334 E. Main Street.

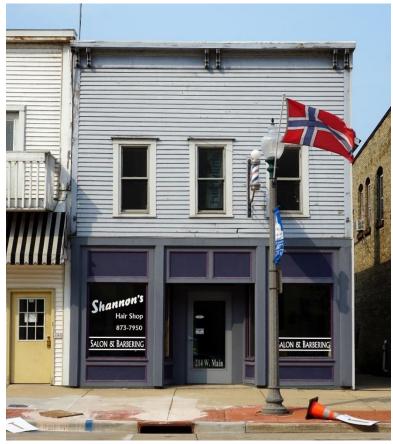
Figure 40: Example of mid-nineteenth century Commercial Vernacular in the district, 214 W. Main Street.

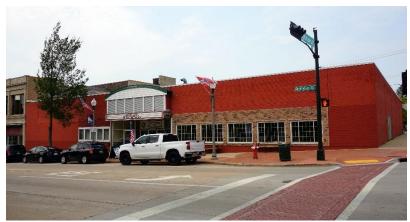
Figure 41: Example of a one-part commercial block in the district, 124 W. Main Street.

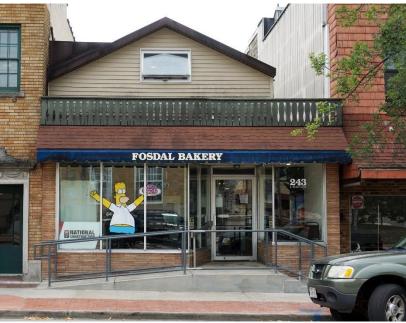
Figure 42: Example of a one-part commercial block in the district, 243 E. Main Street.

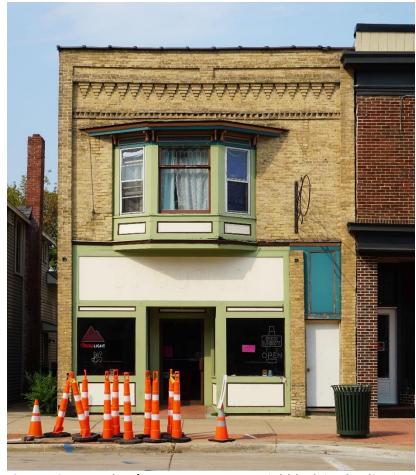
Figure 43: Example of a two-part commercial block in the district, 208 W. Main Street.

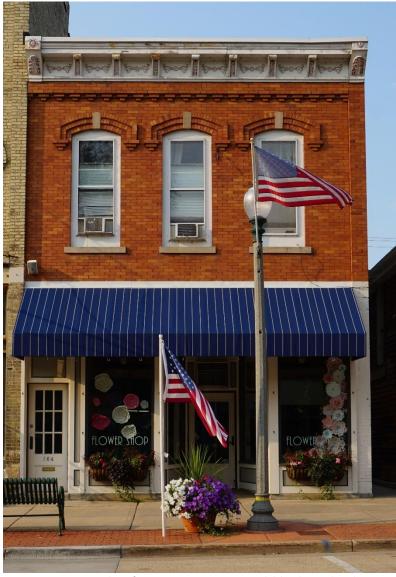
Figure 44: Example of two-part commercial block in the district, 164 E. Main Street.

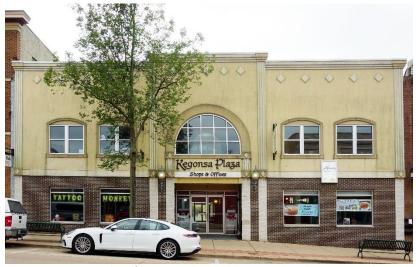
Figure 45: Example of an Arcade Building in the district at the Kegonsa Plaza, 135 W. Main Street.

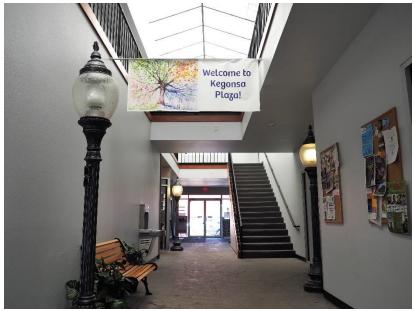
Figure 46: Example of an Arcade Building in the district at the Kegonsa Plaza, 135 W. Main Street.

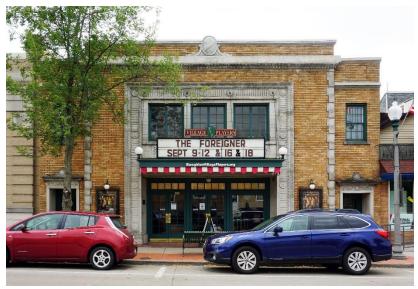
Figure 47: Example of a Vault exterior in the district at Village Players Theater, formerly Badger Theatre, 255 E. Main Street.

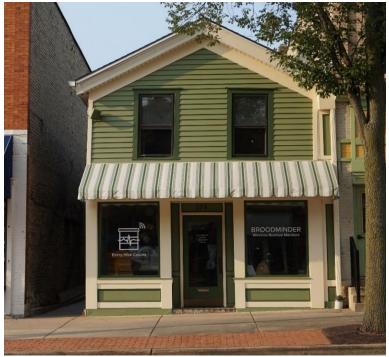
Figure 48: Example of a Gable-front in the district, 174 E. Main Street.

Characterized by its roof shape, the gable-front roof has two sloped sides that meet at a center ridge. The triangular ends of the walls on the other two sides are called gables. In the gable-front form, the gable end faces the street and forms the front of the house. The gable-front form is commonly found in Midwestern towns because it was a simple type for local builders to construct and could fit on narrow lots.

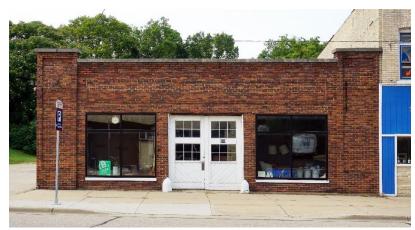
Figure 49: Example of an automobile garage and showroom in the district at the Stoughton Buick Co. Garage and Showroom, 500 E. Main Street.

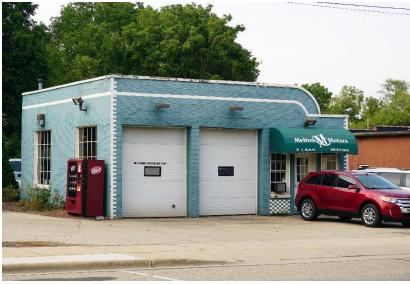
Figure 50: Example of a garage and service station in the district at the Abe Holtan Service Station, 480 E. Main Street.

The filling or service station provided repair, garage, and filling services to residents and visitors of Stoughton. Filling stations are typically located on the corner of prominent intersections, onestory in height with masonry exterior walls, a flat roof, and constructed in variety of shapes to accommodate the lot or based on prominent architectural styles of the period.

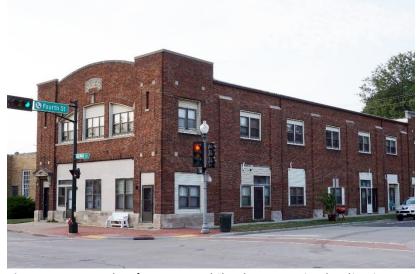
Figure 51: Example of an automobile showroom in the district at the former Roe Automobile Company building, 288 E. Main Street.

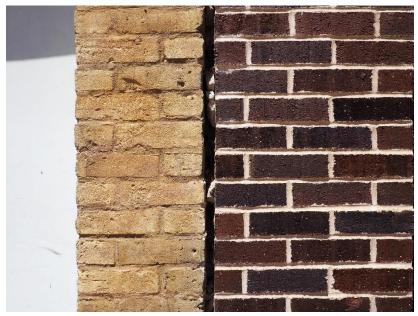
Figure 52: Example of cream or tan brick adjacent to a blended of dark red and brown brick in the district.

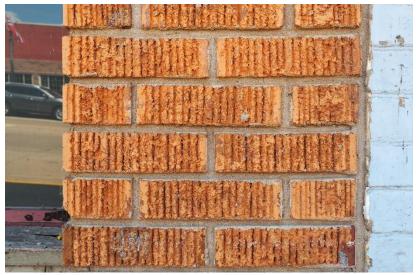
Figure 53: Example of orange brick with a scratched texture in the district.

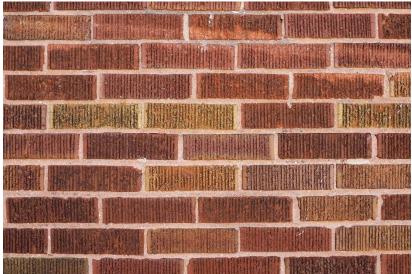
Figure 54: Example of a blend of orange, yellow, and shades of red brick with a scratched texture in the district.

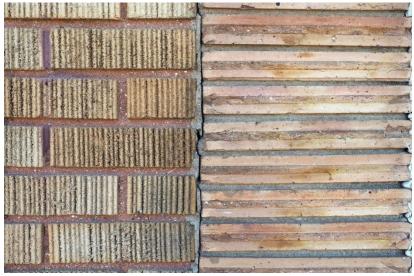
Figure 55: Example of cream brick with scratched texture adjacent to a split-face roman brick in the district.

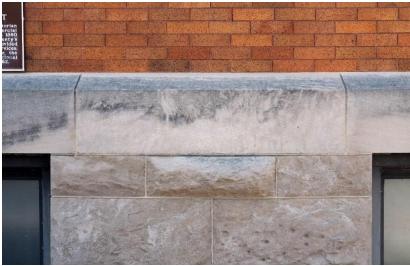
Figure 56: Example of rough-hewn and smooth Indiana limestone at the base of a building with iron spot brick as the exterior wall cladding in the district.

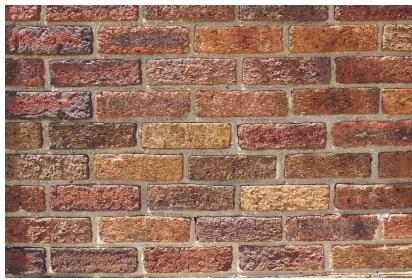
Figure 57: Example of a blend of orange, yellow, purplish-brown, and shades of red brick with a rough texture in the district.

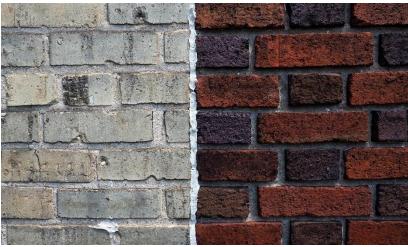
Figure 58: Example of Milwaukee "Silver Fox" common brick at a side façade and a blend of purple dark red, and brown brick at the front façade of a building and in the district.

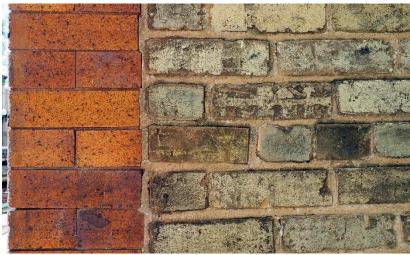
Figure 59: Example of iron spot brick at the front façade and Milwaukee cream common brick at the side façade of a building in the district.

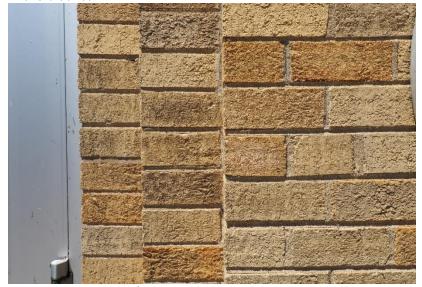
Figure 60: Example of a cream brick with a semi-smooth texture in the district.

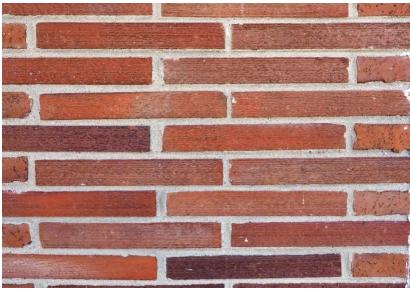
Figure 61: Example of Roman brick in the district.

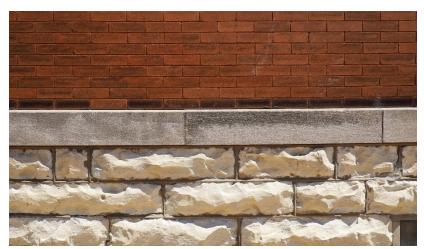
Figure 62: Example of rough-hewn Wisconsin limestone at the foundation wall, a smooth belt course composed of Indiana limestone, and iron spot brick as the exterior wall cladding on a building in the district.

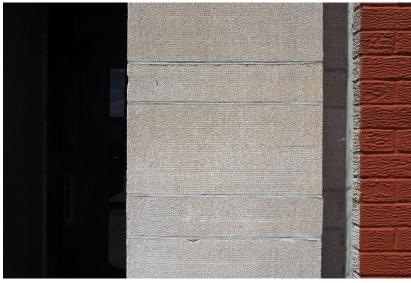
Figure 63: Example of smooth Indiana limestone in the district.

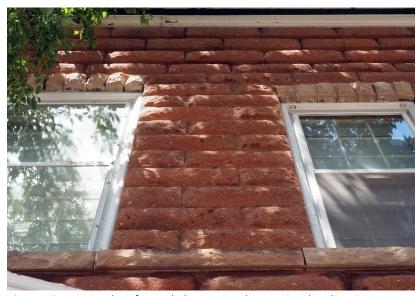
Figure 64: Example of rough-hewn sandstone in the district.

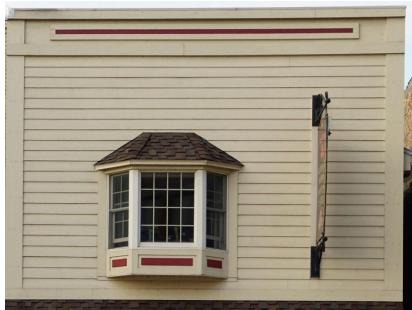
Figure 65: Example of non-historic siding in the district.

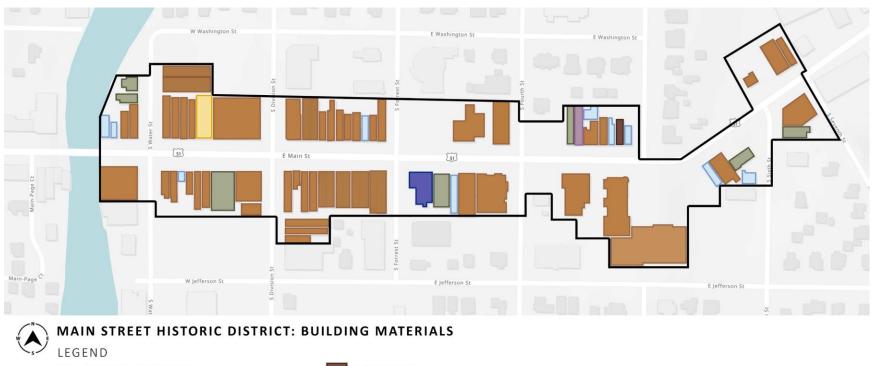
Figure 66: This map illustrates the type and quantity of material used per building in the district, specifically the prevalent use of brick which has created an overall sense of uniformity and is a significant character-defining feature in the district.

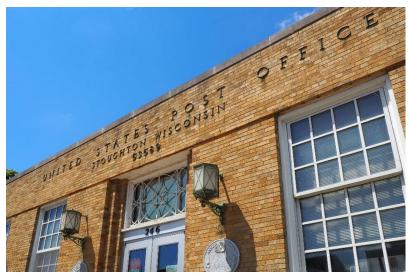
Figure 67: Example of historic exterior wall lighting at the Stoughton Post Office, 246 E. Main Street, in the district.

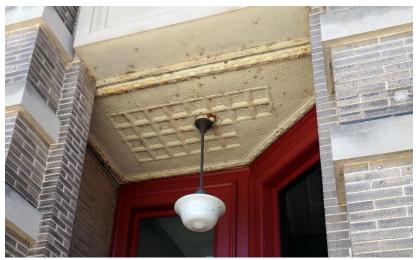
Figure 68: Example of historic exterior entrance pendant lighting and tin ceiling at the Citizens State Bank building, 171 W. Main Street, in the district.

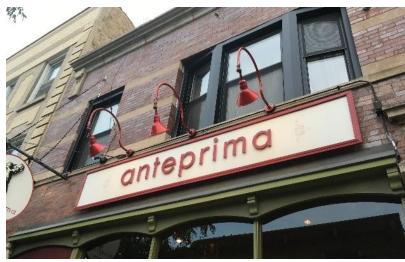
Figure 69: Example of inappropriate gooseneck exterior lighting and exposed conduit not in the district.

- Industrial wall pack lights.
- Historic industrial lighting, such as gooseneck lights.
- Box lights.
- Lighting that creates glare.
- Animated, flashing, or "rope" lighting.

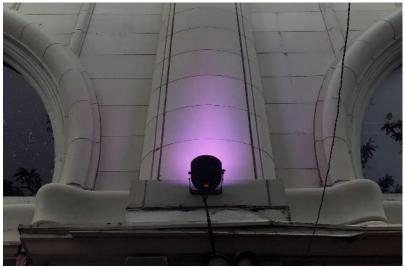
Figure 70: Example of contemporary architectural lighting, located outside of the district, that appropriately lights an architectural feature, but is not concealed.

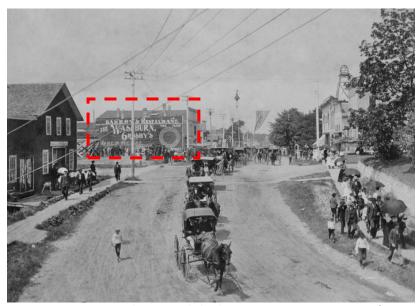
Figure 71: Historic photograph looking west on Main Street from immediately east of present-day Fifth Street. Note the painted sign on 355-357 E. Main Street. Courtesy of the Stoughton Historical Society.

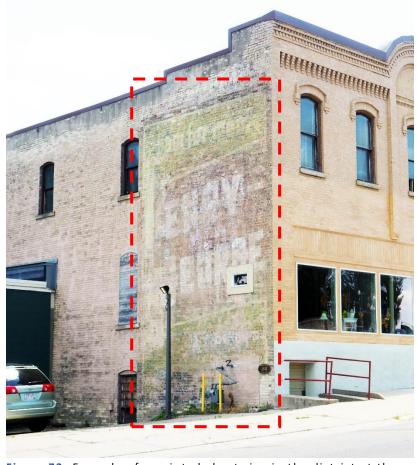
Figure 72: Example of a painted ghost sign in the district at the east façade at the Hanson House-Grand Hotel building at 421-427 E. Main Street.

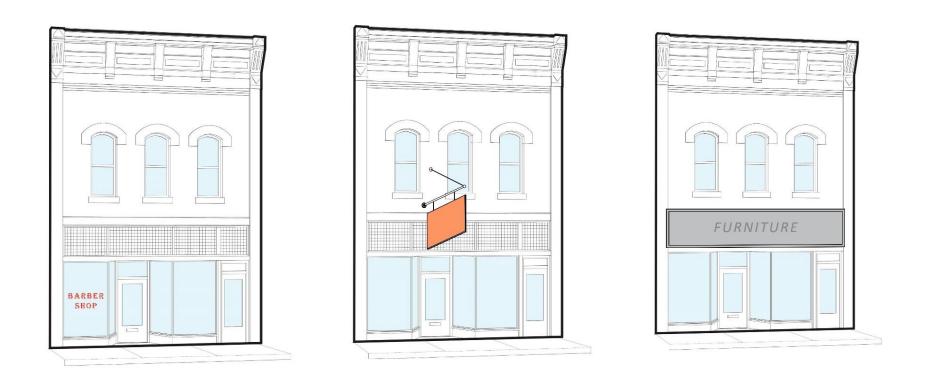
Figure 73: Examples of the three appropriate types of contemporary signage in the district: window signage (left); a projecting hanging or blade sign (center); and a banner or fascia sign (right) which is only appropriate at storefronts that do not have transom windows.

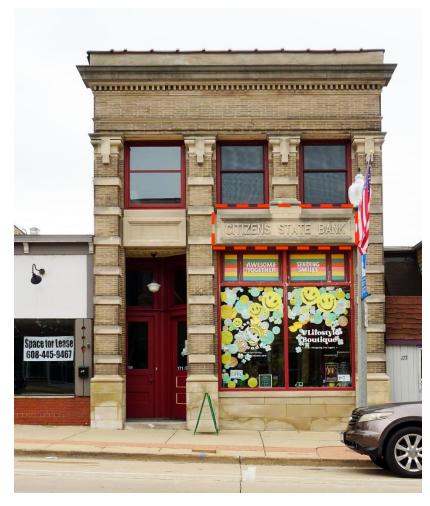
Figure 74: Example of historic bas relief carved name sign integrated into the exterior cladding at the Citizens State Bank building, 171 W. Main Street, in the district.

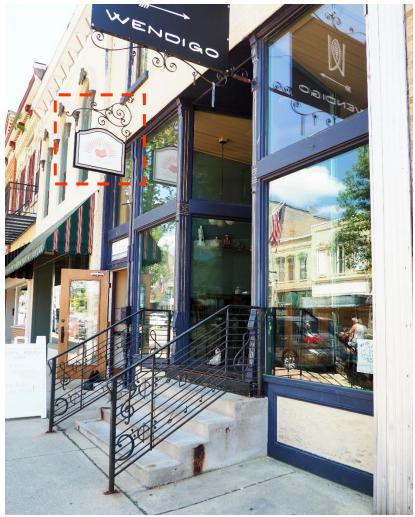
Figure 75: Example of an appropriate contemporary horizontal projecting sign anchored into the masonry mortar joints in the district.

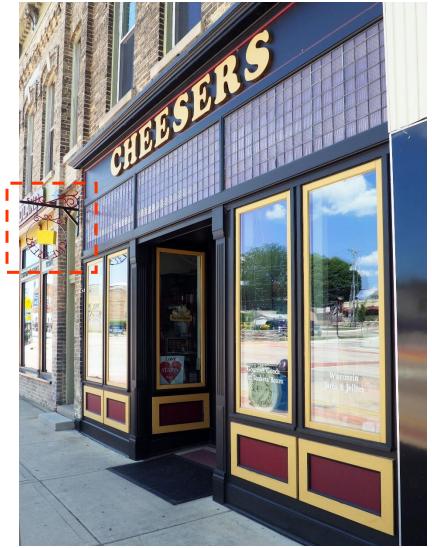
Figure 76: Example of an appropriate contemporary horizontal projecting sign anchored into the masonry mortar joints and individual lettering sign which does not obscure or damage the historic prism glass transoms in the district.

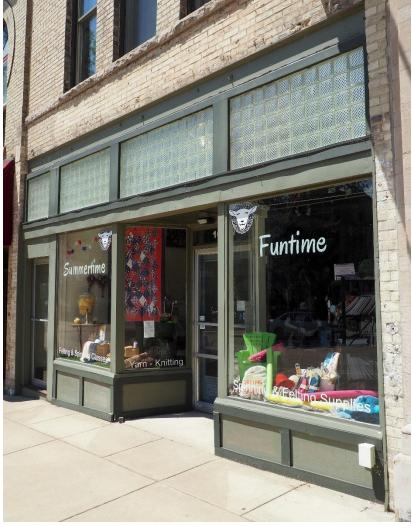
Figure 77: Example of appropriate vinyl signage minimally applied to storefront display windows in the district.

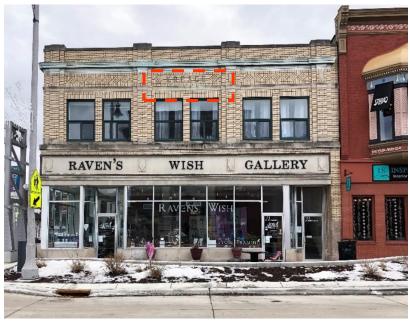
Figure 78: Example of retained historic signage with contemporary signage outside of the district.

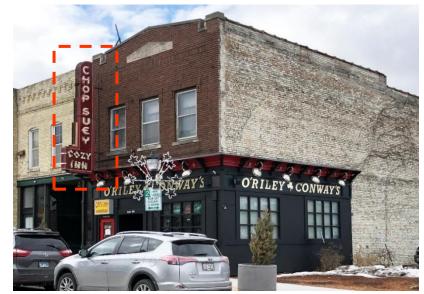
Figure 80: Example of a reused, historic neon vertical projecting sign alongside new signage for the current business outside of the district.

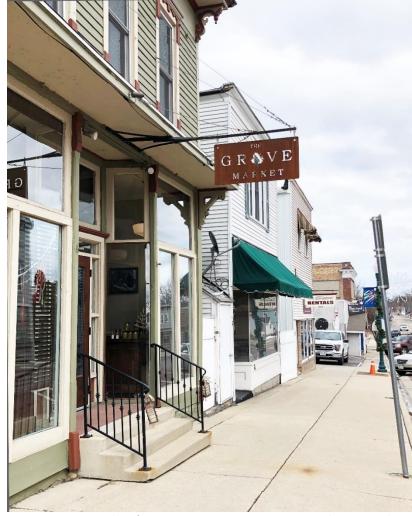
Figure 81: Example of an appropriate contemporary horizontal projecting sign not in the district.

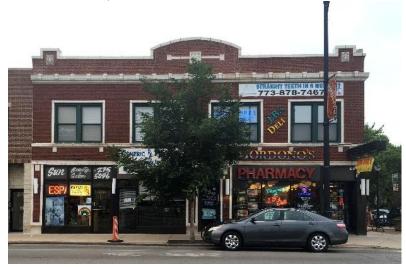
Figure 83: Example of incompatible, excessive signage and signage mounted into the brick, not in the district.

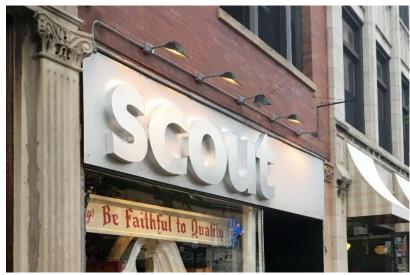
Figure 84: Example of an inappropriate contemporary sign not in the district. The letters are disproportionately scaled and obscure the historic storefront/transom configuration.

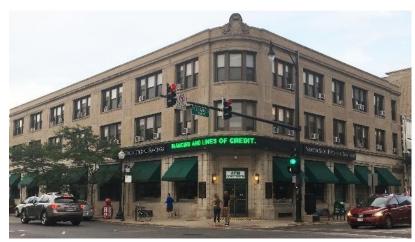
Figure 85: Example of an inappropriate digital banner sign not in the district, that is directly mounted into the building's limestone façade and obscures architectural features at the first floor.

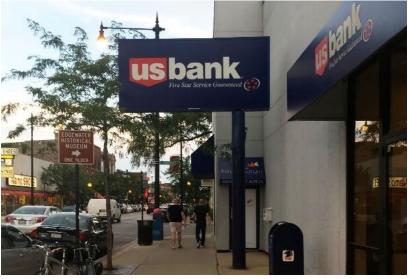
Figure 86: Example of inappropriate freestanding sign not in the district. Signage should not be located in the pedestrian right-ofway.

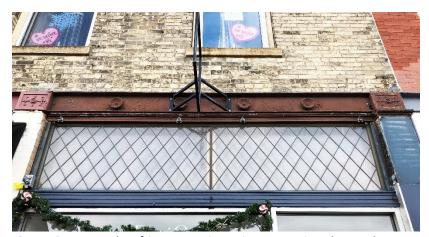
Figure 87: Example of inappropriate sign mounting, located outside of the district, as the sign is directly attached to the historic cast iron header.

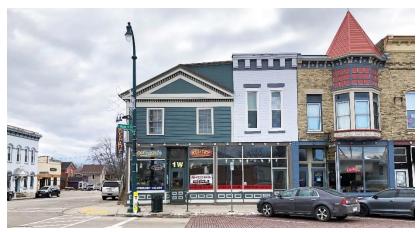
Figure 88: Example of incompatible, excessive window signage not in the district.

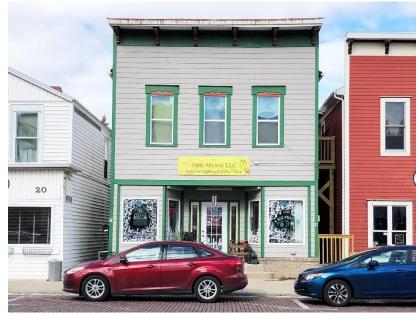
Figure 89: Example of an incompatible, excessive window signage not in the district.

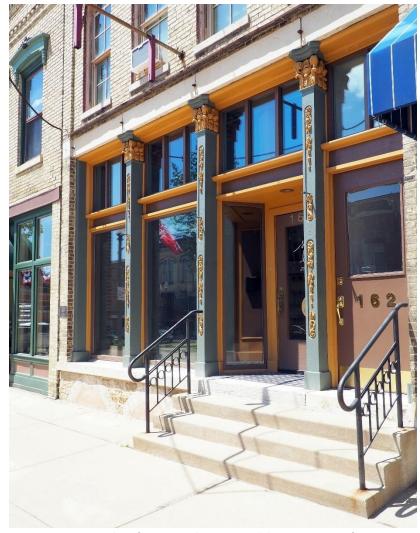
Figure 90: Example of a recently restored historic storefront at the Masonic Hall building, 160-162 E. Main Street, in the district.

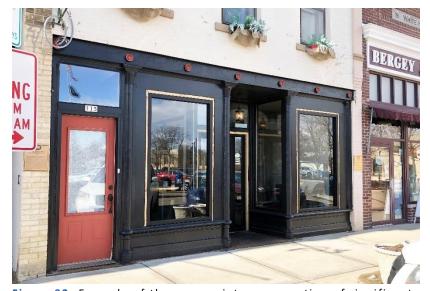
Figure 92: Example of the appropriate preservation of significant storefront elements, such as the columns, header, bulkhead, but the inappropriate installation of display windows that have been reduced in size from the original design outside of the district.

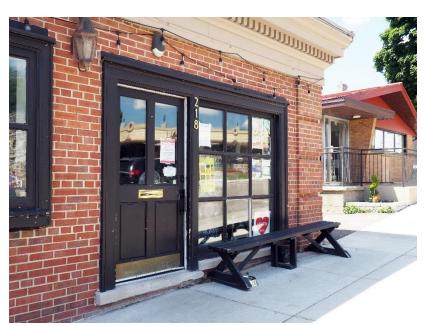
Figure 93: Example of an original mid-twentieth century storefront at Chalet Travel, 218 S. Forrest Street, in the district.

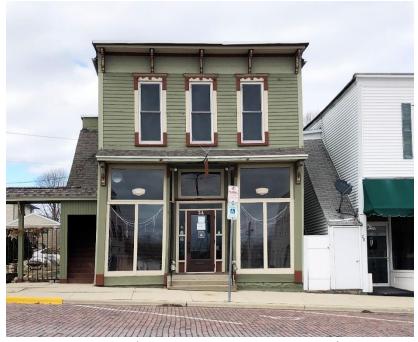
Figure 94: Example of the appropriate preservation of the original storefront configuration, but the installation of historically inappropriate multi-light display windows and shed roof canopy outside of the district.

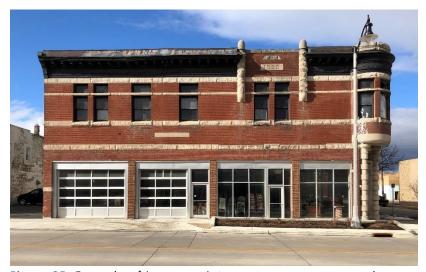
Figure 95: Example of inappropriate contemporary garage doors at the primary façade and historic storefront location and the inappropriate use of a metallic finish at the storefront components not in the district.

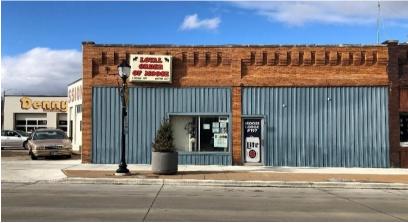
Figure 96: Example of inappropriate contemporary infill at a historic storefront with metal siding not in the district.

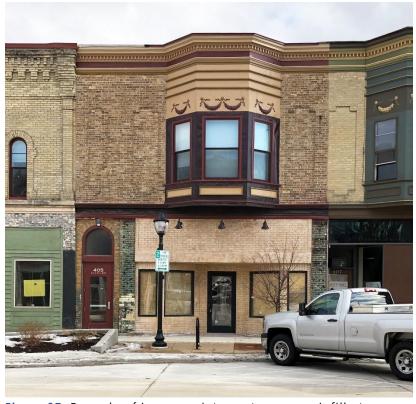
Figure 97: Example of inappropriate contemporary infill at a historic storefront with brick veneer and the inappropriate installation of display windows that have been reduced in size from the original design outside of the district.

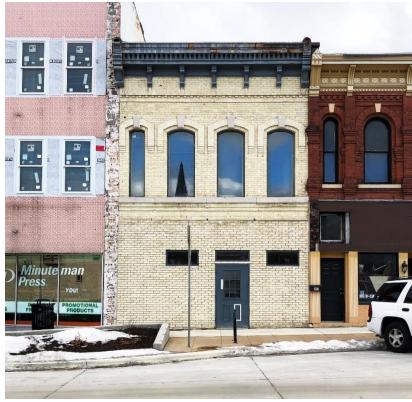
Figure 98: Example of inappropriate contemporary infill at a historic storefront with brick veneer, the installation of historically inappropriate non-storefront windows, and the inappropriate reconfiguration of fenestration openings outside of the district.

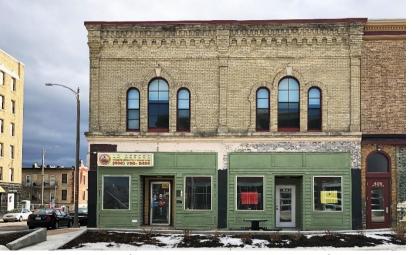
Figure 99: Example of inappropriate contemporary infill at a historic storefront with wood siding or wood panels and the inappropriate installation of display windows that have been reduced in size from the original design outside of the district.

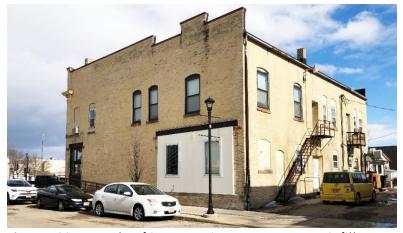
Figure 100: Example of inappropriate contemporary infill at a historic storefront and the inappropriate installation of display windows that have been reduced in size and reconfigured from the original design outside of the district.

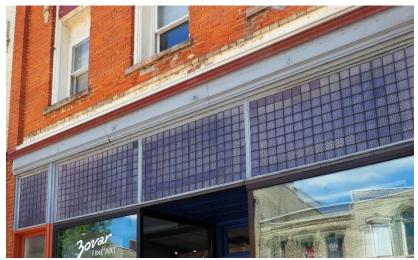
Figure 101: Example of original prism glass transom in the district.

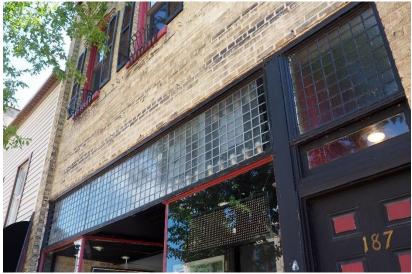
Figure 102: Example of historic leaded glass transom, possibly a historic replacement to prism glass, in the district.

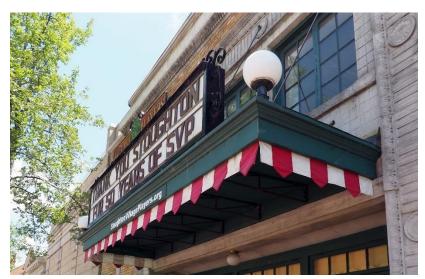
Figure 104: Example of a historic replica canopy with integrated lighting at Village Players Theater, formerly the Badger Theatre, 255 E. Main Street, in the district.

While historically prevalent, awnings, mounted on buildings to protect individual storefronts and entrances, are currently not common in the Stoughton Main Street Historic District, but are encouraged. Canopies, typically mounted above masonry openings and extended to protect a main entrance, are not common in the district. Only the former Badger Theatre (now the Stoughton Village Players Theater) located at 255 E. Main Street has a historic replica canopy, integrated into the marquee.

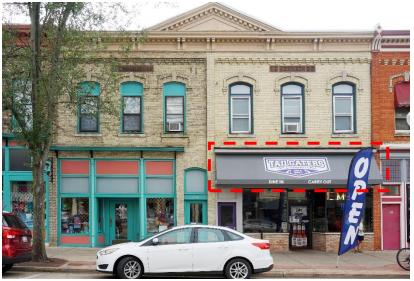
Figure 106: Example of a historically-appropriate "standard" awning in the district.

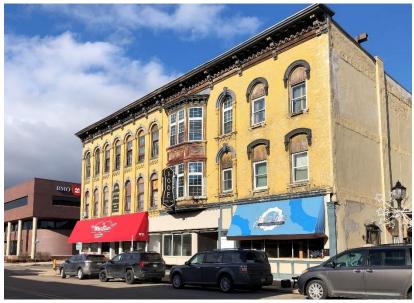
Figure 107: Example of an inappropriate contemporary "standard" awning outside of the district that is disproportionate to the storefront opening and overall front façade of the building.

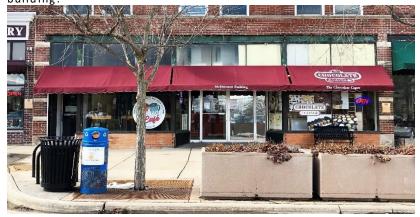
Figure 108: Example of an appropriate contemporary "standard" awning outside of the district that has been inappropriately installed below the masonry opening obscuring and damaging the remaining historic storefront components.

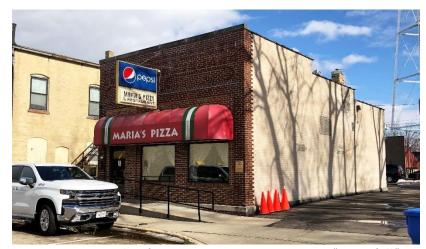
Figure 109: Example of inappropriate contemporary "waterfall" or domed awning, located outside of the district.

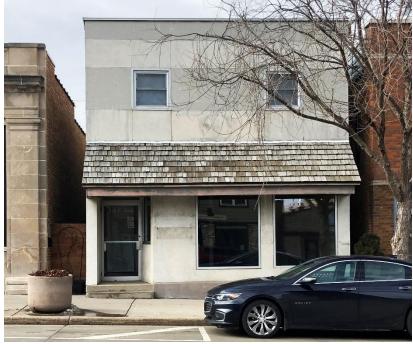
Figure 110: Example of inappropriate contemporary shed roof canopy at a storefront outside of the district.

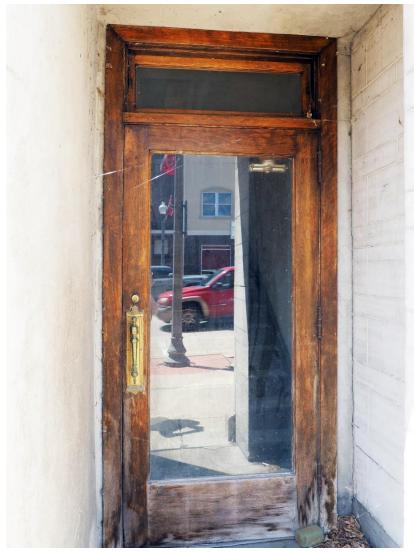
Figure 112: Example of a historic full-light wood stile and rail door and transom in the district.

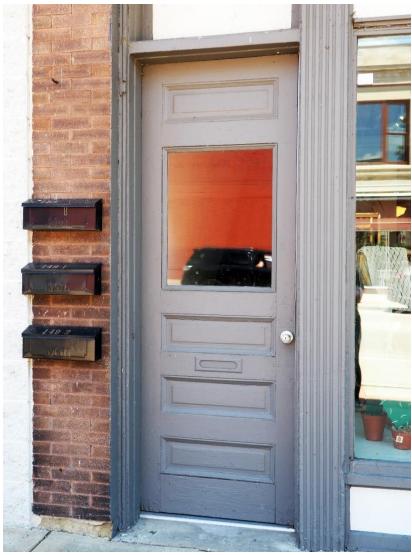
Figure 113: Example of a historic wood stile and rail door with four decorative panels and an upper light in the district.

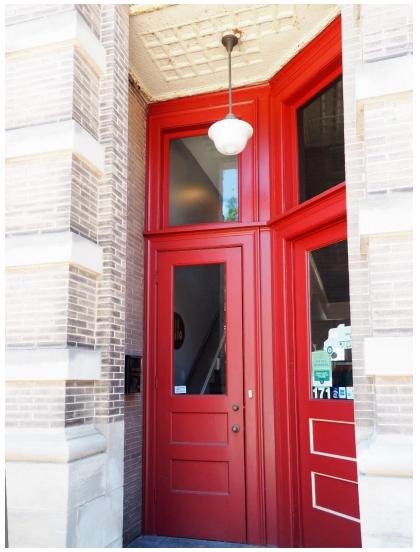
Figure 114: Example of an appropriate contemporary wood stile and rail door in the district.

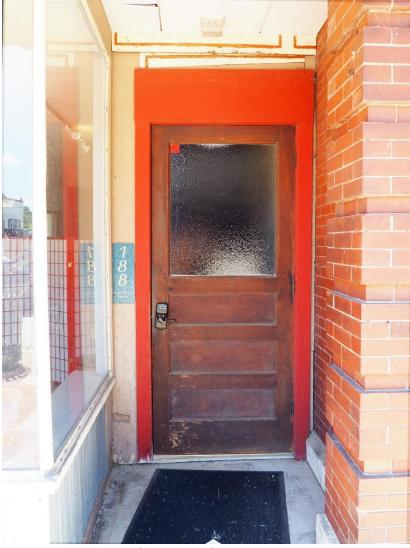
Figure 115: Example of a historic full-light wood stile and rail door with three decorative panels and an upper light composed of frosted glass in the district.

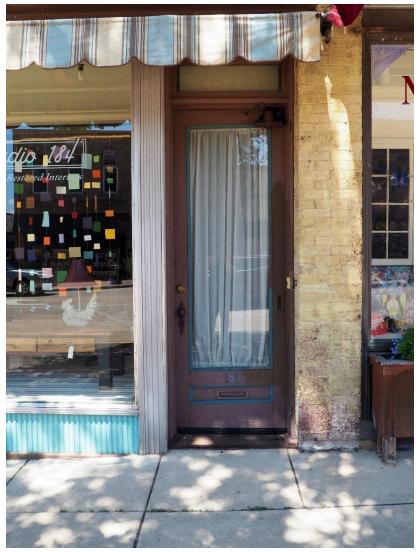
Figure 116: Example of a historic full-light wood stile and rail door with a lower decorative panel and a large upper light in the district.

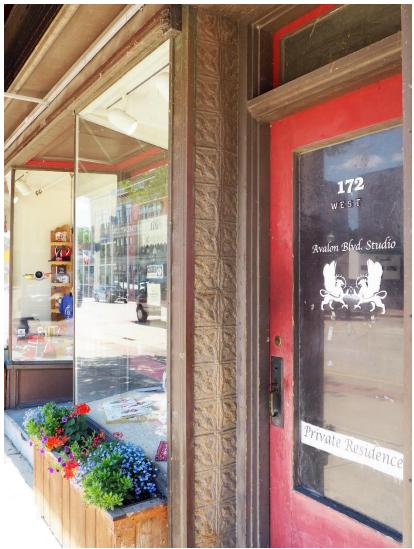
Figure 117: Example of a historic full-light wood stile and rail door and transom in the district with historic tin cladding in the door frame.

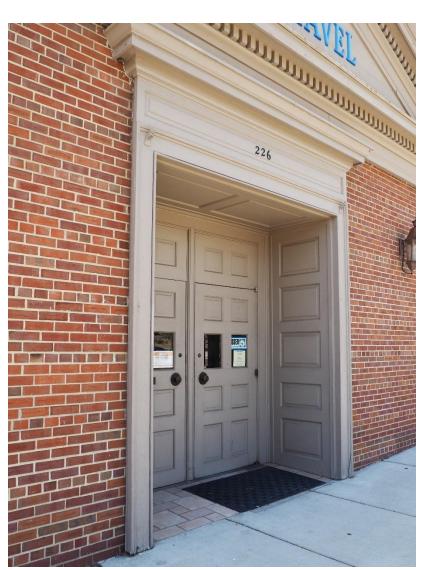
Figure 118: Example of a historic stile and rail door with decorative panels and the original wood entrance surround at the exterior façade and paneling in the door frame.

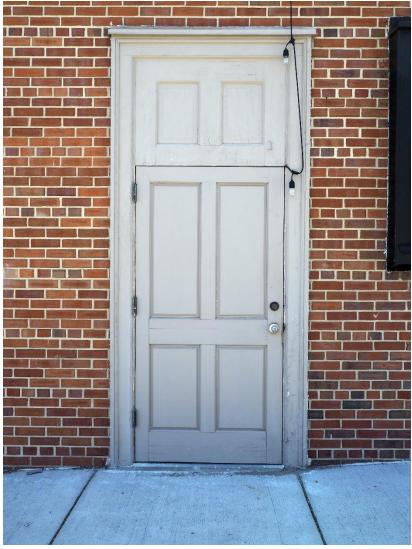
Figure 119: Example of a historic wood stile and rail door with decorative panels and a decorative wood panel at the transom in the district.

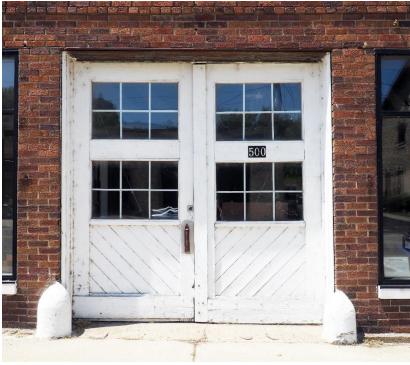
Figure 120: Example of a historic pair of wood stile and rail garage doors with decorative lower panels and upper lights in the district.

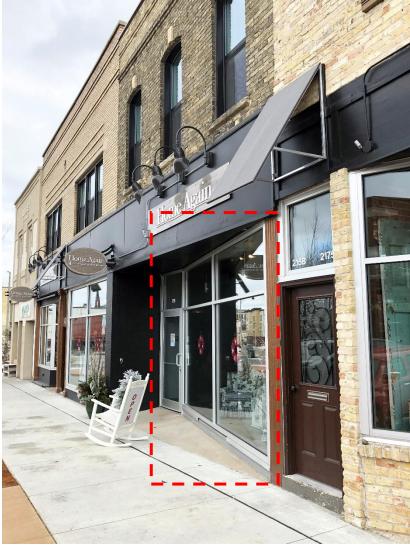
Figure 121: Example of an appropriate contemporary full-light aluminum door with an inappropriate storefront window design as it did not maintain the historic bulkhead, not located in the district.

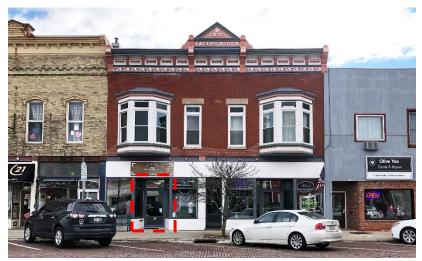
Figure 122: Example of an appropriate contemporary full-light aluminum door not located in the district.

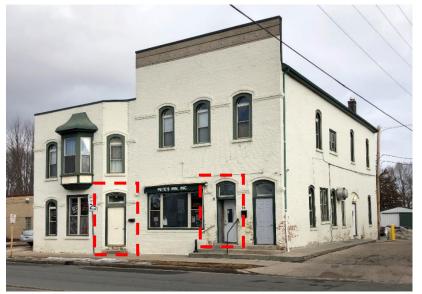
Figure 123: Example of an inappropriate contemporary paneled aluminum door not located in the district.

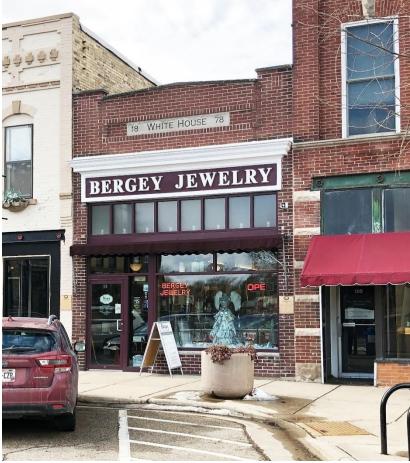
Figure 124: Example of an appropriate contemporary full-light aluminum door and storefront design not located in the district.

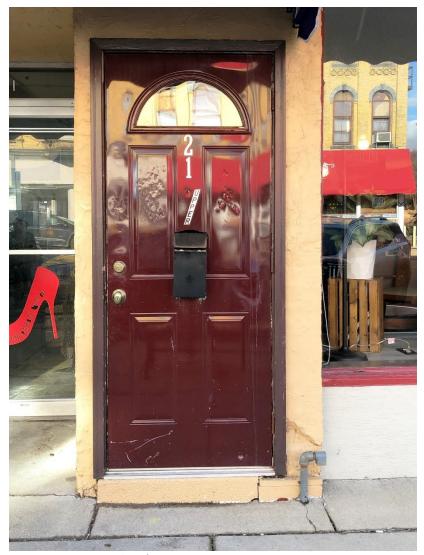
Figure 125: Example of an inappropriate contemporary residential-style paneled aluminum door with a fanlight not located in the district.

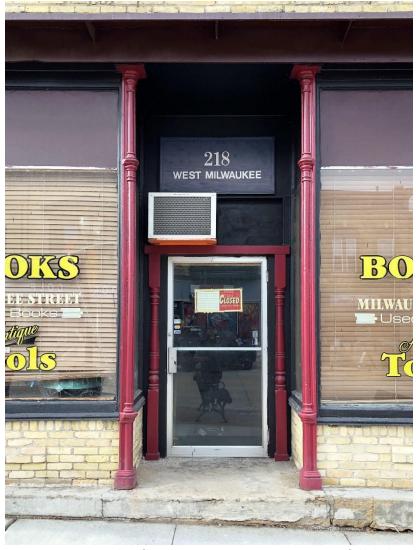
Figure 126: Example of an inappropriate contemporary full-light aluminum door not located in the district. The new door does not fit in the historic opening altering and reconfiguring the historic entrance. Additionally, a historic transom has been replaced with a wood board and a portable air conditioning unit.

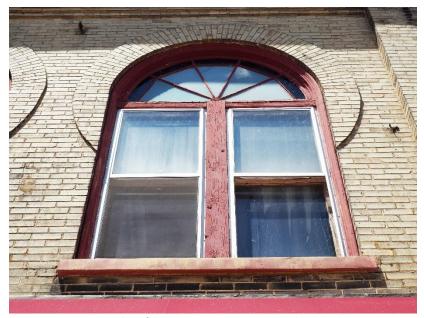
Figure 127: Example of historic one-over-one double-hung windows with a historic arched top multi-light transom in the district.

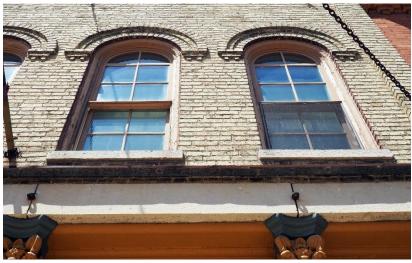
Figure 128: Example of appropriate contemporary wood arched top windows to replicate the original windows which had been previously removed in the district.

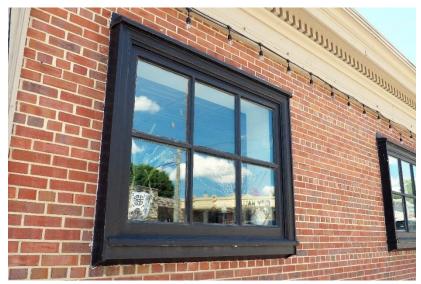
Figure 129: Example of a historic oriel window in the district.

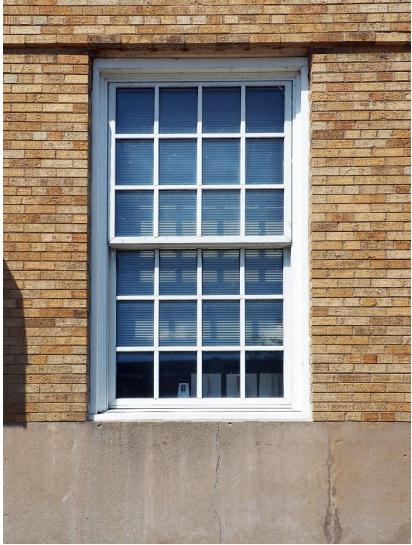
Figure 130: Example of non-historic twelve-over-twelve doublehung vinyl window in the district.

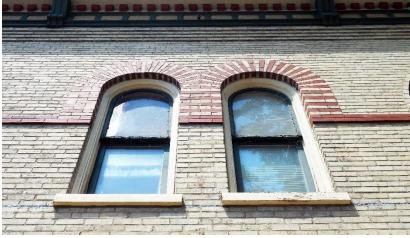
Figure 131: Example of historic one-over-one arched top doublehung windows in the district.

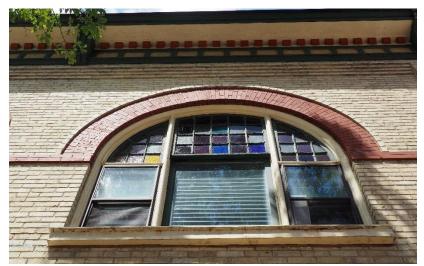
Figure 132: Example of historic tripartite window with a center fixed window flanked by two one-over-one double-hung wood windows with fixed multi-light stained glass transoms.

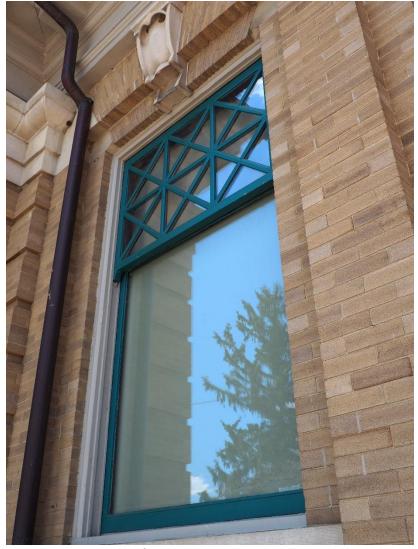
Figure 133: Example of appropriate contemporary wood windows to replicate the original windows which had been previously removed in the district.

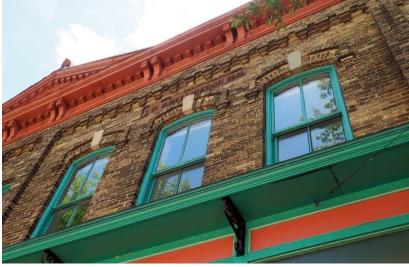
Figure 134: Example of appropriate contemporary wood two-overtop arched top double-hung windows to replicate the original windows which had been previously removed in the district.

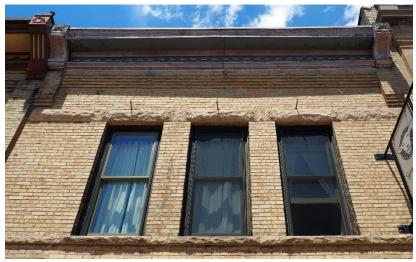
Figure 135: Example of non-historic one-over-one double-hung vinyl-clad wood or vinyl windows in the district.
