1.0 INTRODUCTION

The locally landmarked Stoughton Main Street Historic District is significant for its role in regional commerce, trade, and transportation, and locally for architecture, government, and education. The district is also listed on the National Register of Historic Places and has fourteen properties individually designated as local landmarks. These designations have helped to preserve the character of Stoughton's Main Street through the conservation of the historic building stock and the encouragement of maintenance, repair, and restoration.

The developed guidelines provide information on the architectural and historical significance of the district, available financial incentives, and preservation recommendations and best practices for the repair, restoration, and maintenance of contributing buildings located within the district. The district's history, pattern of development, and rich architectural character provide a basis to help guide compatible infill redevelopment on vacant lots and alterations to non-contributing buildings in the district.

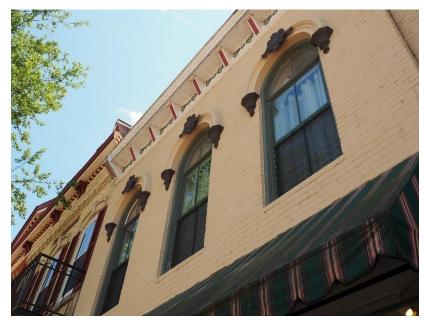
Figure 136: Example of appropriate contemporary two-over-two double-hung wood windows with a two-light arched wood transom to replicate the original windows which had been previously removed in the district.

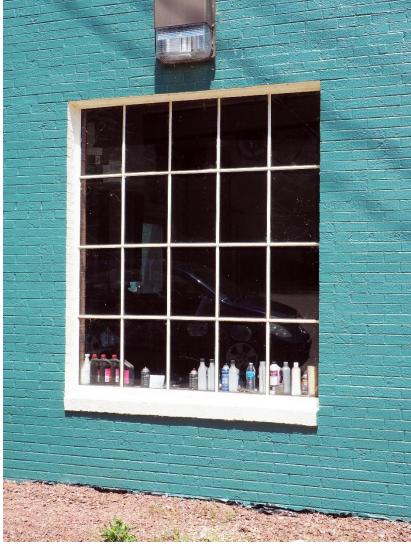
Figure 137: Example of a historic multi-light fixed steel window in the district.

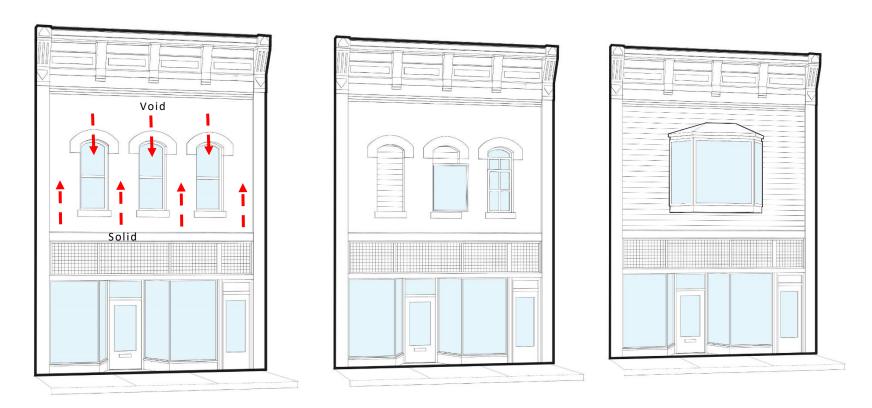
Figure 138: When rehabilitating existing windows and window openings, the work should seek to maintain the existing rhythm of solids and voids. In the district, the existing primary façades have a greater proportion of glass on the first floor than in the upper stories due to the presence of the first floor storefronts which span the full width of the façade, which creates a large "void" and dominates the primary façade. The small upper story windows are punched through walls of masonry, giving a repeated rhythm of solid, void, solid, void, solid as seen in the left illustration. The resultant solid to void relationship is characterized by the lower floor having a majority of its surface as "void" or window, and the upper floors having a majority of their surface as "solid" punctuated by repeated "voids" or windows. When rehabilitating a building, window openings should not be altered to infill or enlarge a historic opening as seen in the center illustration or obscure or reconfigure the existing openings in one large opening or bay window as seen in the illustration on the right.

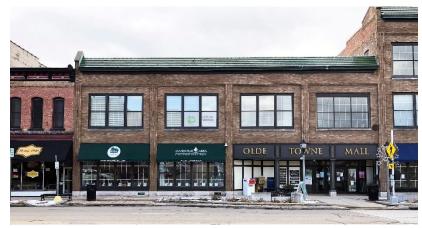
Figure 139: Example of appropriate contemporary window configuration and double-hung operation style at the second floor, but inappropriate fake muntins have been added to simulate a six-over-six double-hung window, not in the district.

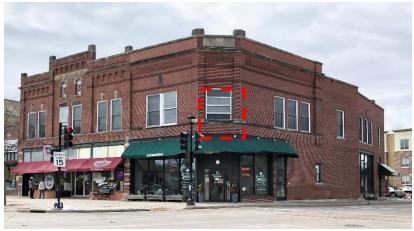
Figure 140: Example of inappropriate contemporary vinyl windows at the second floor and the inappropriate change in the operation style at the center window, not in the district. The original design of the center window is unknown, but based on the date of construction and historic architectural style the four horizontal fixed windows are not appropriate.

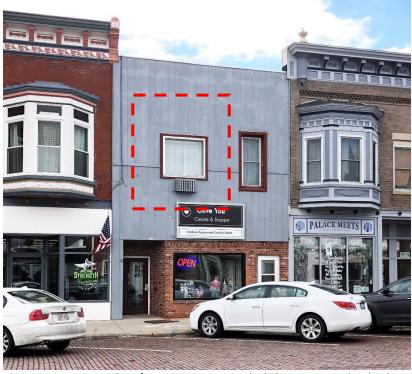
Figure 141: Example of inappropriate rehabilitation work which obscured the original window openings at the second floor and reconfigured the left and central openings into one larger opening, not in the district.

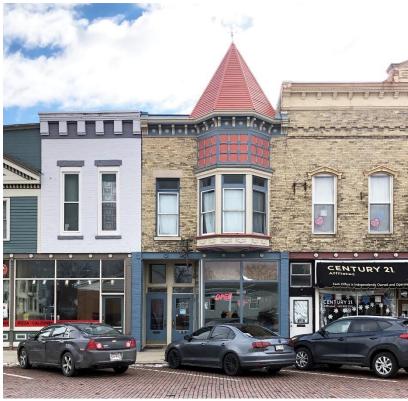
Figure 142: Example of inappropriate contemporary vinyl windows at the second floor, but appropriate preservation of the window opening and operation style, not in the district.

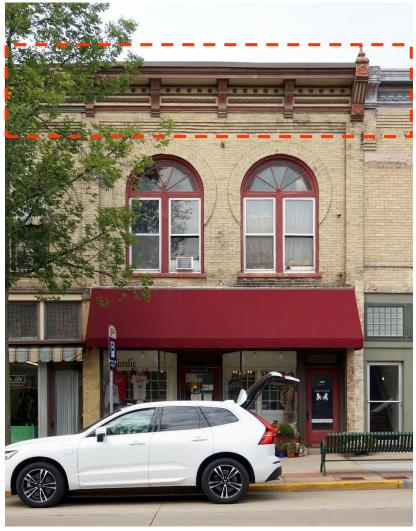
Figure 143: Example of an elaborate and ornamental historic projecting cornice at 172-176 W. Main Street in the district.

- Skylights may be permissible if they are not visible from the public right-of-way.
- A distinctive architectural feature at the roof line of many of Stoughton's commercial buildings is an elaborate masonry, wood, or metal cornice, sometimes crowned with a masonry shaped parapet or metal pediment. This unique character-defining feature should be preserved through repair and maintenance. If a cornice has been previously removed, it may be replaced in wood, metal, brick, or in modern materials like fiberglass and lightweight cement, using historic photographs or original architectural drawings as a guide.

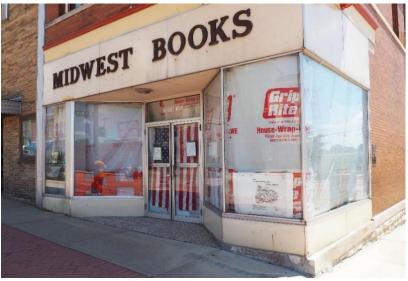
Figure 144: Example of a historic mid-twentieth century storefront at the Hausmann Brewing Company Saloon building, 105-111 E. Main Street, in the district.

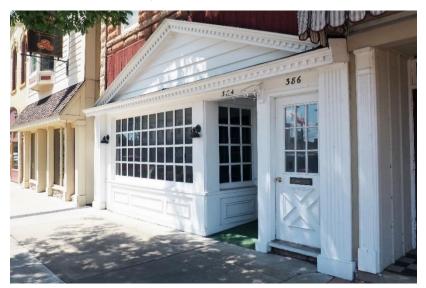
Figure 145: Example of a historic mid-twentieth century Colonial Revival style storefront at 384 E. Main Street in the district.

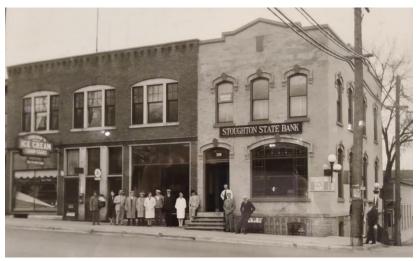
Figure 146: Photograph of the former Stoughton State Bank (right) and Post Office with storefronts (left) at 209-211 E. Main Street, October 29, 1929. Courtesy of the Stoughton Historical Society.

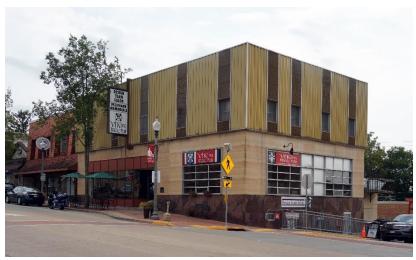
Figure 147: Current photograph of 209-211 E. Main Street, currently the Viking Brew Pub, 2021.

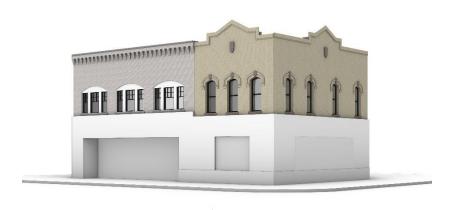
Figure 148: Rendering of the restored second story façade of 209-211 E. Main Street after the slipcover is removed.

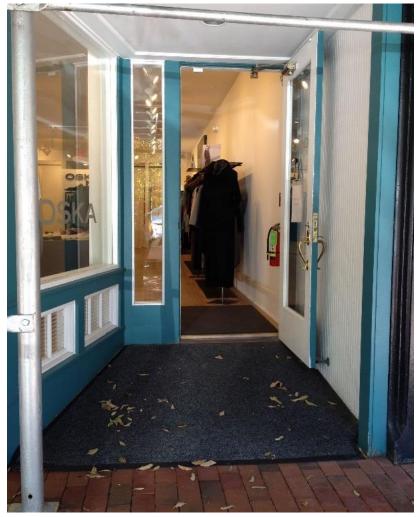
Figure 162: Example of an appropriate contemporary exterior ramp at a front entrance not in the district.

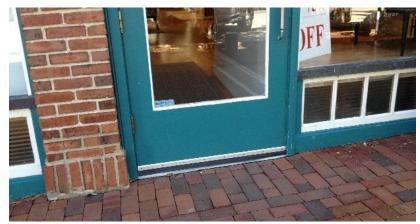
Figure 163: Example of an ADA-compliant threshold not in the district.

- Historic door hardware should be retained and retrofitted to meet accessibility standards.
- Historic thresholds that do not meet accessibility standards may be altered or replaced. A historic threshold can be adapted by adding a beveled element. Or a new, visually compatible threshold may be installed.

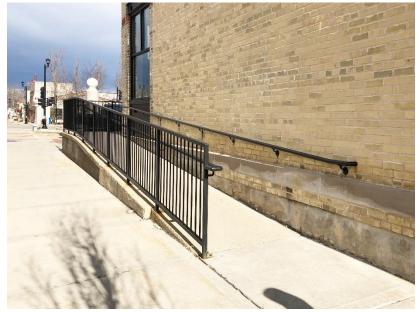
Figure 164: Example of an appropriate contemporary exterior ramp at a secondary façade not in the district.

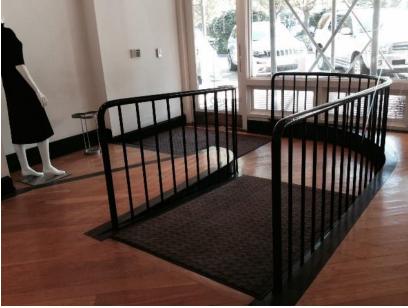
Figure 165: Example of an appropriate contemporary interior ramp in a retail space not in the district.

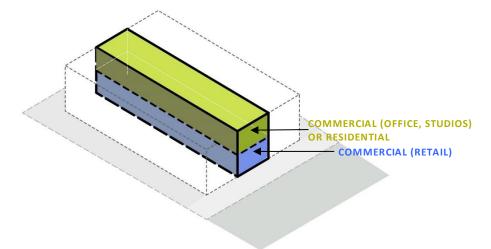
Figure 166: New construction in the district should maintain the existing development pattern in the district by providing first floor retail spaces and additional commercial or residential space at the upper floors.

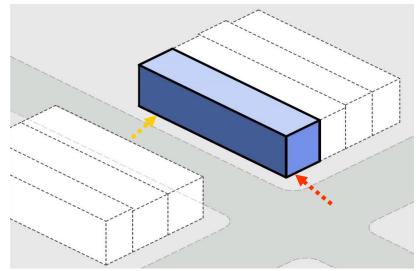
Figure 167: New construction at corner lots should not have a front or side setback, but may take advantage of a corner entrance and may have two primary facades, both facades facing the streets along which the building is located. A greater visual emphasis, through architectural detailing, should be placed on primary façade "A", depicted by the orange arrow, located on Main Street.

- New construction located on a corner site may take advantage of a corner entrance and may have two primary façades, both façades facing the streets along which the building is located. In designing corner buildings, consider providing greater visual emphasis with more architectural detailing, designing both street façades as "front" facades. Primary façade "A", located on Main Street, should have a clear primary entrance. Primary façade "B", located on a collector street, should be architecturally treated like a primary facade and may have secondary entrance.

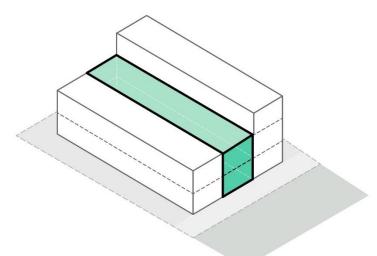
Figure 171: The height of new infill construction should be compatible with the surrounding buildings. New buildings constructed between two existing buildings should match the lower height of the two existing buildings.

- The height of new infill construction should be compatible with the surrounding buildings. Existing buildings in the district range in height from one to five stories with the majority of buildings being two stories in height (seventyfive percent), followed by one-story buildings (nineteen percent) creating a low-density, pedestrian-friendly district.

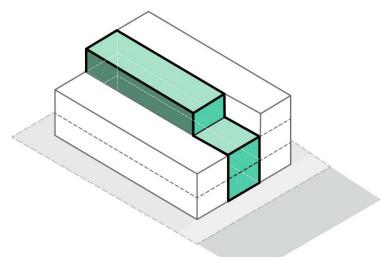
Figure 172: A new building may add an additional floor to match the tallest height of an adjacent existing building if it is setback from the front façade per the guidelines provided on pages 86-89 in this document.

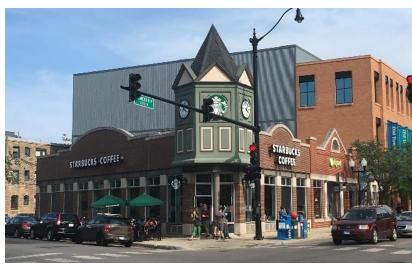
Figure 173: Example of inappropriate new construction not in the district. The design is pseudo-historic and out of scale to its surroundings.

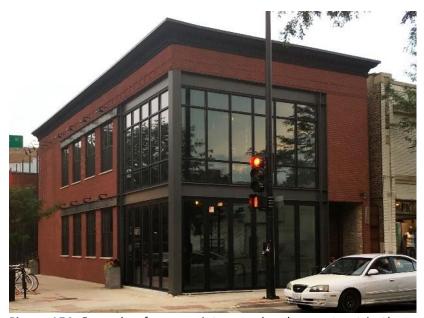
Figure 174: Example of appropriate new development not in the district. The design maintained the scale and massing and reassembled the original masonry material and cornice while integrating a contemporary aesthetic.

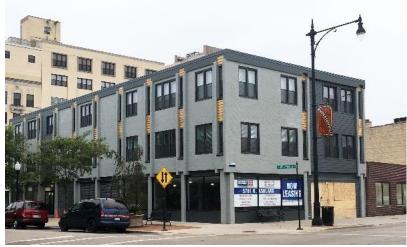
Figure 175: Located outside of the district, this new infill construction maintains an appropriate scale and massing and rhythm of the storefront at the first floor, but uses inappropriate materials such as painted brick and wood shakes and siding.

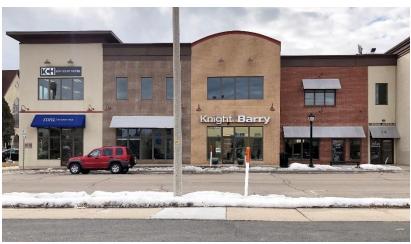
Figure 176: Example of inappropriate new construction not in the district. The design is pseudo-historic and setback back from the street.

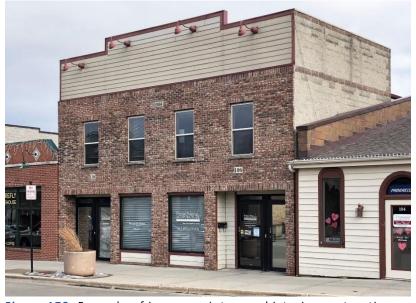
Figure 178: Example of inappropriate non-historic construction not in the district. The building is disproportionate in scale to the adjacent existing buildings and uses inappropriate materials such as brick veneer, siding, and concrete block.

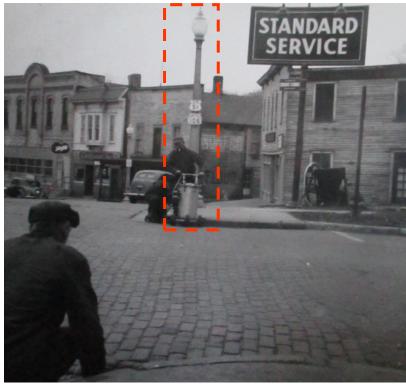
Figure 179: Historic photograph at the intersection of Main and Fifth Streets depicting Lighting Type No. 1, undated. Courtesy of the Stoughton Historical Society.

Lighting Type No. 1: This lighting type spanned the length of Main Street through the district and featured a narrow, fluted cast iron post that tapered and terminated into an acorn-shaped globe. The lamp base, which holds the bulb, mimicked a classical column capital, and was manufactured out of pressed metal ornamented with acanthus leaves. The base of the post was unadorned. These posts were common and the most historically prevalent along Main Street.

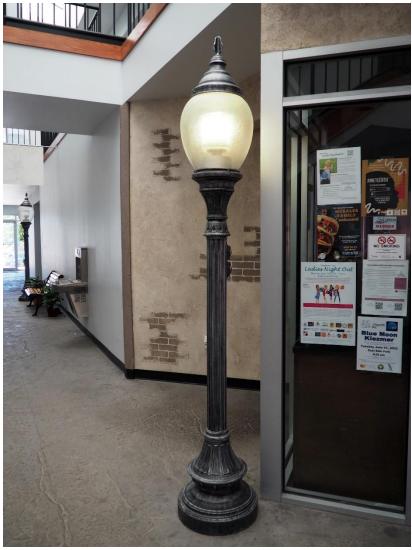
Figure 180: Replica of Lighting Type No. 1 located on the first floor of the Kegonsa Plaza building at 135 W. Main Street in the district, 2021.

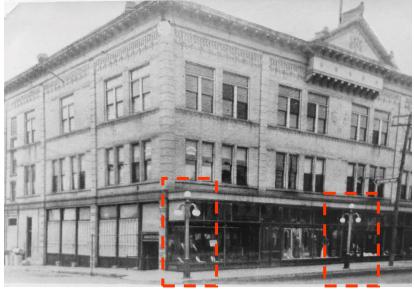
Figure 181: Historic photograph of the Hyland-Olsen Block at the southwest corner of Main and Water Streets depicting Lighting Type No. 2, undated. Courtesy of the Stoughton Historical Society.

Lighting Type No. 2: In historic photographs, this lighting type appears to only be located at the southwest corner of Main and Water Streets and may be closely associated with the development of the Hyland-Olsen Block. This type featured a narrow cast iron post that tapered and terminated at a spherical globe. Below the lamp base for the center globe, four crooks descend from the main post and each terminated at a spherical globe. The post and lamp base appear to be embellished with ornamental metal work, but the exact design is not visible in the historic photograph.

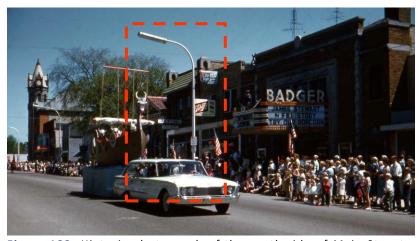
Figure 182: Historic photograph of the south side of Main Street between Forrest and Fourth Streets depicting Lighting Type No. 3, 1960s. Courtesy of the Stoughton Historical Society.

Lighting Type No.3: Mid-twentieth century version of the mast-arm post. This lighting type had no additional ornamentation or stylistic details.

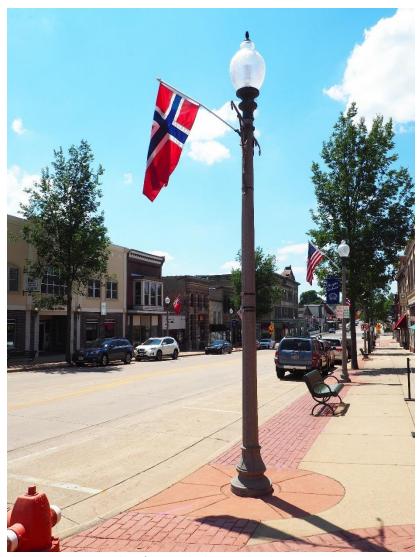
Figure 183: Example of streetlights in the district today, 2022.

Lighting in the district today is reminiscent, but not an exact replication, of historic type No. 1. The existing streetlights feature a smooth concrete with exposed aggregate post, in lieu of the fluted metal post. It is recommended that the existing lighting be maintained as part of the streetscape.

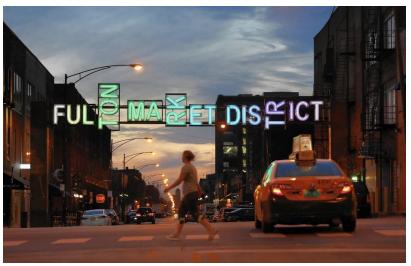
Figure 184: Example of inappropriate wayfinding signage at an entrance to a historic commercial district, outside of the district. The sign is out of scale to its surroundings, incompatible in design, and projects over the public right-of-way obscuring the view of the district from the public right-of-way.

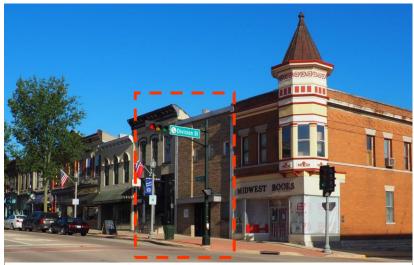
Figure 185: Example of mast arm traffic signal in the district.

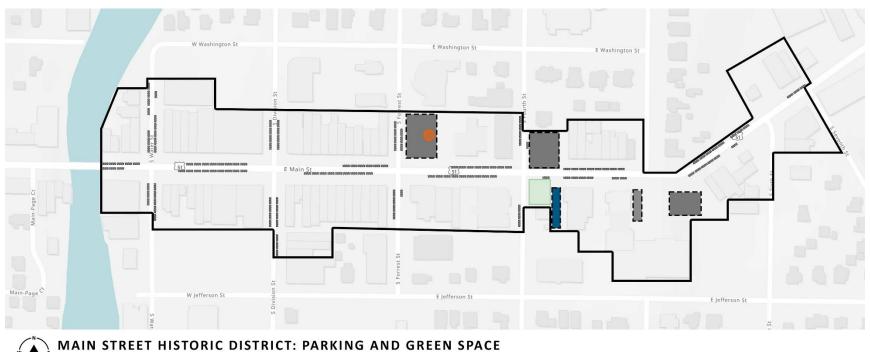
Figure 186: This map identifies existing public and private parking lots, public on-street parking, electric vehicle charging stations, and green space in the district.
