# AGENDA

## DOWNTOWN DEVELOPMENT AUTHORITY

**SUBJECT: Downtown Accessibility Audit Recommendations**

The updated Audit, attached for your review, contains an overview of the findings of the audit conducted from December 2016 – October 2017, and makes several recommendations for improvements, including to streets identified as being the most inaccessible in Downtown. Those streets are:

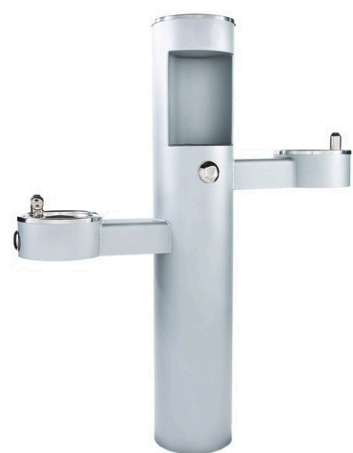
**DRINKING FOUNTAIN  
w/ BOTTLE FILLER  
AND ACCESSIBLE  
DRINKING FOUNTAINS**

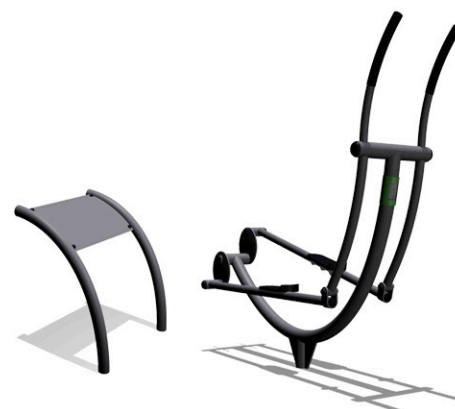
**STATION 1  
CROSS ELLIPTICAL  
(2) TOTAL  
AND SIGN**

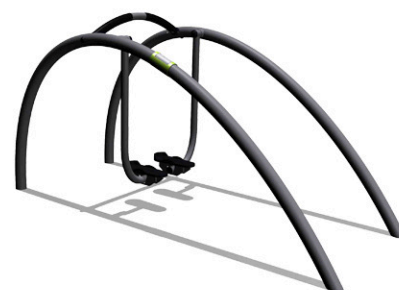
**STATION 2  
AIRWALKER  
(2) TOTAL**

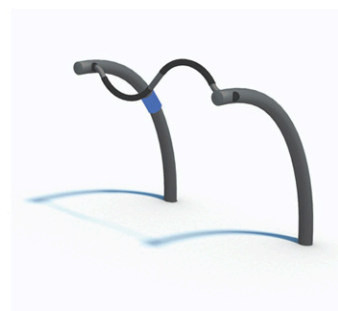
**STATION 3  
HAND  
CYCLER**

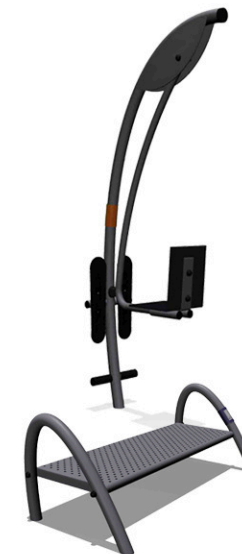
**STATION 4  
LEG PRESS  
AND BENCH**

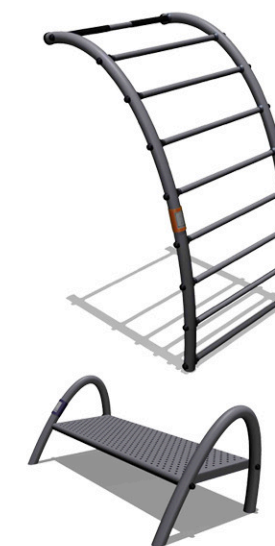
**STATION 5  
PULL UP  
AND BENCH**

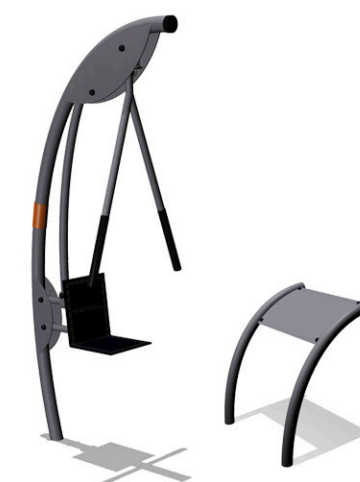
**STATION 6  
CHEST PRESS  
AND SIGN**

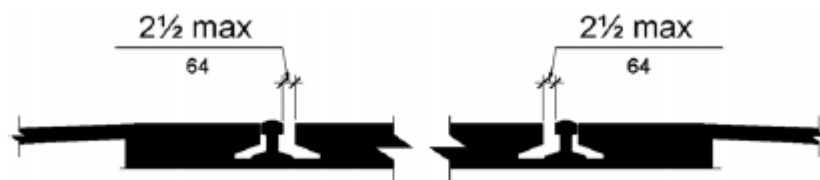
**Figure 810.10 (Exception) Track Crossings**

EXCEPTION: Openings for wheel flanges shall be permitted to be 2 1/2 inches (64 mm) maximum.
