Indiana DOT's MRU Experience

New England ATSSA

November 2015

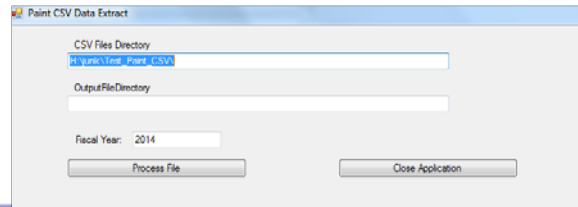
- At a network level, this will result in a LOT of files!
 - Develop standard series naming conventions
- Fortunately, our IT section developed a "quickie" compiler
 - Combines all text files in a folder into one file

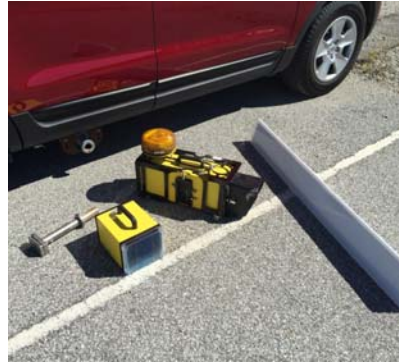
- Sensor
- Mounting Bracket
- Calibration Block
- Alignment Bar

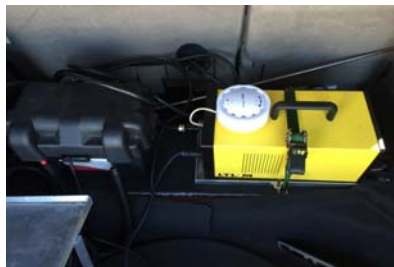
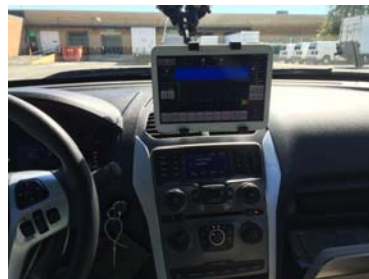
- Processor
- Battery
- Tablet (Android)

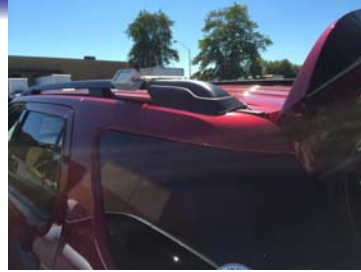
- GPS
- DMI

- DMI on LTL-M is not permanently attached to vehicle
 - Uses suction cup that occasionally fell off
- Determined GPS worked well enough

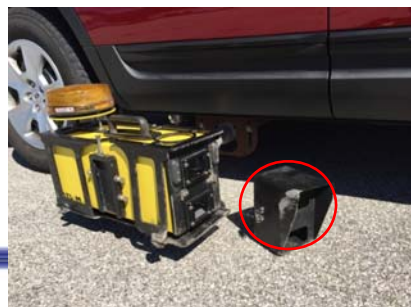
- Clean windows – Daily
- Replace Windows – As Needed
 - We needed to replace halfway through
- Replace Flash Bulb – Not needed yet
 - ~500 hour of operation

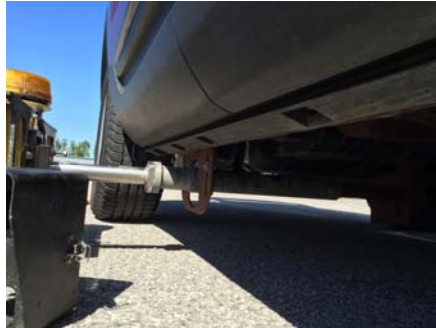
- **Run Alignment ~ Monthly**
- **Adjust Support Bracket Height**
 - Needed maybe twice

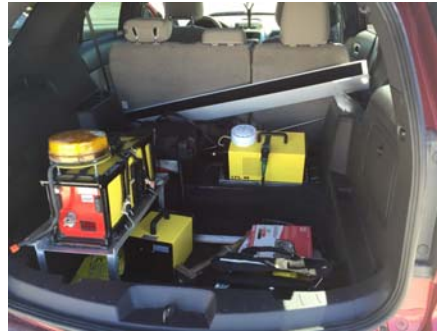
- Needed Tools (wrenches, screw drivers, tape, level, etc)
- Built our own platform to hold/secure sensor when not in use
