#### **NIST Response to the World Trade Center Disaster**

Federal Building and Fire Safety Investigation of the World Trade Center Disaster

August 21, 2008

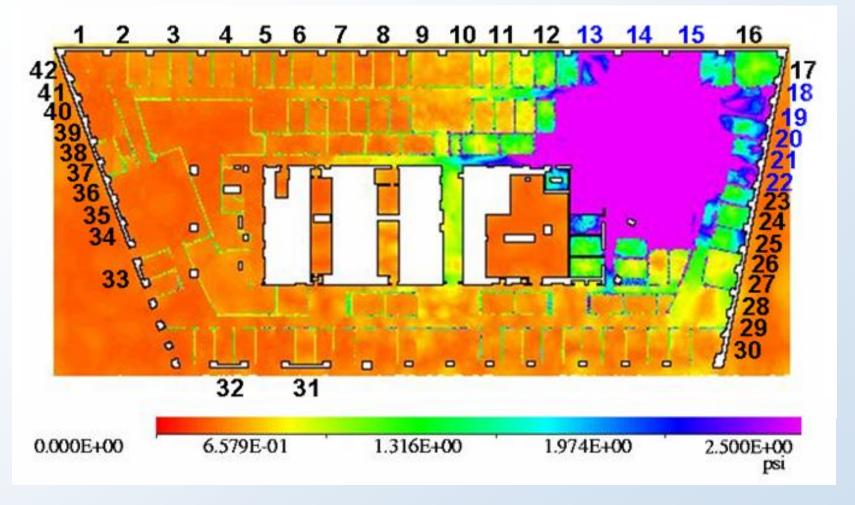
## **Hypothetical Blast Simulations**

Peak over pressures for 9 lb shaped charge.

It did not collapse from explosives or from fuel oil fires

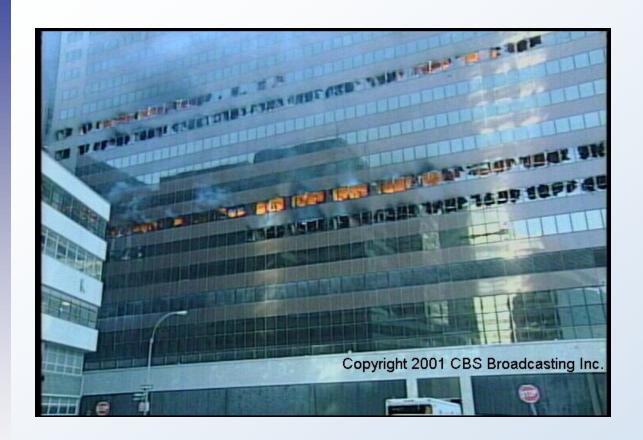
#### Fire Growth and Spread

Progression of fires on Floor 12

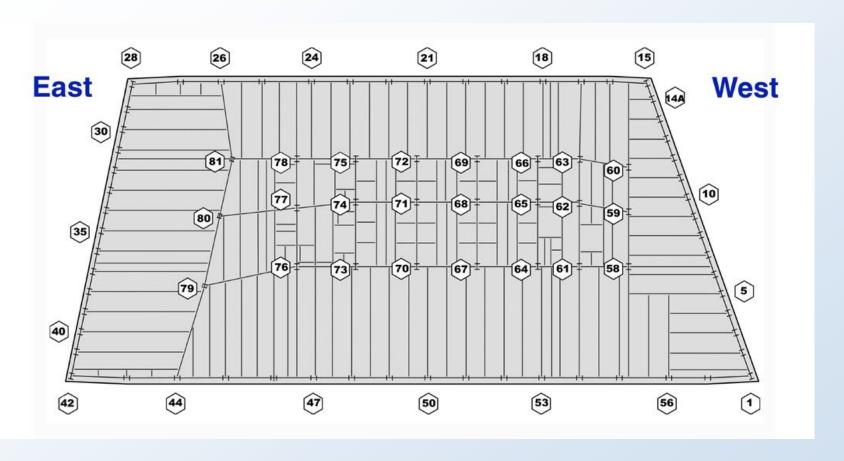
## **Typical Layout: Interior Columns, Floor Framing**

**WTC 7 Typical Floor**

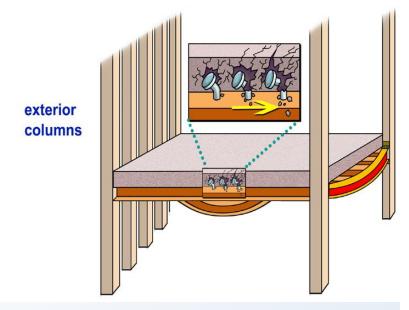
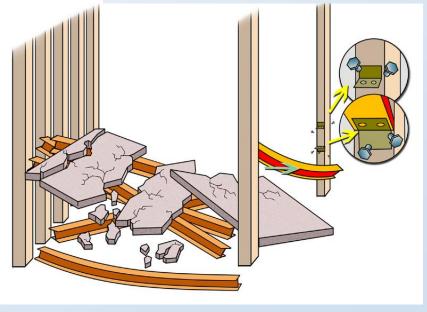
## **Thermal Expansion Causes Floor Failures**

interior columns

Building owners, operators and designers should evaluate fire performance of structural systems, especially

- Long-span floor systems;
- Connections not designed for thermal effects
- Asymmetric floor framing
- Composite floor systems

- Strengthen connections
- Strengthen floor framing
- Increase structural redundancy
- Add additional fireproofing in vulnerable areas
