## General Information

This Service Bulletin contains information on how to diagnose problems and troubleshoot the J1939 datalinks.

## Freightliner Custom Chassis Service Bulletin

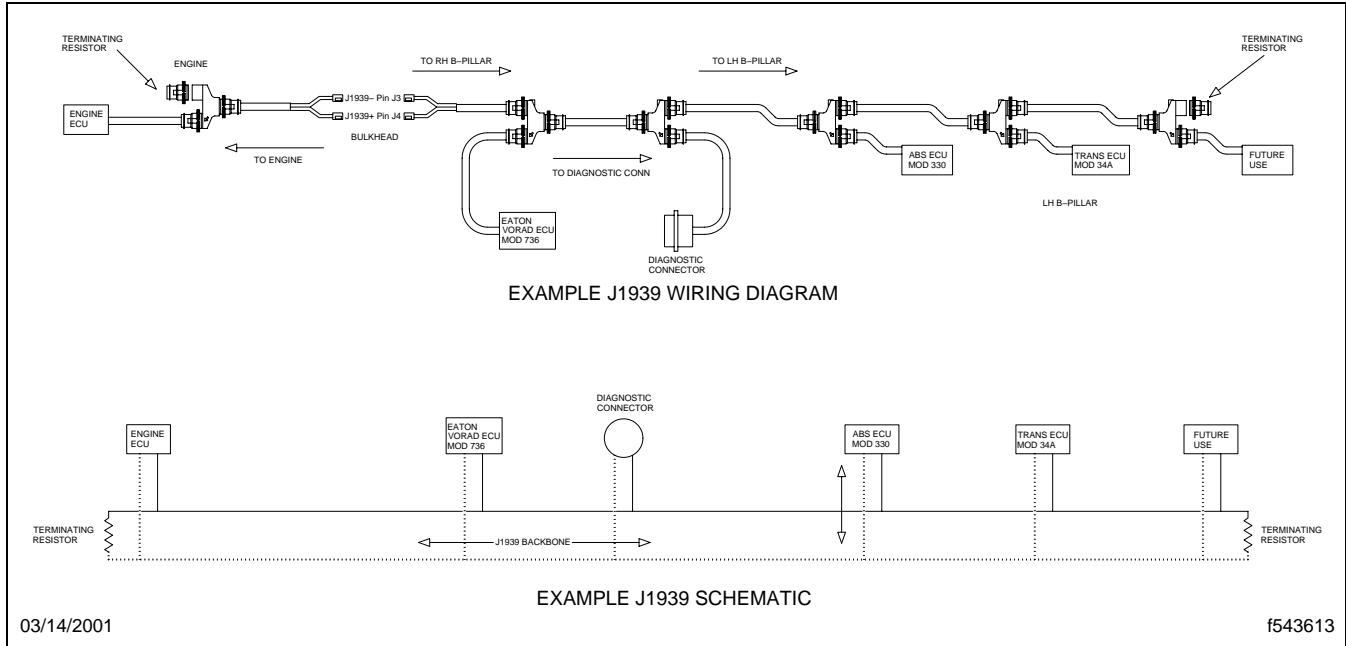
**Fig. 1, J1939 Wiring Diagram And Schematic Examples**

- **Backbone**—The main J1939 datalink wiring from one end of the datalink to the other. It does not include the branch circuits to each ECU or diagnostic connector.

- **Branch Circuit**—The section of J1939 datalink wiring between the backbone and each ECU that has J1939, and between the backbone and the diagnostic connector.

- **J1939 Datalink Wiring**—
  - Yellow (J1939+)
  - Green (J1939-)
  - Shield (optional; used only with J1939 "heavy" cable)
- **Terminating Resistors**—Located one at each end of the backbone, for a total of two. Each resistor is  $120\Omega$ . With two in parallel the total resistance is  $60\Omega$ .  
On vehicles equipped with a Mercedes MBE 900 engine, one of the terminating resistors may be located inside the VCU. This only applies to VCU part number MBT A0004461435. This resistor can be tested by checking the resistance across terminals 19 and 21 of the 21-pin connector on the VCU. If this resistor fails, the VCU must be replaced. New VCUs (p/n MBT A0004461735) do not contain an internal terminating resistor. If an older VCU is replaced with a newer one, a terminating resistor will have to be added to the J1939 backbone. See Subject 1.2 for more information.

- **ECU**—Electronic Control Unit. These connect to the J1939 datalink with a branch circuit.
- **Diagnostic Connector**—Most vehicles with J1939 use a 9-pin diagnostic connector (see Section 3, Frequently Asked Questions, for exceptions to this). Not all vehicles with 9-pin connectors have J1939. Vehicles with J1939 will have terminals in cavities C and D.

See **Fig. 1** and **Fig. 2**.
