# Lessons learned from the Napa quake

**Details** Category: Design & Construction Column Published on Friday, 03 October 2014 01:00 Written by Brandon Erickson

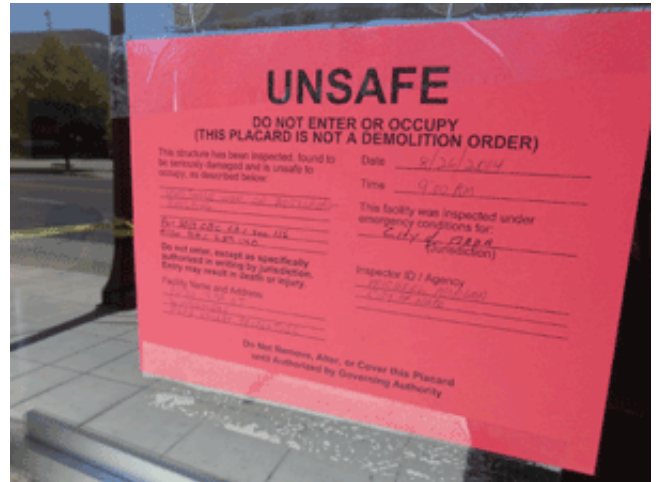
As expected, many older buildings, especially those constructed of brick and mortar without internal steel reinforcement, fared very poorly. Several of these types of buildings suffered collapsed exterior walls and roofs, leaving piles of debris on the sidewalk and gaping holes that exposed interior spaces. Many of these buildings, primarily in the historic downtown area, were "red tagged," preventing entry or use until the building could be repaired. Depending on the nature of the damage and the costs of repair, demolition may prove to be the most appropriate course of action. With a few notable exceptions, newer buildings performed better than similar, older buildings. Newer buildings generally exhibited less damage, and were typically "green tagged" or "yellow tagged," allowing faster re-entry and representing a much less challenging repair task. In some cases, however, re-entry to undamaged buildings was prevented because of the risk presented by an adjacent, typically taller, damaged building. Often the recognition of structural damage, or the implications of observed damage, was not immediately apparent until an inspection by an engineer could be completed. Given the high demand for such inspections, many building owners were forced to wait for an inspection until a qualified engineer became available.

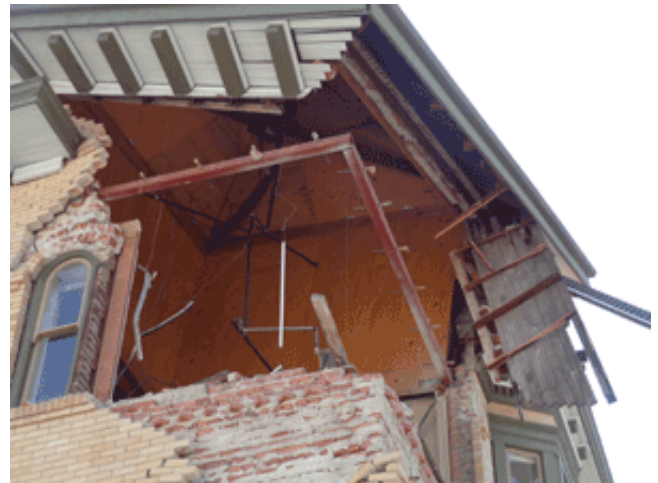
Though structural damage to buildings was widespread, extensive economic loss was also suffered because of non-structural building systems damage, such as to water lines, ceilings, windows and gas lines. Buildings that avoided structural damage often still suffered extensive interior damage, typically rendering the building inhabitable due to flooding, debris and disarray to building contents. Often broken overhead windows, with dangling glass shards, prevented access through doors below or to adjacent sidewalks until the risk was removed. Broken storefront windows also created a security risk for business owners.

Extensive damage occurred to many buildings when unbraced water lines ruptured, extensively damaging building contents, ceilings, floors and wall finishes, and rendering the building unusable for an extended period of time. Several flooded retail stores, for example, suffered extensive content damage, expensive repairs and costly cleanup, and prolonged downtime. Many office buildings, restaurants and other commercial businesses were forced to close as they dealt with the fallout of non-structural damage to their buildings. A large grocery store suffered a near-complete loss of its contents when store shelves toppled and electric power was lost, leaving the perishable food to rot.

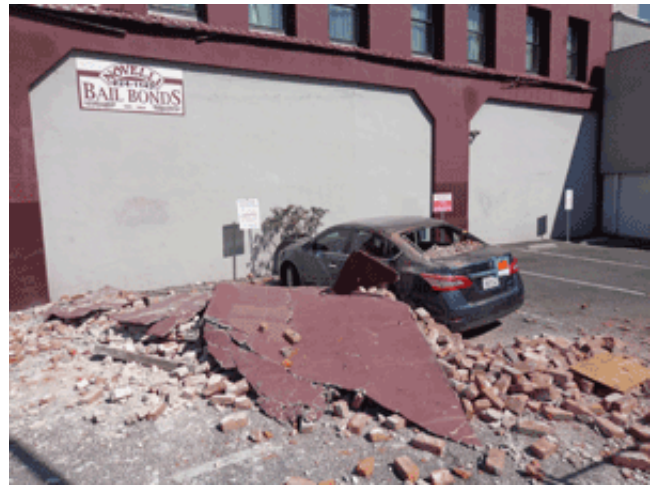
Businesses housed in structurally damaged buildings were closed and unable to serve their customers. Many storefronts exhibited hastily written signs informing potential customers that the business was closed, often indicating that a re-opening date was uncertain. Water damage, broken glass, downed ceilings or toppled contents, loss of electric power and water service often exacerbated the plight of businesses closed by structural damage. Some fortunate buildings and business that escaped unscathed were still forced to close as they waited for power and water to be restored. Entire blocks of businesses were left dark, often with chain link fences forming a stark barrier to would-be customers. How, or if, these businesses will recover from the cost of repairs, prolonged closures, customer attrition and lost inventory will likely rival any past challenge these businesses have faced.

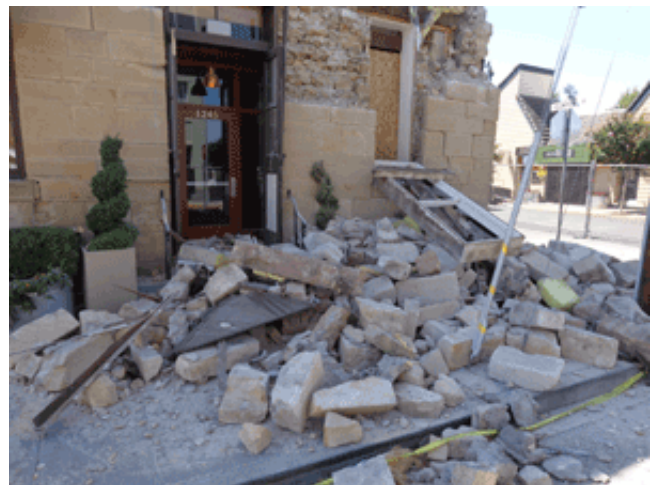
An extensive volume of debris was generated as businesses and homeowners attempted to clean up earthquake damage. With trash service disrupted and overwhelmed, some parking lots became impromptu dumping grounds. Some citizens took advantage of these dump sites to unload non-earthquake generated refuse, resulting in an even larger volume of garbage. The city of Napa appeared challenged to control these developments, often bringing in heavy equipment to haul away debris and posting city personnel as sentinels charged with preventing further dumping.
