## Court Analysis Survey Report

Huntsville Tennis Center  
2305 Airport Road  
Huntsville, AL 35805

**May 19, 2011**  
Actual Survey Date

*Report Information*  
*Author: Roy Hey*  
*Company: Har-Tru Sports*  
*Date: 7/2011*

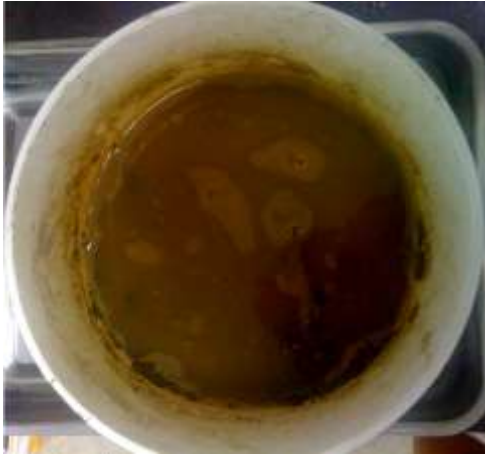
**Results:** The water took an unusual amount of time to drain down through the sample base profile. Pictures below document process and time.

**Picture 2** Water first introduced to sample

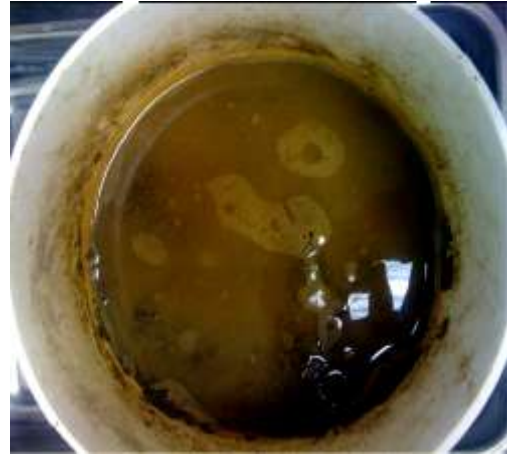
**Picture 3** 15 minutes after water introduced to sample

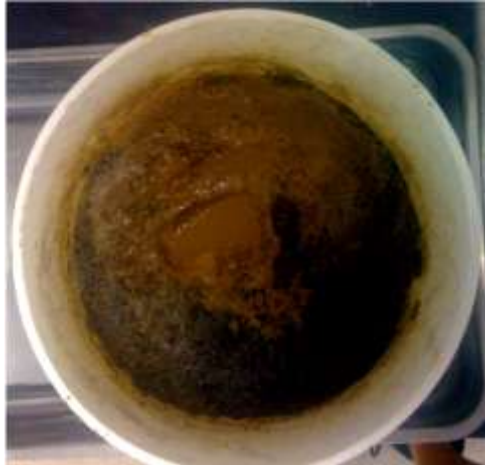
**Picture 4** 1 hour after water introduced to sample

The base material seems to have a lot of fine particles or dust that delays the water from seeping down through the stone base profile. This causes the Har-Tru surface layer to become overly saturated and lose its integrity thereby becoming soft and mushy. The courts then take a long time to drain and dry for play. Once the water has saturated the base profile, the overly dusty material then absorbs that moisture and holds on to it longer. All of this keeps the courts too saturated for a longer period of time than usual.

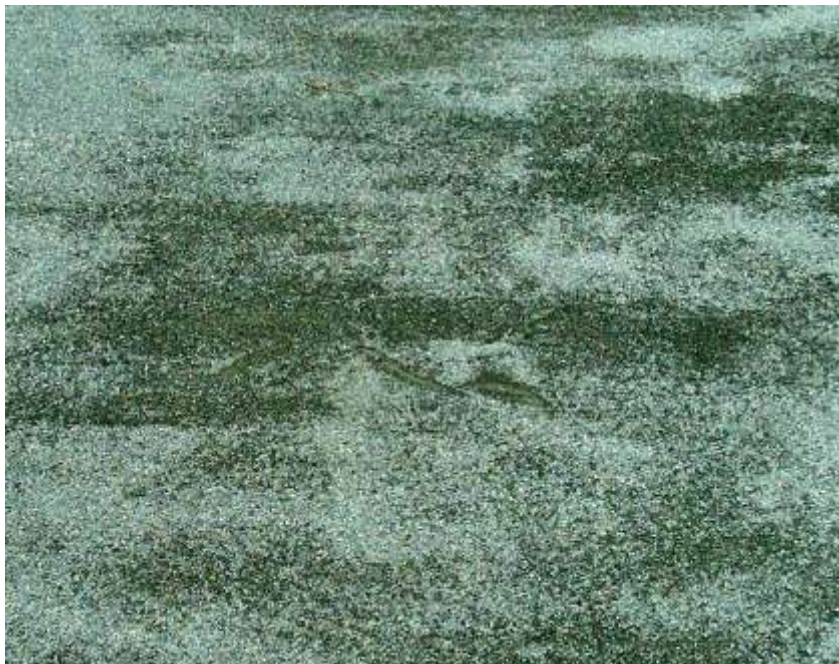
Picture 8 Dead material

During the physical survey, an abundance of “dead material” or loose particles were found on most courts. This dead material should be periodically scraped and removed as these particles will not compact back into the surface profile. Dead material dries quicker than the compacted surface and may create too much slide. See picture below.

- Scrape the surface periodically to remove excessive “dead material” of stone particles which have fallen out of the surface profile and will not bind back into the surface. These stone particles can become a slipping hazard as well. You can identify dead material because it’s the first stone particles to dry and they move about the surface loosely. Reference the Har-Tru Maintenance Manual for when and how to scrape.

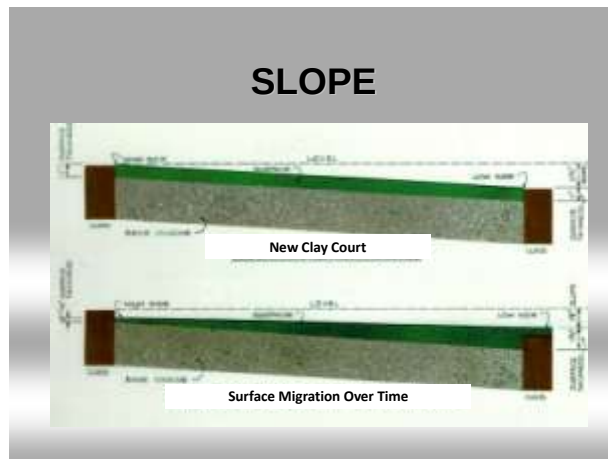
Picture 9 Surface migration over time.

2. Performing an annual top-dressing each year will replace the needed Har-Tru surface material that has migrated off of the courts. Adding 2 tons of new Har-Tru surface material each year will also help to keep the surface in check by providing surface material that has the right stone particle specification. Naturally during rolling and play, the surface's stone particles break down and the courts are left with more fines or finer stone particles. If these "fines" are not migrated off of the courts, because the courts become flattened, the surface layer can become harder and less impervious to water which then keeps more water on top of the surface just like we see in the present stone base profile. Also, maintaining the elevation of the surface is important when you are looking at the channel drain systems that are on each court. In some cases the surface is becoming lower than the channel drain. When this happens, the drainage system does not work properly and more water is left on the surface.

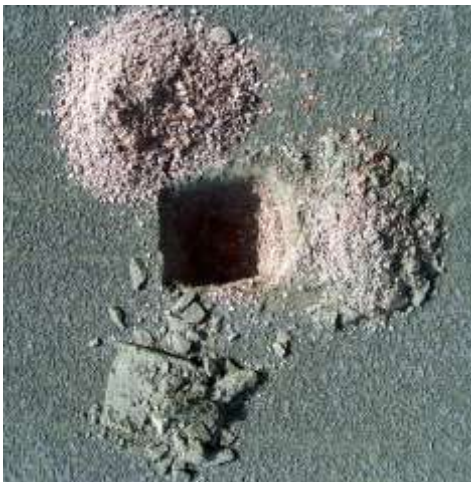
**Picture 13** Surface Thickness

Core testing was taken in strategic locations on the 24 Har-Tru tennis courts. Har-Tru surfacing thicknesses were found to be as follows.

These variations in surface thickness may affect uniform drainage and water retention, particularly in dry weather. These courts are not within ASBA specification of 1" consistent surface thickness throughout the courts.

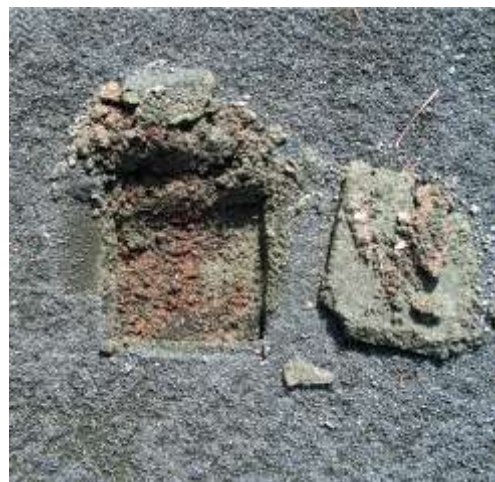
**Picture 14** Surface Thickness

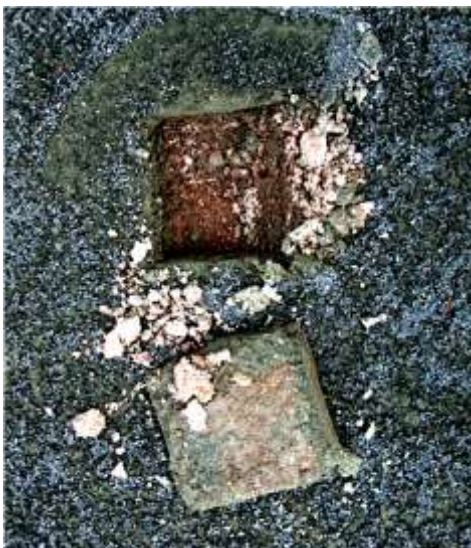
**Picture 15** Surface Thickness

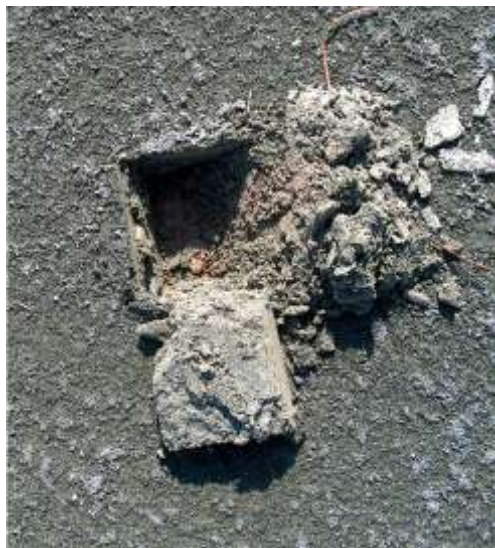
**Picture 16** Surface Thickness

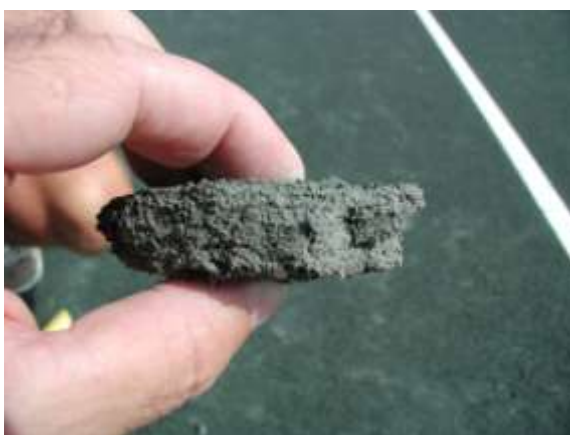
**Picture 17** shows ideal surface thickness of 1"

Chart #2 below illustrates the average surface thickness of the Har-Tru courts. As the slope changes over time so does the thickness of the Har-Tru surface. A new court is built with 1" of compacted Har-Tru.

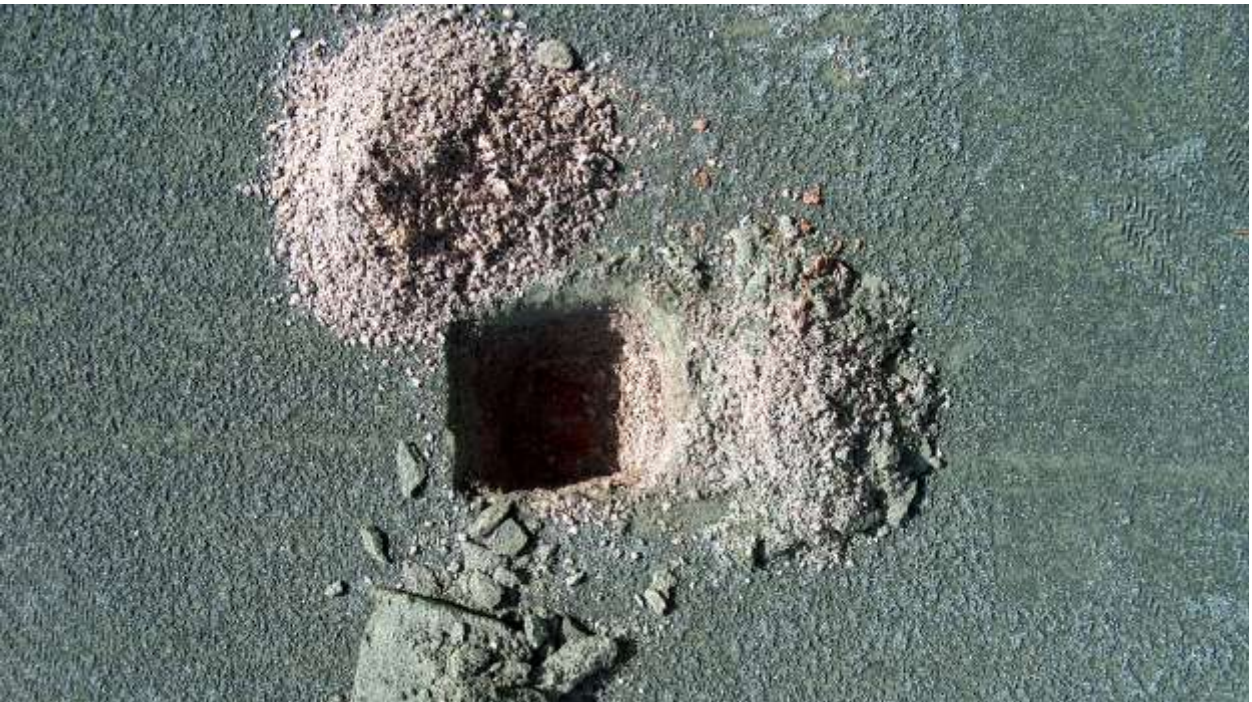
These courts have a stable and permeable base layer of 2-1/2" to 3-1/4" of Stone Screenings down to the soil.

**Picture 18** Base Material – Stone Screenings

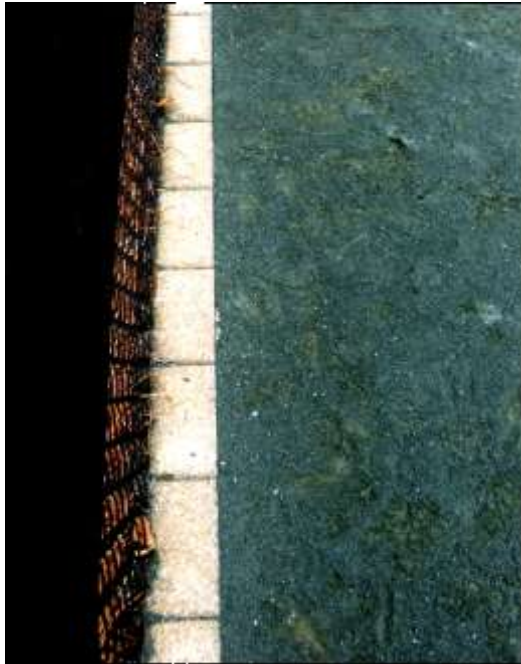
**Picture 19 Court Curbing**

Clay court curbing is designed to maintain the integrity of the court as it stabilizes both the stone base and holds the Har-Tru surface material in place.

The curbing around the 24 courts is in good shape, holding the integrity of the courts in place and very consistent. No loose or displaced curbing observed during site visit.

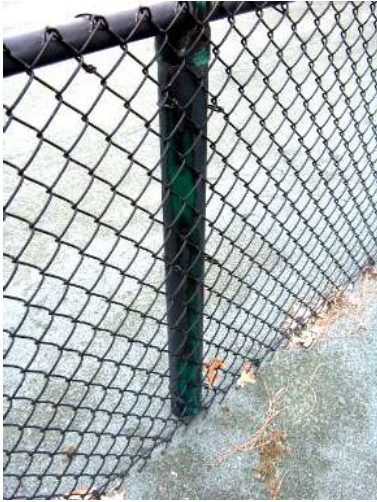
**Picture 22** Fencing

The fencing around the 12 batteries of tennis courts is in good structural condition. All gates open and close correctly. The fence looks good ascetically except for a few places where the fence posts will need to be re-painted.

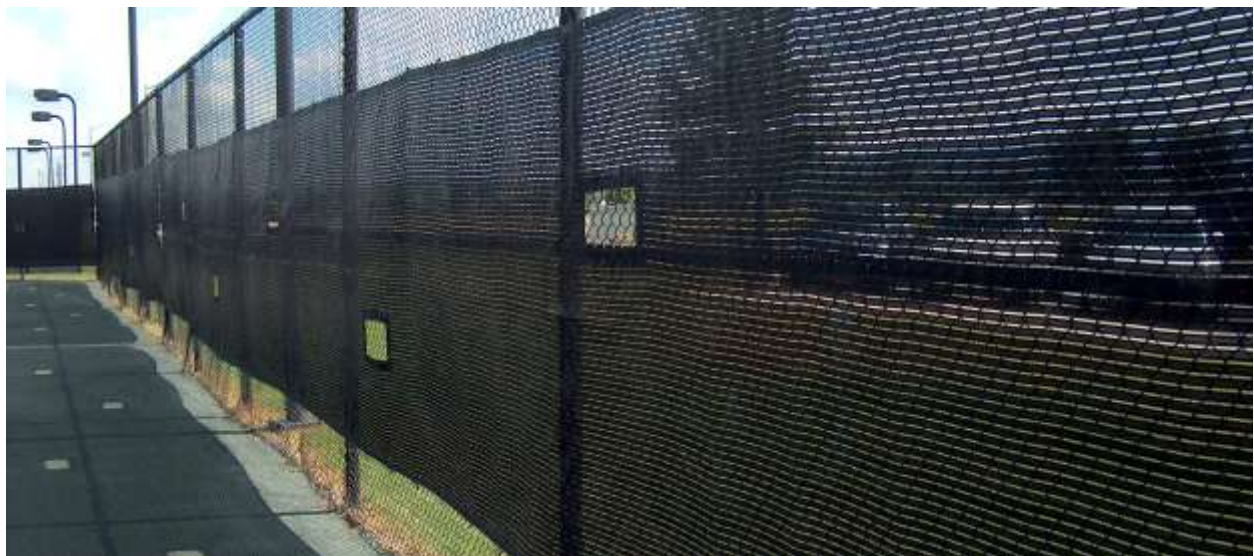
**Picture 24** Wind Screen

The Windscreen around the 12 batteries of courts is in good condition with no holes or faded areas.

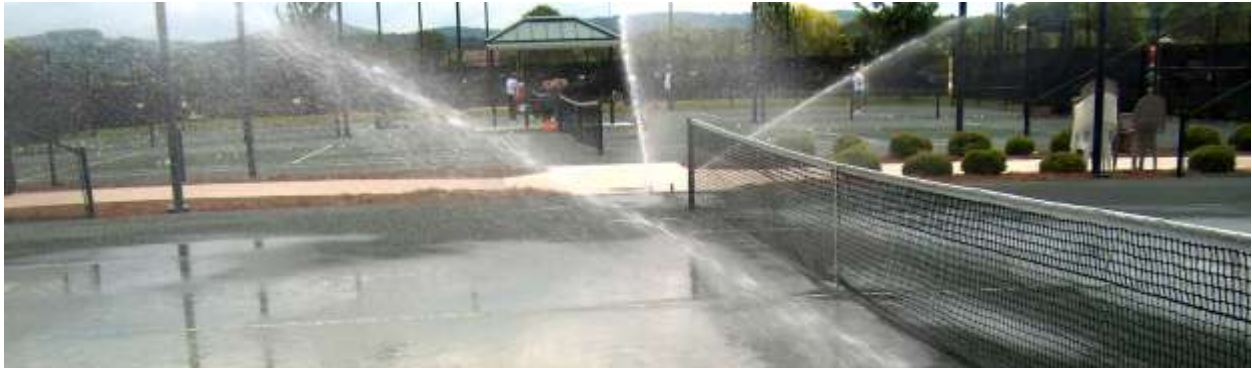
**Picture 25** Sprinklers

The court's irrigation system is made up of 8 heads per court. All of the heads are Rainbird #6504 Falcon sprinkler heads. The sprinklers were observed while the system was turned on. The sprinklers are providing approximately 65-70% head to head coverage. The sprinkler system seems to be delivering consistent water coverage. Water Pressure is said to be 60-65 psi.

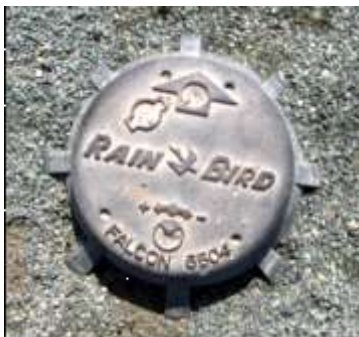
**Picture 26** Rainbird 6504 Falcon

- 1" (26/34) female NPT or BSP threaded inlet
- SAM check device holds up to 10 feet (3,1 m) of head
- Rain Curtain nozzles: 04-black; 06-light blue; 08-dark green; 10-gray; 12-beige; 14-light green; 16-dark brown; 18-dark blue
- Nozzle outlet trajectory is 25°

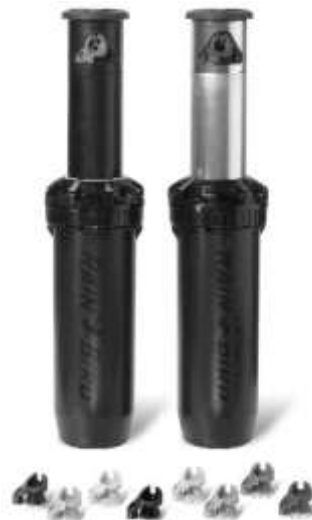
**Picture 27** Rainbird 6504 Falcon

- Precipitation Rate: 0.37 to 1.14 inches per hour (9 to 29 mm/h)
- Radius: 39 to 65 feet (11,9 to 19,8 m)
- Pressure - 30 to 90 psi (2,1 to 6,2 Bars)
- Flow: 2.9 to 21.7 GPM (0,66 to 4,93 m3/h; 0,18 to 1,37 l/s)

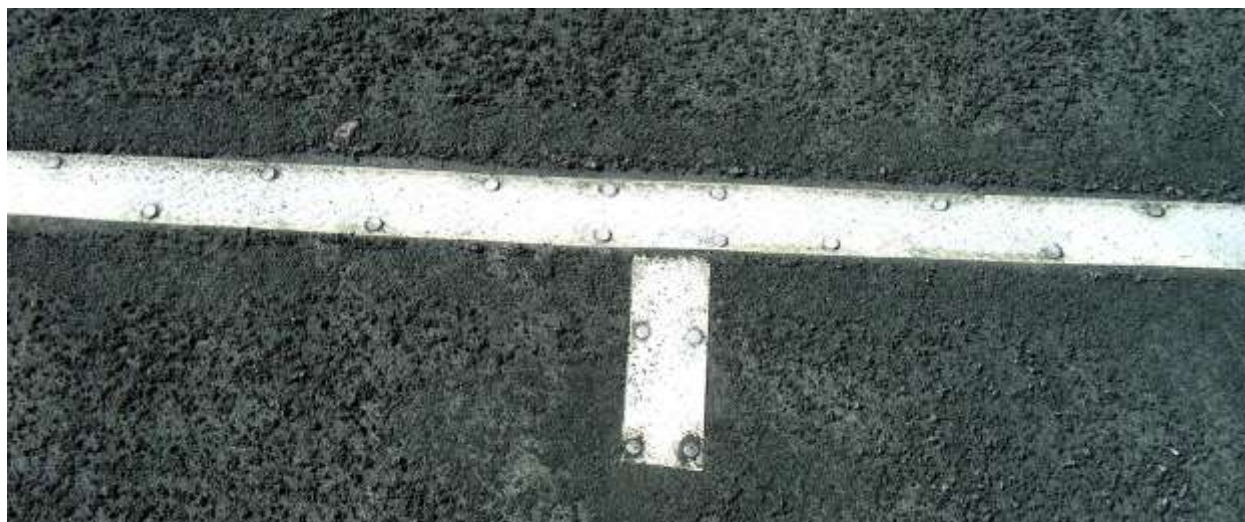
**Picture 28** Court Lines

The Court Lines on the 24 tennis courts are Herringbone punched. Some of the Court Lines are worn, especially on the base lines. Some of the edges have started to curl up which could be a tripping hazard. The facility does not replace Court Lines each year.

Court lines that have worn smooth with no pattern can become slippery.

Tapes should be removed each year prior to top-dressing and then replaced after top-dressing has occurred. This practice will ensure that the surface material does not build up around the court lines.

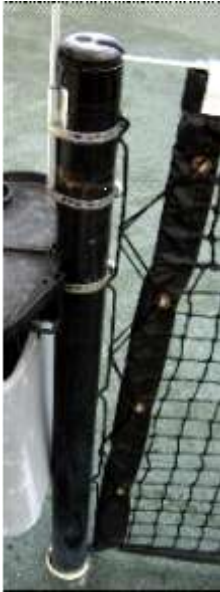
**Picture 29** Net Post

The Net Posts on all 24 courts are holding consistent net tension and seem to be structurally good. Some of the posts need to be re-painted.

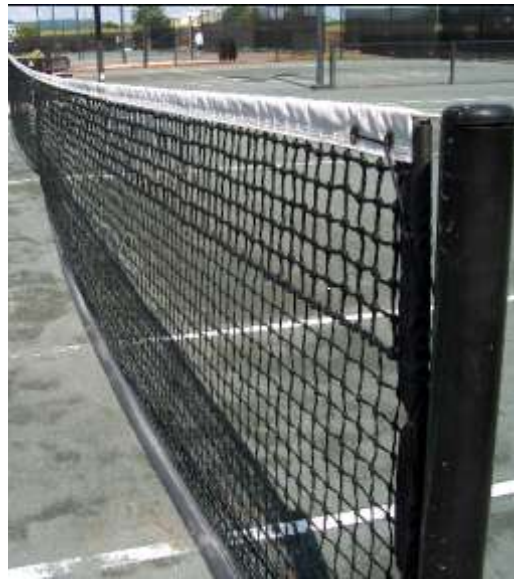
**Picture 31** Net

The nets on all 24 tennis courts are in good condition with no holes or frayed areas. There are a couple of nets that have head bands which are slightly mildewed.

Note: Please reference the Har-Tru Maintenance Manual for tips on how to attach nets to net posts.

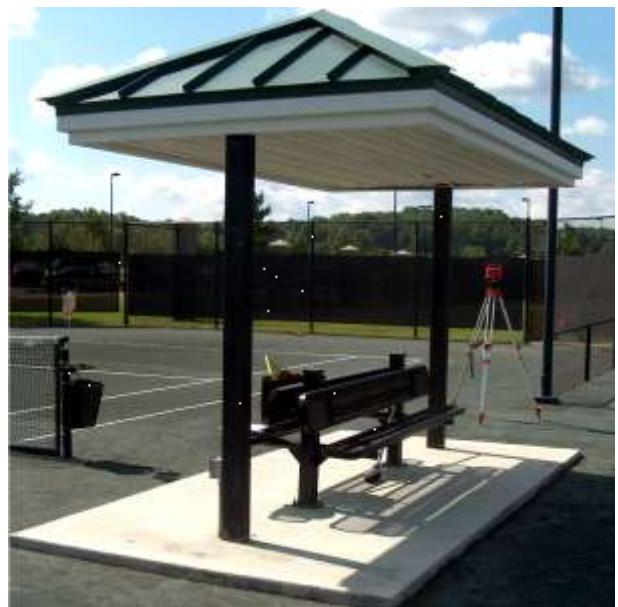
**Picture 33** Court Seating / Shade Shelter

The courts have metal seating under Shade Shelters on each battery of courts. The Shade Shelters and seating are in good condition and structurally good.

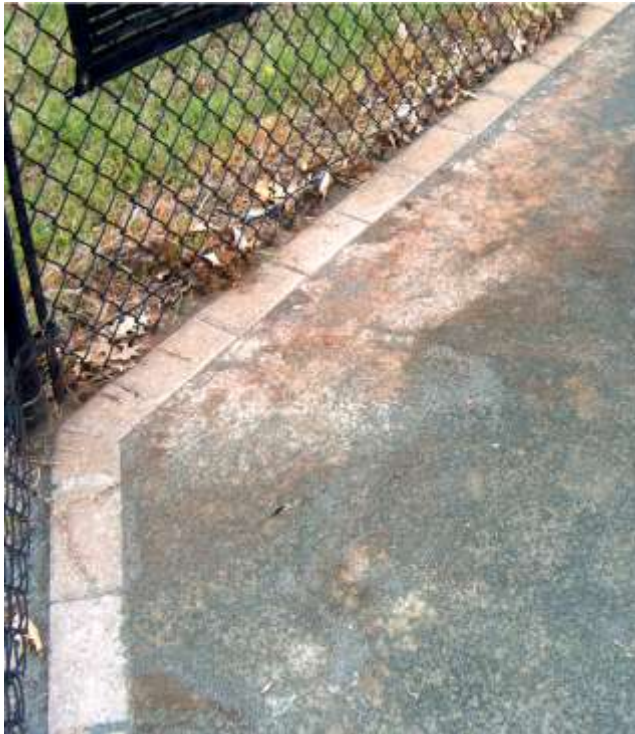
**Picture 34** Algae growth

The tennis courts have very little or no weeds, algae or moss growth in the playing area on the tennis courts. Good maintenance practices have kept these growths to a minimum. However there are some algae & moss growing around the perimeter of a few courts. Surface Agitation is the best solution for algae & moss growths. See the Har-Tru Maintenance Manual for weed control recommendations.

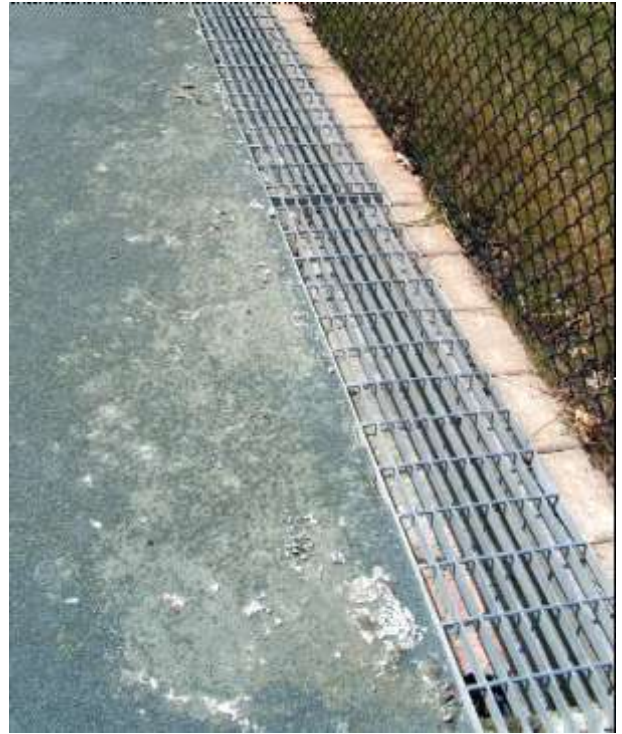
**Picture 35** Algae growth

**Did you know**, When algae problems occur on your clay courts, you can spread the contamination by not discarding the contaminate surface? Spreading the contaminated surface just spreads the problem!

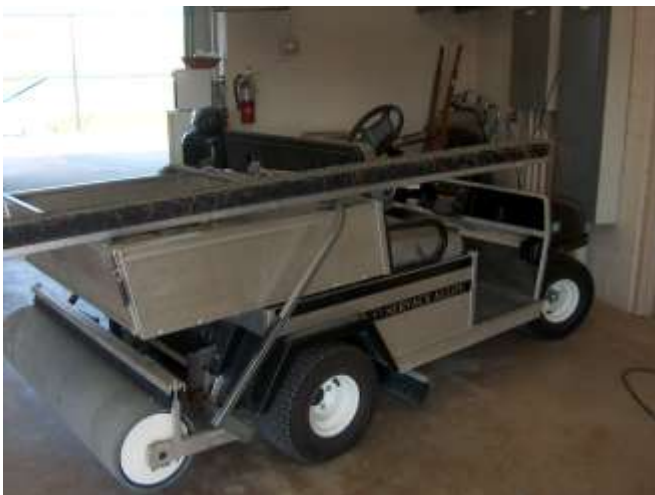
**Picture 38** ServAce

| <b>Item</b> | <b>How many</b> |
|---|---|
| Rollers | 2 Court Pac Pro Rollers –<br>Good Condition although Throttle<br>Cables keeps breaking<br>2 Giliberti ServAces – Good<br>2 Hand Rollers - Good<br>1 Herring Roller |
