**Local Government Energy Program
Energy Audit Draft Report**

***Borough of Frenchtown
Borough Hall
29 2nd Street
Frenchtown, NJ 08825***

Project Number: LGEA61

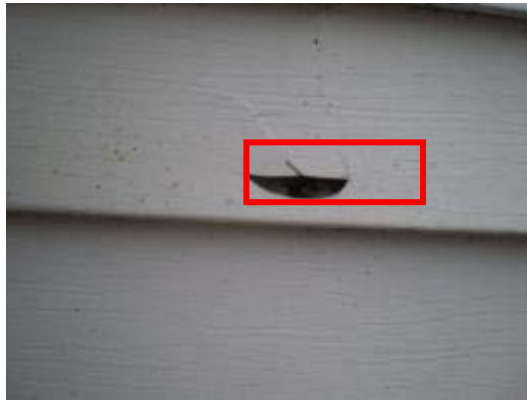
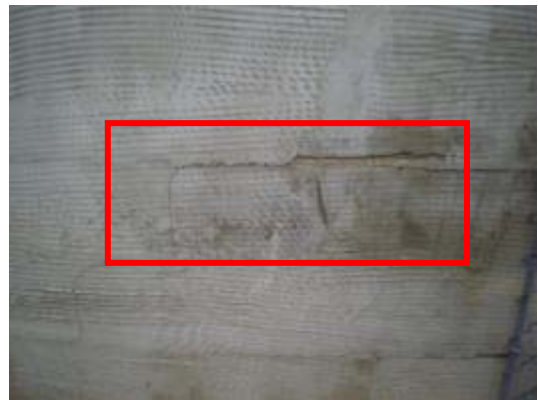
Damaged exterior wall finish with a damaged vinyl siding that exposes the interior wall to the elements and is a source of infiltration. Cracked concrete base and signs of water damage.

- Extend natural gas service from road to buildings
- Install premium motors when replacements are required
- Replace portions of damaged siding on the exterior wall
- Add insulation to under-insulated roof sections
- Openings around window air-conditioning units need airtight gaskets/sealants
- Replace all original, single-glazed windows with a low-E, double glazed type.

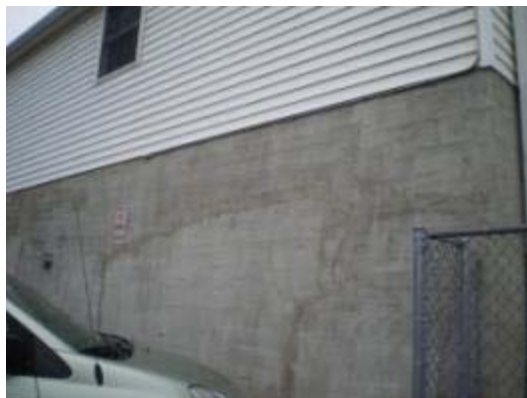
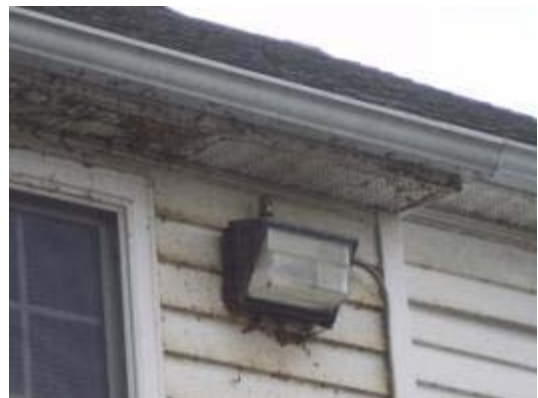
Damaged exterior walls with signs of water damage, sections with vegetation overgrowth and insect infestation.

- Maintain roofs
- Maintain exterior walls
- Maintain downspouts and cap flashing
- Provide weather-stripping/air-sealing
- Provide water-efficient fixtures and controls
- SWA recommends that the building considers purchasing the most energy-efficient equipment
- Use smart power electric strips
- Create an energy educational program

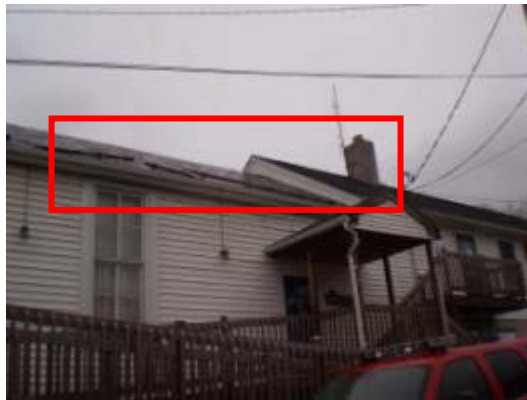
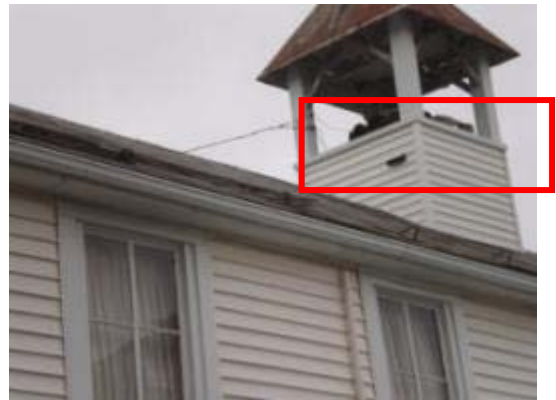
Sections of roof with damaged or displaced asphalt shingles and an improperly sealed cupola.

- Install/ repair and maintain roof flashing.
- Replace/repair and maintain damaged window units.
- Install/replace and maintain weather-stripping around all exterior doors and roof hatches.

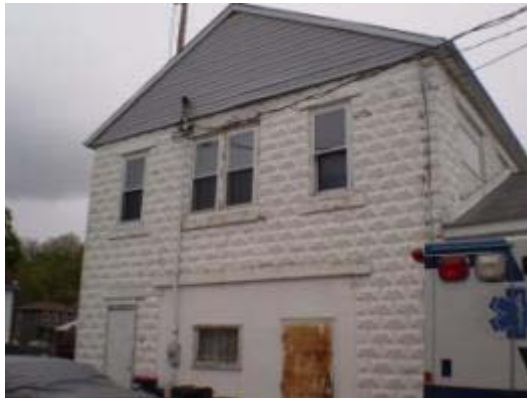
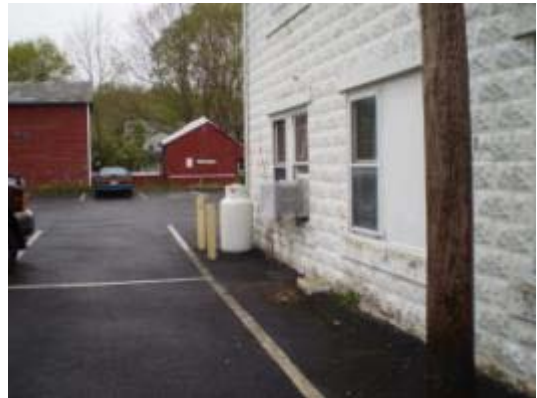
Damaged/aged window frame and air-leakage at sleeved window/wall air-conditioning units. Single-glazed window with ineffective frame

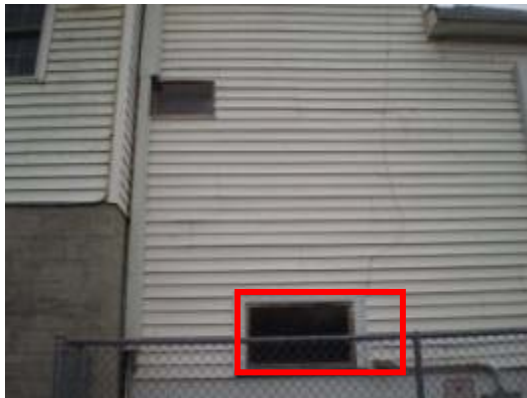
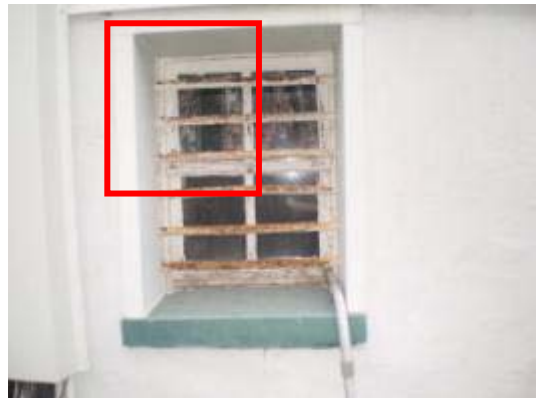
Damaged/aged window frame and single-glazed window with ineffective frame

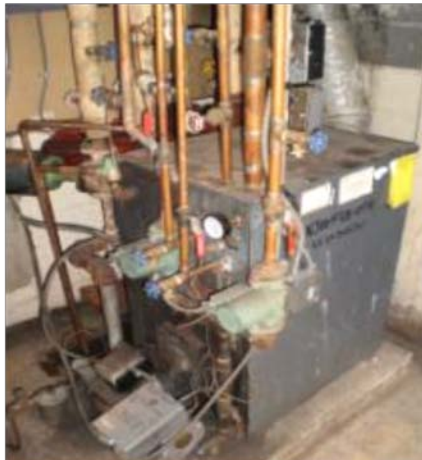
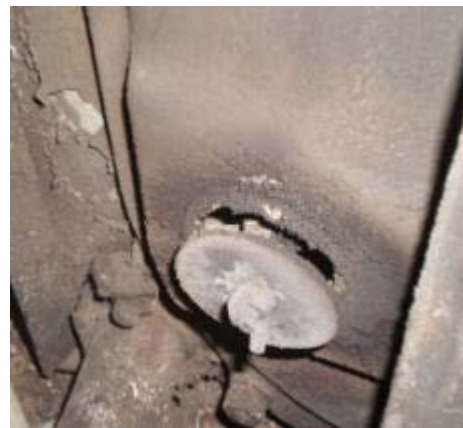
The Borough Hall building is heated primarily by a 37 year old, oil-fired boiler. This boiler is showing signs of extreme wear and should be replaced immediately. It was observed that the burner of this boiler is partially detached from the boiler, allowing gas vapors as well as heat to escape the boiler and reduce the efficiency. It was also noted by building staff that a local HVAC contractor had evaluated this boiler and determined that the inside is corroding and is falling apart from the inside out. In addition to the boiler, there are two newer, oil-fired Trane air handling units installed in the attic that provide forced air for heating as well as DX cooling. There are three Trane condensing units outside of the building that serve the two Trane air handlers. The garage area is served by one Modine unit heater that is connected to a hot water loop.

Weil-McLain boiler (L); Burner dislodge from boiler (R)

ECM#9: Borough Hall/Fire Department – Replace oil-fired boilers with gas-fired units

On the day of the site visit, SWA completed a mechanical inventory of the Borough of Frenchtown Borough Hall and Fire Department (see Appendix B). Both buildings relied on inefficient, oil-fired boilers to meet their primary heating needs. Each boiler was observed to be at the end of its useful life cycle and should be replaced with newer, more efficient units. Recently, natural gas service has been extended through the Town and is available to both buildings. This will first require that the Borough of Frenchtown contact the natural gas supplier and have lines extended onto the property and a gas meter installed at each building.

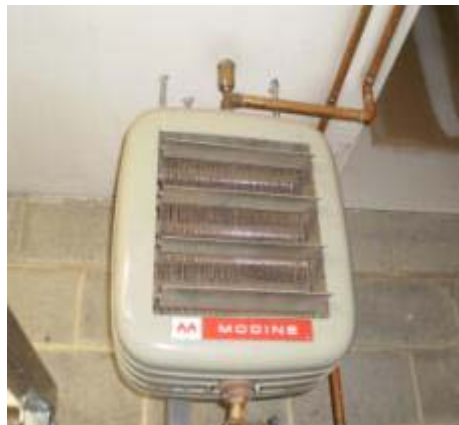
Modine unit heater in Garage

On the day of the site visit, SWA observed that the Modine unit heater and all hot water baseboards located at the Borough Hall building are all controlled with 5 non-programmable thermostats. SWA recommends retro-fitting the building with 5 programmable thermostats that can reduce setpoint temperatures at night when the building is not being used. SWA recommends that programmable thermostats with a manual override are installed. The manual override option would allow any employees that needed to work outside of typical hours to override the automatic programming and would allow them to adjust the setpoint for a period of 2 hours. Once the building is well-sealed, the thermostat temperature should also be lowered to a reasonable temperature such as 70°F.

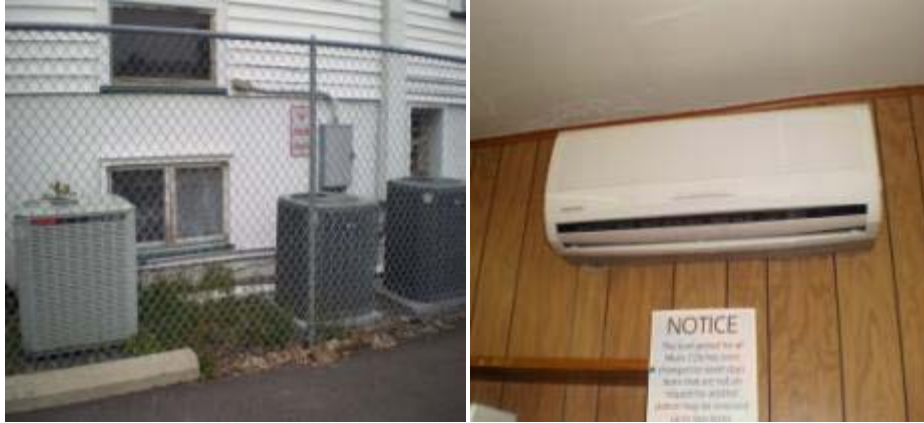
In addition to the Trane air handling units that provide central cooling to the Borough Hall offices and meeting area, there are two Samsung split air conditioning units for the Library space. These units each have an 11,500 Btuh cooling capacity and a SEER value of 10.0. The Library area also contains one GE with 11,000 Btuh cooling capacity and an EER value of 9.0.

View of (3) Trane condensers (L); Typical Samsung evaporative unit in Library (R)

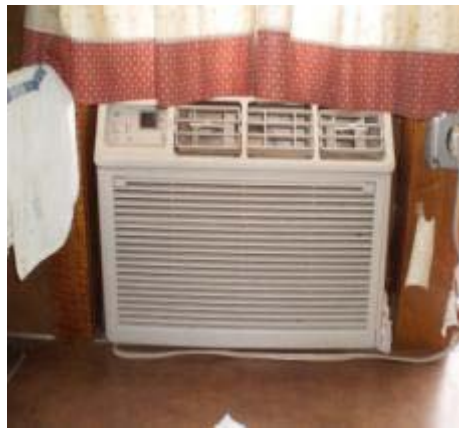
GE window AC unit in Library

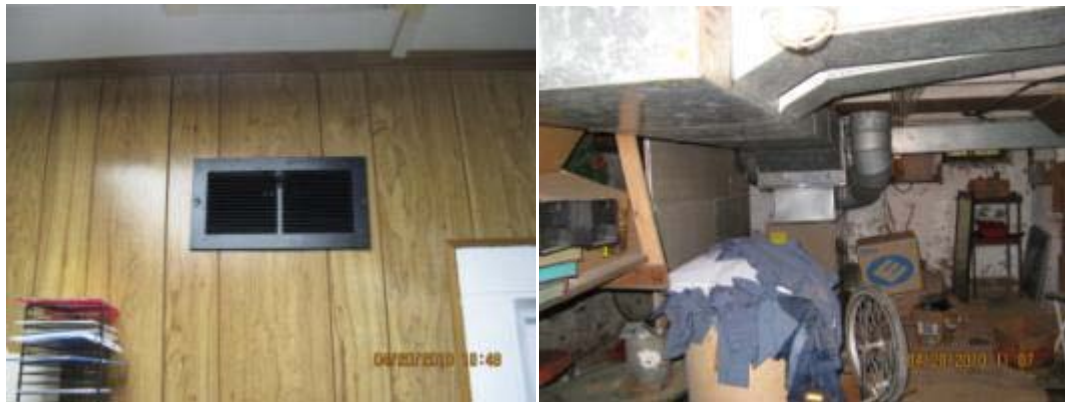
The Weil-McLain boiler provides hot water heating via piping and baseboards throughout the entire building. One area of concern is at the staging area inside of the meeting room. This staging area is built out of a platform that was added to the space in order to elevate the front area to stage a desk. This platform was built in a way that the baseboard heaters in the front of the room are obstructed. This obstruction prevents the front perimeter area from being heated properly and can cause comfort complaints. Conditioned air is served by the Trane air handling units and is distributed through a network of ducts and diffusers. They are embedded into the floors and walls of the building, but most diffusers are found in the walls near ceiling height. Hot water is distributed by insulated copper piping.

Examples of typical diffuser and distribution system in the basement

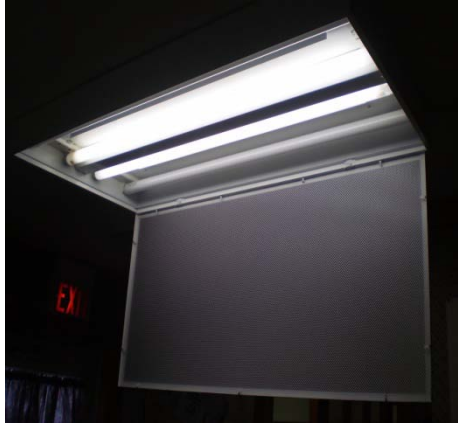
Interior Lighting - The Borough Hall currently contains mostly inefficient T12 fixtures, and incandescent fixtures. Based on measurements of lighting levels for each space, there are no vastly over-illuminated areas. All lighting is controlled by manual switches.

Typical Ceiling Mounted Fixture with T12 Magnetically Ballasted Bulbs

On the day of the site visit, SWA completed a lighting inventory of the Borough of Frenchtown Borough Hall (see Appendix B). The existing lighting inventory contained mostly inefficient T12 fluorescent fixtures with magnetic ballasts. SWA recommends replacing each existing fixture with more efficient, T8 fluorescent fixtures with electronic ballasts. T8 fixtures with electronic ballasts provide equivalent or better light output while reducing energy consumption by 30% when compared to a T12 fixture with magnetic ballast.
