**Local Government Energy Program  
Final Energy Audit Report**

***The Union Fire Co. & Rescue Building  
Township of Hopewell  
Titusville, NJ 08560***

***Project Number: LGEA14***

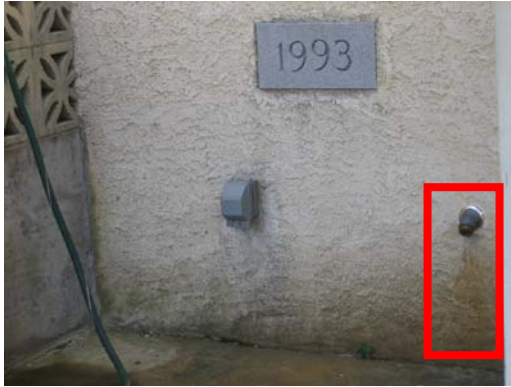
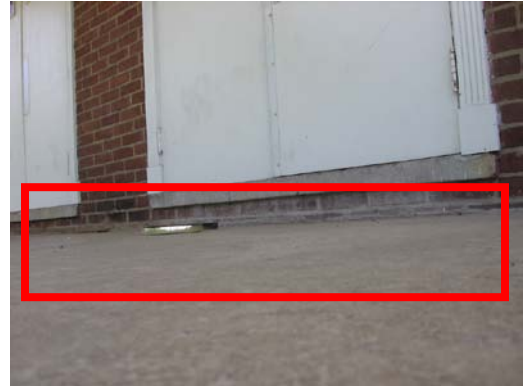
The exterior walls appear to be in good condition. SWA observed water damage near the parking lot entrance on the stucco façade and below the left side entrance. Extra maintenance and care should be taken to these exterior areas as moisture will work into the walls. The water spigot should have an end cap so water does not drip causing water damage.

- Exterior Wall Integrity - SWA observed water damage near the parking lot entrance on the stucco façade and below the left side entrance. Extra maintenance and care should be taken to these exterior areas as moisture will work into the walls. The water spigot should have an end cap so water does not drip causing water damage.

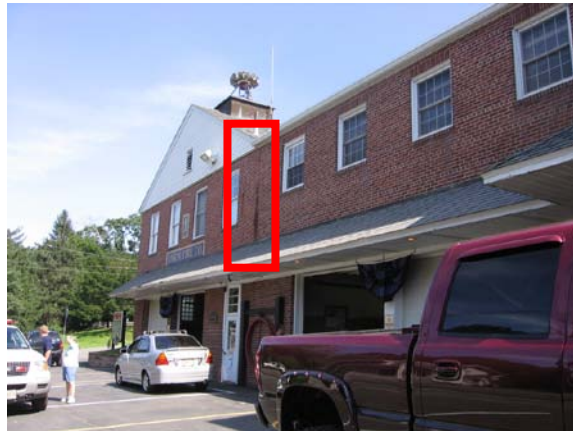
The following image shows water stains, potentially from overflowing gutters or an unsealed gutter end cap. Special attention and maintenance should be given to this area as the water could be soaked both into the exterior façade and the wall cavity.

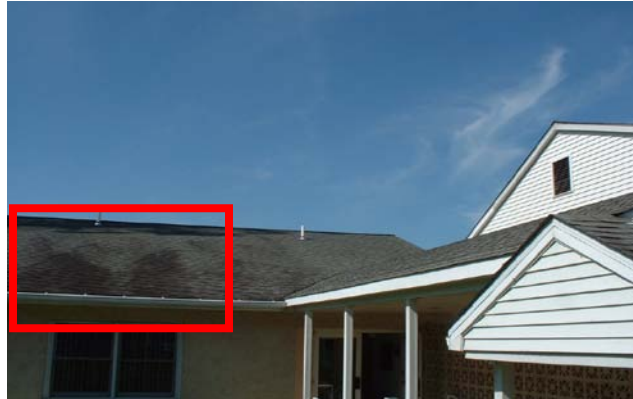
The asphalt shingle roof appeared to be in good condition, original to the 1993 renovations. The northeast roof area (shown in the image below) shows signs of moisture or mildew. Regular maintenance should track any unusual signs of leaks, interior moisture or mold in the attic below this roof area. The building appears to have proper attic ventilation as there weren't any signs of moisture or mildew on the ceiling. Insulation could not be verified above the garage bays. Due to warm temperature conditions at the time of the field visits, insulation levels could not be verified with help of infrared technology. If desired, the building could contract a separate envelope inspection during cooler months.

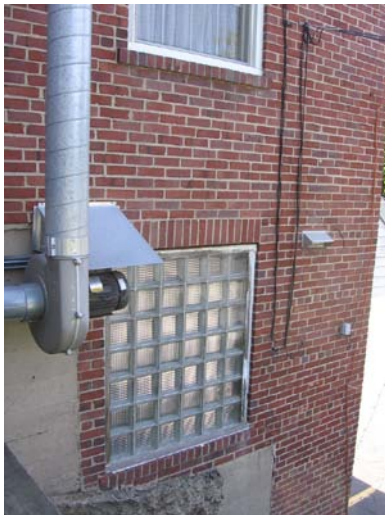
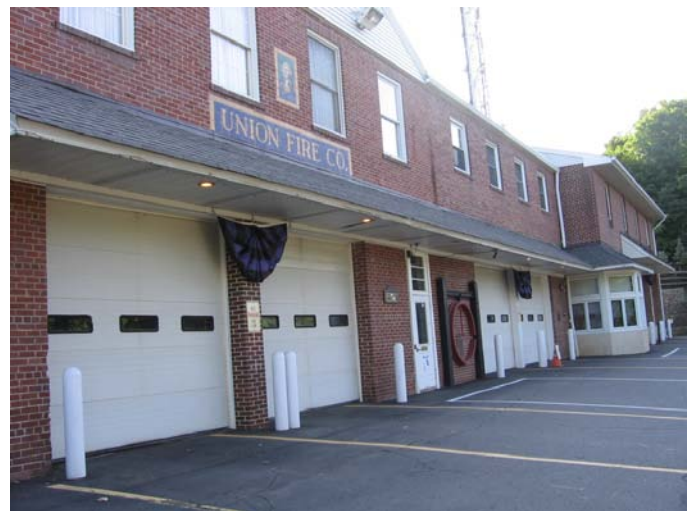
The building contains double pane, double hung vinyl windows. The windows appeared to be in age-appropriate condition. SWA recommends regular maintenance on the windows verifying the seals are in good condition and caulking around the frame is performed. When replacement is warranted, SWA recommends Energy Star rated low-e windows as replacements.

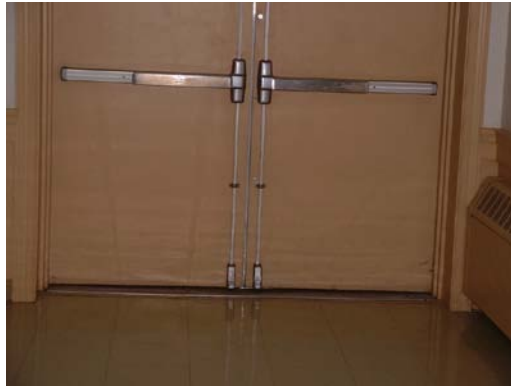
The aluminum framed exterior doors were observed to be in good condition except for some missing or worn weather-stripping. SWA recommends that all exterior doors of the office area be weather-stripped in order to decrease the amount of conditioned air that is lost around each door. SWA also recommends checking the weather-stripping of each door on a regular basis and replacing any broken seals immediately. Tight seals around the doors will help ensure that the building is kept continuously tight and insulated; this includes the overhead doors in the truck/ garage bays.

- Weather Stripping / Air Sealing - SWA observed that exterior door weather-stripping in places was beginning to deteriorate. Doors and vestibules should be observed annually for deficient weather-stripping and replaced as needed. The perimeter of all window frames should also be regularly inspected and any missing or deteriorated caulking should be re-caulked to provide an unbroken seal around the window frames. Any other accessible gaps or penetrations in the thermal envelope penetrations should also be sealed with caulk or spray foam.
