**Local Government Energy Program
Energy Audit Report**

***Denville Township
Denville Municipal Complex
1 Saint Mary's Place
Denville, NJ 07834***

Project Number: LGEA08

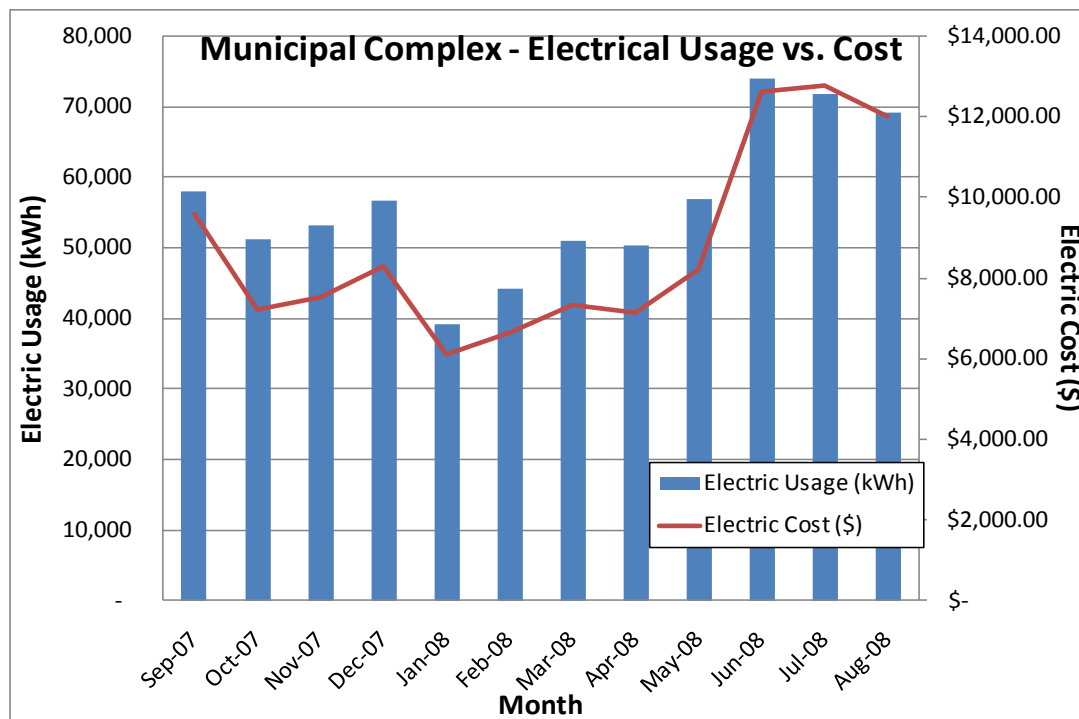
The following chart shows electricity use versus cost for the Municipal Complex building based on utility bills for the 12 month period of September 2007 to September 2008.

Electricity use follows a trend as expected; peaking during the summer months when air conditioning units are used most and decreases during the winter. The cost of electricity fluctuates as expected with usage.

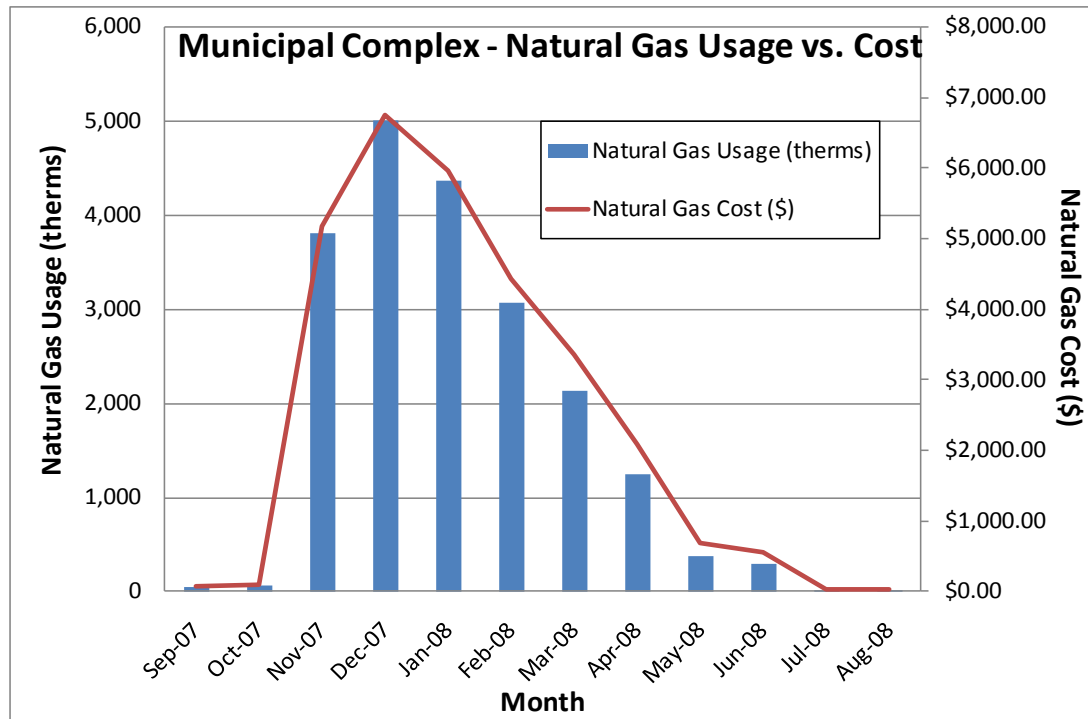
The following is a chart of the natural gas annual load profile for the building versus natural gas costs, peaking in the coldest months of the year and a chart showing natural gas consumption following the “heating degree days” curve.

In the above chart, the natural gas use follows a heating trend as expected. During the summer it is clear that the natural gas use is very minimal which reflects that heat is not being used and the domestic hot water (DHW) load is minimal.

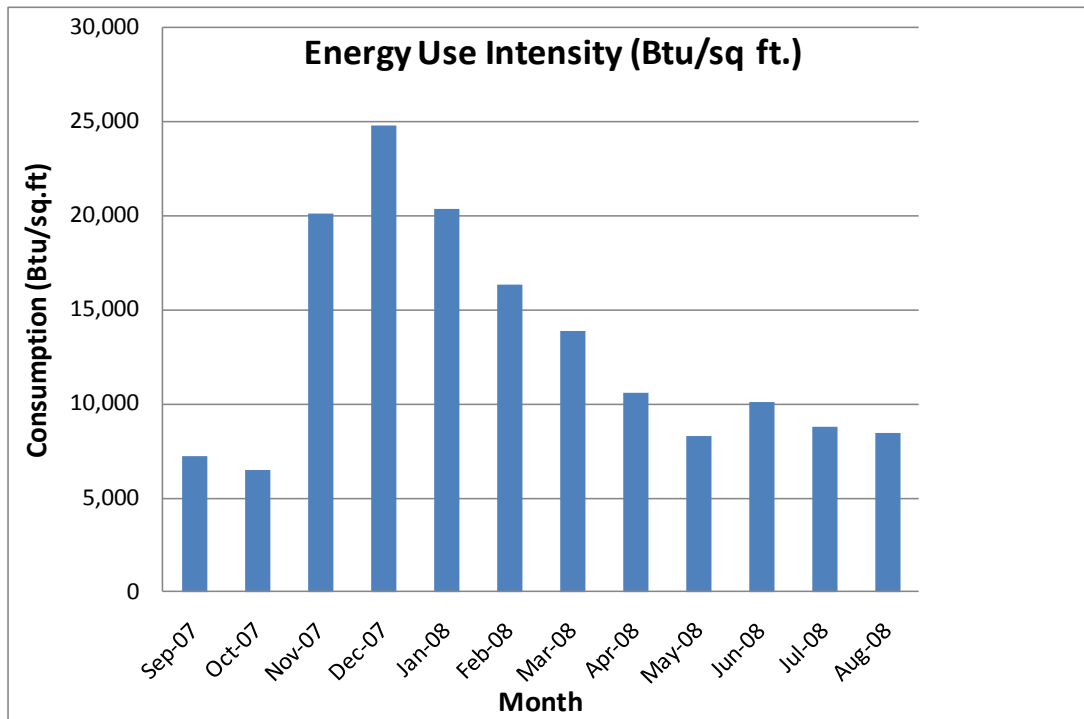
The following chart shows combined natural gas and electric consumption in Btu/sq ft for the Municipal Complex building based on utility bills for the 12 month period of September 2007 to September 2008.

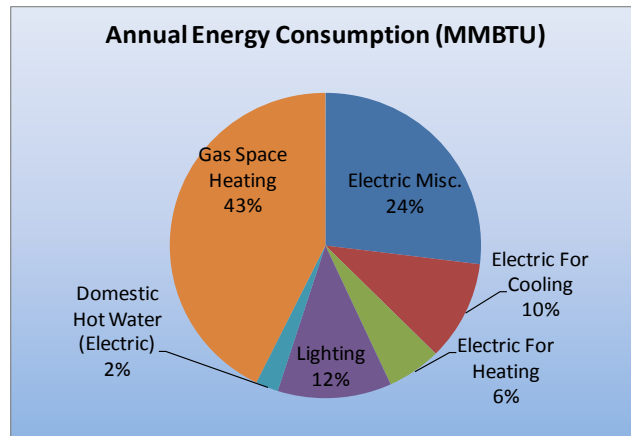
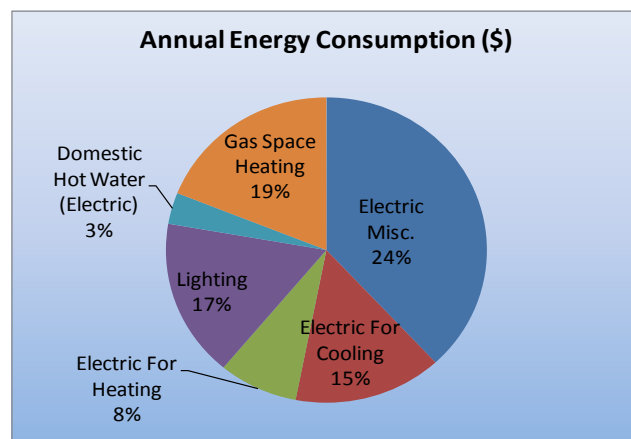
The following table and chart pies show energy use for the Municipal Complex building based on utility bills for the 12 month period of September 2007 to September 2008. The Annual Energy Consumption chart includes energy usage associated with the Police Department since it is not separately metered from the Municipal Complex. Note electrical cost at \$45.7/MMBtu of energy is more than 3 times as expensive to use as natural gas at \$14.3/MMBtu.

2008 Annual Energy Consumption / Costs					
	MMBtu	% MMBtu	\$	% \$	\$/MMBtu
Electric Miscellaneous	1172	27%	\$53,560	44%	45.7
Electric For Cooling	458	11%	\$20,931	17%	45.7
Electric For Heating	245	6%	\$11,197	13%	45.7
Lighting	514	12%	\$23,490	6%	45.7
Domestic Hot Water (Electric)	102	2%	\$4,661	2%	45.7
Gas Space Heating	1856	43%	\$26,541	18%	14.3
Totals	4,347	100%	\$140,380	100%	-
Total Electric Usage	2305	53%	\$105,430	78%	45.7
Total Gas Usage	2042	47%	\$29,260	22%	14.3
Totals	4,347	100%	\$134,690	100%	-

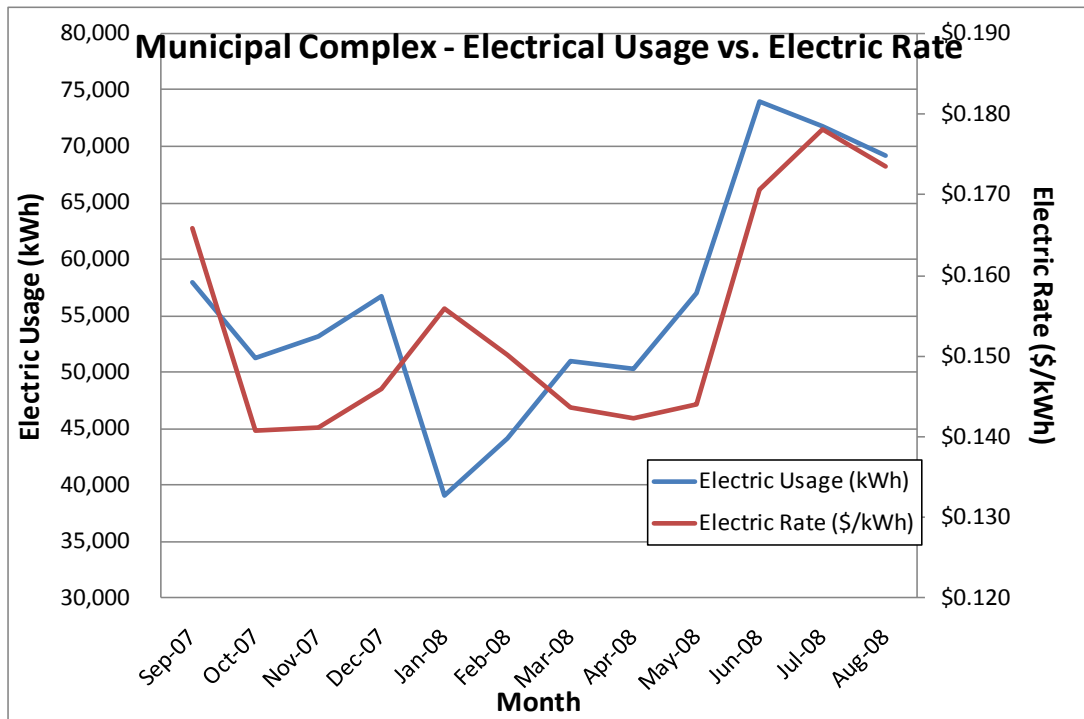
The Municipal Complex building currently purchases electricity from JCP&L at a general service market rate for electricity use (kWh) including a separate (kW) demand charge that is factored into each monthly bill. The Municipal Complex building currently pays an average rate of approximately \$0.156/kWh based on the 12 months of utility bills of September 2007 to September 2008. Demand prices are reflected in the utility bills and can be verified by observing the price fluctuations throughout the year. The electric rate does not show large fluctuations throughout the year and therefore appears to be the appropriate rate for the building.

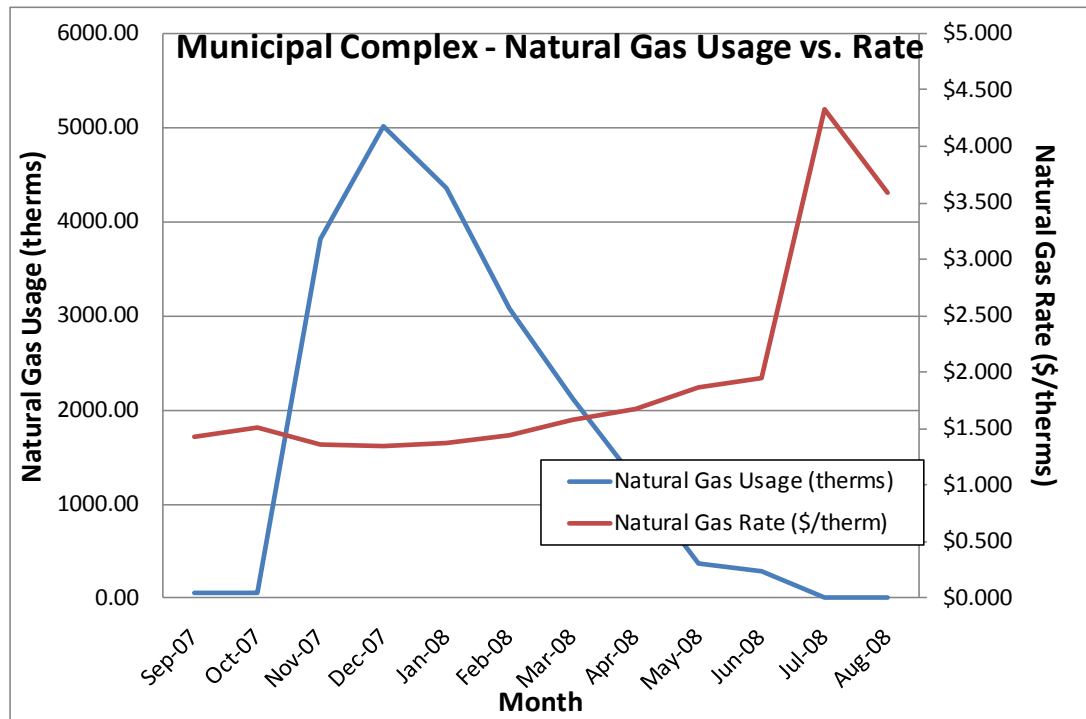
The Municipal Complex building currently purchases natural gas supply from the NJNG at a general service market rate for natural gas (therms). There is one gas meter that provides natural gas service to the Municipal Complex building currently. The average aggregated rate (supply and transport) for the meter is approximately \$1.43/therm based on 12 months of utility bills for September 2007 to September 2008. The suppliers' general service rate for natural gas charges a market-rate price based on use and the Municipal Complex billing does not breakdown demand costs for all periods. Demand prices are reflected in the utility bills and can be verified by observing the price fluctuations throughout the year. Typically, the natural gas prices increase during the heating months when natural gas is used by the hot water boilers. The high gas price per therm fluctuations in the summer may be due to high energy costs that occurred in 2008 and low use caps for the non-heating months. Thus the building pays for fixed costs such as meter reading charges during the summer months.

Some of the minor unusual utility fluctuations that showed up for a couple of months on the utility bills may be due to adjustments between estimated and actual meter readings.

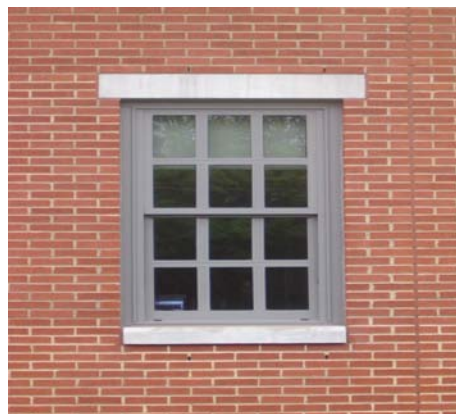
Typical Window installation

The existing windows of the Municipal Complex building are aluminum frame units with dual glazing. These windows were purchased for the building since they were high performance-rated windows. These windows are equipped with a thermal break that is supposed to prevent heat transfer across the frame of the window. Interviews with Municipal staff and the Facilities manager indicate that the windows have not been performing as expected. Due to seasonal conditions at the time of the site visit, SWA could not review the reported comfort concerns directly. Measurements taken by the

facilities manager when the outside temperature was below 30°F have found that the window glass is consistently 10°F warmer than outside air temperature. Similarly, measurements of the aluminum frame temperature have also been found to be lower than expected.

SWA has reviewed the specifications for the installed windows and they appear to have a thermal break. SWA recommends contacting the manufacturer in order to determine if deficient windows have been installed. If it is determined that the window does include a thermal break, the window installer should be contacted to review potential installation issues. SWA was not able to identify a thermal break in the window based on visual inspection. There may be repairs that can be addressed under the installation warranty.

Installation of new windows would not be economically viable. There are interior and exterior retrofit strategies that may provide increased comfort for building occupants. IN areas with the greatest comfort complaints, one alternative may be the installation of an interior storm window system. In some cases, these systems have been found to reduce drafts and minimize radiation from cold surfaces. Although there may be a minimal amount of energy savings, it is difficult to verify the rate energy performance of site-built assemblies. As a result, interior storm windows will address comfort concerns and not necessarily energy concerns. Selection of the appropriate alternative should be made with consideration to comfort, durability, window functionality and aesthetics.

As a best practice, SWA recommends that all windows be inspected at least once a year. Any gaps, cracks, or damage to weather-stripping or caulking should be repaired or replaced, as needed, to minimize energy loss around those openings. Building staff should also verify that windows open and close properly and repair, as needed.

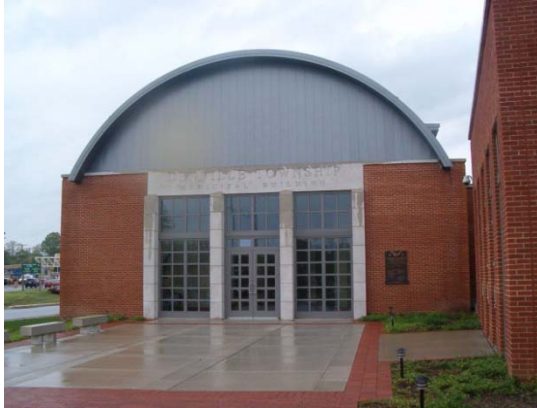
The exterior doors are insulated metal with double-glazed glass panes. The exterior doors are in excellent condition and virtually all of the weather-stripping is still intact. If not properly maintained, exterior doors can become major sources of heat loss and infiltration. As a best practice, SWA recommends checking the weather-stripping of each door on a regular basis and replacing any broken seals immediately. This will help optimize comfort and energy performance.
