**Local Government Energy Program  
Energy Audit Report**

**Washington Township Public School District  
Grenloch Terrace Early Childhood Center  
251 Woodbury-Turnersville Rd  
Sewell, NJ 08080**

**Project Number: LGEA95**

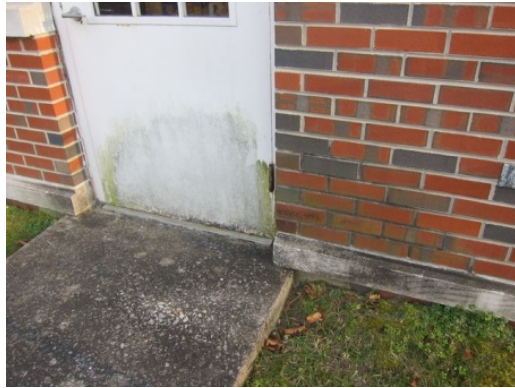
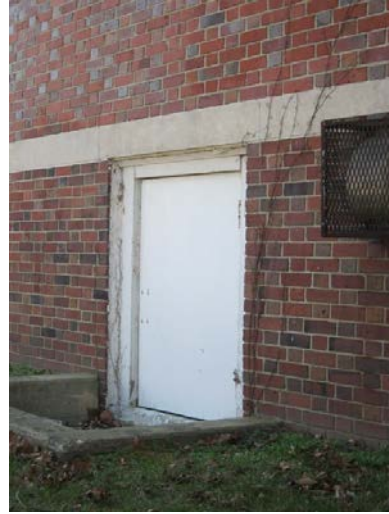
*Signs of moisture in the brick façade and ground vegetation growing on wall (moisture in the wall)*

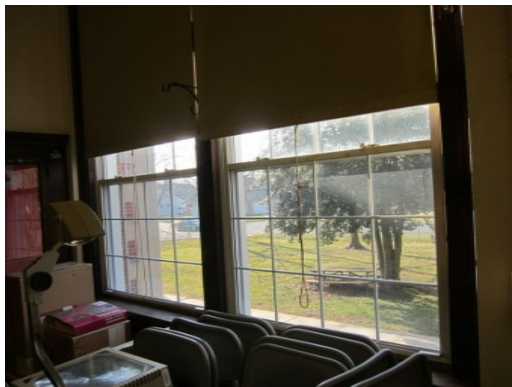
*Typical single-hung type windows with clear double glazing and a non-insulated frame. Note: the green light on the low-E detector indicates clear glazing. (Old Building)*

### **CI #4: Replace existing non-insulated windows with ENERGY STAR® windows, with low-E glazing and with two or more panes**

Throughout both buildings the existing windows have poor thermal properties that allow heat loss in the winter and solar heat gain in the summer. Due to the high capital costs, it is recommended that

these units are replaced based on available funds or upon failure. SWA recommends replacing the windows with ENERGY STAR® certified models, which would provide better insulating properties, and potentially reduce cooling and heating loads.

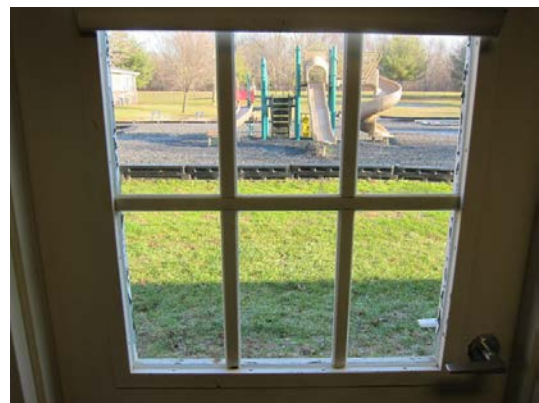
*Typical exterior doors are non-insulated aluminum with single-pane glass panels*

#### **CI #5: Replace existing non-insulated doors with fire rated insulated models, with low-E double glazing for the window panels**

Throughout both buildings the existing doors have poor thermal properties that allow heat loss in the winter and heat gain in the summer. Due to the high capital costs, it is recommended that these units are replaced based on available funds or upon failure. SWA recommends replacing the doors with better insulating properties and new weather-stripping. Better insulated doors would potentially reduce cooling and heating loads, and save energy in the long-term.

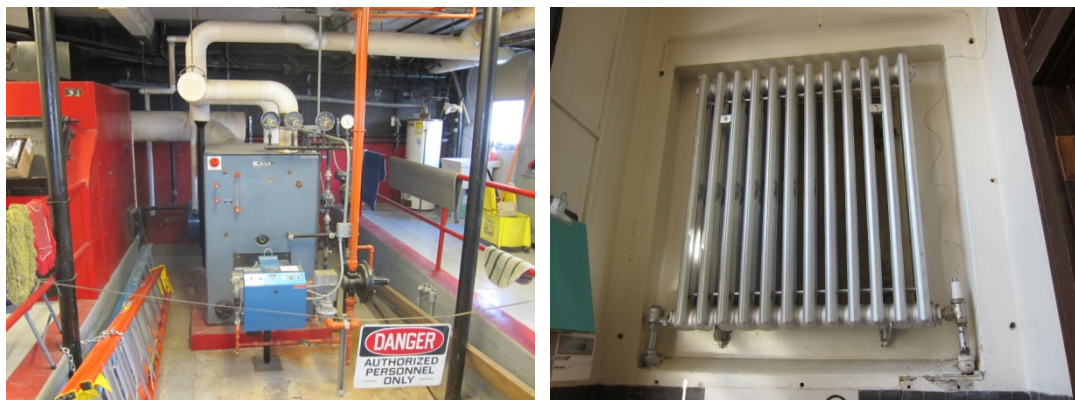
The older building consists of a two story building plus basement that is heated entirely by steam provided by a central natural gas boiler system. The single Weil-McLain boiler has a total input of 2,049 MBH and 1,632 MBH input; giving it a nominal efficiency of 79.6%. The boiler was installed in 1989 and still has approximately 8% of its useful lifetime remaining. The boiler provides steam that is sent to radiators throughout the entire building. The heating plant is not connected to the central Washington Township Building Automation System but is controlled by a local control panel with no digital interface. HVAC technicians are capable of hooking up a laptop computer and reading local setpoints. In general, when the boiler is turned on for the heating season, a outdoor temperature cutoff point of 60°F is set to allow the system to turn on and run in standby mode under the specified temperature. Steam is sent to radiators, where temperature is controlled via Thermostatic Radiator Valves (TRVs). Condensate from the steam system returns to the boiler room where it is mixed with incoming city water before being fed back into the boiler.

*Weil-McLain boiler (L); Typical Steam Radiator (R)*

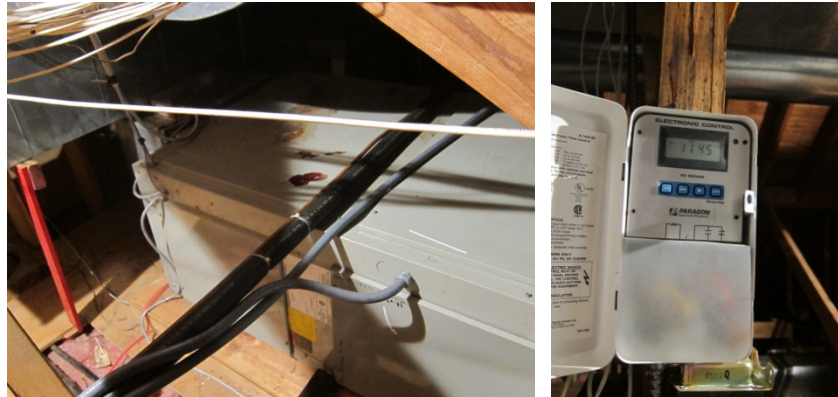
In addition to steam heating, ventilation is provided by 6 air handling units (AHU) located in the attic that each serves an individual classroom. These 6 AHUs are each connected to a condenser located on the ground in front of the building. Several small ventilation units and window AC units are located in 1<sup>st</sup> floor spaces to provide additional conditioning to small office and storage areas. Each AHU is controlled by a local manual, non-programmable thermostat. Time clocks located in the attic near the AHUs allow AHU temperatures to be controlled only during occupied hours.

*Air Handling Unit in Attic (L); Time Clock for AHU in Attic (R)*

### **CI #1: Replace 6 AHUs and condensing units in Old Building**

The old building contains 6 AHUs located in the attic that are attached to 6 condensing units to provide ventilation and cooling to the 6 main classrooms in the building. Currently, these units are operating and show no sign of failure. These units were installed in 1994 and are operating beyond their expected useful lifetime. Replacing these units will not result in a substantial energy savings opportunity.

This Capital Improvement consists of replacing both the AHUs and Condensing units. Based on failure of the equipment and available funds, this equipment may be replaced at the same time or condensing units may be replaced prior to replacement of the AHUs. Implementation costs are presented below:

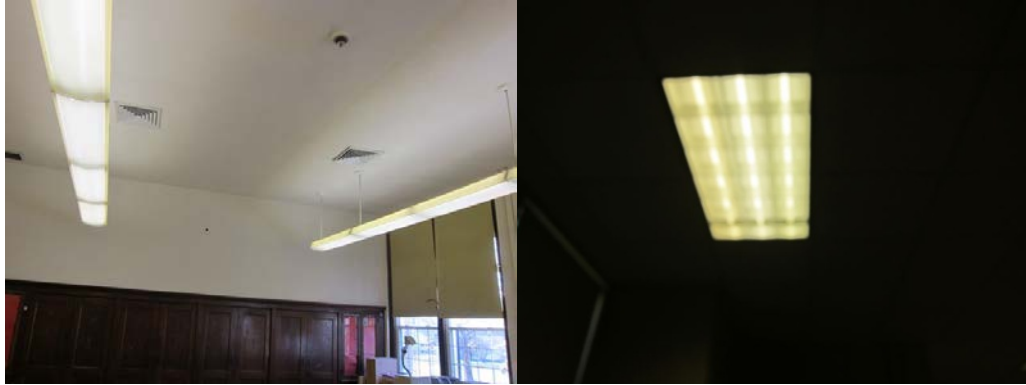
Interior Lighting - The primary interior lighting at the Washington Township Grenloch Terrace Early Childhood Center is electronically ballasted T8 lamped fixtures. Also installed are pulse start metal halides, compact fluorescent and LED fixtures on the exterior. Based on measurements of lighting levels for each space, there are no vastly over-illuminated areas.

*Typical interior T8 lighting in the old building (L.) classroom T8 lighting in the new building (R.)*

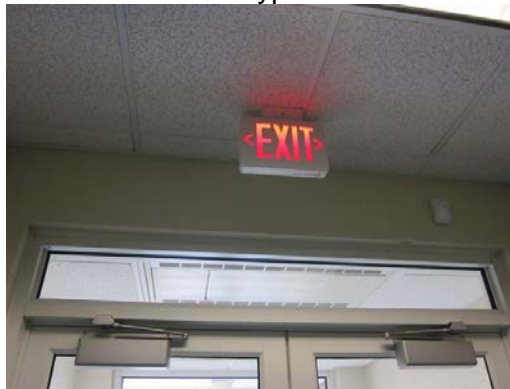
Exit Lights - Exit signs were found to be LED type

*Typical LED exit sign*

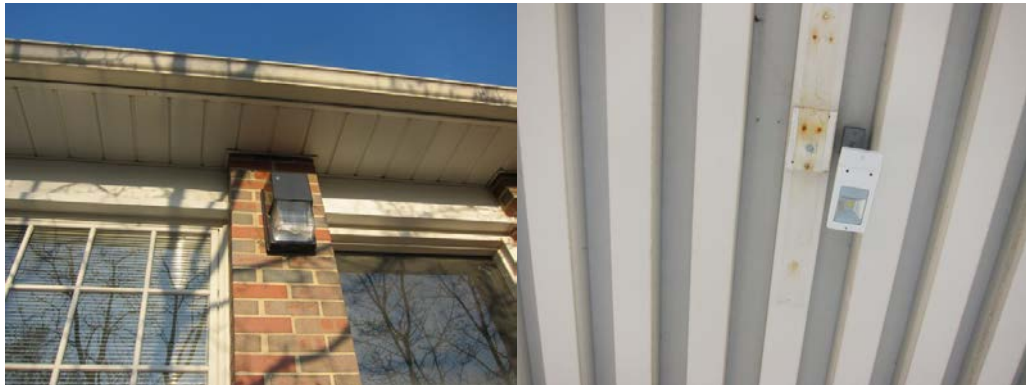
Exterior Lighting - The exterior lighting surveyed during the building audit was found to be a combination of pulse start metal halide, mercury vapor, CFL, and LED lamped fixtures. Exterior lighting is controlled by both photocells and timers.

*Typical metal halide and LED exterior fixtures*

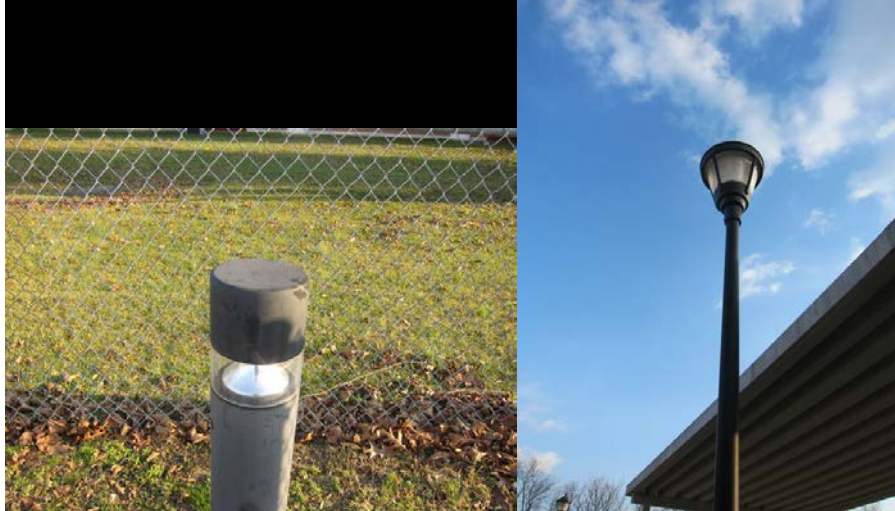
*Typical CFL bollard and pole mounted mercury vapor fixtures*

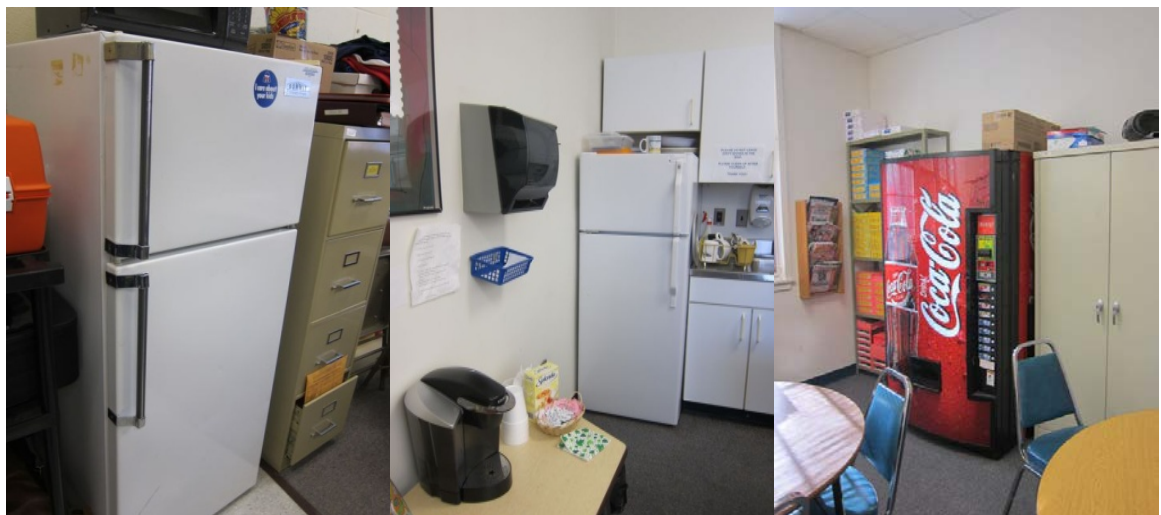
Installed at Washington Township Grenloch Terrace facility are two refrigerators, and one refrigerated vending machine.

*Typical refrigerators and vending machine*
