**Local Government Energy Program
Energy Audit Final Report**

***Livingston Board of Education Offices
Livingston, NJ 07039***

Project Number: LGEA37

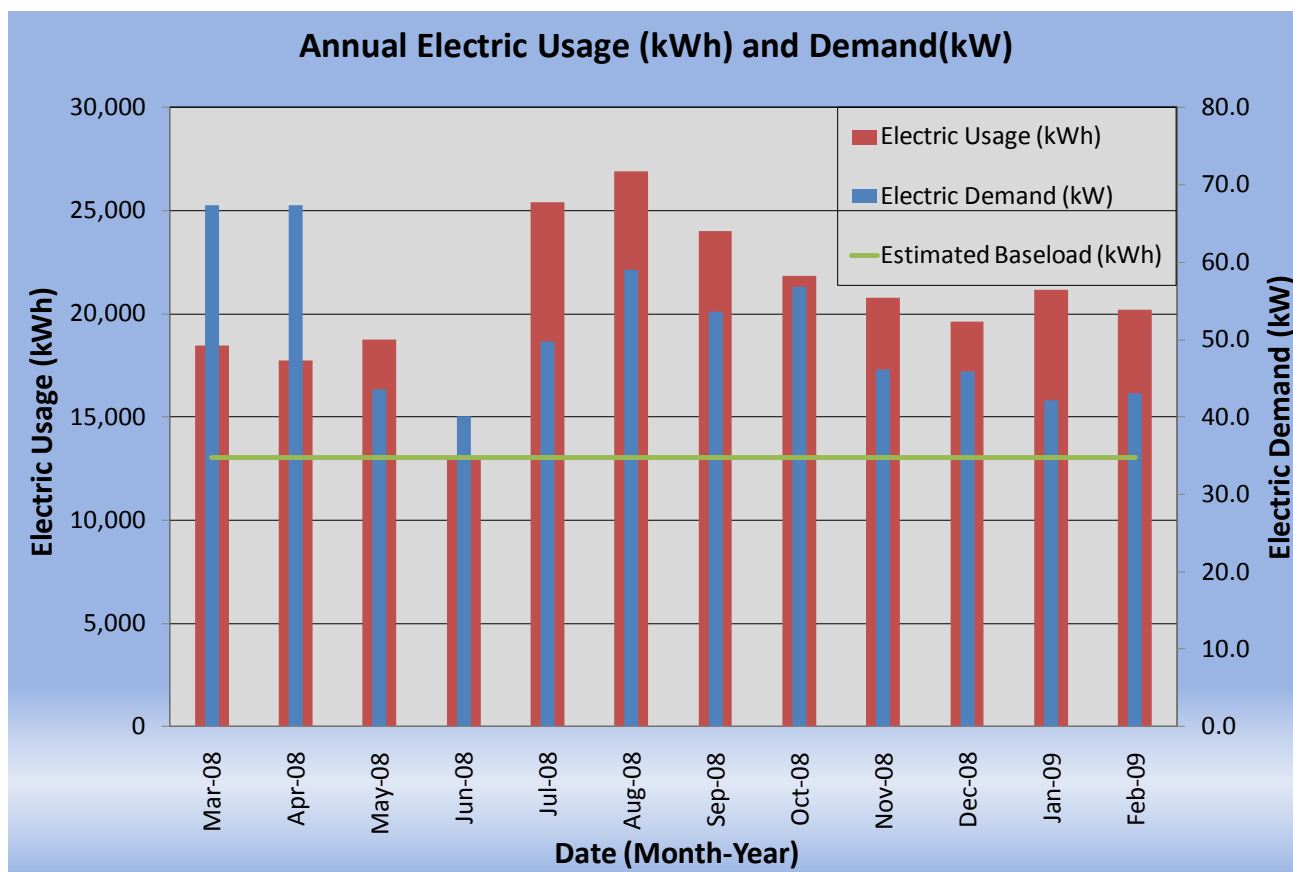
The following chart shows electricity use for the Livingston Board of Education Office building based on utility bills for the 12 month period of March 2008 to February 2009.

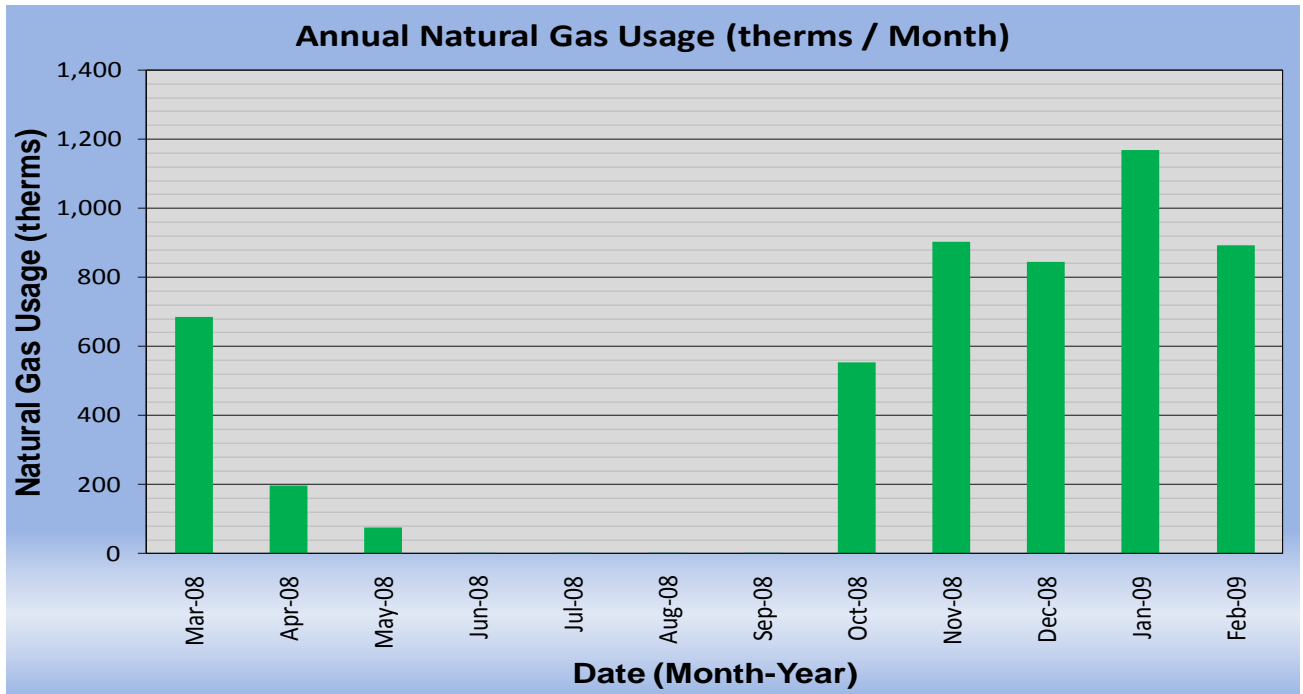
The following chart shows the natural gas consumption for the Livingston Board of Education Office building based on natural gas bills for the 12 month period of March 2008 to February 2009.

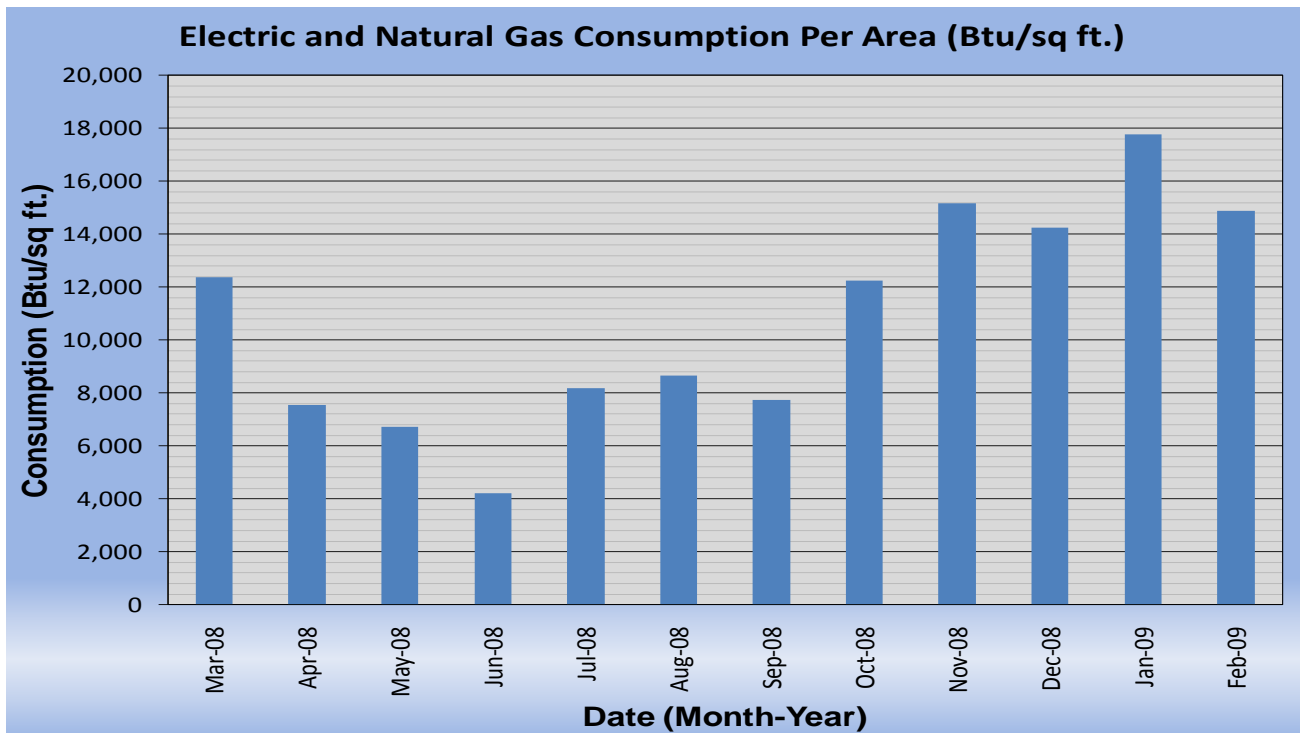
The following chart shows combined natural gas and electric consumption in Btu/sq ft for the Livingston Board of Education Office building based on utility bills for the 12 month period of March 2008 to February 2009.

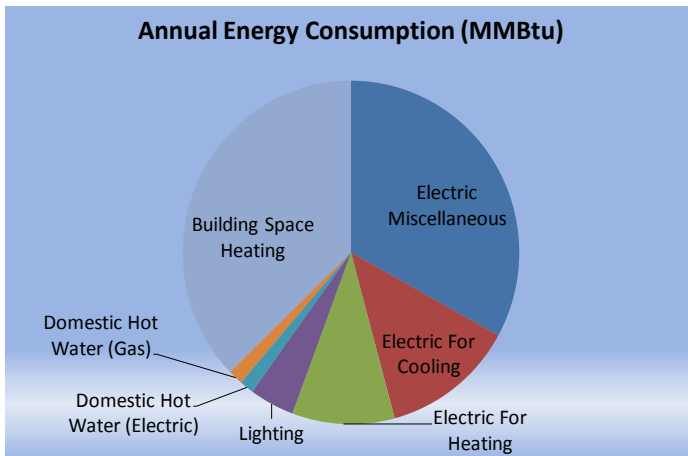
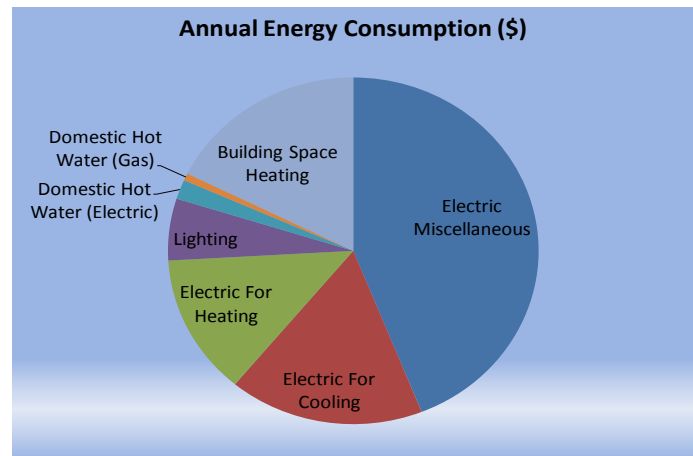
The following table and chart pies show energy use for the Livingston Board of Education Office building based on utility bills for the 12 month period of March 2008 to February 2009. Note electrical cost at \$46/MMBtu of energy is more than 2.5 times as expensive to use as natural gas at \$17/MMBtu.

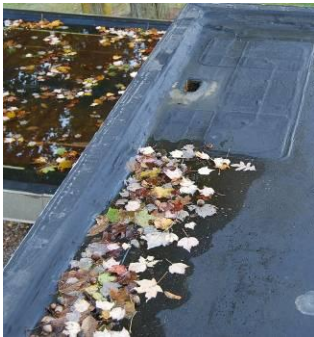
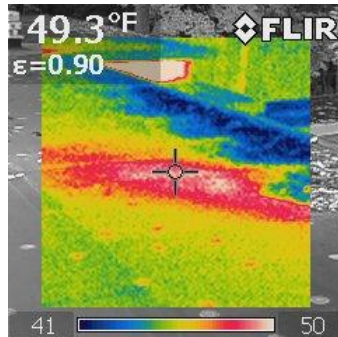
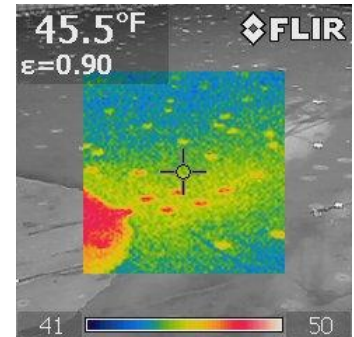
The flat roof finish is mostly dark colored EPDM with a small area of built up type roofing. The roof was found to be in age appropriate condition with some signs of pooling. Little, uneven or no insulation was found throughout the building. SWA recommends adding 10" of fiberglass insulation at the interior or 3" exterior XPS during future reroofing.

Pooling and IR images showing signs of no or little roof insulation

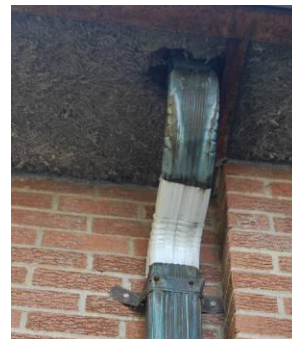
Gutters and downspouts were inspected and some were found to be disconnected or damaged. The above mentioned exterior walls cracks can partially be caused by uncontrolled roof runoff water penetrating the veneer walls and expanding during frost periods or causing soil saturation. SWA recommends having all downspouts inspected and replaced as needed.

Damaged and disconnected downspouts

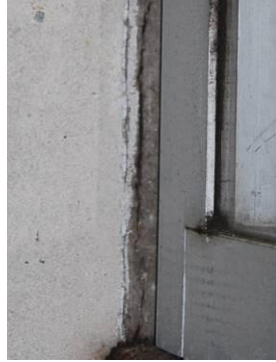
The building's windows are original, aluminum, single glazed, except a few windows in the addition which were found to be double glazed and in acceptable condition. Caulking at window frames showed signs of age.

Window caulk showing cracks

SWA recommends replacing approximately 33 windows (back windows which are part of the 1996 addition are excluded) with double-glazed thermal break low-E aluminum framed windows. All the window caulking needs to be replaced and openings around window air conditioning units need airtight gaskets/ sealing for optimal performance.

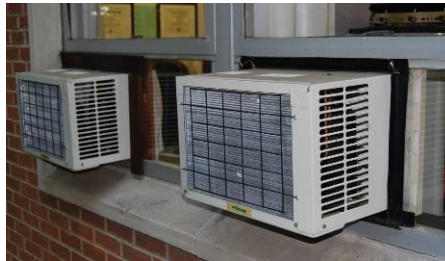
Window air conditioning units sealed with thermal tape

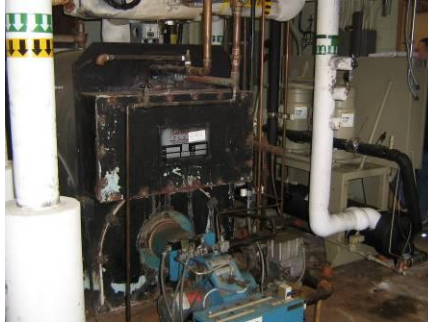
The heating hot water is produced by one (1) fire-tube style hot water boiler located in the boiler room on the basement level. The boiler was designed for 40 boiler horsepower, or 1,339 MBtu/hr. SWA estimates that this boiler was oversized for the expected heating load of the building. The boiler was installed in 1968 and has surpassed its expected service life of 25 years per 2007 ASHRAE HVAC Applications Handbook. The boiler burner is rated for 1,700 MBtu/hr. The burner was replaced in 1990 and is at the end of its expected service life of 20 years.

Original 1968 firebox boiler

There weren't many complaints about the ability of the heating system to provide adequate comfort to the building occupants. SWA recommends that the existing boiler be replaced with two (2) fully condensing hot water boilers with pulse combustion burners. The boiler sizes should be specified to more closely match the actual heating load of the building. The boilers should be managed by one (1) controller that controls the firing rate of both burners to ensure maximum efficiency at all times, and that can communicate with the district-wide Johnson Metasys EMS system.

It should be noted that condensing boilers require a stainless steel flue or chimney liner that must be accounted for when calculating the replacement cost of the system.

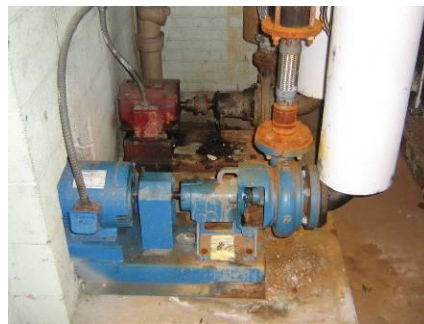
It is assumed that the circulating pumps are the original pumps installed in the system. The pump motors are beyond their expected service life of 20 years and should be replaced. SWA recommends that the pumps are replaced with new pumps with premium efficiency motors.

Corrosion evident on pump bodies and piping connections

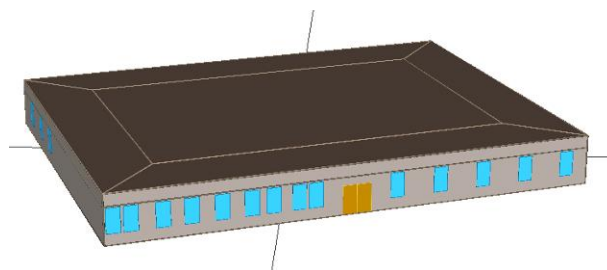
e-Quest model of the Administration Building

The assumptions made in the e-Quest model were that existing window U-Value is 1.09 Btu/hr sq ft °F vs. the improved thermally insulated window U-Value of 0.51 Btu/hr sq ft °F. Replacing all the proposed 35 windows is estimated to cost approximately \$35,000, providing a \$1,150 annual energy savings and a 30 year simple payback, which could reduce the building's energy requirements by at least 4.6 kBtu/sq ft yr. This investment cannot be justified by energy savings alone and should be considered as part of a major renovation plan.

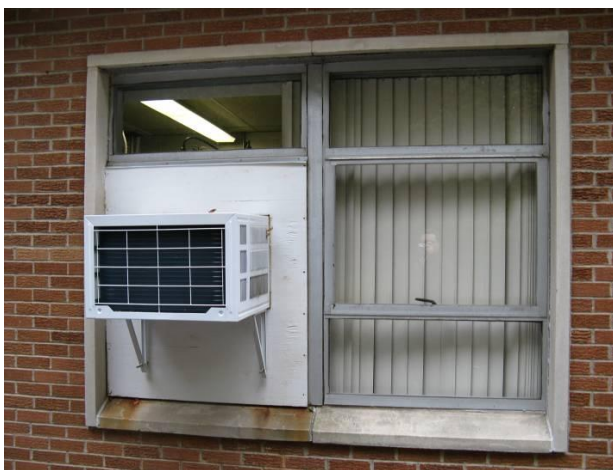
The building contains approximately 33 single-pane fixed and casement aluminum-framed windows with single-glazing. These windows appear to be original to the building. In context of other energy measures proposed in this report and in an effort to maximize the cost-benefit factor for improvements, SWA recommends to delay window replacements at this time and make it part of the next major capital improvement / renovation project. Windows considered for replacement should have the following outline specifications besides conforming to local code and regulations: the windows shall be aluminum frame thermally manufactured as double hung commercial type modules. The clear, low-e, argon filled dual glazing should be 2 independent panes. The walls should be extruded aluminum with integral poured-in-place thermal barrier. All horizontal rails should be of tubular shape and joinery should be butted and coped with stainless steel screws. Air infiltration shall not exceed 0.10 cfm/sf of unit. The conductive thermal transmittance (U-Value) shall not be more than 0.51 Btu/hr sq ft °F.

sample existing window proposed for replacement

The installed cost of approximately 33 replacement office building window units of the type outlined above is estimated to cost \$33,000, based on similar projects. Window replacement rebates and tax incentives are available only for residential buildings at this time. A DOE e-Quest model was performed to estimate energy savings with the new proposed windows.

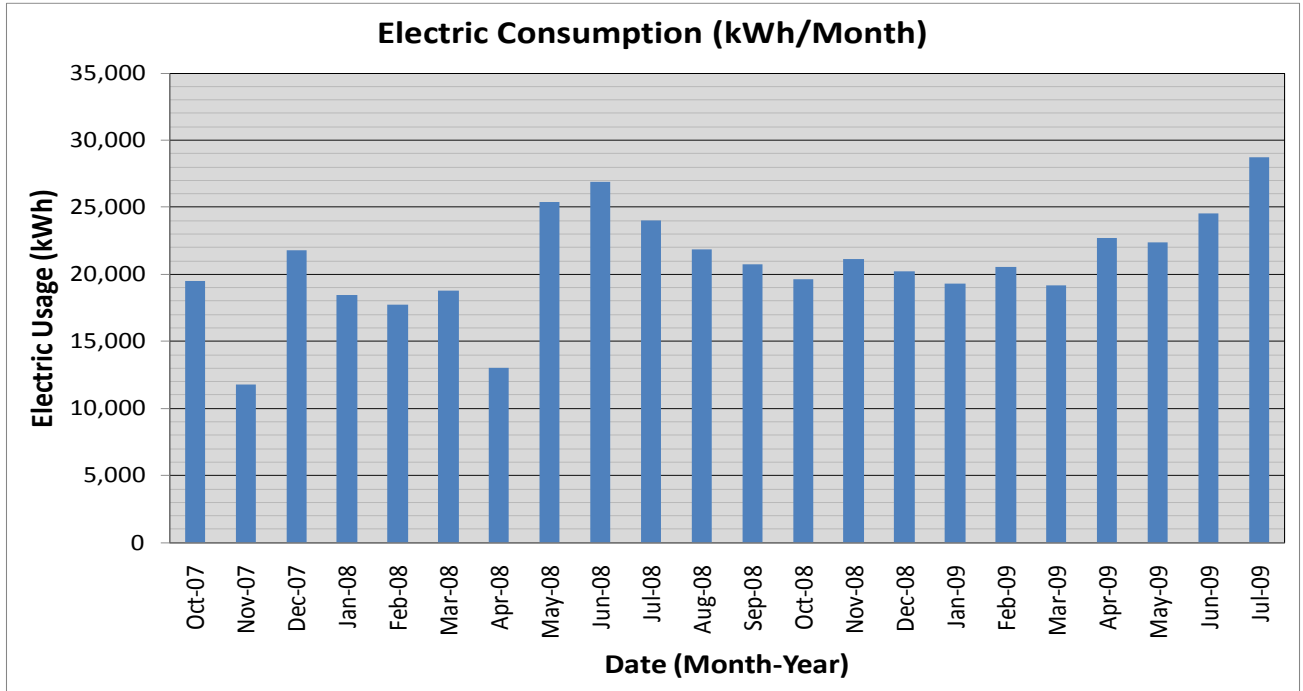
The following are charts that show the annual electric and natural gas load profiles for the Livingston Board of Education Offices building.

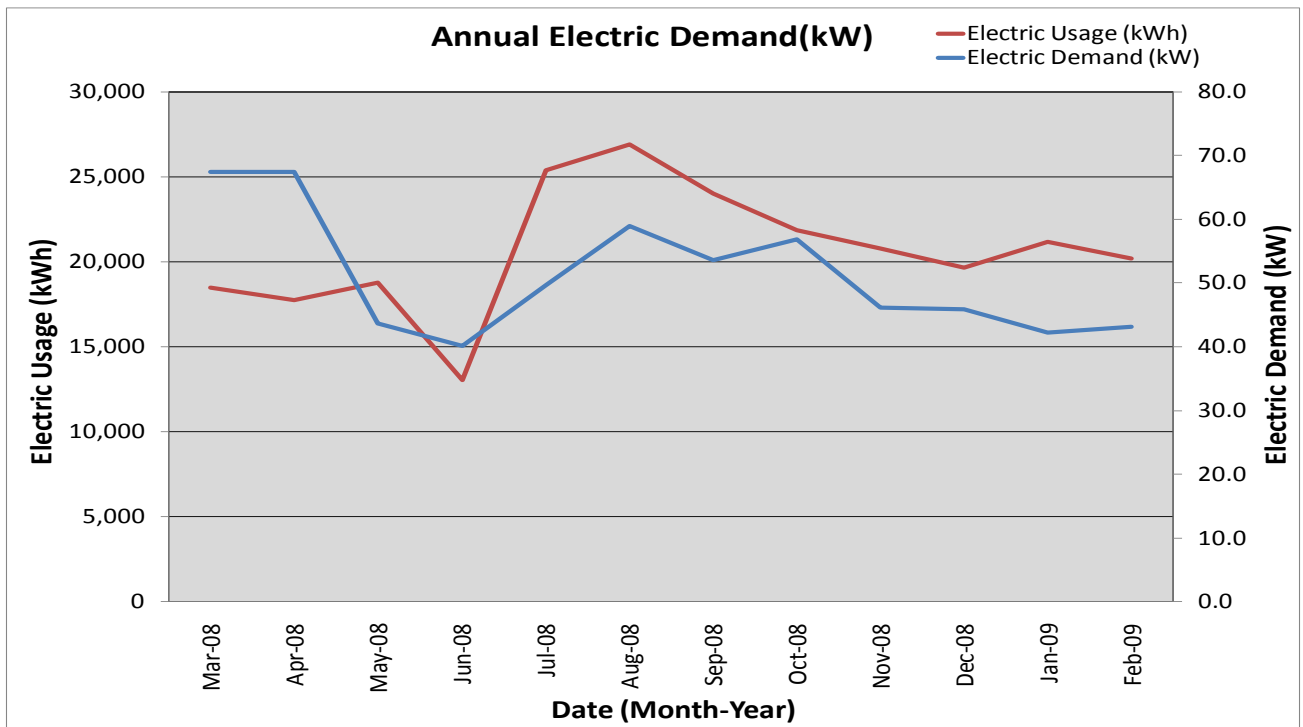
Some minor unusual electric fluctuations shown may be due to adjustments between estimated and actual meter readings. Also, note on the following chart how the electrical Demand peaks (except for a few unusual fluctuation anomalies) follow the electrical consumption peaks.

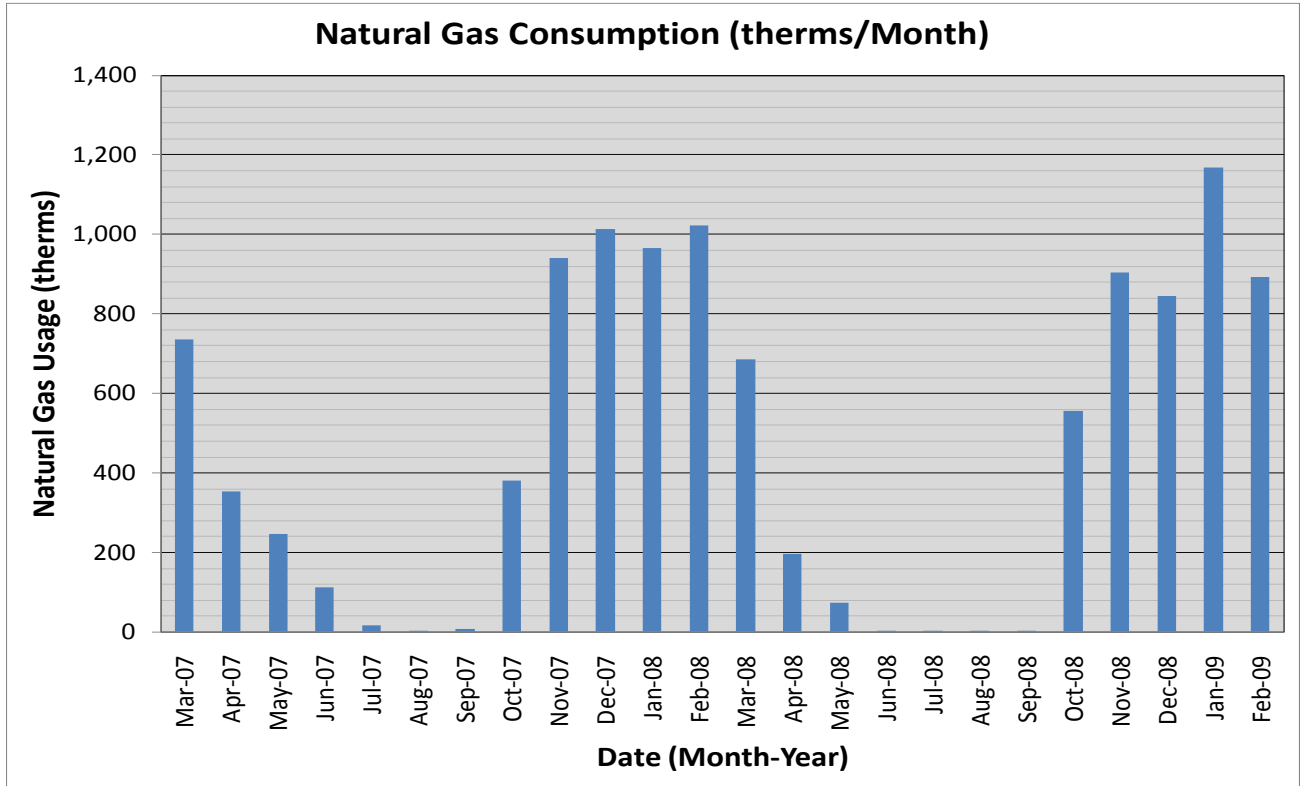
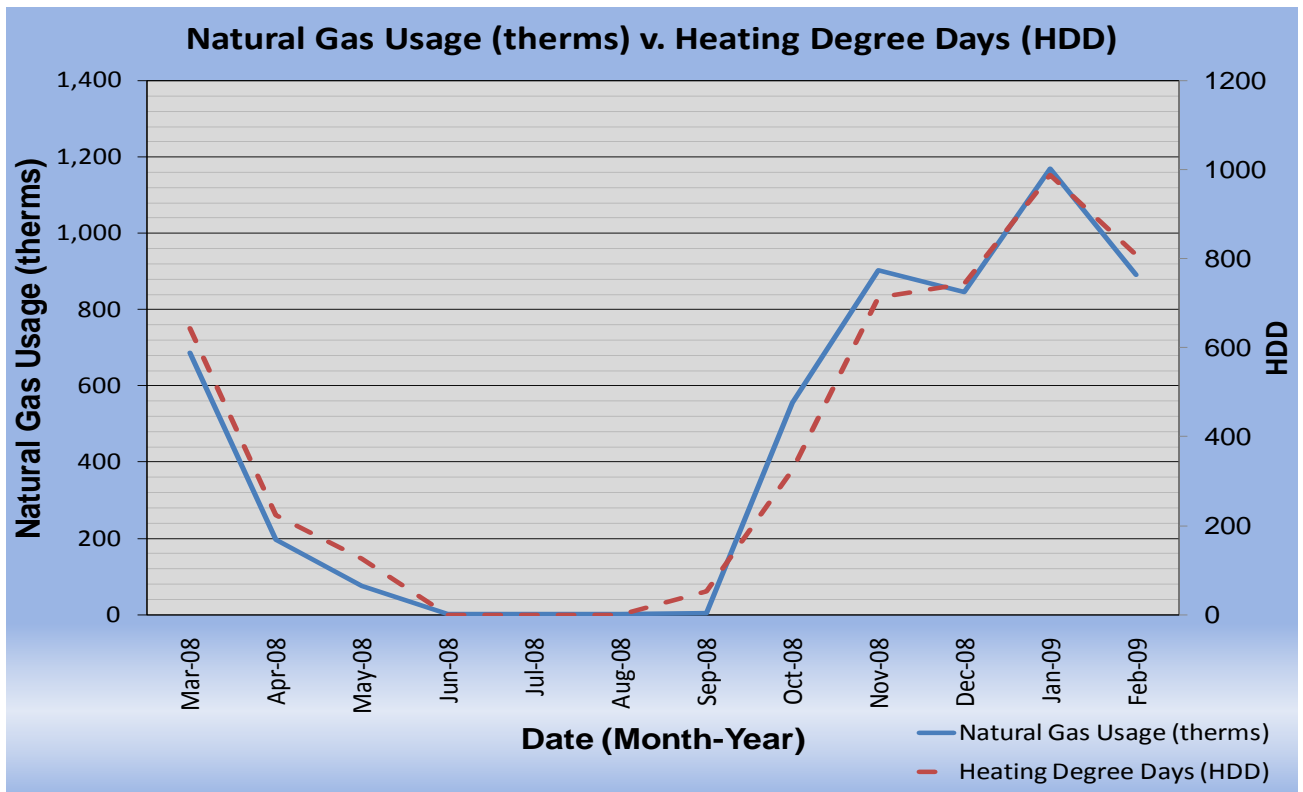
The following is a chart of the natural gas annual load profile for the building, peaking in the coldest months of the year and a chart showing natural gas consumption following the “heating degree days” curve.

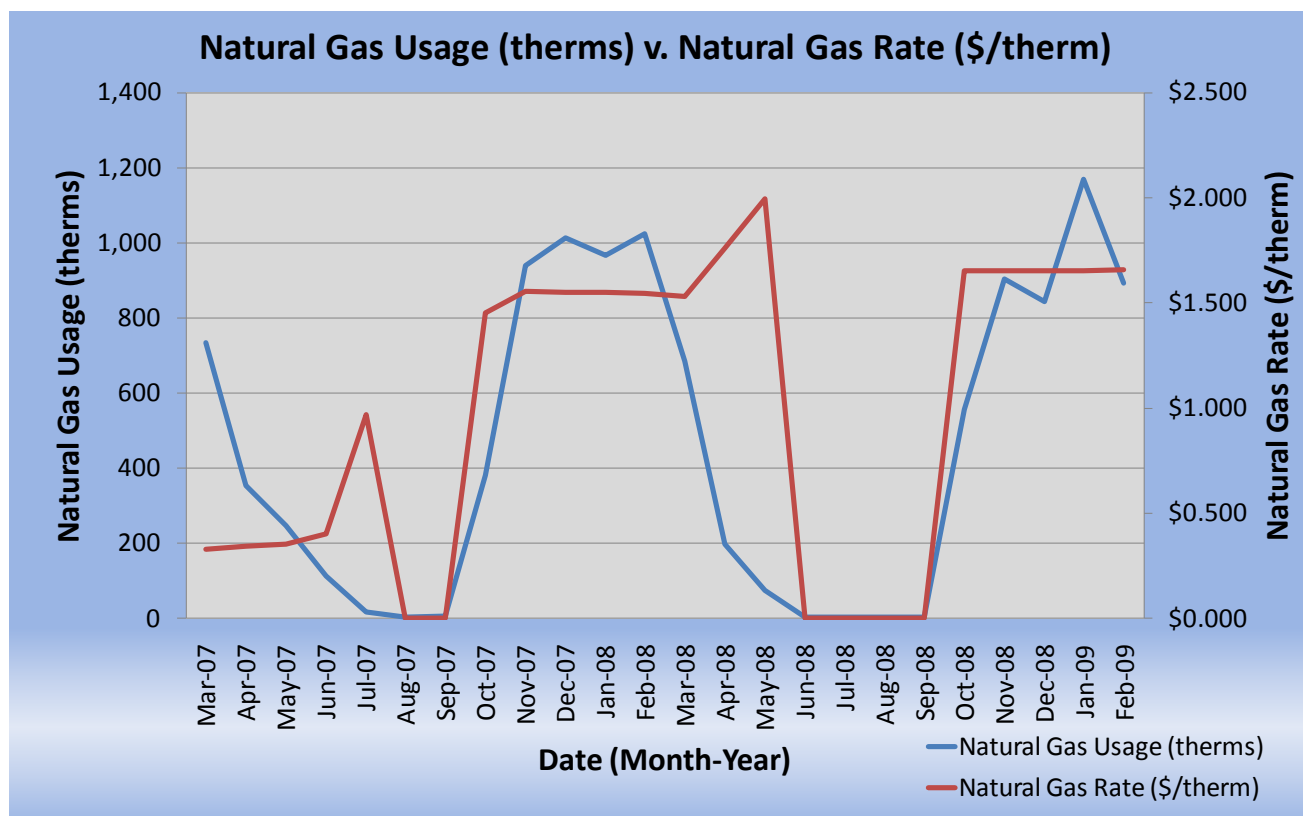
Currently, natural gas is provided to the Livingston Board of Education Office building via one gas meter with the Hess Corporation acting as the supply and PSE&G acting as the transport company. Gas is provided by the Hess Corporation at a general service rate. The suppliers' general service rate for natural gas charges a market-rate price based on use and the Livingston Board of Education Office billing does not breakdown demand costs for all periods. Demand prices are reflected in the utility bills and can be verified by observing the price fluctuations throughout the year. Typically, the natural gas prices increase during the heating months when natural gas is used by the hot water boiler units. The high gas price per therm fluctuations in the summer may be due to high energy costs that occurred in 2008 and low use caps for the non-heating months. Thus the building pays for fixed costs such as meter reading charges during the summer months. So June, July, August and September cap payment are excluded from the following chart.

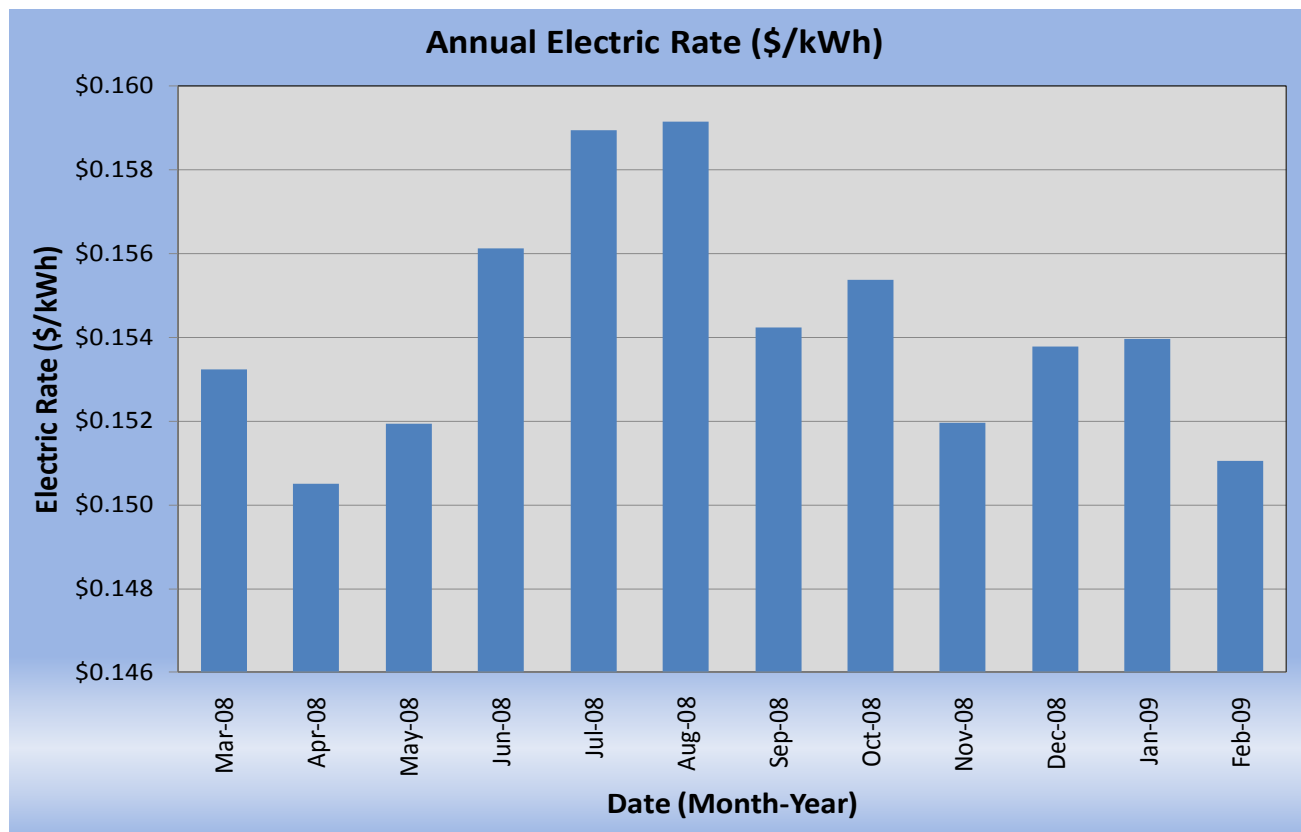
based contract with a client firm to implement measures which reduce energy consumption and costs in a technically and financially viable manner. Electricity is also purchased via one incoming meter directly for the Livingston Board of Education Office building from JCP&L without an ESCO. SWA analyzed the utility rate for natural gas and electricity supply over an extended period. Electric bill analysis shows fluctuations up to 28% over the most recent 12 month period. Natural gas bill analysis shows fluctuations up to 84% over the most recent 12 month period. Some of these fluctuations may have been caused by adjustments between estimated and actual meter readings, others may be due to unusual high and escalating energy costs in 2008. The average estimated NJ commercial utility rates for electric and gas are \$0.150/kWh and \$1.550/therm respectively. The building's annual utility costs are \$2,231 higher for electric and \$560 higher for natural gas for a total of \$2,791 higher, when compared to the average estimated NJ commercial utility rates. SWA recommends that the Livingston Board of Education further explore opportunities of purchasing both natural gas and electricity from ESCOs in order to reduce rate fluctuation and ultimately reduce the annual cost of energy for the Livingston Board of Education Office building. Appendix B contains a complete list of third party energy suppliers for the Livingston Township service area. The Livingston Board of Education may want to consider partnering with other school districts, municipalities, townships and communities to aggregate a substantial electric and natural gas use for better leveraging in negotiations with ESCOs and of improving the pricing structures. This sort of activity is happening in many parts of the country and in New Jersey. Also, the Livingston Board of Education Office building would not be eligible for enrollment in a Demand Response Program, because there isn't the capability at this time to shed a minimum of 150 kW electric demand when requested by the utility during peak demand periods, which is the typical threshold for considering this option. Demand Response could be an option in the future when the Livingston Board of Education may install a large enough back-up emergency generator. The following charts show the Livingston Board of Education Office building monthly spending per unit of energy in 2008.
