**Local Government Energy Program
Energy Audit Final Report**

***Livingston Hillside Elementary School
Livingston, NJ 07039***

Project Number: LGEA37

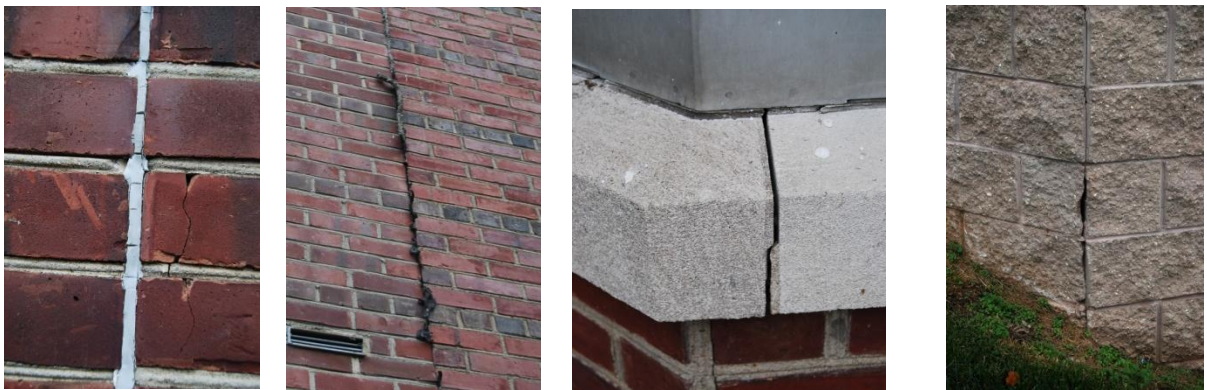
Cracked caulk and mortar, inappropriate filler materials were found in isolated areas

SWA recommends caulking and re-pointing the veneer with appropriate materials to prevent further cracking due to moisture and water infiltration, especially around window sills and all other wall penetrations. Trees and shrubs that touch any parts of the structure should be trimmed, cut back or cut down to ensure that wall and roof assemblies perform as intended.

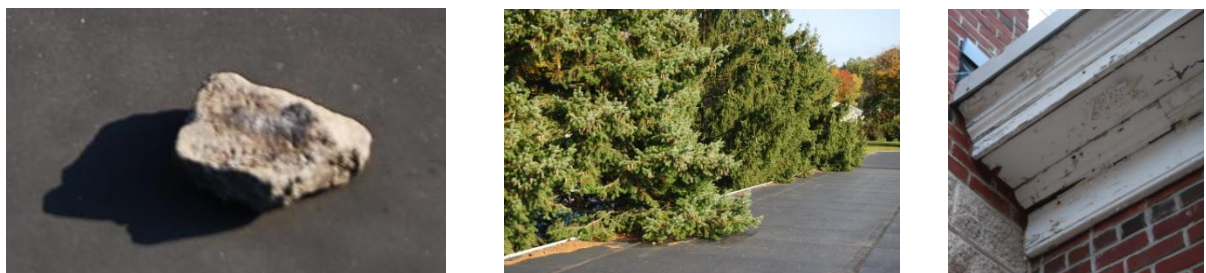
Besides the roof surface and insulation conditions, sharp rocks were noticed to be laying on the roof in all areas, a possible cause of leakage by foot traffic or impact. Vegetation should also be trimmed back not to overhang or touch roof perimeter, which has a negative impact on the roof's warranties and life span. SWA also noticed chipped paint at the wood cornice / soffit likely due to age. However, SWA recommends keeping the cornice in good condition to prevent future moisture related energy loss issues.

Sharp edged rocks, overhanging vegetation and chipped paint at cornice noticed

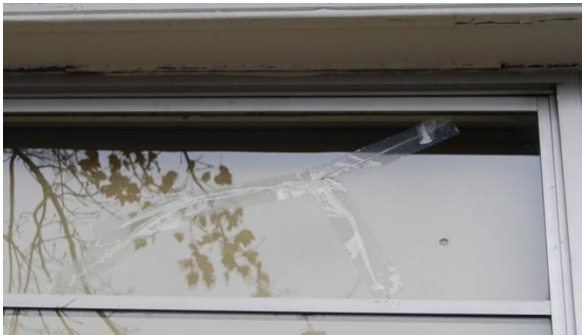
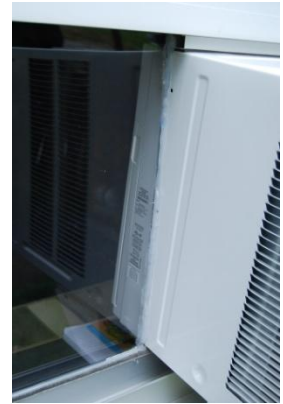
Most of the building's windows were found to be recently updated double glazed aluminum framed windows in good condition. About 42 units are original, aluminum, single glazed type windows with cracked caulking and some isolated glass damage.

Windows showing damaged glass and air conditioning units with inefficient seal

SWA recommends replacing all original windows with double glazed, low-e type units. All caulking at windows need to be inspected and replaced if necessary and openings around window air conditioning units need airtight gaskets / sealing for optimal all year performance. Insulated hoods should be installed during winter months if removing the units is not an option.

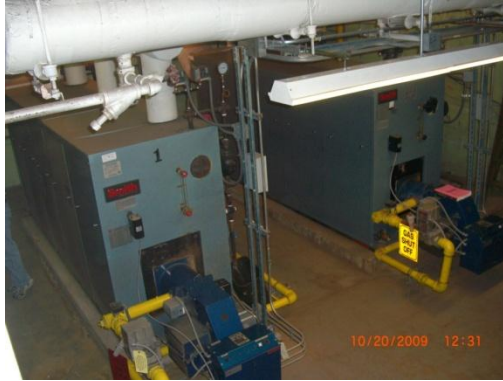
Boilers

The heating steam is produced by two (2) HB Smith cast iron sectional steam boilers located in the Boiler Room in the basement. One of the boilers was installed in year 2000 approximately, while the other is new from October, 2009. These boilers have a life expectancy of 30 years as published in the 2007 ASHRAE HVAC Applications Handbook, so replacement of this boiler #2 due to failure would be very premature. Some investigation into water quality or other factors should be performed. One boiler has about 22 years remaining on its expected service life of 30 years, depending on the results of the water quality investigation. The burners were installed in 2001 and are approaching halfway through their expected service life of 20 years.

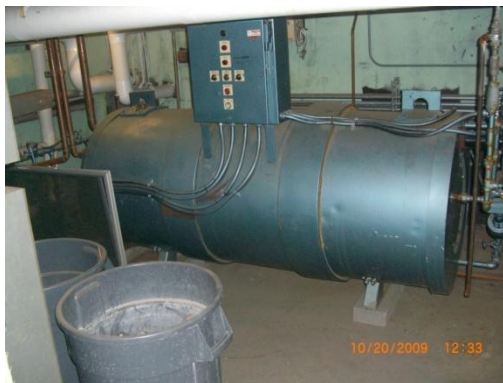
Boiler Feed-water Tank

Portions of the heating system return steam condensate back to receivers located in the Boiler Room. In addition, the steam supply lines are served by various steam traps to remove steam condensate that collects in the supply lines. This practice is typical for a steam heating system, although it should be noted that these traps are often the source of operations and maintenance issues within the system. The steam condensate is piped to a separate condensate receiver tank, containing a duplex pump set which pumps to a boiler feed-water system. There is a feed-water tank with a triplex pump set, one pump for boiler #1, one pump for boiler #2, and one standby for either of the primary pumps. The condensate system is not gravity but rather a vacuum system, requiring two additional pumps. SWA recommends that this equipment is replaced as part of a capital improvement plan in the Livingston Public Schools, since they are nearing the end of their service life.

- Replace two (2) duplex condensate receiver pump sets in the boiler room, one (1) duplex condensate receiver pump sets in the second boiler room, one (1) vacuum condensate pump assembly and one (1)

boiler feed-water tank with pump set in the boiler room. Although this equipment may still have a few years of life per the 2007 ASHRAE HVAC Applications Handbook, the Livingston Public Schools should consider replacement as part of the capital improvement plan. This is a replacement in kind that offers negligible energy savings.

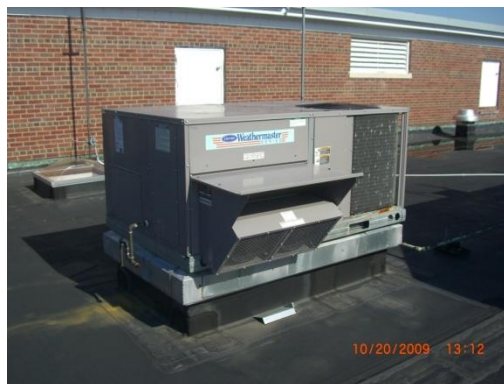
The majority of the cooling present in the building is in the form of window air conditioning units in several of the classrooms and offices. A rooftop HVAC unit serving one SGI and the Nurse's Office, and one rooftop HVAC unit serving the Media Center and ancillary spaces. There is one 2.5-ton condensing unit which appears to be for a split system AC unit serving the Resource Room in the original building near the Art Room, perhaps added when the Media Center was constructed in 2003. According to the head custodian, most of the window air conditioning units are 1-10 years old, and most appeared to be in fair condition.

Packaged HVAC Rooftop Unit Serving Front Offices, Nurse's Office and SGI
