**Local Government Energy Program  
Energy Audit Final Report**

***Livingston Riker Hill Elementary School  
Livingston, NJ 07039***

***Project Number: LGEA37***

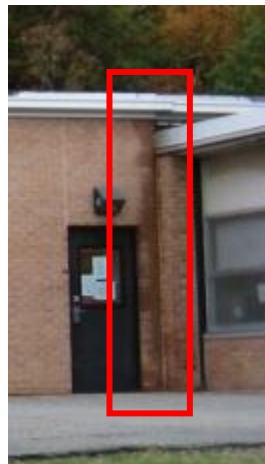
*Water infiltrated veneer caused by faulty flashing*

The above image shows damage to the exterior brick veneer due to uncontrolled roof water run-off. Noted in section 2.3.2, special attention should be given to roof drainage to avoid water damage to exterior wall assemblies. At the time of the audit the exterior walls appeared to be in age appropriate condition and there weren't other major visible issues such as cracked bricks or mortar joints.

Attention and maintenance should be given to these areas as water will find points of entry and cause future damage with freezing and thawing through the wintertime conditions.

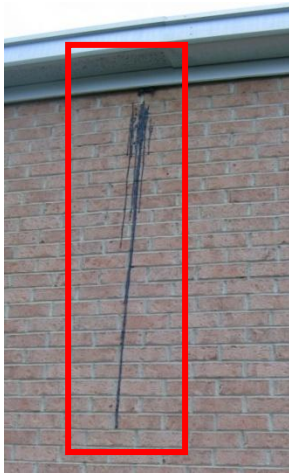
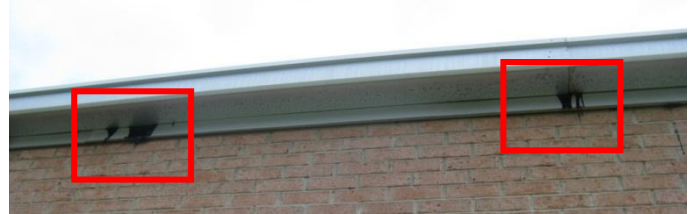
The 1999 section of the building has the original built-up roof. The roofing tar used around the perimeter of the roof has melted due to high temperatures in gutters, onto exterior wall facades, and onto the walls in room 16. These areas need immediate attention and the roofing contractor should be responsible for extracting substances from the damaged areas.

*Roof tar melting on exterior and interior of building*

Regular maintenance should be performed on all roof areas to prevent leaks such as the leak in classroom 16. SWA recommends replacement of the 1989 and 1992 roof sections with an Energy Star certified membrane and insulation (3" rigid) assembly.

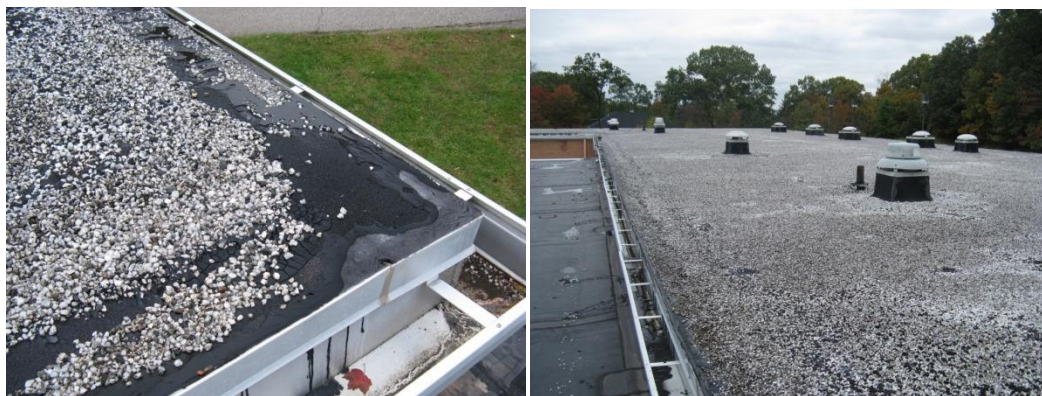
*Built up roof area showing tar run-off into and behind gutters*

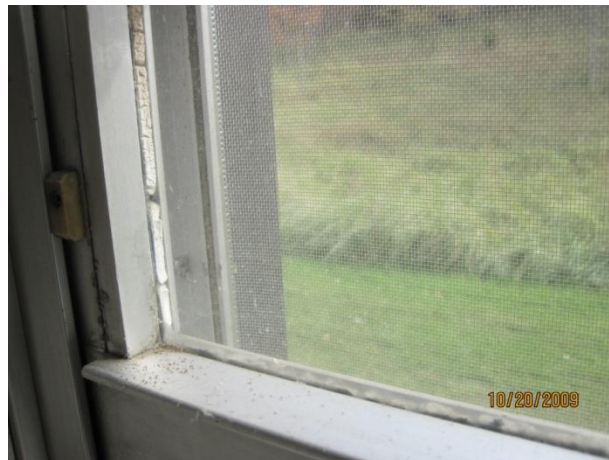
Most of the building’s windows are original, aluminum, single glazed and in need of replacement. Due to the fact that the windows are non-thermal break single glazed with un-insulated panels above them, they are extremely energy inefficient. The building also contains some double glazed windows found to be in good condition.

*Older windows showing cracked and damaged caulk*

SWA recommends replacing approximately 221 windows with double-glazed thermal break low-E aluminum framed windows. Regular maintenance should be performed, re-caulking around the perimeter of windows (exterior and interior) to ensure a tight air seal. Additionally, window AC units should be removed for winter conditions. If removal of these units is not feasible, SWA recommends airtight covers such as Chill Stop-R or a gasketed cover for optimal performance.

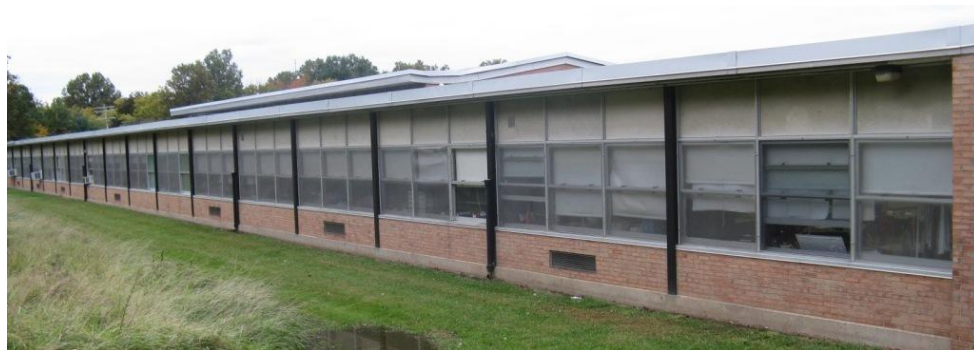
*Older aluminum window wall section*

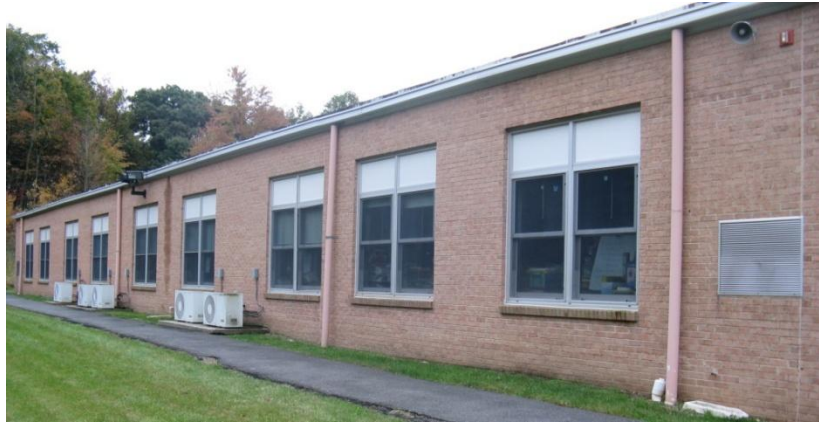
*1999 building section with new windows*

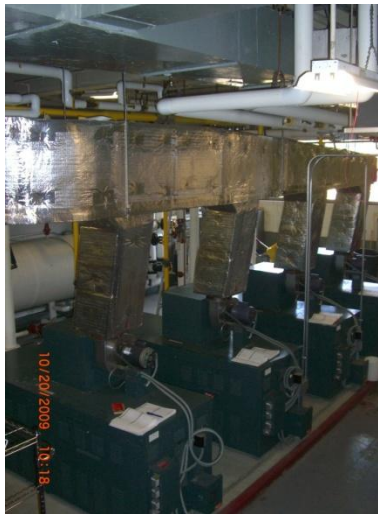
*Boilers*

The heating hot water is produced by four (4) Raypak atmospheric boilers of equal capacity located in the boiler room. The boilers were installed in year 1999 approximately. According to their age, the boilers have about 20 years remaining on their expected service life of 30 years, as published in the 2007 ASHRAE HVAC Applications Handbook. The burners are integral to the boilers.

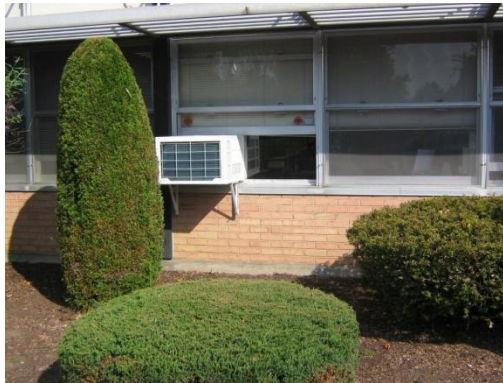
The majority of the cooling in the original and all early additions to the building is in the form of window air conditioning units in several of the classrooms and offices. According to the head custodian, most of the window air conditioning units are 1-5 years old, and they appear to be in operating condition. The Principal's Office no longer has a window air conditioner, which was removed due to noise, discomfort, and the desire of the occupant to have the use of the operable window restored.

*Typical Classroom Window Air Conditioning Unit*

- Replace window air conditioners - The existing window air conditioners and ceiling cassette type split systems still have some useful life remaining (on the average 5-10 years left) but replacement should be considered with more modern and energy efficient systems. The window air conditioners should be replaced with split systems to allow for closing up of the existing window penetrations. These upgrades cannot be justified by energy savings alone but will result in a decrease in energy usage versus the existing equipment. In addition, several of the existing systems utilize R-22 refrigerant, which is not an ozone-friendly refrigerant. Newer systems should be specified with R-410A refrigerant.

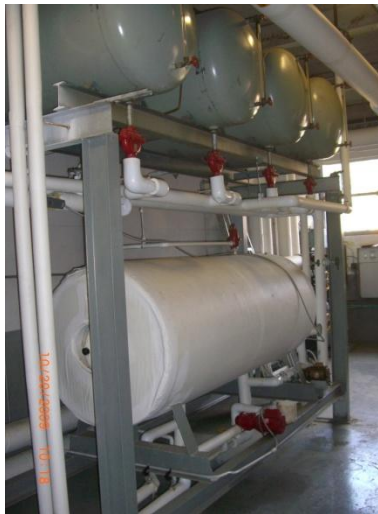
There is one (1) gas fired floor-mounted Burkey type domestic water heater located in the boiler room that produces the domestic hot water in the summer months. The water heater utilizes an external storage tank and one (1) booster-type circulating pump. The heater was installed in 2003 and is in relatively good condition (it appears to have been a replacement for one similar that was originally installed). Based on the age and expected service life of 10-15 years, the Livingston Public Schools may wish to keep this heater until it is in need of replacement, and then replace it with a more efficient heater as part of a capital improvement plan and maintain use of the existing storage tank. The associated pumps appear to be operating adequately and are fractional horsepower, so replacement would not yield significant energy savings.

*Domestic Water Storage Tank with Expansion Tanks Above*
