**Local Government Energy Program  
Energy Audit Report**

***Township of Livingston  
Municipal Court  
20 Robert Harp Drive  
Livingston, NJ 07039***

***Project Number: LGEA50***

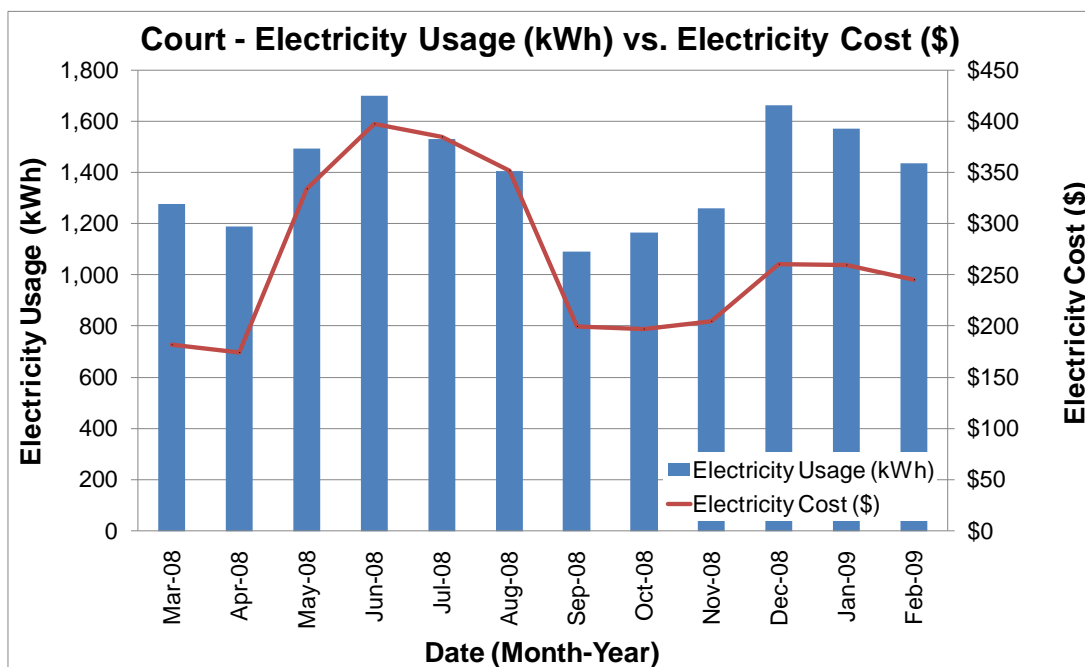
The following chart shows electricity use versus cost for the Municipal Court based on utility bills for the 12 month period of March 2008 to February 2009.

Electricity use follows a trend that is expected for this building with usage peaking during the summer cooling season and winter. SWA believes that the winter time peak is due to heating related pumps, fans and motors, and possibly evidence of the use of personal heating units that were not present at the time of the audit. The cost of electricity fluctuates as expected with usage peaking in the summer during the time of highest usage.

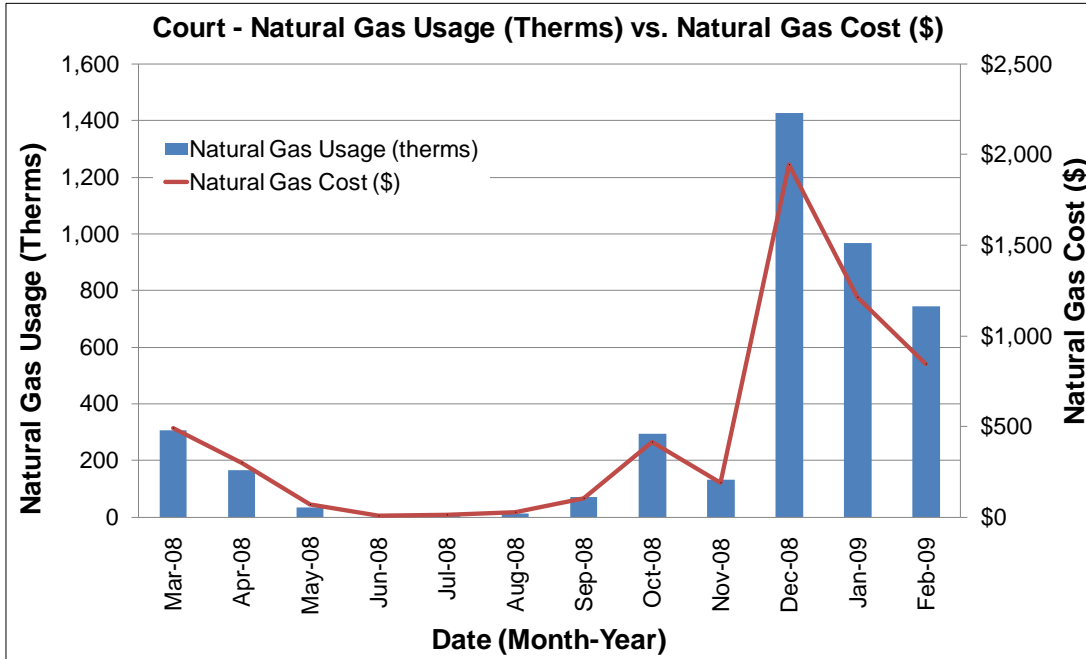
The following is a chart of the natural gas annual load profile for the building versus natural gas costs, peaking in the coldest months of the year and a chart showing natural gas consumption following the “heating degree days” curve.

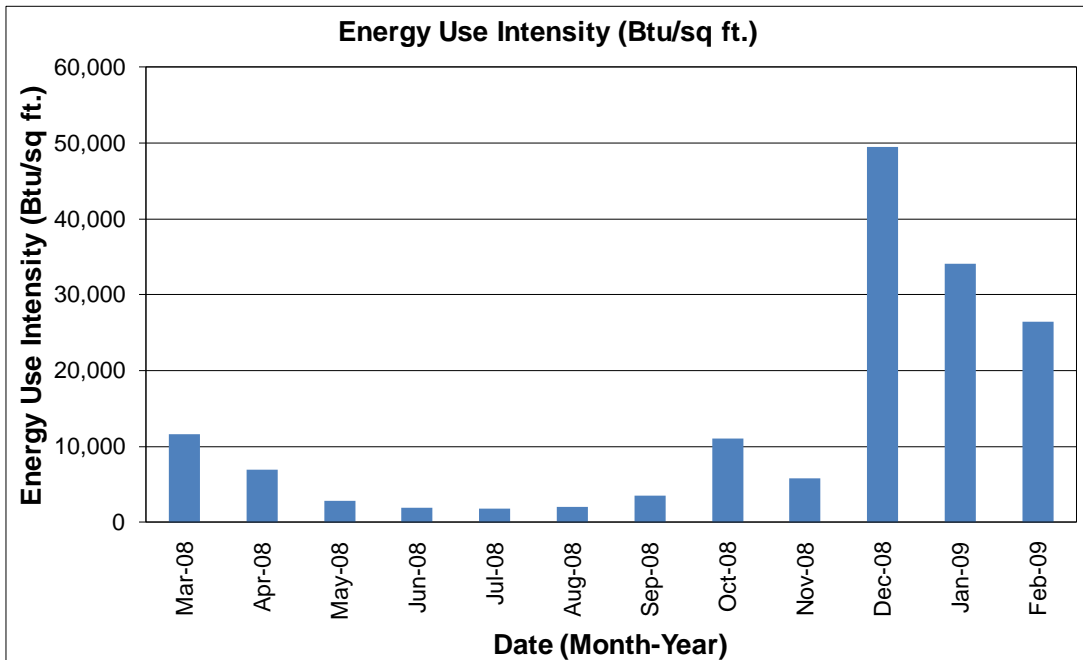
The following chart shows electric consumption in Btu/sq ft for the Municipal Court based on utility bills for the 12 month period of March 2008 to February 2009.

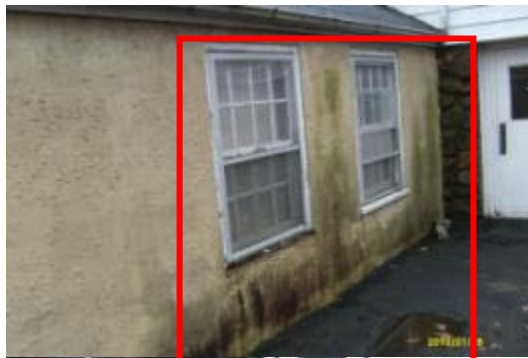
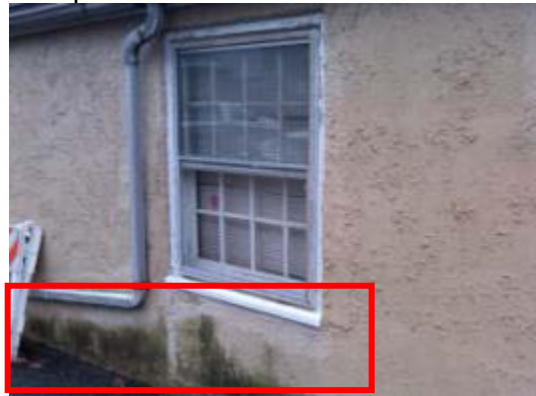
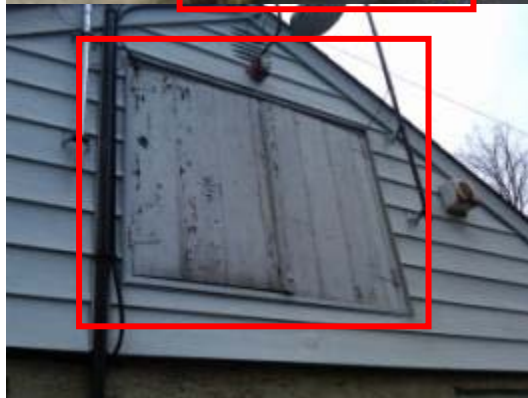
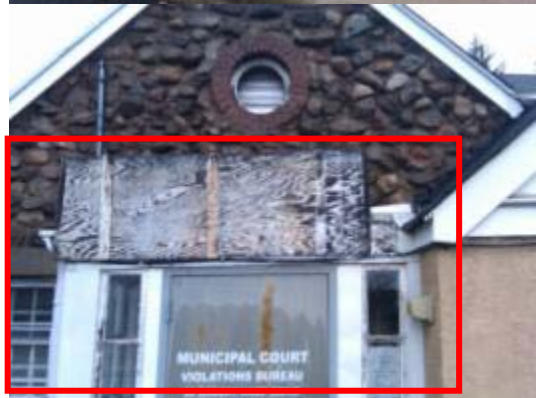
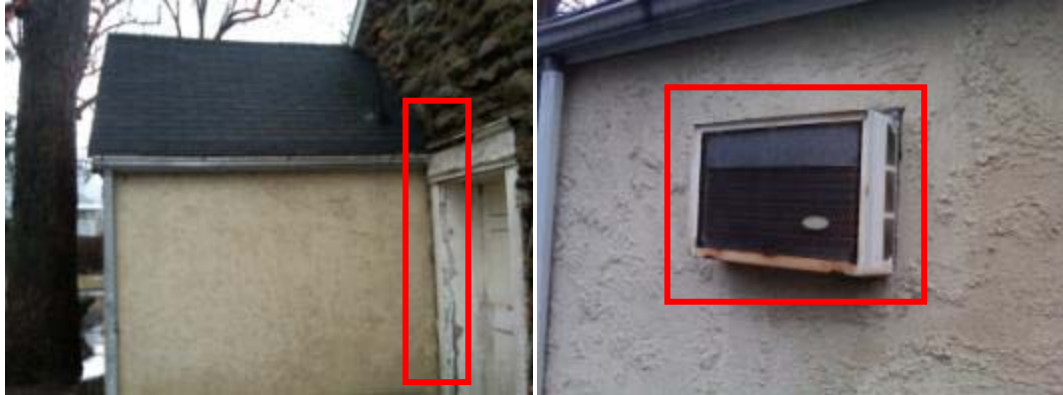
Signs of uncontrolled roof water runoff on walls due to missing/ defective roof flashing and defective/ clogged gutters and downspouts as well as unsealed penetrations and aged / damaged caulk at surface transitions

1. Replace cracked/ ineffective caulk.
2. Apply appropriate air-sealing strategies around all exterior wall penetrations (incl. electrical, plumbing and HVAC).
3. Repair and maintain flashing to minimize uncontrolled wind driven and roof water run-off causing exterior wall damage.
4. Install/ repair and maintain gutters, downspouts and downspout deflectors to minimize uncontrolled roof water run-off causing exterior wall damage.
5. Maintain and inspect all exterior wall surfaces with a focus on the condition of caulking, cracked stucco, signs of water damage, and locations that correspond to areas of known infiltration.

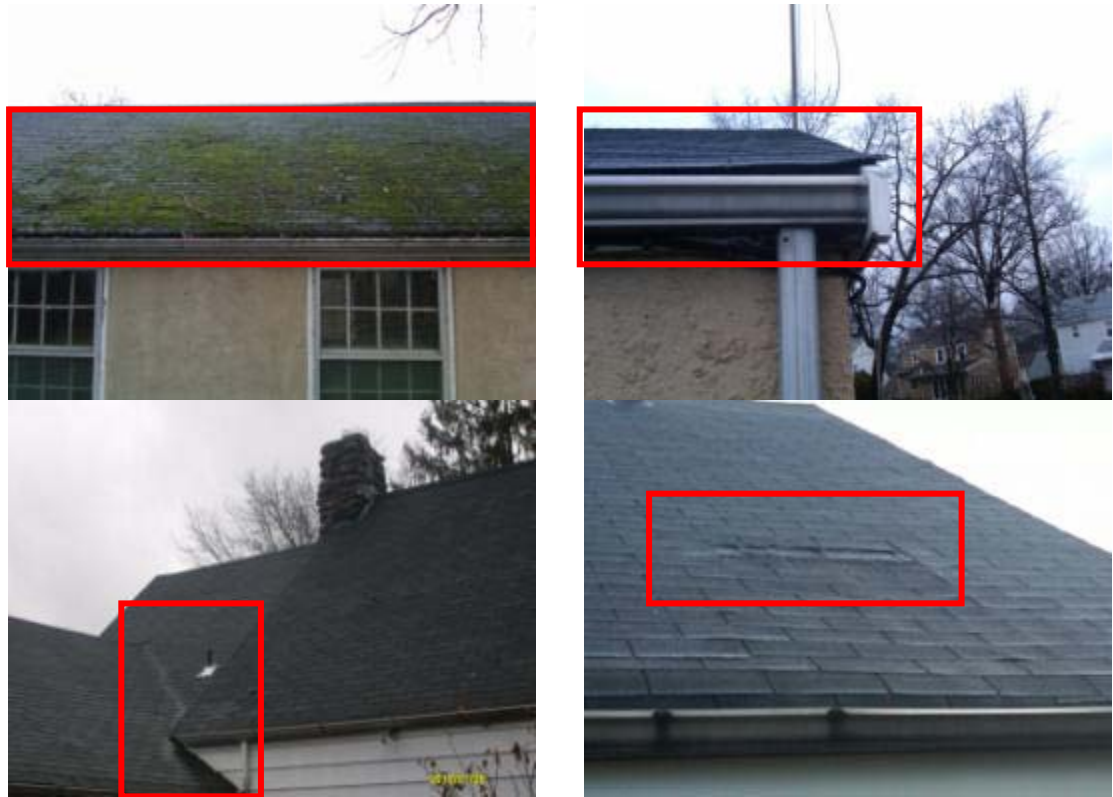
Typical asphalt shingle roof with mold, water damage and uncontrolled vegetation growth on the roof, missing and displaced shingles, defective gutters, and missing / ineffective flashing

1. Add insulation to ineffectively and under-insulated roof/ ceiling sections. SWA suggests applying closed-cell spray-foam (R-30 min.) to the underside of the roof framing.
2. Install/ repair and maintain roof flashing.
3. Overgrown mold should be removed and overgrown vegetation should be trimmed/ removed to not touch or block wall surfaces from necessary access, ventilation and sunlight.
4. Clean gutters and downspouts.
5. Repair or replace all damaged roof shingles and install new shingles in place of missing units.
6. Maintain/ inspect all roof surfaces on a regular basis.

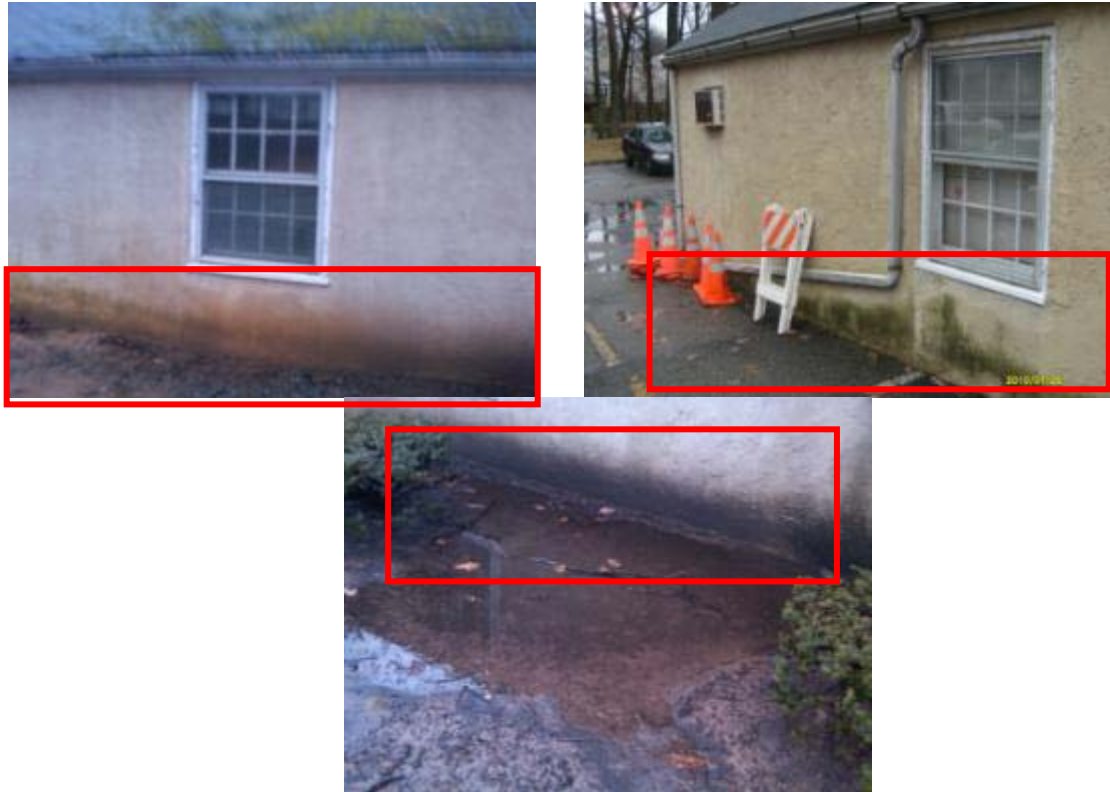
Water damage at base of the building and moisture seepage through cracks detected in the slab

- Roof shingle repair - repair or replace all damaged roof shingles and install new shingles in place of missing units.
- Building slab sealing - apply appropriate air/ water-sealing strategies around all slab penetrations (incl. electrical, plumbing and HVAC).

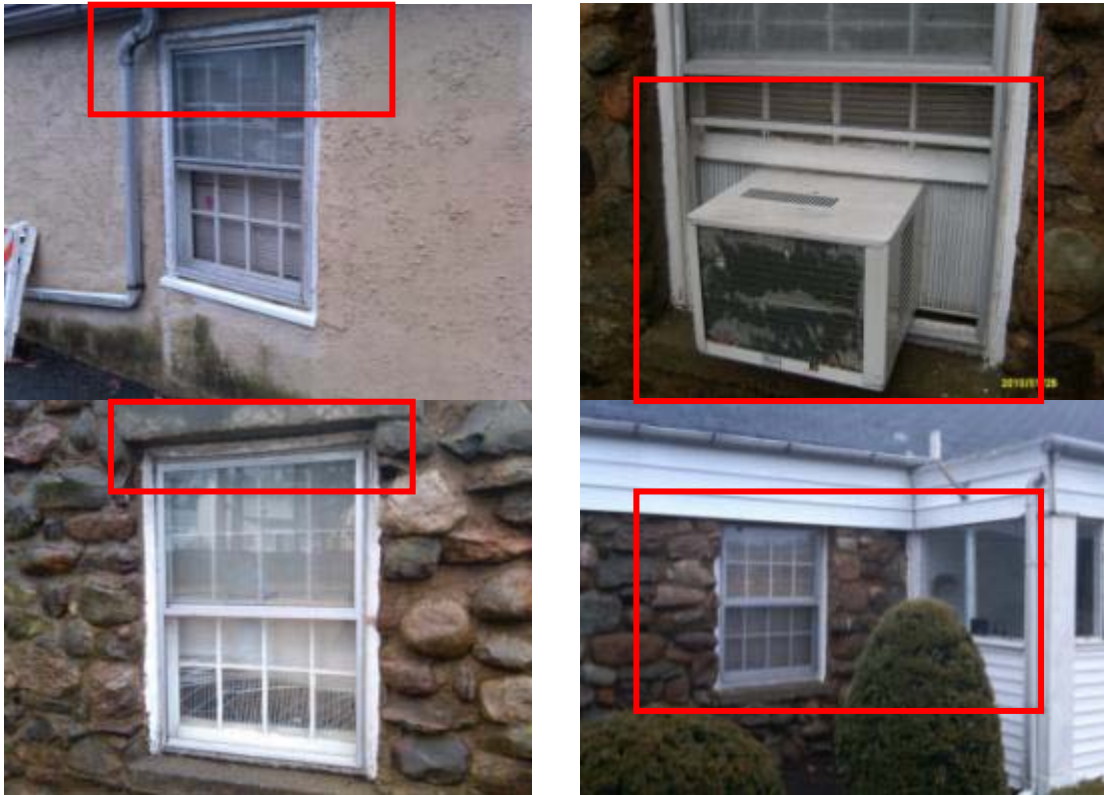
Damaged/ aged window frames, improperly sealed window A/C units, water pooling at window sill

1. Openings around window/ sleeved air conditioning units need airtight gaskets/ sealants for optimal all year performance. Insulated hoods should be installed during winter months if removing the units is not an option.
2. Install/ repair pan or strip flashing and drip edge detail at window sill.

3. Replace all windows with damaged frames during next capital improvement project with ENERGY STAR® units.
4. Maintain and inspect all exterior windows with a focus on the condition of the frames, glazing, proper hardware operation and signs of water damage/leakage and infiltration

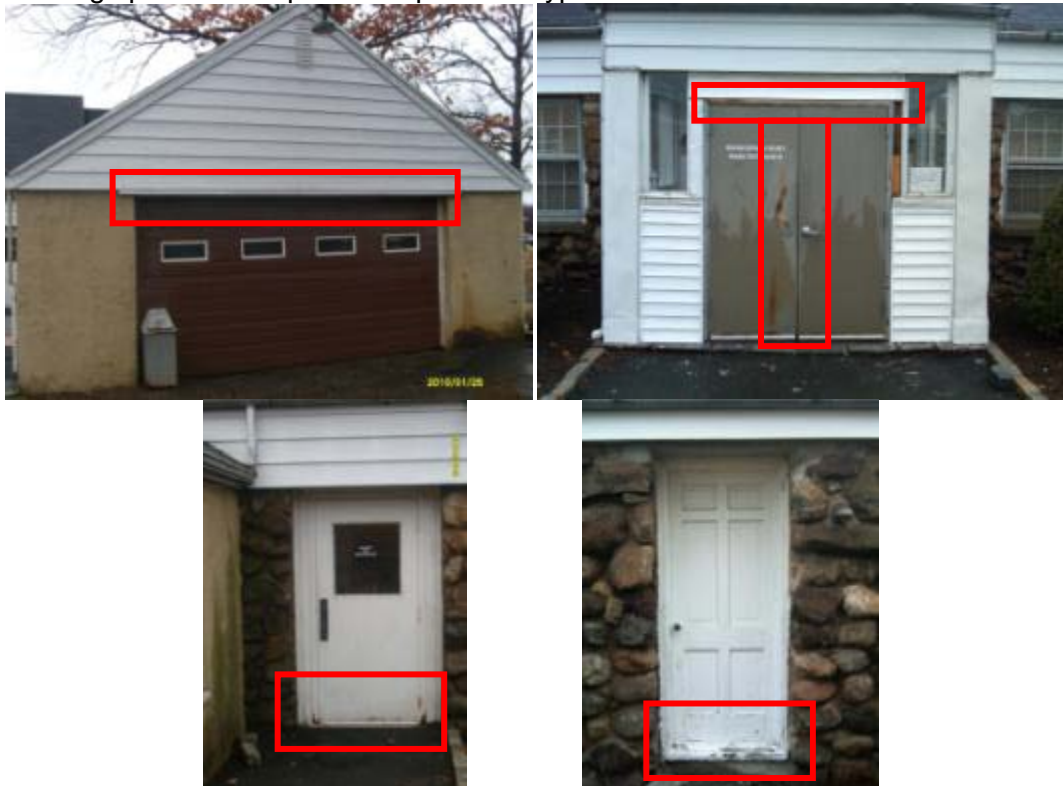
Damaged/ warped/ aged door frame

1. Repair and maintain damaged door frames and replace units during next major capital improvement.
2. Maintain and inspect all doors with a focus on the condition of the weather-stripping, door frame, air tight seal and signs of water damage and infiltration.

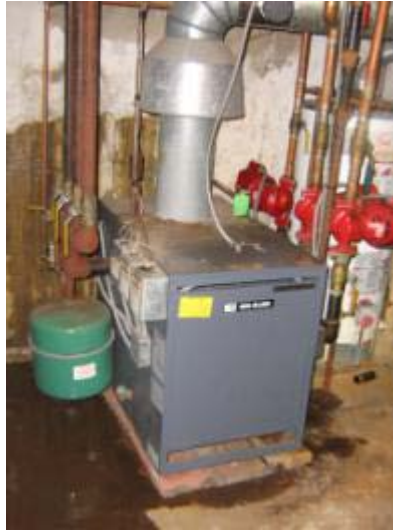
The entire building is heated via a Weil-McLain 'PFG' gas fired boiler. This boiler is circa 1998 and provides 215,000 btuh of output. It has an estimated remaining life of 60%. It appears that the building is split into three zones: 'Large Room' (the courtroom), 'offices', and the 'garage'. Heating hot water is supplied to each of these three zones via a dedicated Bell & Gossett pump, one for each zone. The pumps serving the garage and courtroom are in good condition, and the pump serving the offices has recently been replaced. The pumps provide the heating hot water to an assortment of radiators throughout the building. The offices and core areas of the building are heated by free-standing radiators and baseboard radiators located around the perimeter walls of the office wing. The courtroom and adjoining offices in the rear of the space have radiators mounted below the windows, and the garage is served by a very old hydronic unit heater that is

Gas fired boiler and three heating hot water supply pumps in basement

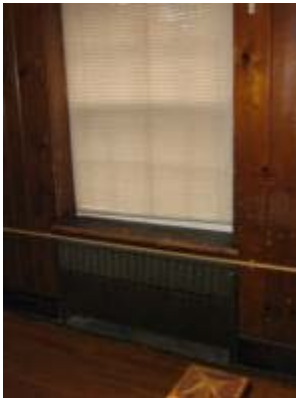
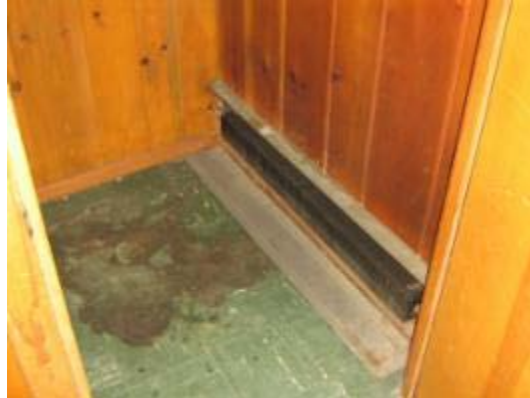
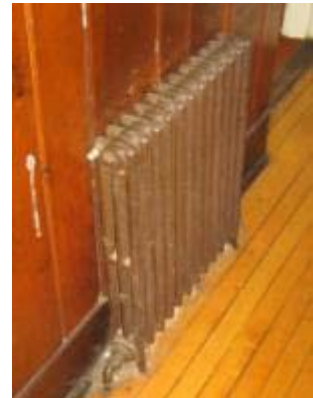
Radiators throughout the building.

- Replace heating terminal equipment - such as finned tube radiation and free standing radiators in the main building, and the hydronic unit heater in the garage. This equipment is in fair to poor condition, and age and wear have reduced the heat transfer capacity. This equipment should be replaced with more modern equipment suited for the intended use. These changes cannot be justified based on energy savings alone. However, replacement is strongly recommended to improve the overall efficiency of the heating system. This is a replacement in kind recommendation which offers negligible energy savings.

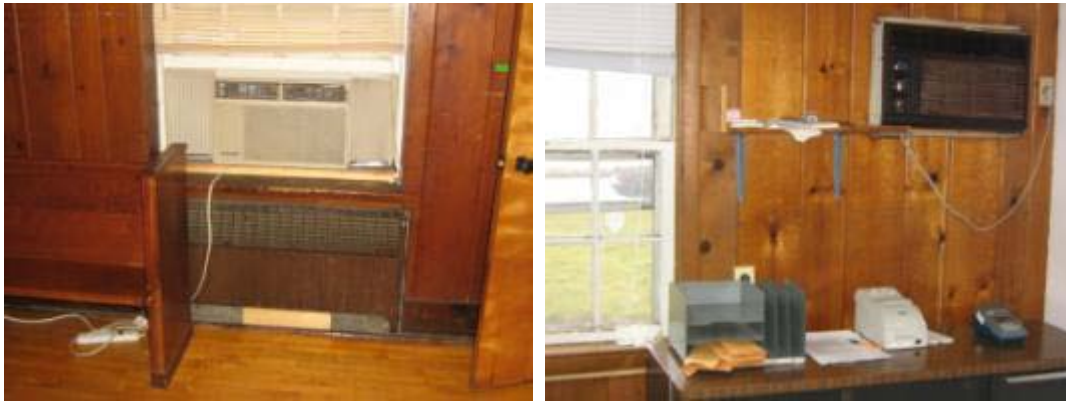
Cooling is provided to the building exclusively by thru-the-wall air conditioning units. The eight (8) plus air conditioners range in age and are anywhere from 2 to 10+ years old.

Thru-the-wall air conditioners

- window air conditioners – A few of the existing window air conditioners still have some useful life remaining (on the average 0-5 years left) but replacement should be considered with more modern, energy efficient systems. The window air conditioners should be replaced with split systems to allow for closing up of the existing window penetrations. These upgrades cannot be justified by energy savings alone but will result in a decrease in energy usage versus the existing equipment. In addition, the existing systems utilize R-22 refrigerant, which is not an ozone-friendly refrigerant. Newer systems should be specified with R-410A refrigerant.

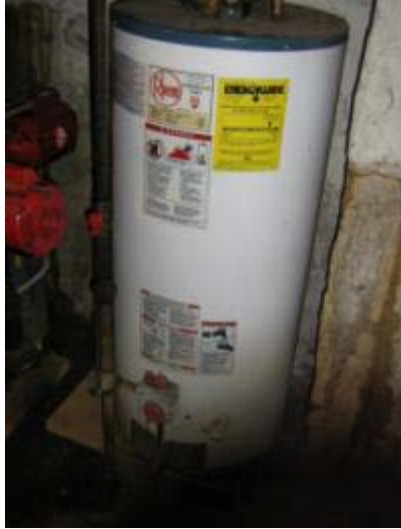
The domestic hot water for the building is provided by a gas-fired, 40 gallon, 28 MBH tank-type water heater, located in the basement. The heater serves two (2) toilet rooms and a break room sink. This water heater is from 1996 and is nearing the end of its expected useful life.

Domestic Hot Water heater
