**Local Government Energy Program
Energy Audit Report**

***Township of Livingston
Northfield Fire Station
2 East Hobart Gap Road
Livingston, NJ 07039***

Project Number: LGEA50

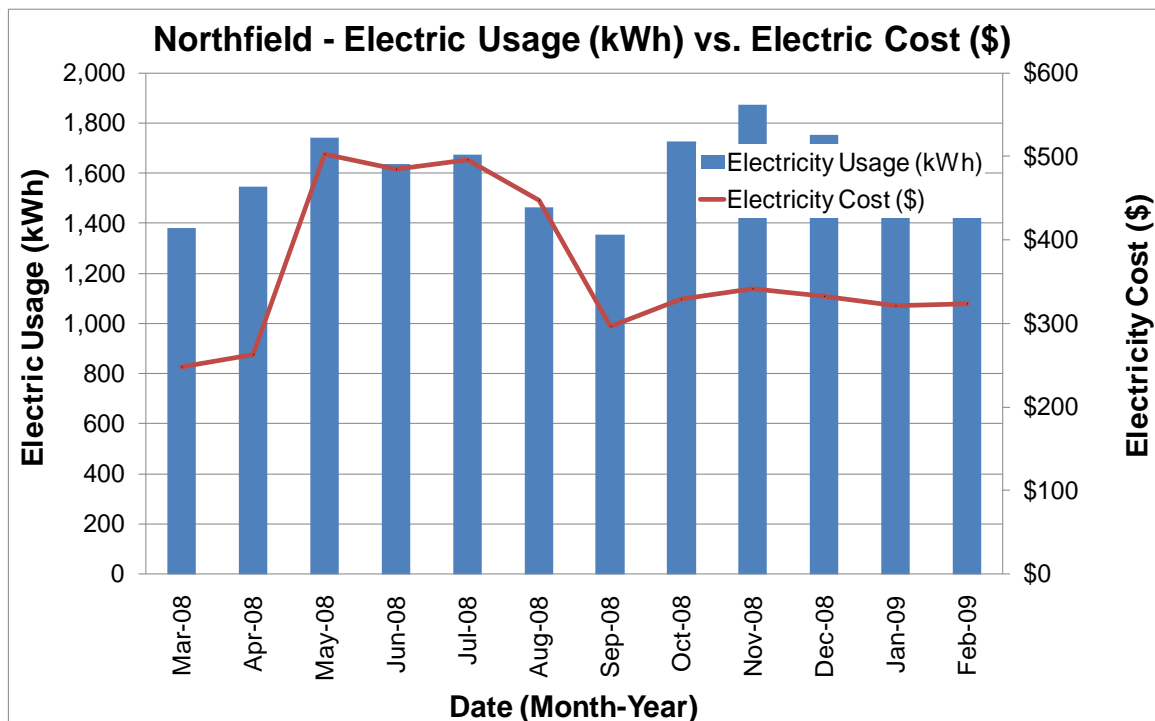
The following chart shows electricity use versus cost for the Northfield Fire Station based on utility bills for the 12 month period of March 2008 to February 2009.

Electricity use follows a trend that is expected for this building with usage peaking during the summer due to DX cooling and also peaks in the winter due to the electric heating equipment. The cost of electricity fluctuates as expected with usage peaking in the summer during the time of highest usage.

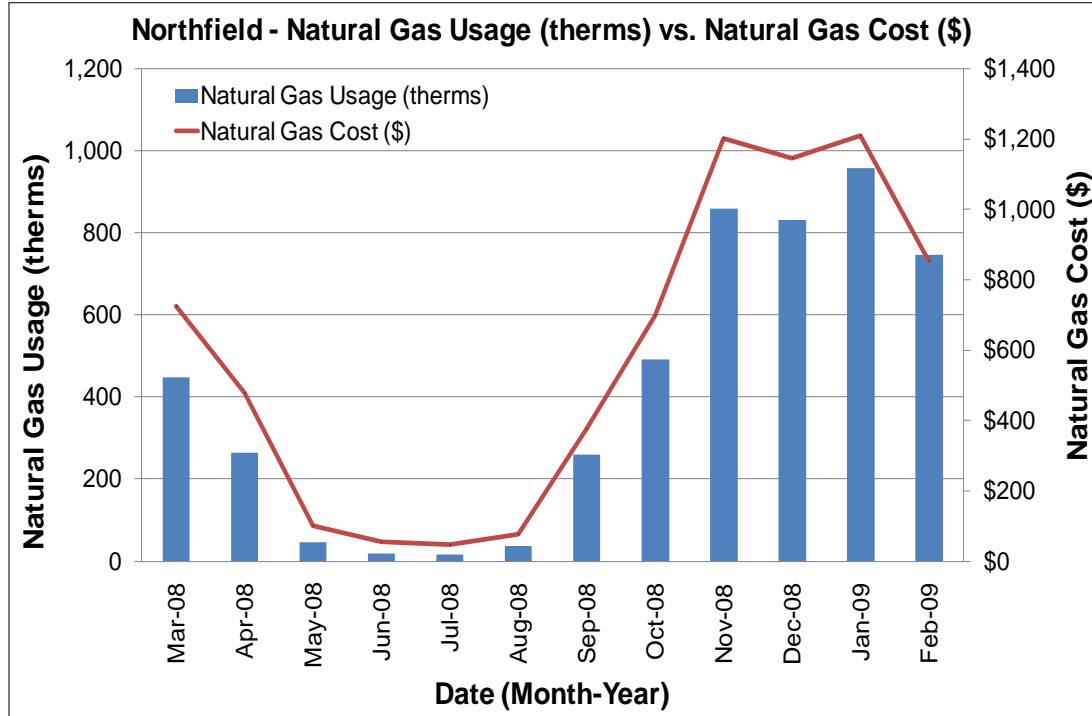
The following is a chart of the natural gas annual load profile for the building versus natural gas costs, peaking in the coldest months of the year and a chart showing natural gas consumption following the “heating degree days” curve.

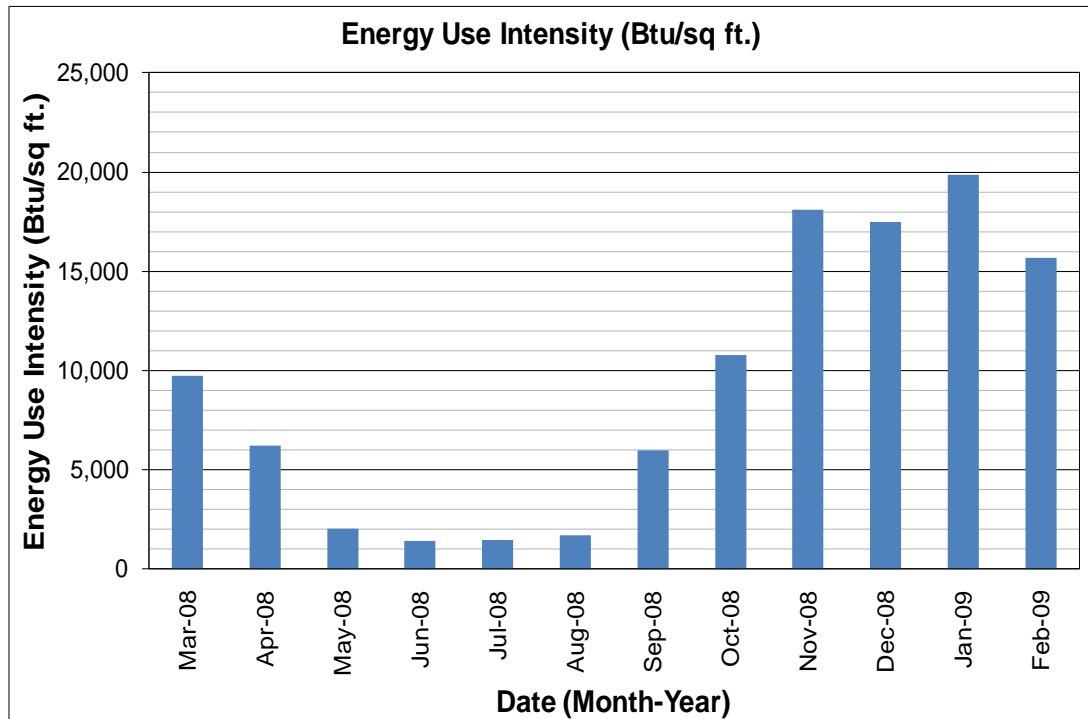
The following chart shows electric consumption in Btu/sq ft for the Northfield Fire Station based on utility bills for the 12 month period of March 2008 to February 2009.

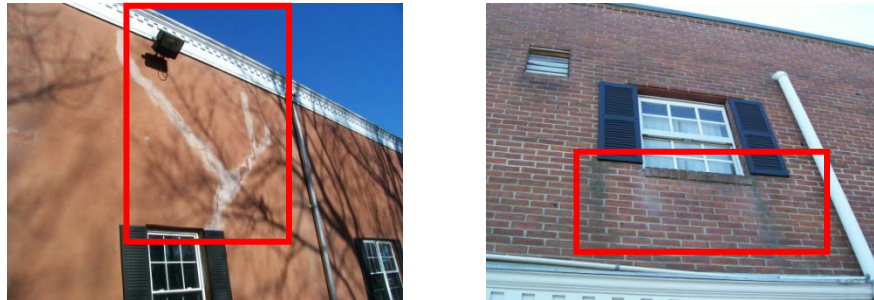
During the field audit exterior and interior wall surfaces were inspected. They were found to be in overall good condition with some signs of uncontrolled moisture, air-leakage and/ or other energy-compromising issues located mostly at the sides of the building.

Examples of water damage and cracked stucco finish

1. Install/ repair and maintain flashing to minimize uncontrolled wind driven and roof water run-off causing exterior wall damage.
2. Insulate original and uninsulated exterior wall sections. SWA suggests applying 2" XPS rigid foam boards to the interior and covering it with gypsum wallboard or other preferred interior finish.
3. Maintain and inspect all exterior wall surfaces with a focus on the condition of caulking, displaced masonry, and signs of water damage and locations that correspond to areas of known infiltration.

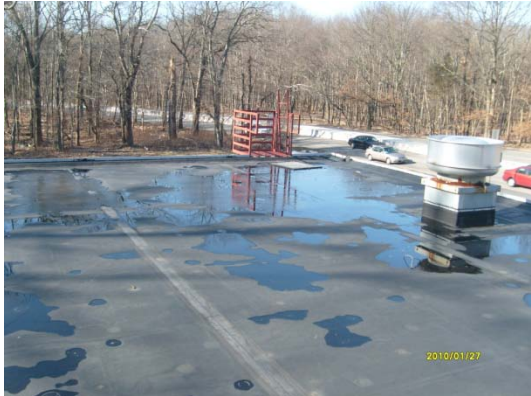
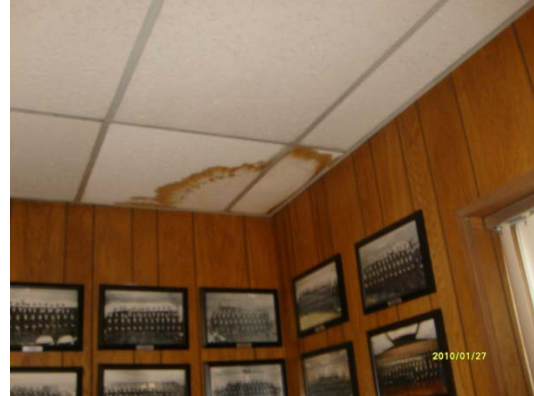
During the field audit roofs, related flashing, gutters and downspouts were inspected. They were found to be in overall age appropriate condition with some signs of water pooling, uncontrolled moisture, air-leakage and other energy-compromising issues mostly detected on flat roof areas.

Signs of water pooling and membrane delaminating on existing roof that correspond with location of known leak visible from the interior.

1. Unclog and maintain all roof drains/scuppers.
2. Repair/ patch roof leakage area.
3. Apply appropriate air/ water-sealing strategies around all roof penetrations (incl. electrical, plumbing and HVAC).
4. Maintain/ inspect all roof surfaces on a regular basis.

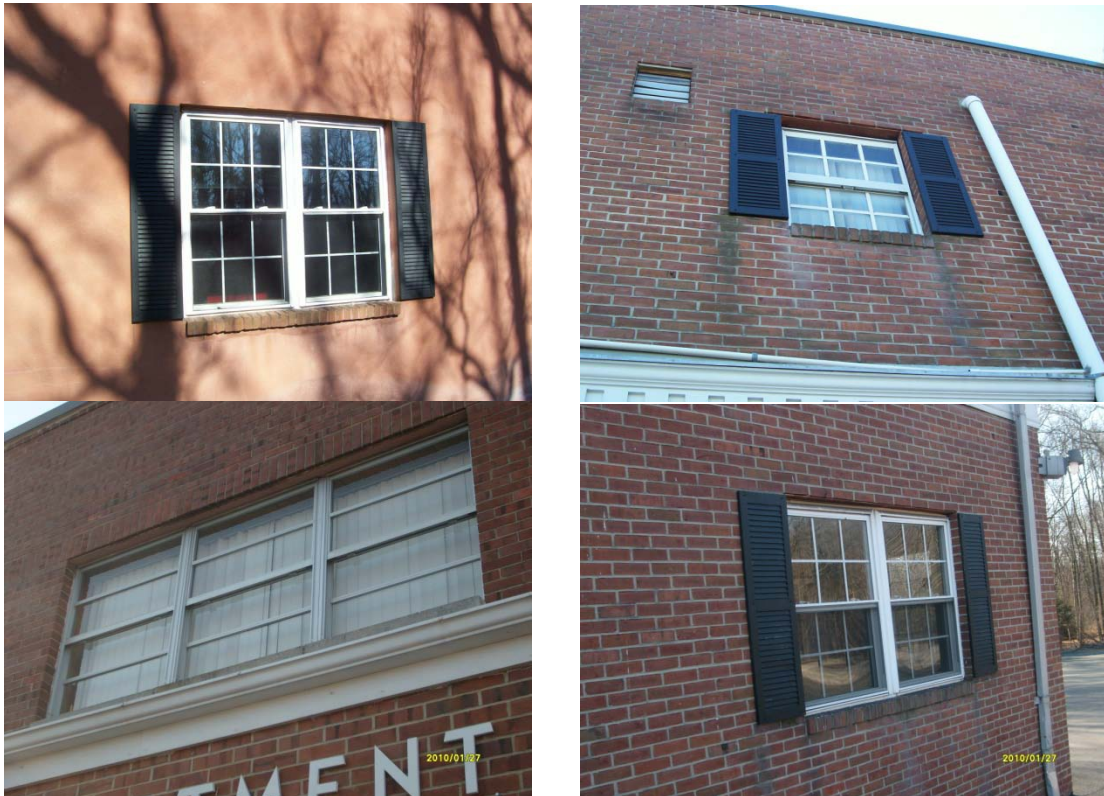
Windows with exposed lintels and signs of water damage at sills and storm doors

1. Replace all original/ single glazed windows with a low-E, double glazed type.
2. Install/ repair pan or strip flashing and drip edge detail at window sill.
3. Maintain and inspect all exterior windows with a focus on the condition of the frames, properly operating hardware, airtight seal and window sill.

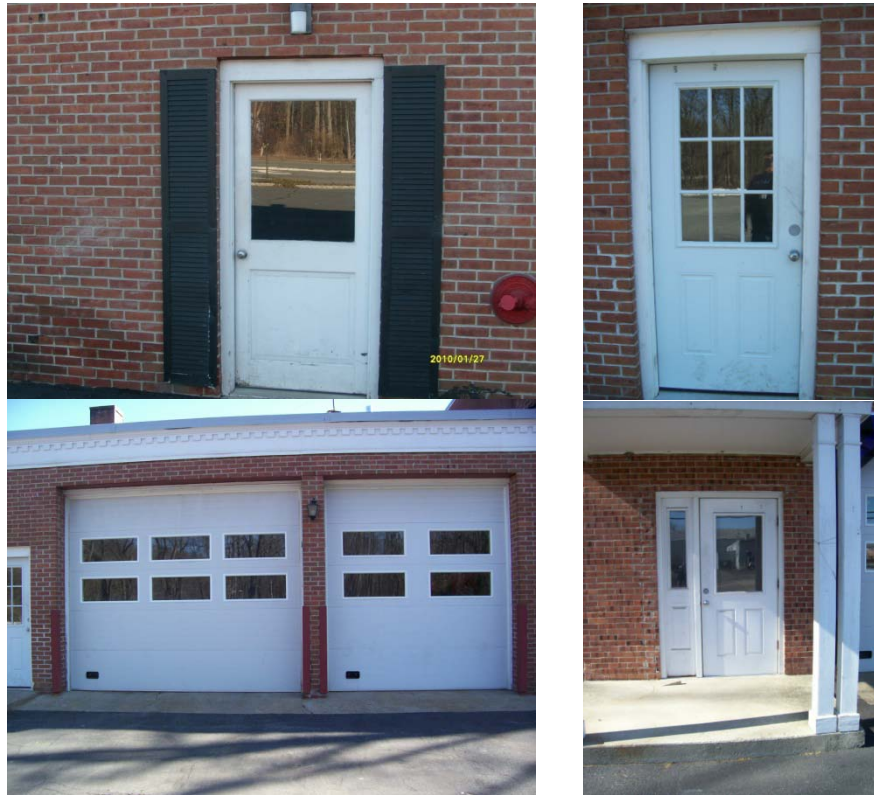
All exterior doors, thresholds, related flashing, caulking and weather-stripping were inspected. Based on signs of moisture, air-leakage and other energy compromising issues, overall the doors were found/ reported to be in acceptable/ age appropriate condition with no signs of uncontrolled moisture, air-leakage and/ or other energy-compromising issues.

All typical exterior doors at the building

1. Maintain and inspect all doors with a focus on the condition of the weather-stripping, door frame, air tight seal and signs of water damage and infiltration.

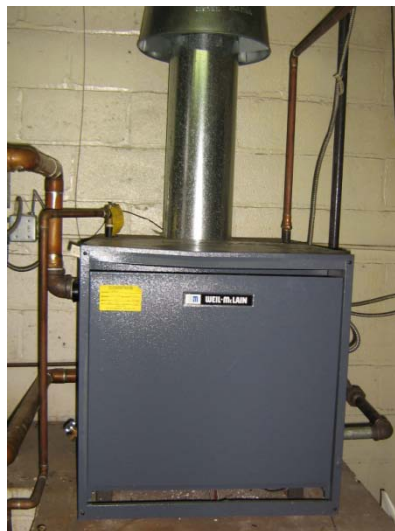
The entire building is heated via a Weil-McLain gas fired boiler. This boiler is circa 2006 and provides 346,000 Btuh of output. It has an estimated remaining life of 85%. Hot water is supplied to radiators in kitchen, stairwells and restrooms, upper level meeting room baseboard radiators, and to (5) forced air unit heaters hanging in the garage. There is also a unit heater in the Tool Room, and one in the Custodian Room. All unit heaters are pre-1990 and are beyond their expected useful life.

Gas fired boiler in Boiler Room

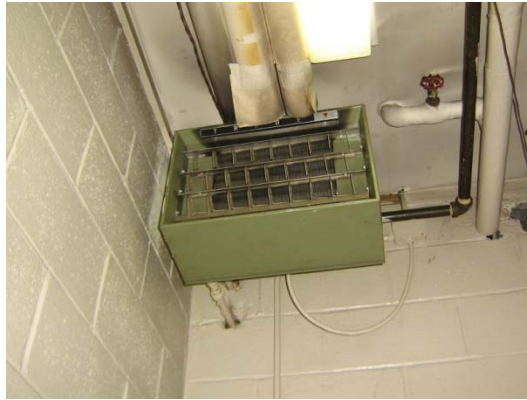
Typical unit heater in Garage.

- Replace heating terminal units- such as baseboard radiators in the finished areas and hydronic unit heaters in the garage. This equipment is in fair condition, but age and wear have reduced the heat transfer capacity. This equipment should be replaced with more modern equipment suited for the intended use. These changes cannot be justified based on energy savings alone. However, replacement is strongly recommended to improve the overall efficiency of the heating system. This is a replacement in kind recommendation which offers negligible energy savings.
- Insulate original and uninsulated exterior wall sections. SWA suggests applying 2" XPS rigid foam boards to the interior and covering it with gypsum wallboard or other preferred interior finish.
- Window replacement - replace all original/ single glazed windows with a low-E, double glazed type.

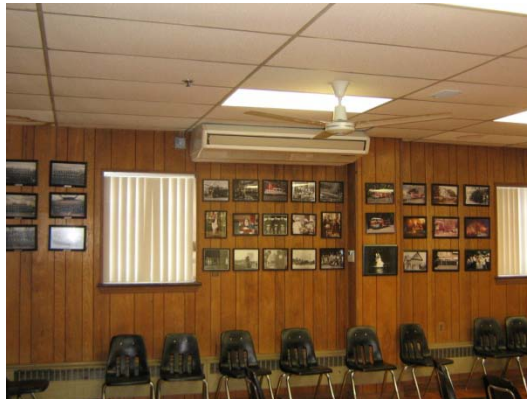
The meeting room is cooled by (2) Mitsubishi split systems, with air handler “cassettes” mounted below the ceiling, and condensing units on the roof outside this area. This system is circa 2003 and has an estimated 65% to 70% remaining life span. The cold air blows out the side of the cassettes into the meeting room (2 locations).

Split system cassette on 2nd floor (typical for 2)

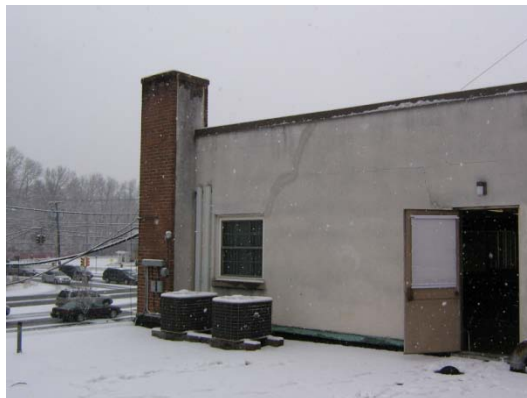
Split system condensing units on roof

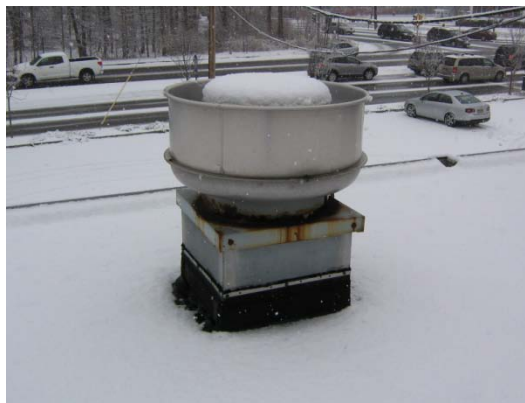
The garage area is ventilated via (2) vehicle exhaust fans. These fans are circa 1993 and have an estimated remaining useful life of 15%. There is a roof exhaust fan that exhausts the restrooms (no nameplate - age unknown). There is also a kitchen hood exhaust fan (no nameplate – age unknown).

Kitchen hood exhaust fan on roof

The building rooftop exhaust fans are in fair condition and should be considered for replacement. SWA recommends replacement of five (5) building roof exhaust fans that are operating near the end of their useful lives. Since this station is for volunteer firefighters and primarily unoccupied except for training and events, SWA estimated 500 annual hours runtime for the fans. The motors are small, in the 1 horsepower range, and replacement units will have small energy savings over the existing.

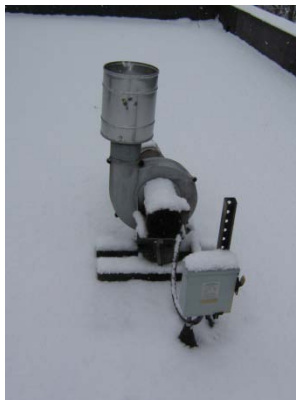
Vehicle exhaust fan on roof

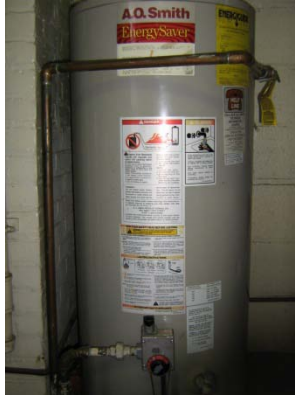
The domestic hot water for the building is provided by a gas-fired, 40 gallon, 40 MBH tank-type water heater, located in the mechanical room. This water heater is from 1997 and is at the end of its expected life span.

Domestic water heater

There is one (1) gas-fired domestic water heater that serves a kitchen and toilet rooms on each level that are utilized for the entire year. This unit typically achieves approximately 70% efficiency in natural gas usage considering its current age. This equipment is approaching the end of its expected service life and should be replaced. The Northfield Fire Department can realize energy savings by installing a direct vent high efficiency water heater. This type of heater can achieve up to 95% efficiency. This measure cannot be justified by energy savings alone, but should be considered as an end-of-life energy savings opportunity.

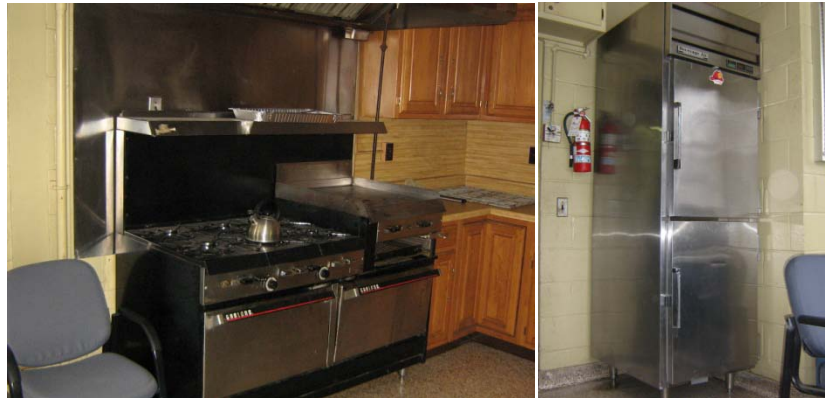
This building has a small commercial type kitchen with exhaust hood over gas range/griddle and a commercial refrigerator. Age of items is unknown. The kitchen contains commercial equipment that was observed in good condition. Based on the condition of the equipment, SWA has determined it would not be cost effective to replace at this time.

Commercial refrigerator and cooking equipment below exhaust hood
