**Local Government Energy Program
Energy Audit Report**

***Township of Livingston
Well Houses No. 3, 4, 9 and 11)
Livingston, NJ 07039***

Project Number: LGEA50

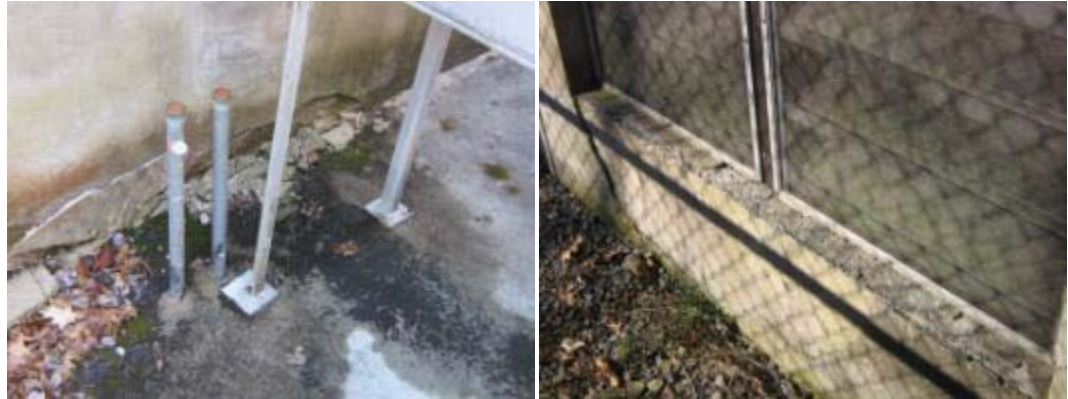
Both buildings are constructed of un-insulated CMU walls with a stucco veneer. The stucco veneer on Deep Well #1 is water marked, stained and deteriorated with significant cracking occurring along the underside of the roof the entire length of the west wall, as were numerous spider cracks on all other sides. Clear Well #2 has significant deterioration of the stucco at the base of the north wall, below the louvers on the east wall and at the N/W corner below the roof.

Serious deterioration of stucco on north and east sides of building

It is recommended that the stucco veneer of both Deep Well #1 and Clear Well #2 be repaired or replaced. Replacement would permit 1" rigid insulation board to be applied to the exterior of the CMU walls and a finished coat of stucco applied over the insulation.

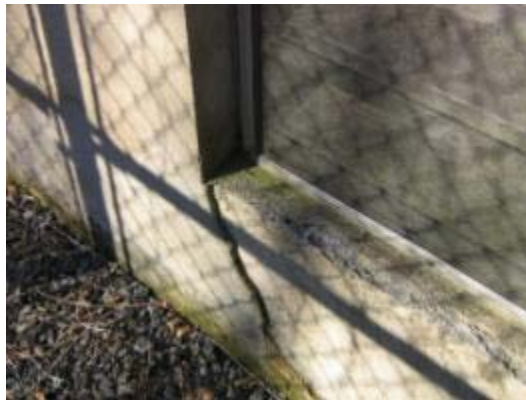
Serious deterioration of stucco on east side of building

Based on the visual inspection it was noted that the stucco along the base of the south wall and east wall of Clear Well #2 was repaired with a patching material. The area surrounding Well Three is constantly flooded during the wet seasons, but the flood waters have not reached the floor elevation of either building, even during significant hurricanes. Animals such as ground hogs have been a persistent problem, burrowing below the slab.

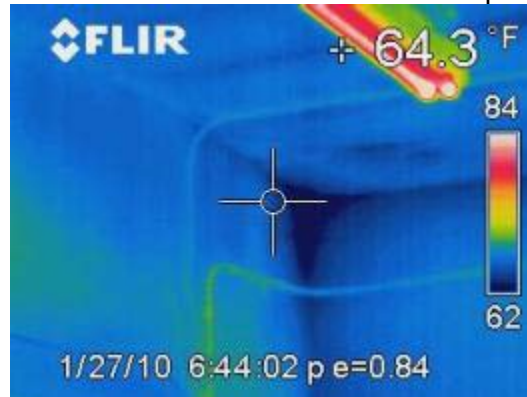
The exterior walls of the Clear Well are constructed as a cavity wall with an exterior wythe of brick and interior wythe of acoustical CMU. The brick is in excellent condition. There are no windows on the exterior walls. The Deep Well is constructed with CMU walls and a stucco finish. It appears from the visual observation that the exterior walls are un-insulated. Since the Deep Well is connected to the pool building only two walls (north and east) are exposed exterior walls, the south and west walls are common to the pool building. At the S/W corner of the building there is a large crack through the structure. The IR image indicates the presence of moisture in the wall. There is also a

Infrared Image at Southwest Corner at Ceiling

large crack through the north wall at the joint connecting it to the pool building. Both conditions should be corrected with installation of an expansion joint cut into both walls.

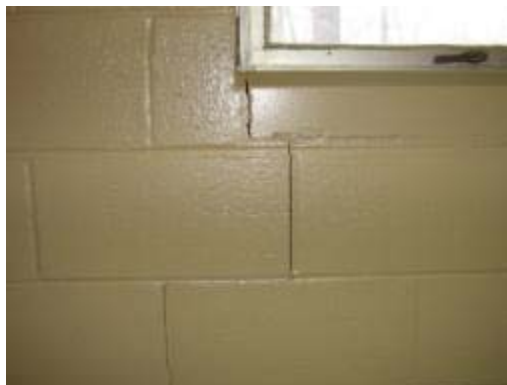
The exterior walls of both buildings are cavity walls constructed of a double wyeth of brick on the exterior and CMU on the interior separated by a cavity. Although the cavity could not be inspected it is assumed there is 1' rigid insulation within the cavity. The exterior of both building is in excellent condition. The only identifiable flaw is a crack through the N/W wall of the Deep Well at the window sill.

Through Wall Crack In Northwest Wall Of Deep Well

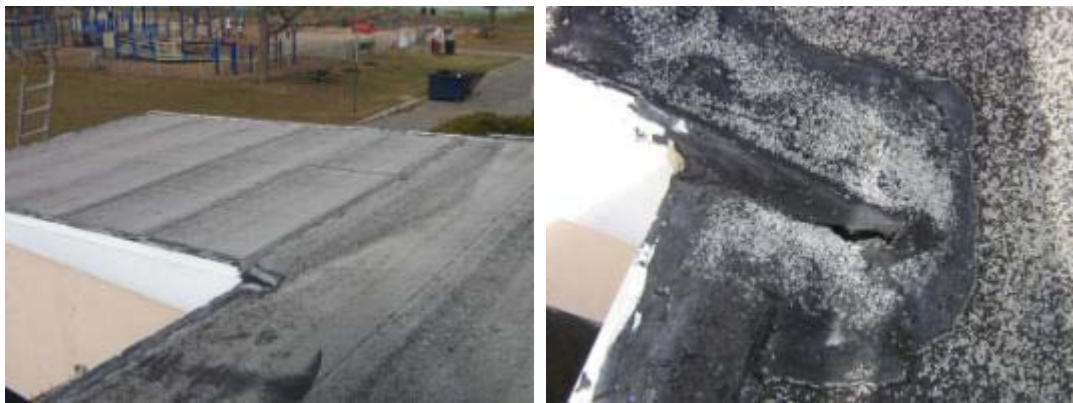
Roof of Deep Well; Roof Joint at Pool Building

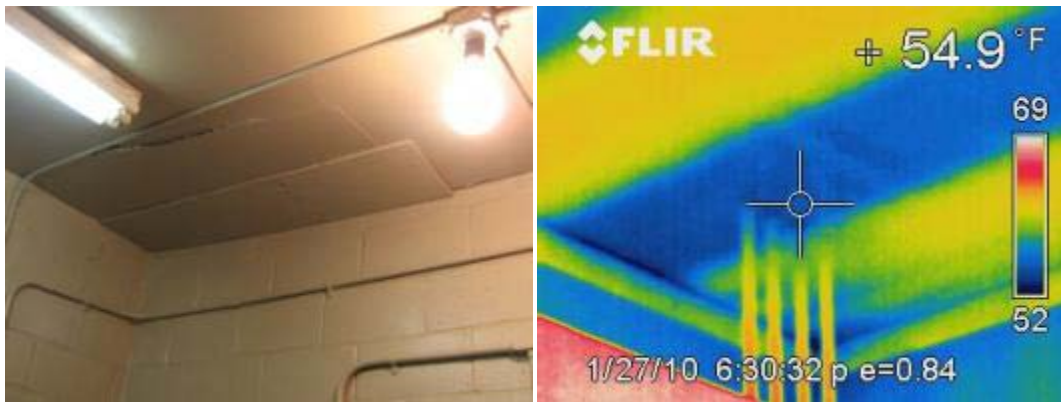
Digital Photo and Infrared Image of Plywood Panel

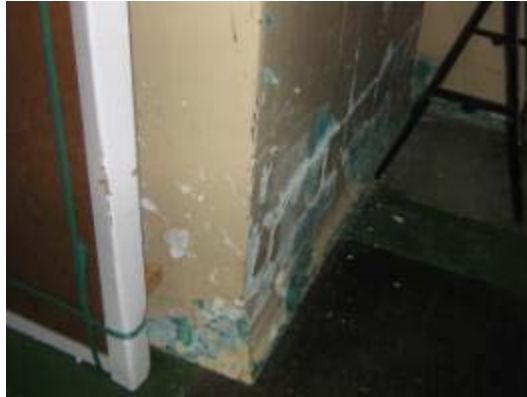
Both buildings are built slab-on-grade with wells below. The slabs are 8" thick and epoxy coated. Based on the visual observation there doesn't appear to be any significant deterioration to the concrete. However, there is paint peeling at the base of the wall surrounding the storage room. This may have been caused by moisture, but no other conditions indicate a moisture problem.

Peeling Paint

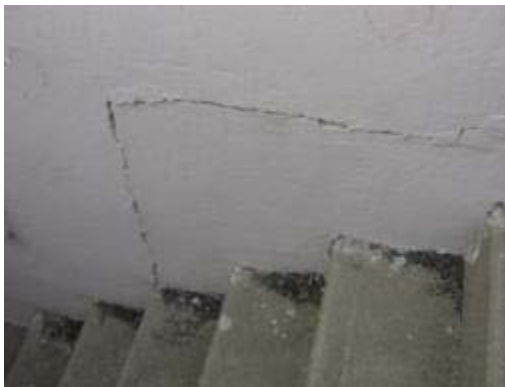
The Clear Well is built on an 8" concrete base and is in excellent condition. The Deep Well has a basement stair alongside its east wall leading to a basement below the pool building. There is deterioration along the east wall below the floor line of the Deep Well.

Deterioration Below Floor Line along East Wall of Deep Well

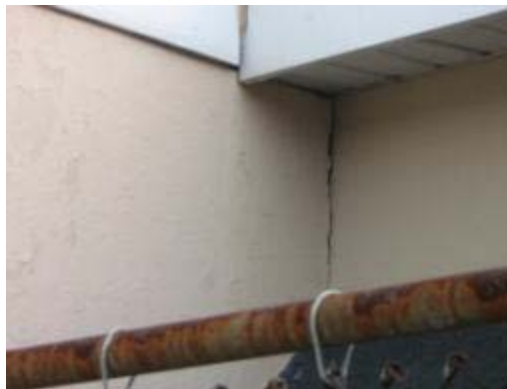
Large Crack Through Wall At Joint With Pool Building

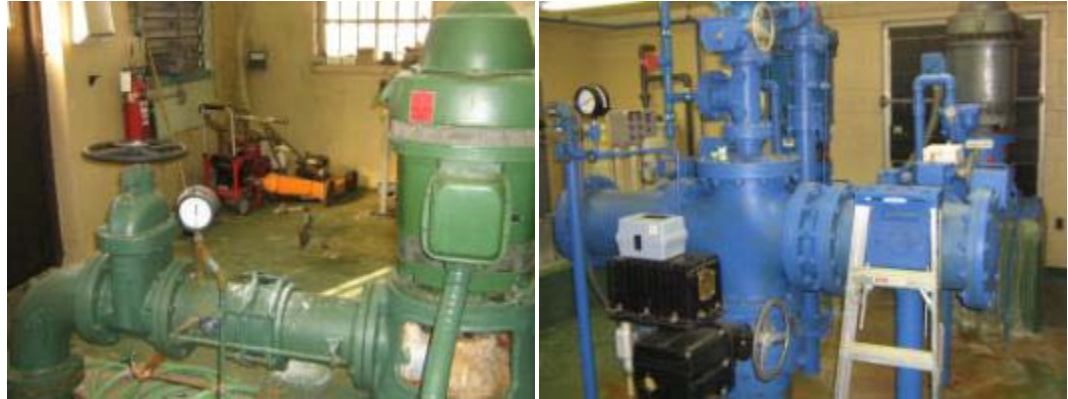
It was reported by the Water Department personnel that the water pumps operate from 5 to 15 hours per day on average, depending on demand. For the purposes of calculating energy conservation measures, SWA will assume an average operating time of 10 hours per day, or 3,650 hours per year. In addition, it is assumed that the stripper tower blowers operate for the same time approximately periods as the pumps.

Deep Well Pump (Left) and Clear Well Pumps (Right)

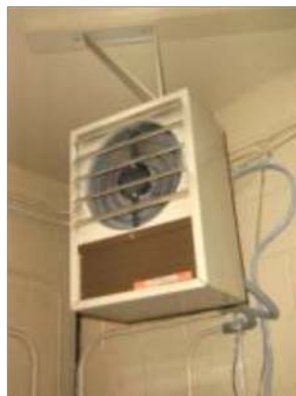
The Clear Well building is heated by a 10 kW electric unit heater that is suspended from the ceiling.. The unit heater is beyond its expected service life but is still in good condition. The Deep Well building is heated by a 7.5 kW electric unit heater that is suspended from the ceiling. The unit heater was installed in 1967 and is in fair to poor condition.

Photo – Electric Unit Heater (circa 1967) in Deep Well Building

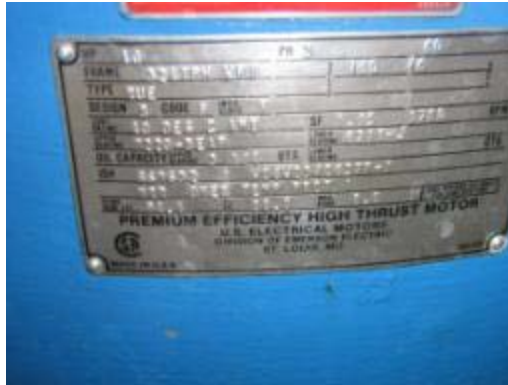
The Clear Well Building contains one (1) 40 HP well pump that was installed in 1993. The pump motor is a premium efficiency unit. In addition, there are two (2) small, fractional horsepower chlorine injection pumps. Aside from this equipment, this facility contains one (1) blower ducted to an exterior stripper tower and also to a dedicated intake louver. This blower had no visible nameplate, but it is estimated that it is served by a standard efficiency, 5 HP motor.

Clear Well Pump Nameplate

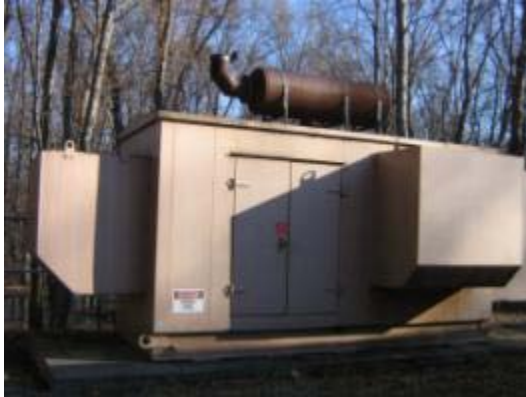
There is one (1) 558.5 KW diesel emergency generator on site. The generator serves the entire facility to provide continuous service during a power outage. This generator was installed in 1993 and is in good condition.

Emergency Generator at Well House #3
