**Local Government Energy Program
Energy Audit Final Report**

***Mullica Hilda Frame School
3410 Nesco Road, Hammonton, NJ***

Project Number: LGEA44

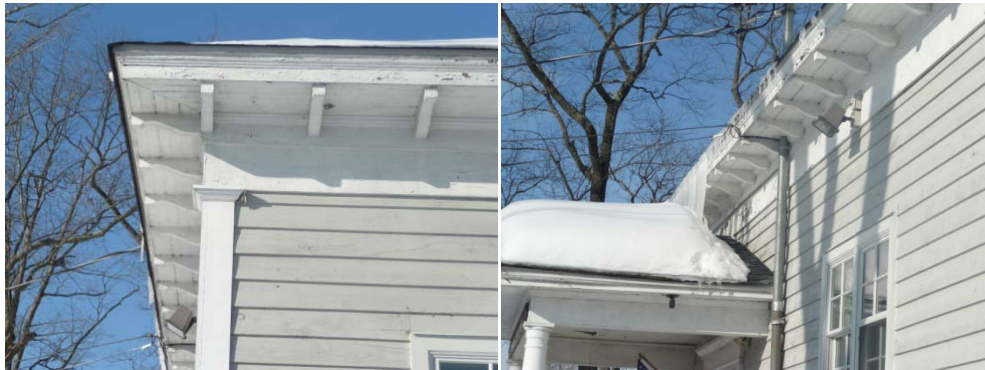
The Mullica Hilda Frame School building is an old wood frame building with a peaked roof and a center roof cupola, which serves as attic ventilation as well as decoration. The inside building walls are plaster-based with the outside covered in recent years with wood clapboards. Exterior wall insulation levels could not be visually verified, however there was minimal to no insulation apparent in the outer walls detected in a couple of exposed places. The basement has concrete walls that appear to stay dry except for outside water running down the back staircase when it is wet outside.

Clapboard wood siding upgraded in 2005

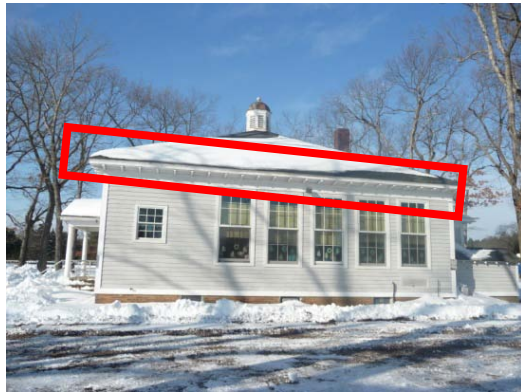
Soffits in need of gutters

panels to prevent access to birds and rodents. Insulation should be consistent and tight throughout the attic. Installation of building gutters is highly recommended.

- Maintain roofs - SWA recommends regular maintenance to verify water is draining correctly.
- Maintain downspouts - Repair/install missing downspouts as needed to prevent water/moisture infiltration and insulation damage.

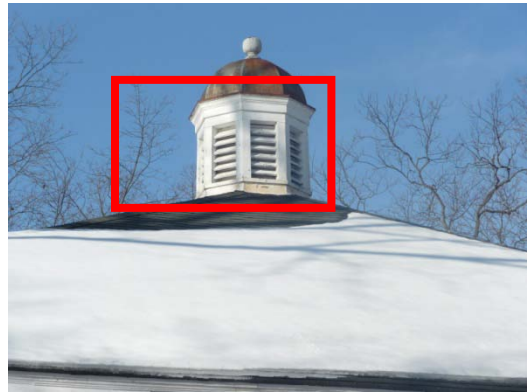
Cupola in need of refurbishing

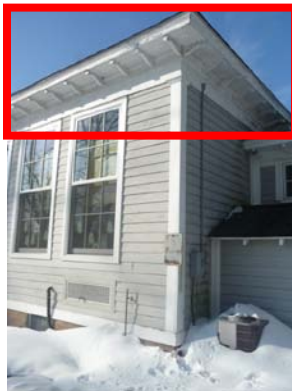
The existing main roof is a pitched roof with new, dark brown asphalt shingles installed in 2005. Underneath the roof shingles is a layer of treated plywood and a vapor barrier above the existing roof framing. The missing gutter is allowing water run-off to wear out the soffits, evident by the peeling paint. The cupola is also in need of refurbishing. There have been reports that squirrels have been entering the attic space, perhaps via rotted soffit wood members or the cupola. The back staircase roof may need to be replaced in the near future,

since the asphalt shingles are showing signs of age such as curling at corners and moss growth in a few areas.

Back staircase roof cover showing wear-and-tear and moss growth

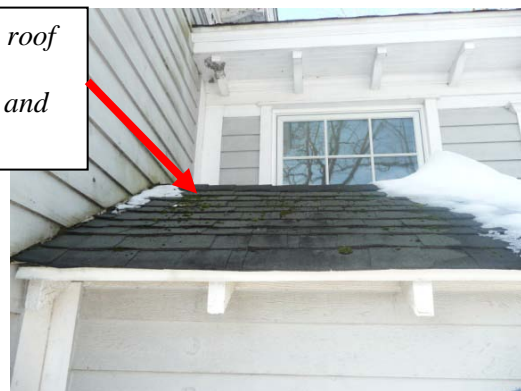
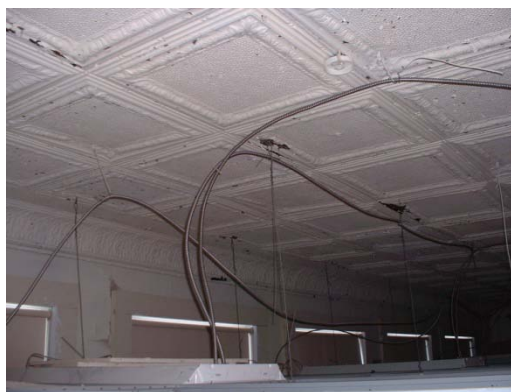
Old metal ceiling above the drop ceiling

The attic insulation is minimal and original to the building. Whatever insulation is still left in the attic is located above the metal ceiling which is above and supporting the drop ceiling. SWA recommends blowing in low density cellulose insulation to approximately 1 ft high, as well as repairing/closing up attic penetrations and wrapping wire meshes on ventilation

- Thoroughly and evenly insulate space above the ceiling tiles, and plug all ceiling penetration. SWA recommends blowing in low-density cellulose insulation above the metal ceiling (which is above the drop ceiling) to approximately 1 ft high

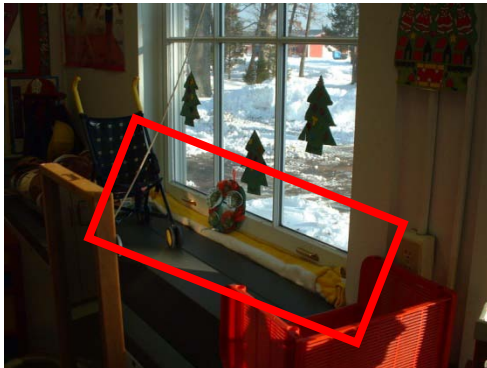
Most of the original building windows have been replaced in 2005 with wood framed, operable double-hung, double-pane low-e windows. The one lingering issue with the new windows is the latch adjustment from summer to winter conditions. At the time of the field audit, the new windows did not close all the way and towels were being used to make the bottom seal.

Window latching issues have caused occupants to use towels to seal bottom of windows

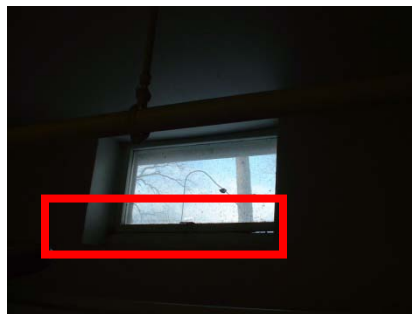
The couple of single-pane, thermally inefficient windows in the basement are not well sealed to the walls and allow conditioned air to escape to the outside. As a best practice, SWA recommends that all windows be inspected at least once a year. Any gaps, cracks, or damage to weather-stripping or caulking should be repaired or replaced, as needed, to minimize energy loss around those openings. Building staff should also verify that windows open and close properly, and repair them as needed.

Basement window in need of perimeter sealing and caulking

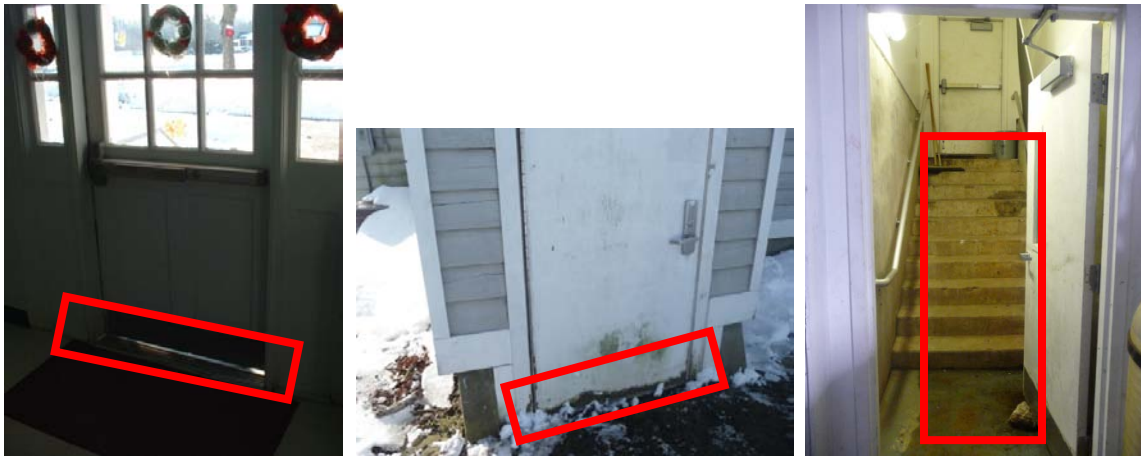
The Mullica Hilda Frame School building has one front exterior aluminum door and one back exterior aluminum door, both with vision panels. The exterior doors were inspected and found to be in acceptable condition. All doors are in need of new weather-stripping. Therefore, all exterior doors of the building should be weather-stripped in order to decrease the amount of conditioned air that is lost around each door. The basement outside door is in very poor condition, and the cost to refurbish it will be more than installing a replacement. SWA also recommends checking the weather-stripping of each door on a regular basis and replacing any broken seals. Tight seals around doors will help ensure the building to be is kept continuously insulated.

Front door in need of stripping (left), Back basement door deteriorating (center), Water on basement stairs (right)

- Replace weather-stripping/air-sealing - SWA observed that exterior door weather-stripping in places was deteriorated, and water was entering the basement through the back exterior door. Doors and vestibules should be observed annually for deficient weather-stripping and replaced as needed. The perimeter of all window frames should also be inspected regularly, and any missing or deteriorated caulking should be re-caulked to provide an unbroken seal around the window frames. Any other accessible gaps or penetrations in the thermal envelope penetrations should also be sealed with caulk or spray foam.

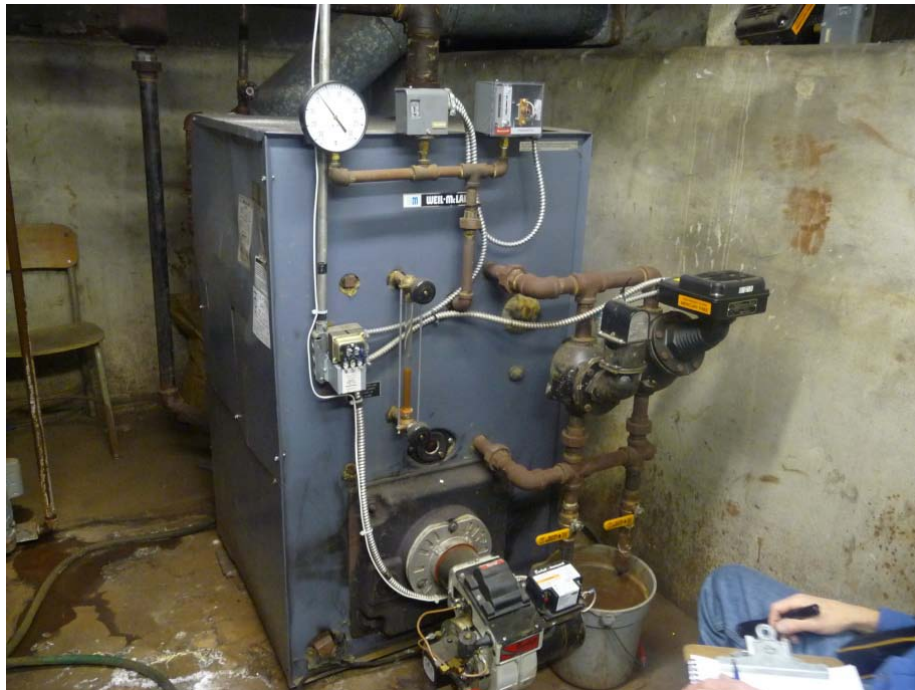
Steam heating is provided by a Weil McLain steam boiler with 400,000 Btu/hr capacity. The boiler serves steam radiators at the perimeter of the building. There are hot water heating coils installed within the unit ventilators, but the hot water system was never installed. The steam radiators adequately provide heat to the space and therefore it is not recommended to install a hot water system to serve the unit ventilators. The boiler burns fuel oil supplied by a 1,000 gallon storage tank located outside.

The steam boiler has 70% remaining useful life and appears in good condition.

Weil McLain steam boiler in basement mechanical room

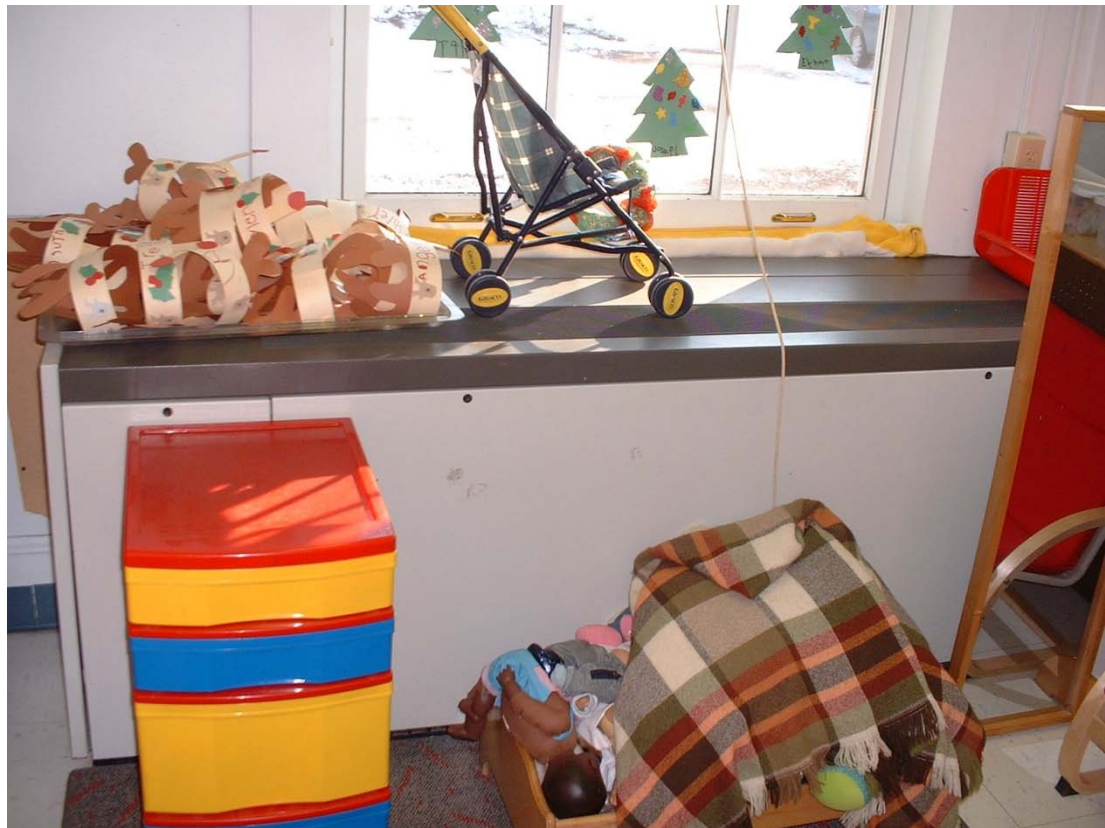
The Mullica Hilda Frame School is cooled by a split DX system consisting of an evaporator section within wall-mounted Unit Ventilators and separate condensing unit outside. There is one 3 Ton unit ventilator per classroom.

Outdoor air enters from the intake of the unit ventilator and a supply fan draws the air past the evaporator coil, which cools the air. This cool air then continues into the occupied space. The refrigerant waste heat is expelled to the atmosphere through separate Trane condensers located outside each classroom. The Trane condensers have 80% remaining estimated useful life and are in good condition. The unit ventilators also have 80% remaining estimated useful life and appear to be in good condition. SWA recommends removing all items from the supply diffuser of the unit ventilator to ensure proper distribution of air, as seen in the photo below.

Typical classroom unit ventilator, providing outside air ventilation and cooling
