**Local Government Energy Program  
Energy Audit Final Report**

***T. Baldwin Demarest Elementary School  
Old Tappan Board of Education  
Old Tappan, NJ 07675***

***Project Number: LGEA07***

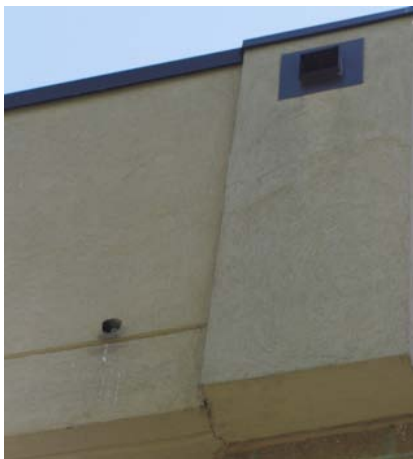
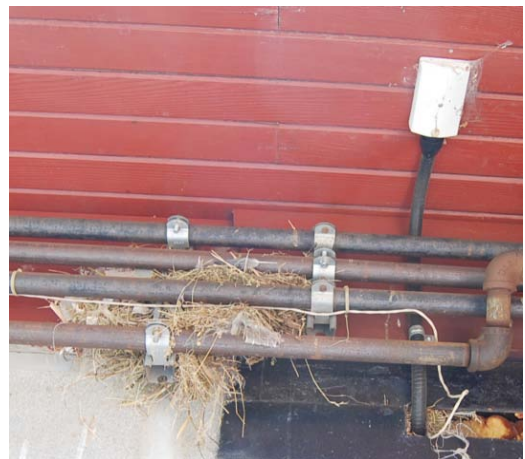
The exterior walls consist of 8" CMU blocks with either a brick veneer or split block finish and some EIFS (Exterior Insulated Finishing System) installed in the gymnasium parapet area. Due to warm temperature conditions at the time of the field visits, insulation levels could not be verified with help of infrared technology. If desired, the school could contract a separate envelope inspection during cooler months.

Except in the parapet area of the new gymnasium and under the soffit in the original school building, where some signs of bird's nesting were observed, overall, exterior and interior finishes of the envelope walls were found to be in age-appropriate, good condition.

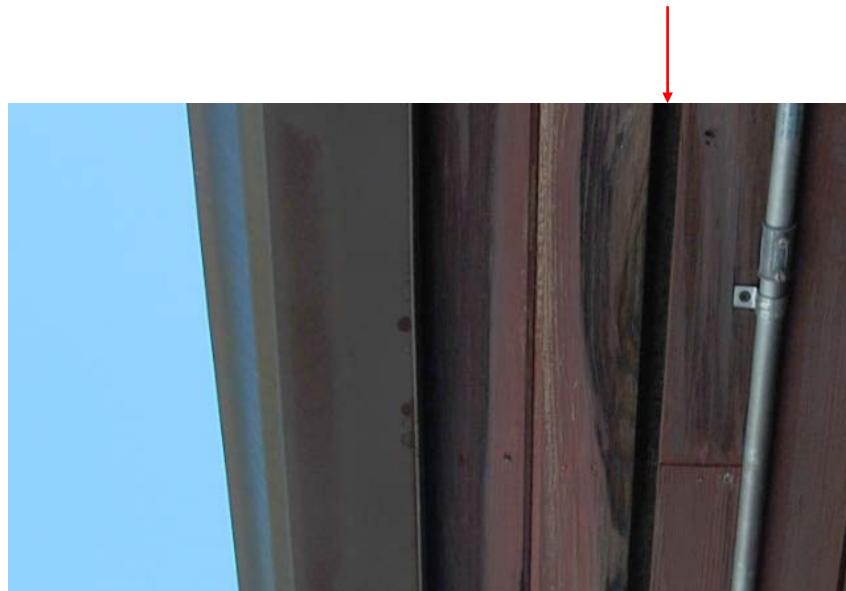
The flat areas are constructed of a dark colored modified bitumen roof with some parapets decorated with standing seam metal mansard type roofing. Light colored newer asphalt shingles cover some of the inclined classroom areas. The specified 4" foam insulation over the steel decking could not be verified on flat roofs and the visual R-19 fiberglass batts under sloped roofs is inadequate. As mentioned under 2.3.1 Exterior Walls, a separate envelope inspection should be conducted during cooler months. SWA suggests basing further insulation related improvement discussions on the outcome of those future findings.

Flashing issues were identified mostly around the perimeter of the TBD Elementary School. Upon further inspection, the installed cap flashing seams on the parapets show signs of leakage. This can be seen on exterior wall surfaces as vertical lines. Identified problems like flashing or other water related issues are pointed out in this report simply since any moisture inside exterior walls can have substantial effect on insulation and other energy related issues.

Warranty and performance of the asphalt roofs might be compromised due to what seemed clogged or dirty soffit ventilation strips. A ridge vent was identified but attic access could not be provided and therefore unobstructed airflow from soffit vents to the ridge vents could not be inspected. SWA suggests replacing and possibly enlarging the vent strips.
