**Local Government Energy Program
Energy Audit Final Report**

Readington Municipal Building
Whitehouse Station, NJ 08889

Project Number: LGEA53

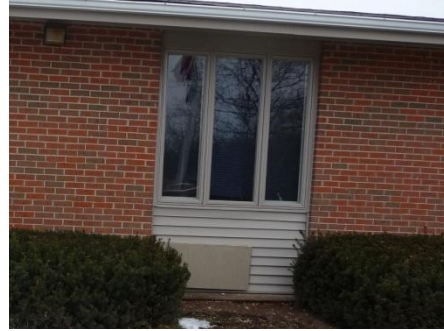
typical window types

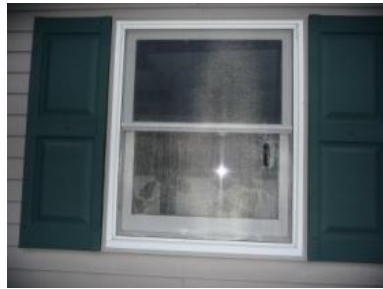
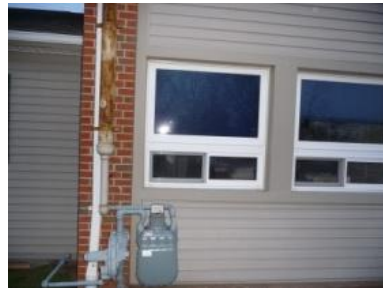
The following specific window problem spots and areas were identified:

1. The perimeter of all window frames should be regularly inspected and any missing or deteriorated caulked areas should be re-caulked to provide an unbroken seal around the window frames.
2. SWA suggests that at the next major renovation replacement of older windows with newer advanced insulated windows with low-E, argon filled double (or triple) glazed type with

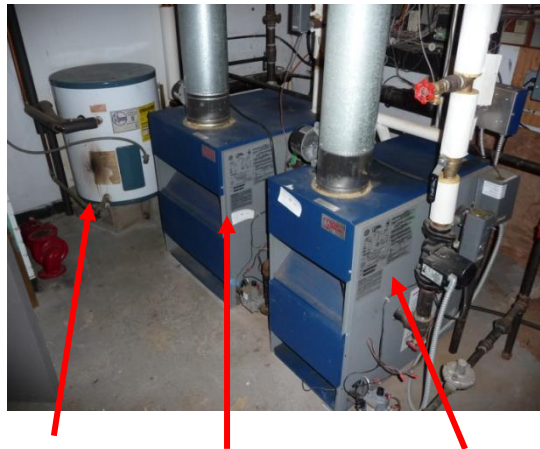
Old Courtroom area DHW; Middles section Utica boiler; Utica boiler for old Courtroom AHUs

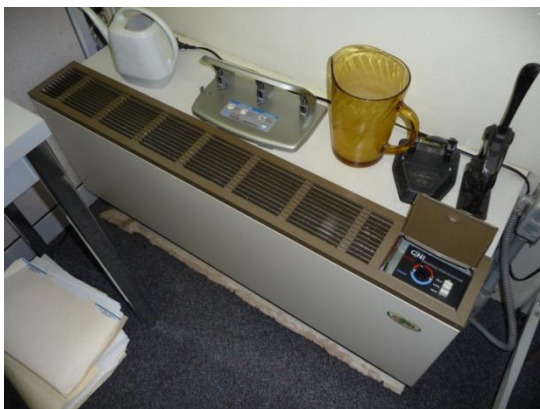
Comitale National Inc. through the wall unit

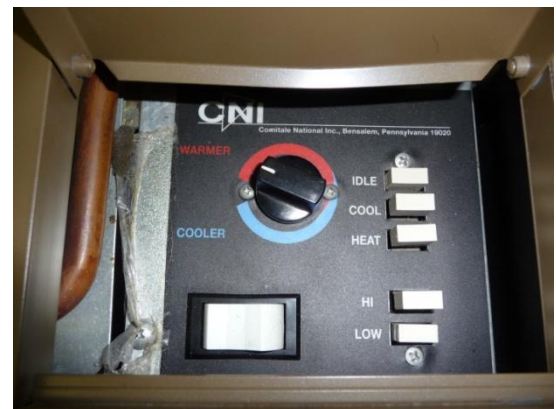
Comitale National Inc. unit manual controls

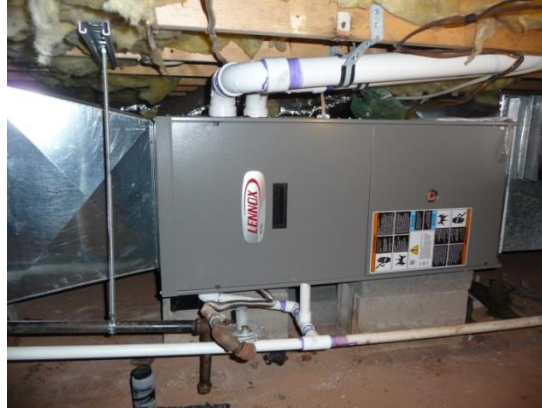
Code Enforcement condensing furnace in crawl space installed on the horizontal

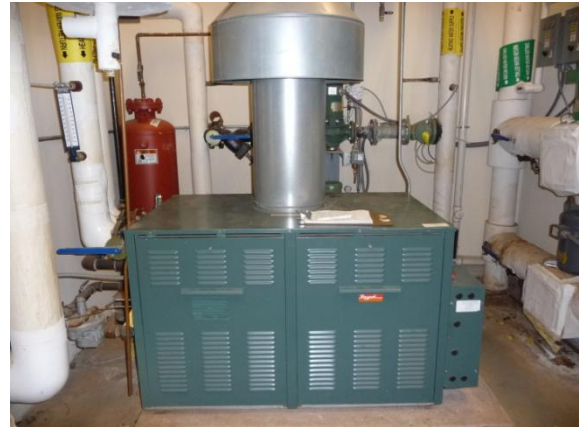
New Addition Raypack boiler

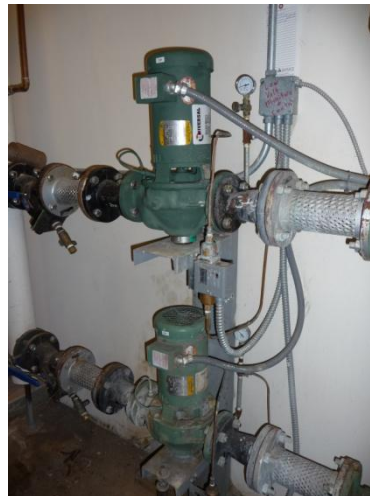
New Addition hot water circulating pumps

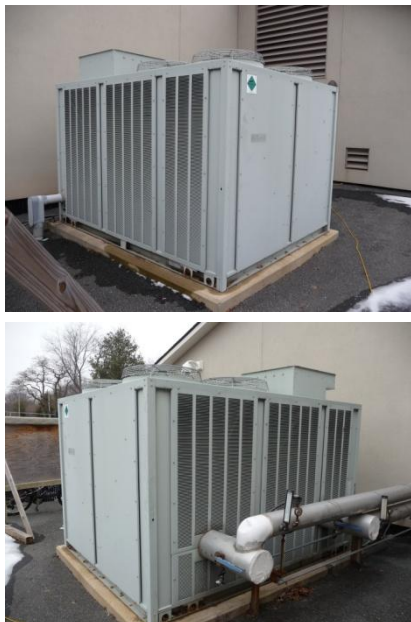
The new 2001 Lobby, Courtroom and Police Department addition is cooled via two attic Trane AHUs described in the above section 2.4.1 Heating. Cold air from the AHUs is delivered via VAVs (with re-heat hot water coils for tempering the cold air as needed) and ceiling diffusers to various spaces the system serves. The AHU cooling evaporator coils are cooled with chilled water glycol solution supplied by an outside 60 Ton Trane air cooled chiller which has 40% left of its estimated useful life. On the day of the audit the chiller circulating pump was running all the time since the glycol-water solution has not yet been tested and Maintenance did not want to risk catastrophic freezing. SWA recommends that the glycol concentration be tested simply by using a specialized density kit and adjustments be made as needed in order to shut pump down when cooling is not required. Also, it was reported that chiller circulating pump motors are frequently replaced. SWA believes that this may be due to cavitation (poor pump suction piping arrangement) which could be heard when standing next to the chiller.

Chiller and water-glycol solution circulator pumps

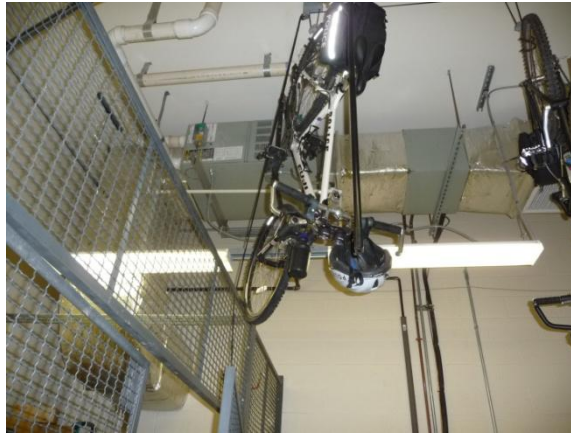
Police Department Sally Port evaporator coil and furnace (back of bicycles)

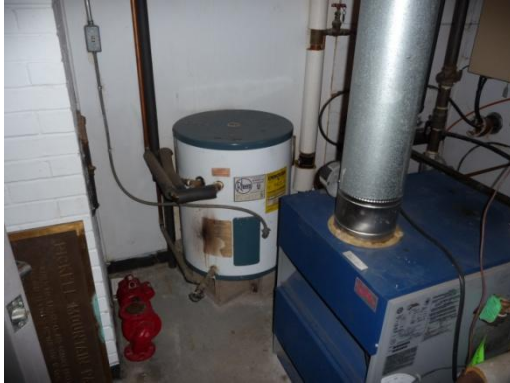
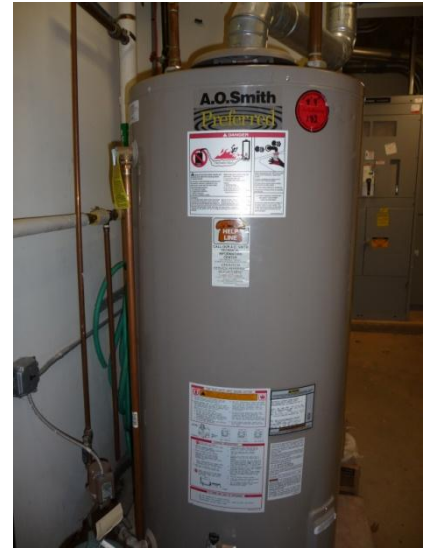
The domestic hot water (DHW) for the old Courtroom bathrooms and utility sink is provided by a RehemGlas electric heater with 20 gal storage and 2,000 Watt upper/2,000 Watt lower electric coils with 10% estimated useful operating life left. SWA recommends that this unit is replaced with a high efficiency inline condensing type gas fired heater when it has reached the end of its operating life. DHW is provided to the rest of the building by an AO Smith natural gas fired heater with 100 gal storage and 75,000 Btu/hr capacity. This heater is 95% efficient and has 70% estimated useful operating life left.

Left: Old Courtroom electric DHW; Right: New Addition natural gas fired DHW

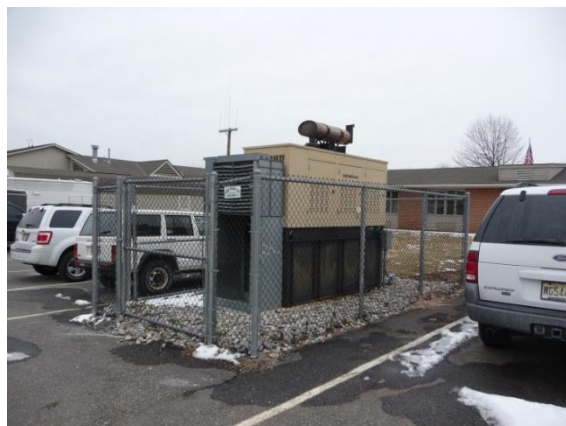
Besides a few small transformers in satisfactory condition and a 130 kW emergency generator (which has 50% left of its estimated useful life), there are not currently any other significant energy impacting electrical systems installed at the Municipal building.

Generac 130 kW Diesel driven generator
