**Local Government Energy Program
Energy Audit Final Report**

South River Human Services Building
South River, NJ 08882

Project Number: LGEA48

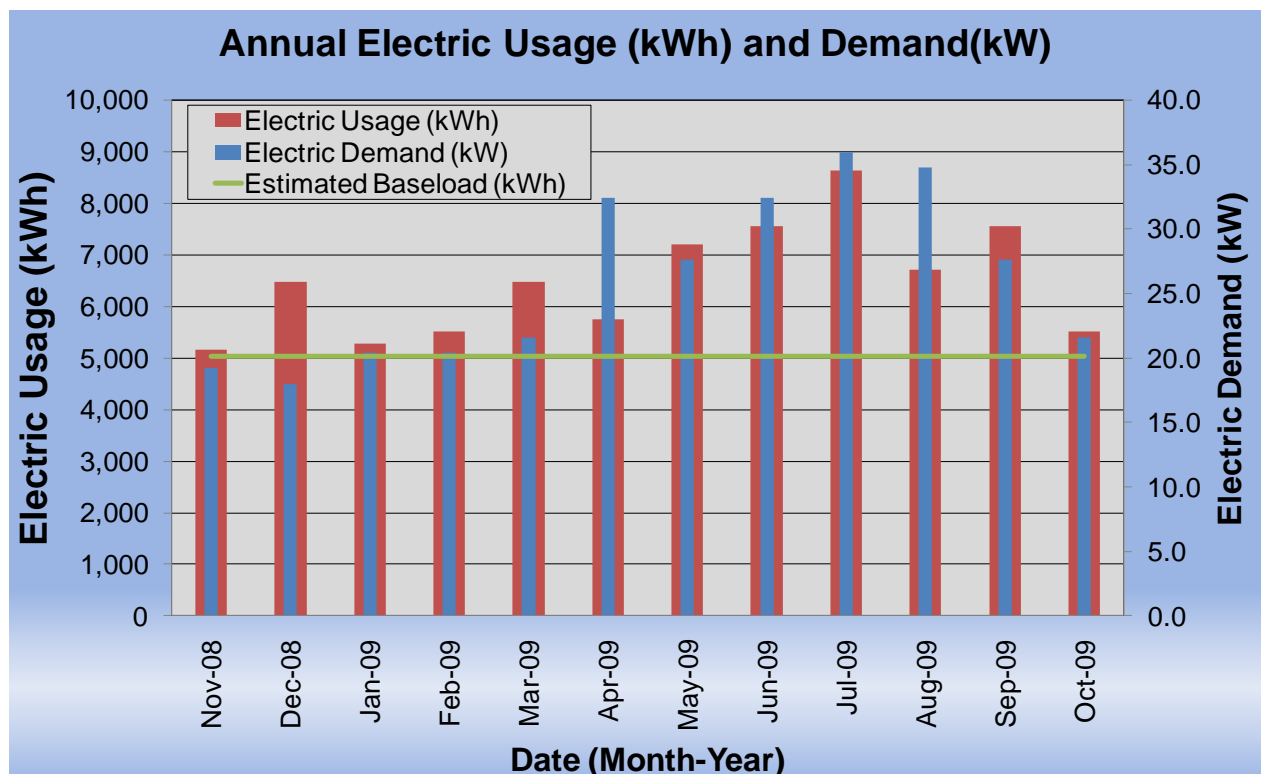
The following chart shows electricity consumption for the Human Services Building based on electric bills for the 12 month period of November 2008 through October 2009.

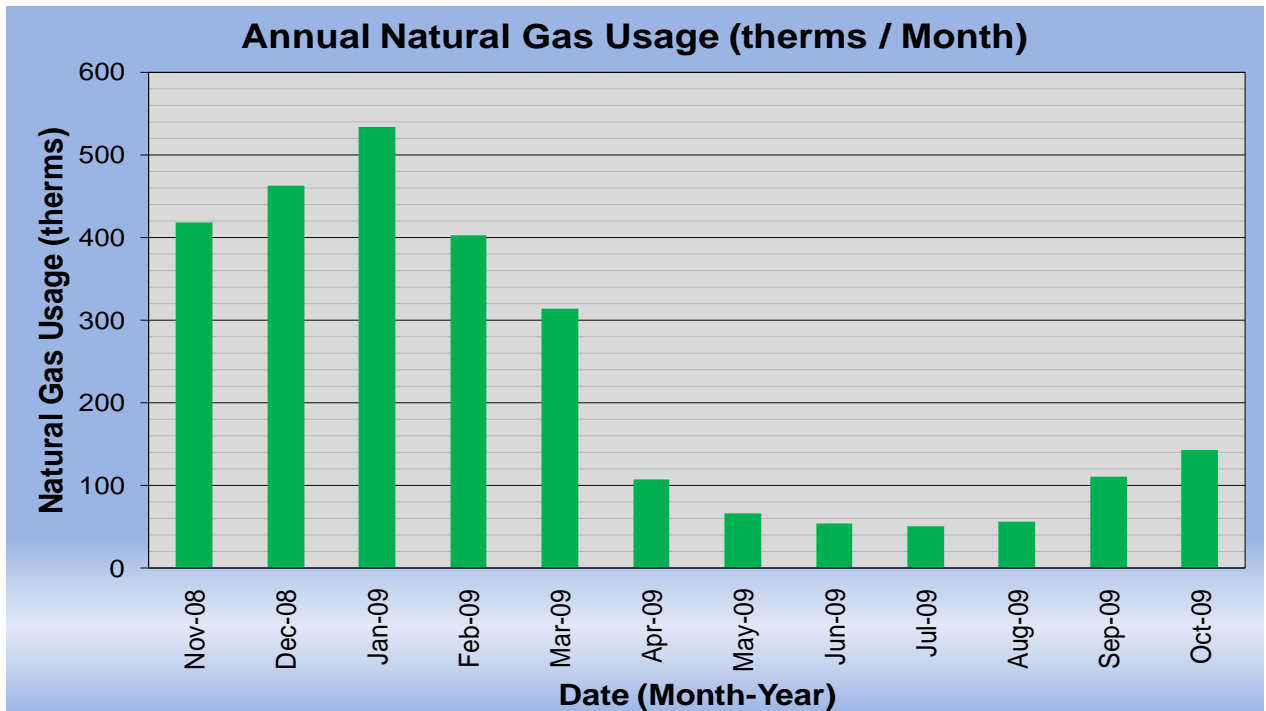
The following chart shows the natural gas consumption for the Human Services Building based on natural gas bills for the 12 month period of November 2008 through October 2009.

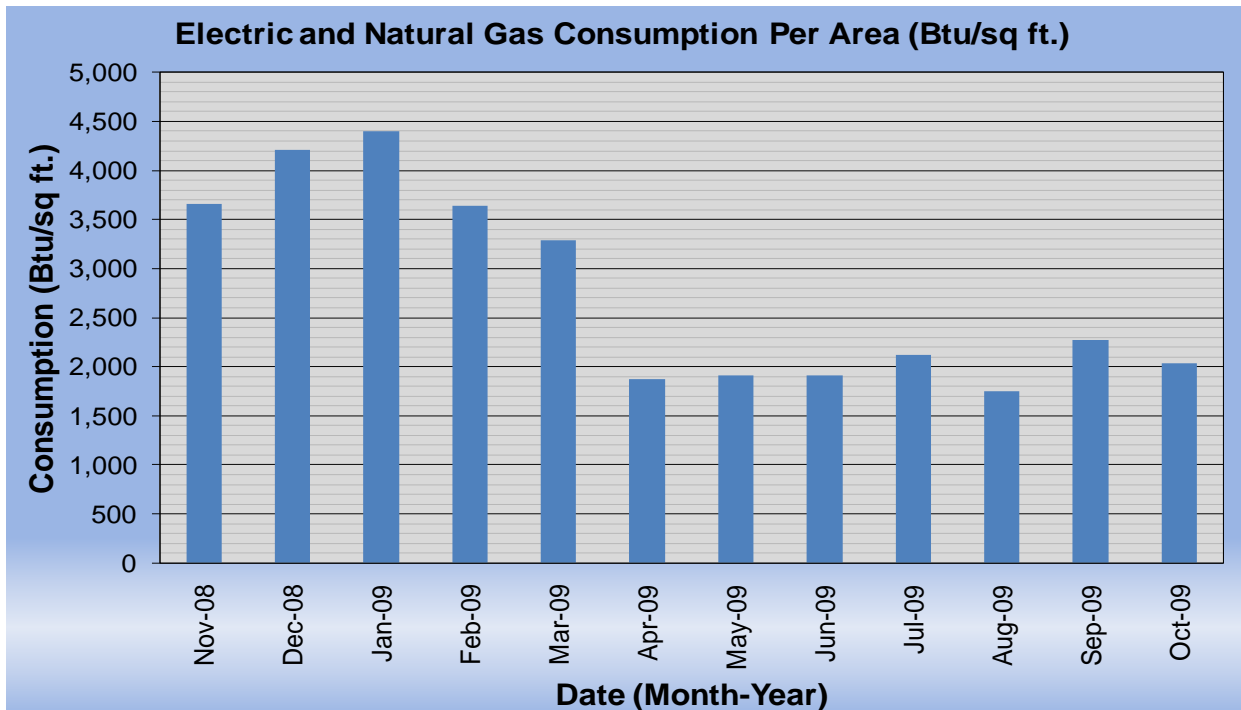
The following chart shows combined natural gas and electric consumption in Btu/sq ft for the Human Services Building based on estimates and utility bills for the 12 month period of November 2008 through October 2009.

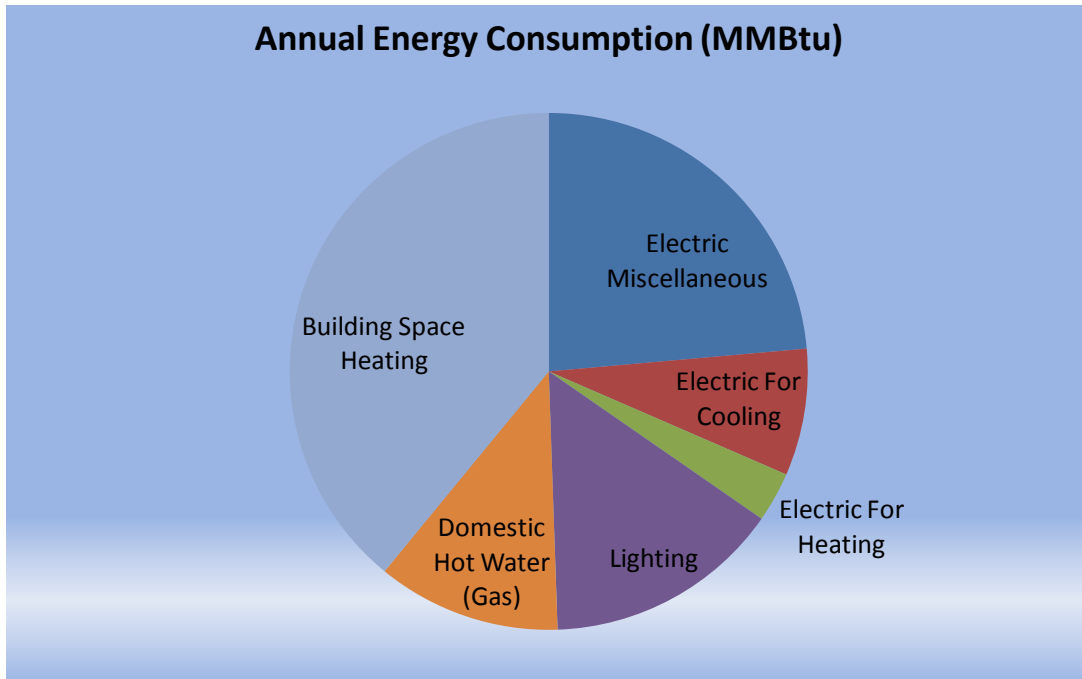
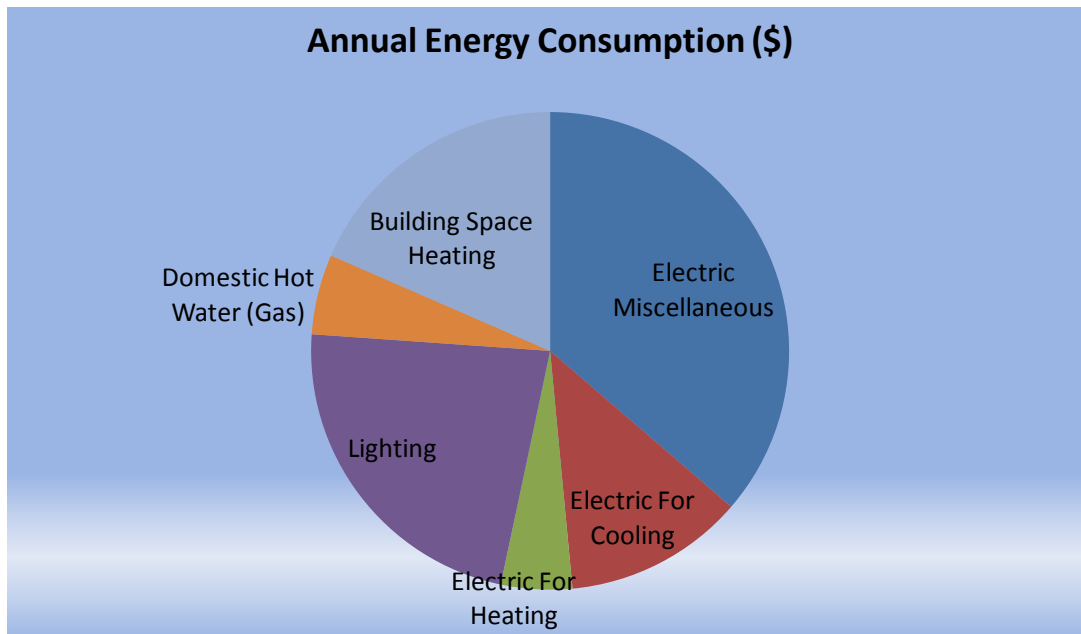
The following table and chart pies show energy use for the Human Services Building based on utility bills for the 12 month period of November 2008 through October 2009. Note electrical cost at \$38/MMBtu of energy is more than 3 times as expensive to use as natural gas at \$12/MMBtu.

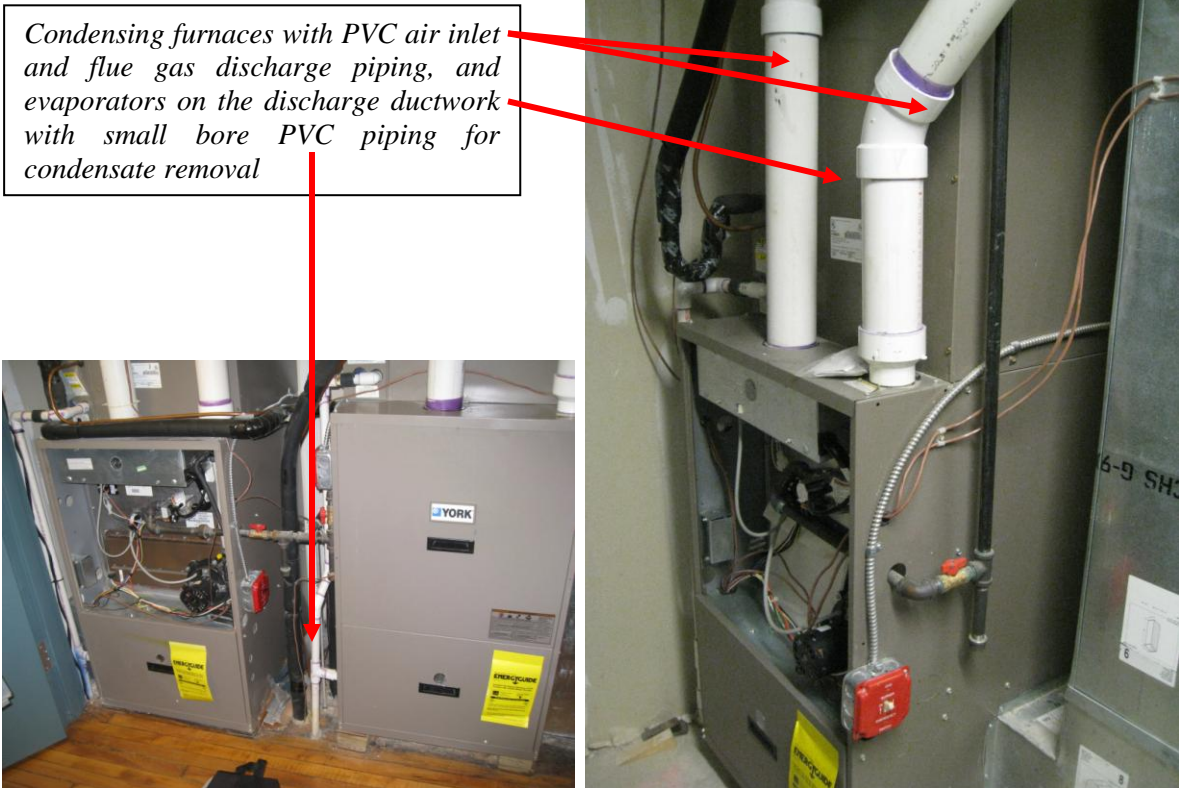
Heating to the building is provided by York condensing furnaces. They were installed during the 2005 building upgrade and have 92-93% AFUE efficiency. They have approximately 70% useful life left on them. Each of the three floors has its dedicated furnace and associated ductwork system. The basement has two separate furnaces, one for the gym / exercise room; the other for the balance of the basement. All forced air heat is distributed via diffusers supported by the drop ceiling. There isn't any wall perimeter heating. There are three small electric heaters mounted in the vestibule walls to overcome the cold air carried into the building from the outside. Generally, each furnace system has a couple of thermostats controlling it. These programmable thermostats are generally located in public areas, such as the first floor arrangement with one thermostat on the corridor, the other in the conversation room area. When doors are closed and depending on the higher activity in

some areas of the building vs. other lower occupancy spaces, the comfort level for heating / cooling varies significantly to the point where floor plug in heaters and room fans are often used to alleviate the ambient conditions. Also, there isn't any heating / cooling / ventilation schedule controlled by a Building Management System (BMS). SWA recommends that some of the diffusers be replaced with variable air volume (VAV) boxes for modulating flow better with more local programmable thermostats, as well as reheat electric elements in the VAV boxes to assist when local temperatures became too cold. SWA also recommends rebalancing the air distribution in the building, as well as investment into a building-wide state of the art BMS (should comfort complaints persist).

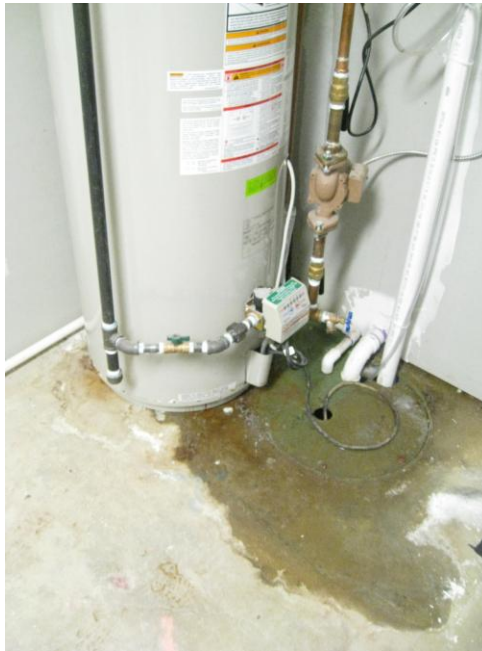
The domestic hot water (DHW) for the Human Resources Building is provided by an A. O. Smith Power Shot natural gas fired heater with 50 gal storage. This unit obtains combustion air from the living space but has fan-assisted exhaust. This heater is leaking water on the bottom and therefore has 0% estimated useful operating life left. SWA recommends that it is replaced soon with another higher efficiency gas fired, condensing type unit, prior to catastrophic failure, and should repair options fail.

Leaking DHW heater

upgrade. The efficiency of the existing leaking water heater is assumed in the 80-85% range, and a new high efficiency water heater would operate with an efficiency of approximately 95%.

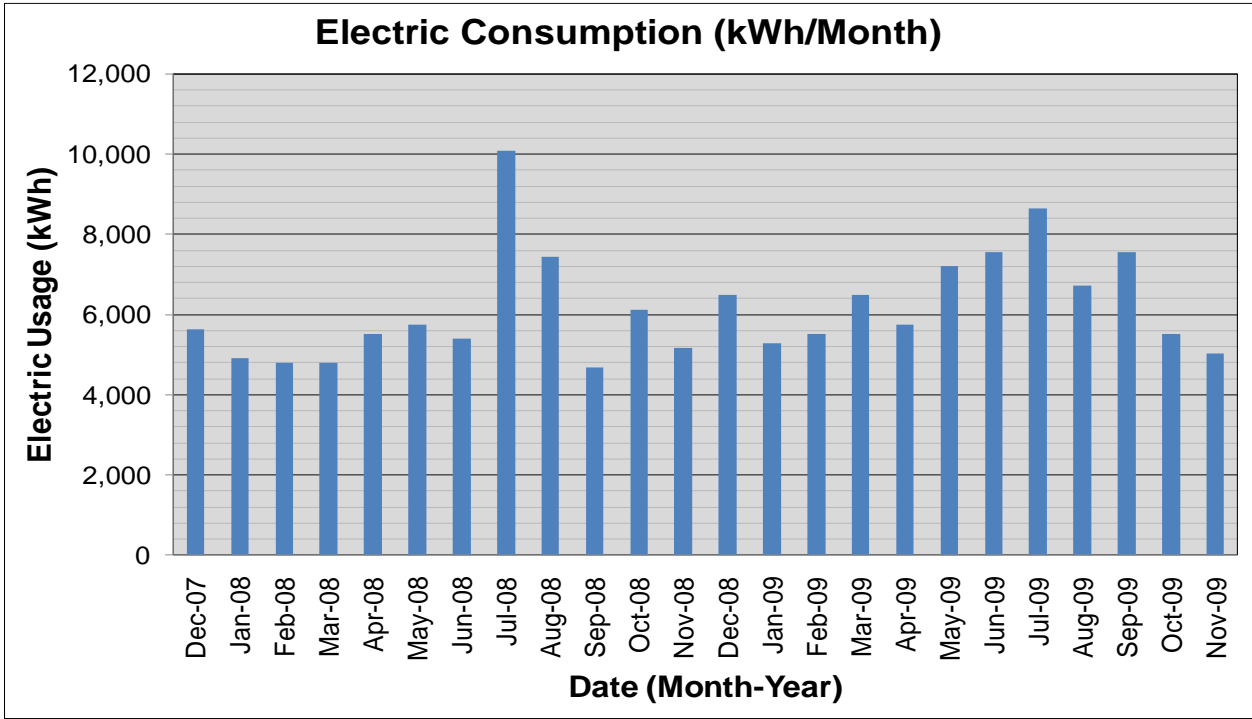
The following are charts that show the annual electric and natural gas load profiles for the South River Human Services Building. For annual electric and natural gas usage please also see Section 1. Historic Energy Consumption.

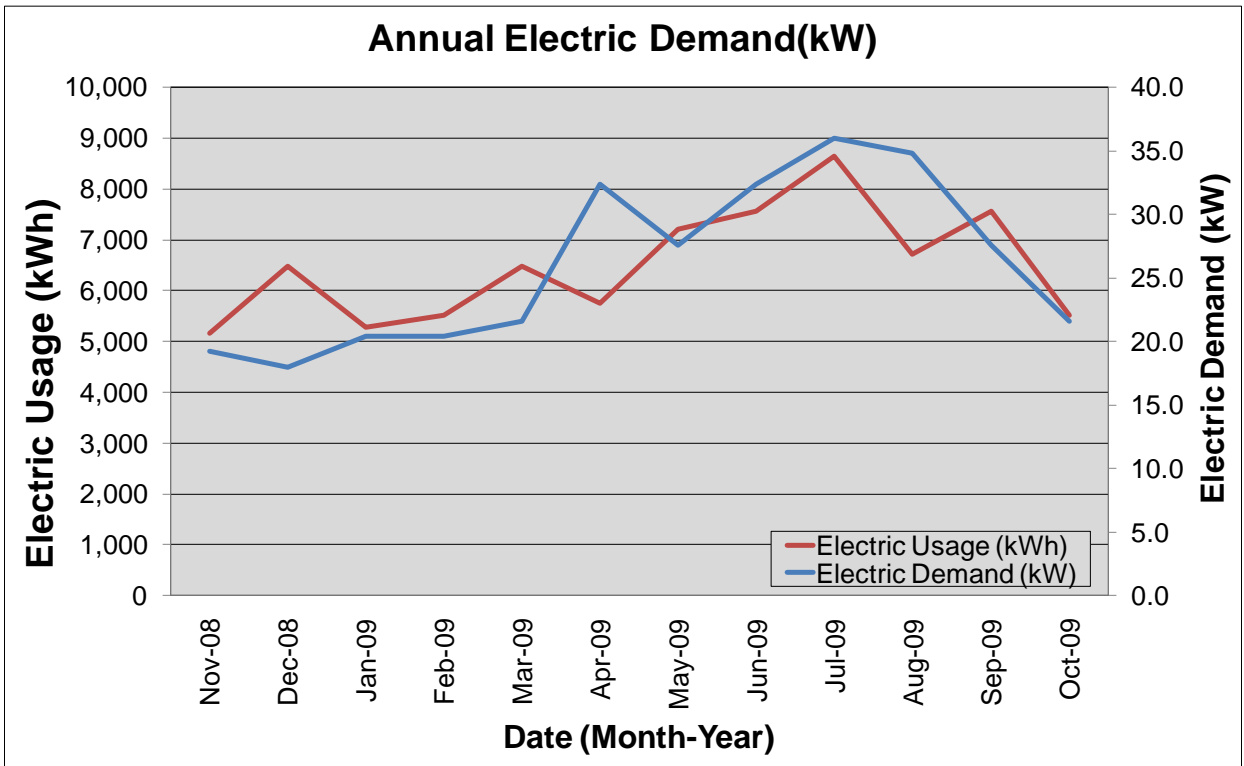
Some minor unusual electric fluctuations shown may be due to adjustments between estimated and actual meter readings. Also, note on the following chart how the electrical Demand peaks (except for a few unusual fluctuation anomalies) follow the electrical consumption peaks.

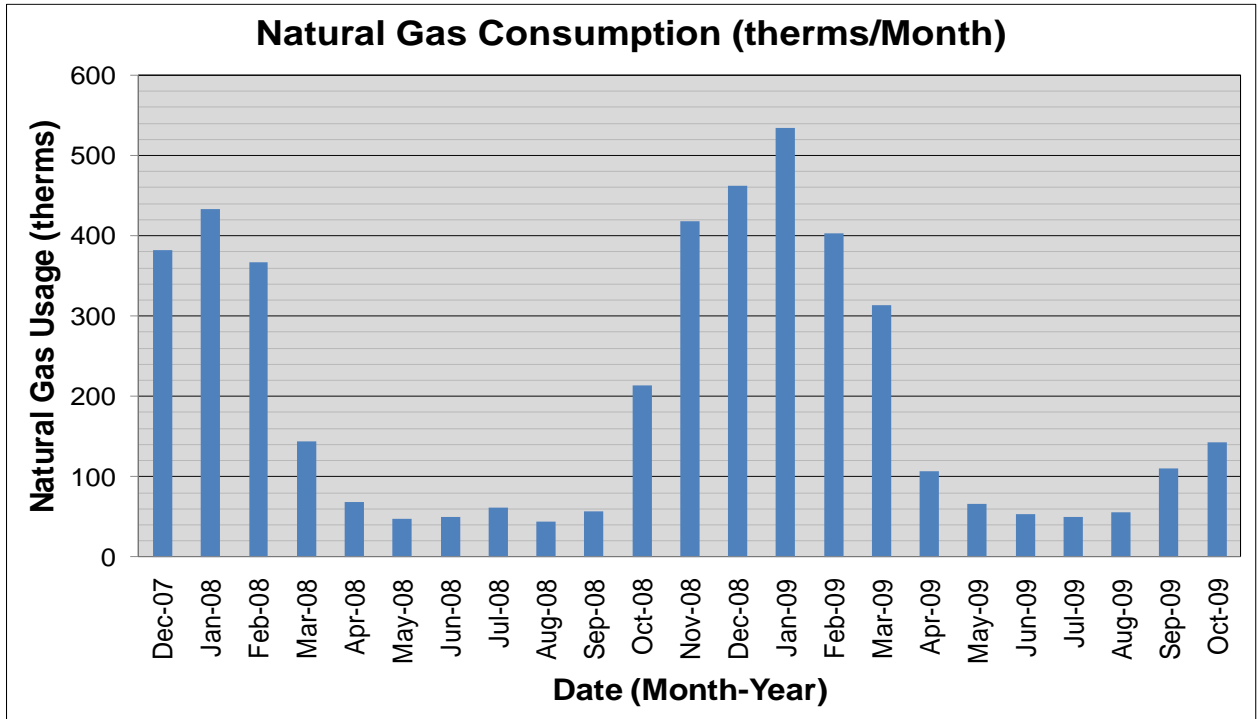
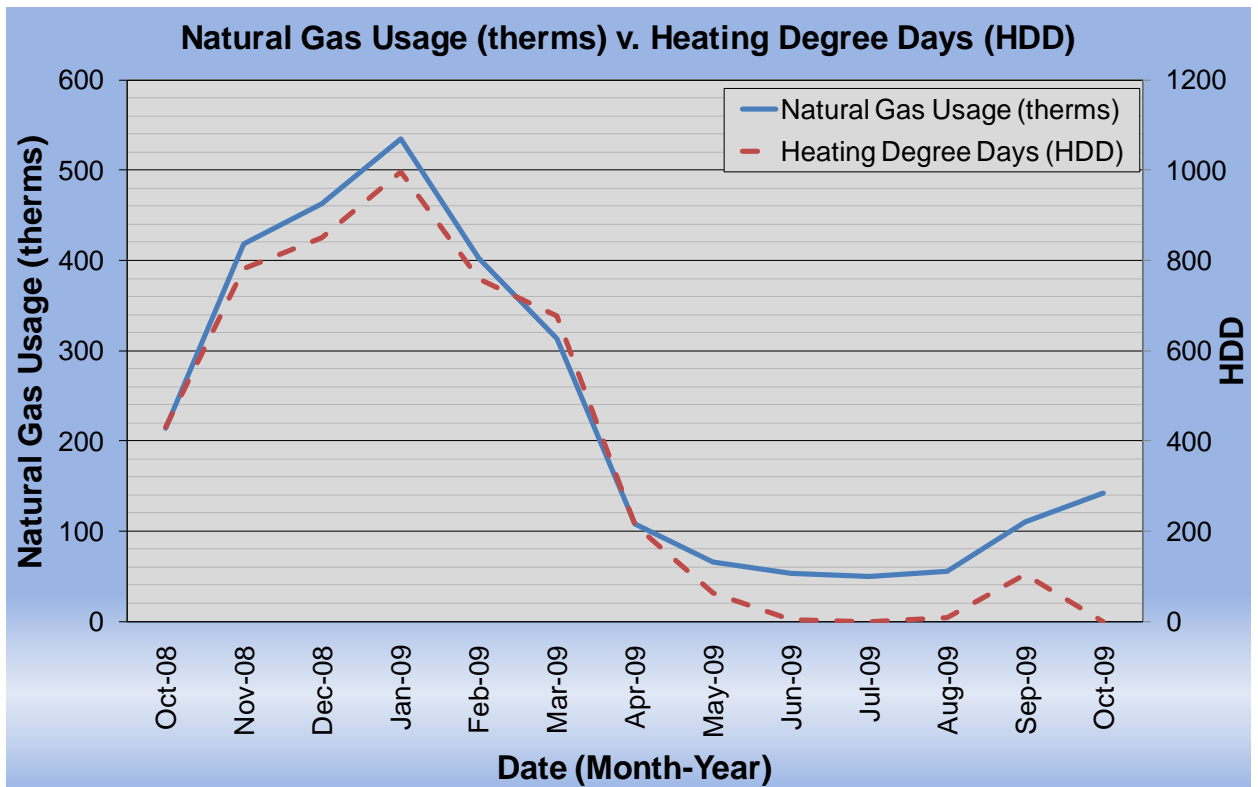
The following is a chart of the natural gas load profile for the building, peaking in the coldest months of the year and a chart showing natural gas consumption following the “heating degree days” curve. Some utility bills have more than one month estimated and combined.

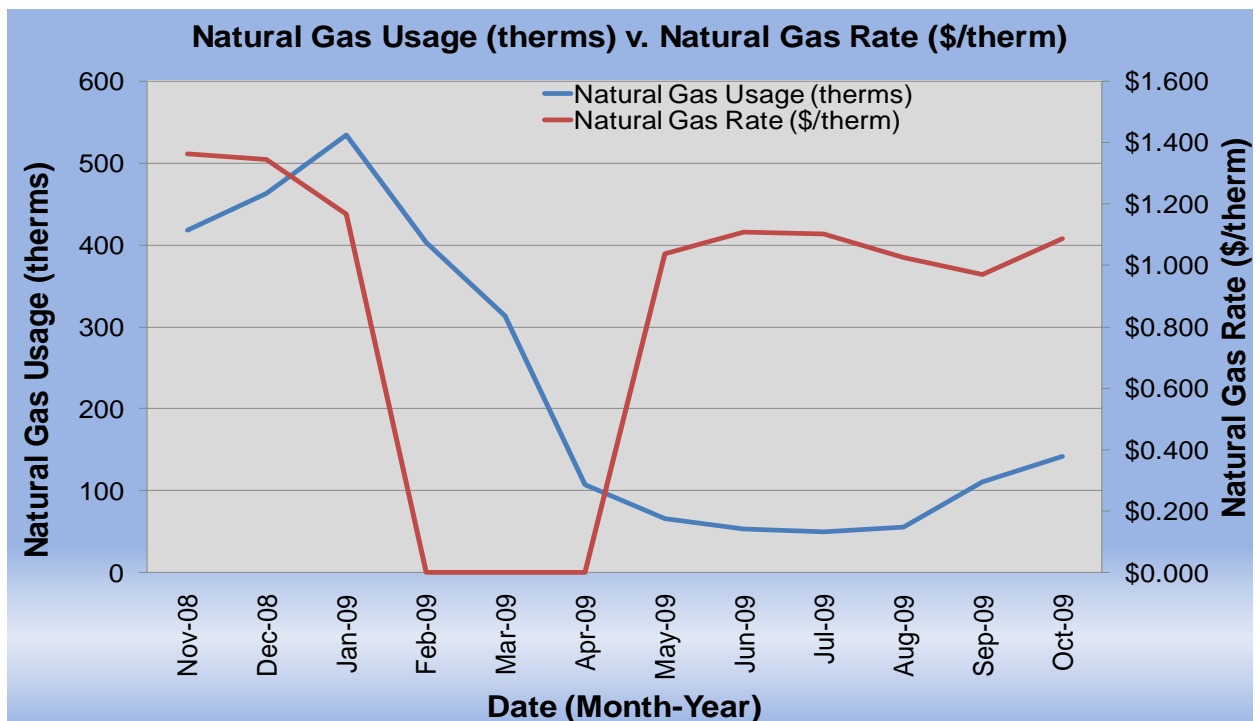
Currently, natural gas is provided to the Human Services Building via one gas meter with the PSE&G acting as the supply and also the transport company. Gas is provided by the PSE&G at a general and very competitive service rate. The suppliers' general service rate for natural gas charges a market-rate price based on use and the Human Services Building billing does not breakdown demand costs for all periods. Demand prices are reflected in the utility bills and can be verified by observing the price fluctuations throughout the year. Typically, the natural gas prices increase during the heating months when natural gas is used by the boiler and the furnace units. Some high gas price per therm fluctuations in the summer may be due to high energy costs that recently occurred and low use caps for the non-heating months. Thus the building pays for fixed costs such as meter reading charges during the summer months. Some of the cap payments are excluded from the following chart.

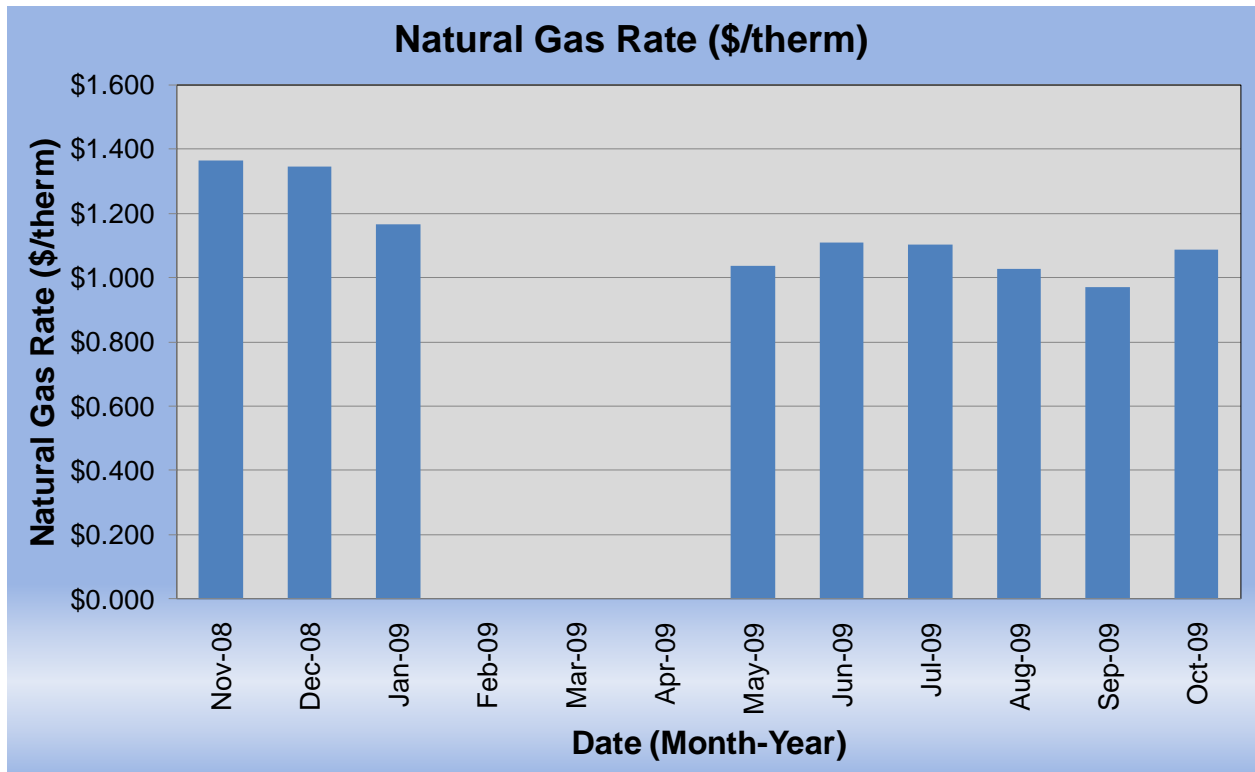
and financially viable manner. Electricity is also purchased via one incoming meter directly for the main Human Services Building from South River Electricity Company without an ESCO. SWA analyzed the utility rate for natural gas and electricity supply over an extended period. Electric rates were estimated by the Borough of South River over the most recent 12 month period. Natural gas bill analysis shows fluctuations up to 19% over the most recent 12 month period. Some of these fluctuations may have been caused by adjustments between estimated and actual meter readings, others may be due to unusual high and recent escalating energy costs. The average estimated NJ commercial utility rates for electric and gas are \$0.150/kWh and \$1.550/therm respectively. The Human Services Building annual utility costs are competitive when compared to the average estimated NJ commercial utility rates. SWA recommends that the Borough of South River further explore opportunities of purchasing both natural gas and electricity from ESCOs in order to reduce rate fluctuation and ultimately reduce the annual cost of energy for the Human Services Building. Appendix B contains a complete list of third party energy suppliers for the Borough of South River service area. The Borough of South River may want to consider partnering with other school districts, municipalities, boroughs and communities to aggregate a substantial electric and natural gas use for better leveraging in negotiations with ESCOs and of improving the pricing structures. This sort of activity is happening in many parts of the country and in New Jersey. Also, the Human Services Building would not be eligible for enrollment in a Demand Response Program, because there isn't the capability at this time to shed a minimum of 150 kW electric demand when requested by the utility during peak demand periods, which is the typical threshold for considering this option. The following chart show the Human Services Building monthly natural gas spending per unit of energy in 2009. Electric rates were estimated by the Borough at a constant rate of \$0.130/kWh.
