**Local Government Energy Program
Energy Audit Report**

***Denville Township
Main Street Fire House
2 Indian Road
Denville, NJ 07834***

Project Number: LGEA08

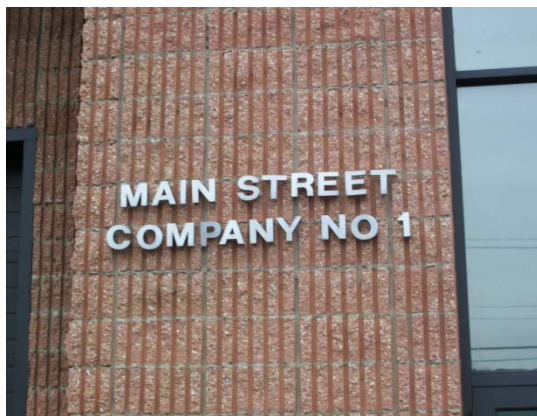
The Fire House walls are concrete blocks with a ribbed face. The exterior walls are a reddish color and showed no major thermal weaknesses. The interior side of the block walls is steel framed, 16" on center. Due to warm temperature conditions at the time of the field visits, insulation levels could also not be verified with help of infrared technology.

Overall, exterior and interior wall finishes of the envelope were found to be in age-appropriate, good condition with no major signs of unusual water or air leakage.

Concrete blocks with ribbed face

- Repair / seal wall cracks and penetrations - SWA recommends as part of the maintenance program to install weep holes, install proper flashing, and correct masonry efflorescence and seal wall cracks and penetrations wherever necessary in order to keep insulation dry and effective.

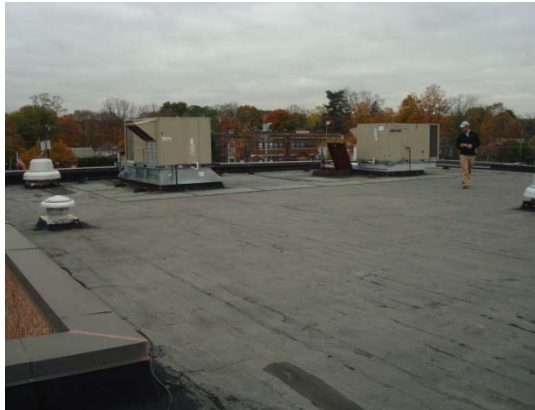
The Fire House has a flat roof that has a dark grey surface consisting of built-up roofing. The roof is supported by steel I-beams and no insulation. The roof, which is believed to be original to the building, is in deteriorating condition and shows signs of water damage. It was observed that there are several structurally weak spots on the roof.

Built-up roofing

The Fire House has a flat roof that has a dark grey surface consisting of built-up roofing. The roof is supported by steel I-beams and no insulation. The roof is in deteriorating condition and shows signs of water damage. It was observed that there are several structurally weak spots on the roof. The roof is believed to be original to the building and will need to be replaced soon.

SWA has determined that the roof has reached the end of its useful life and should be replaced in order to form a proper ceiling at the top of the building. Replacing the roof will prevent future water leaks as well as provide the opportunity for insulation to be added in order to keep warm air from rising directly out of the building. Roof replacements do not typically have a positive return on investment due to the high installation cost but should be incorporated into a capital improvement plan.

SWA has determined that the roof has reached the end of its useful life and should be replaced in order to form a proper ceil at the top of the building. Replacing the roof will prevent future water leaks as well as provide the opportunity for insulation to be added in order to keep warm air from rising directly out of the building. Roof replacements do not typically have a positive return on investment due to the high installation cost but should be incorporated into a capital improvement plan.

Assumptions: SWA estimated the cost and savings of the system based on an eQUEST model where R-30 insulation was added to the surface of the roof. In addition to energy savings, SWA assumes that the Main Street Fire House building will avoid \$500 per year in maintenance costs associated with water damage and other repair issues associated with the age of the roof

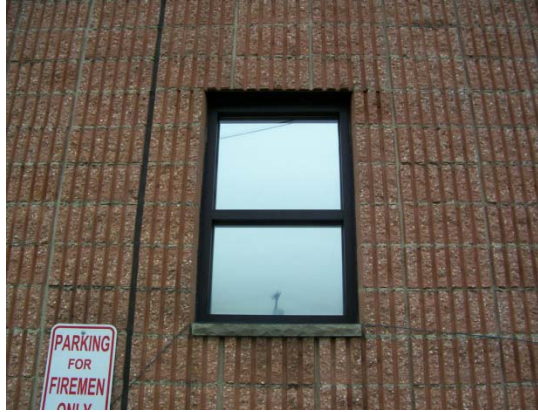
The windows are mostly double-hung operable windows with aluminum frames and double glass panes. The three windows in the conference hall are awning-type operable windows with fixed lights above. The windows are in fair condition, although some of the weather-stripping is in deteriorating condition. The expense of installing new windows would not be cost-effective, especially considering the limited occupancy of the building.

Typical Fire House Window

As a best practice, SWA recommends that all windows be inspected at least once a year. Any gaps, cracks, or damage to weather-stripping or caulking should be repaired or replaced, as needed, to minimize energy loss around those openings. Building staff should also verify that windows open and close properly and repair, as needed.
