**Local Government Energy Program  
Energy Audit Report  
FINAL; May 20, 2010**

***Frankford Township School  
Branchville, NJ 07826***

***Project Number: LGEA52***

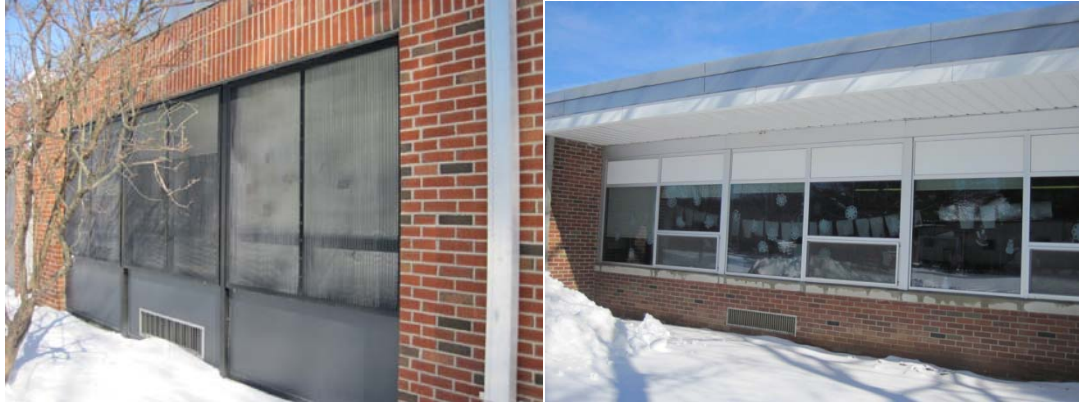
*Exterior wall assembly types*

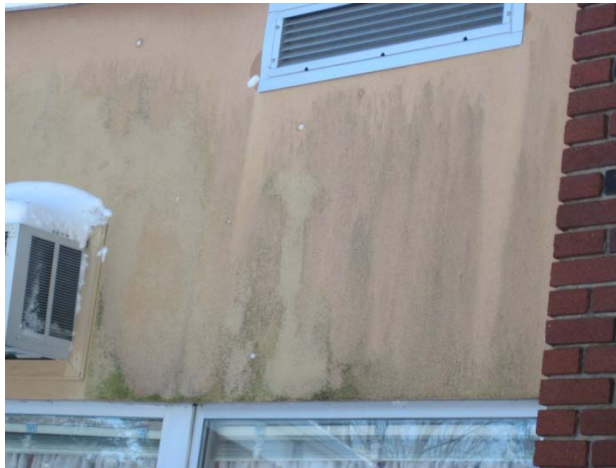
*Water damage EIFS*

Overall the exterior wall assemblies of the building appear to be in excellent condition with no major issues of concern. There were no additional areas of concern mentioned to SWA at the time of the building audit. SWA recommends regular maintenance to exterior walls, re-pointing brick veneer, caulking around windows or doors, and removing all damage due to insects or rodents. Attention and maintenance should be given to these areas as uncontrolled roof water runoff can potentially penetrate exterior walls and cause energy losses and structural damage. Special attention should be given to roof drainage to avoid water damage to exterior wall assemblies.

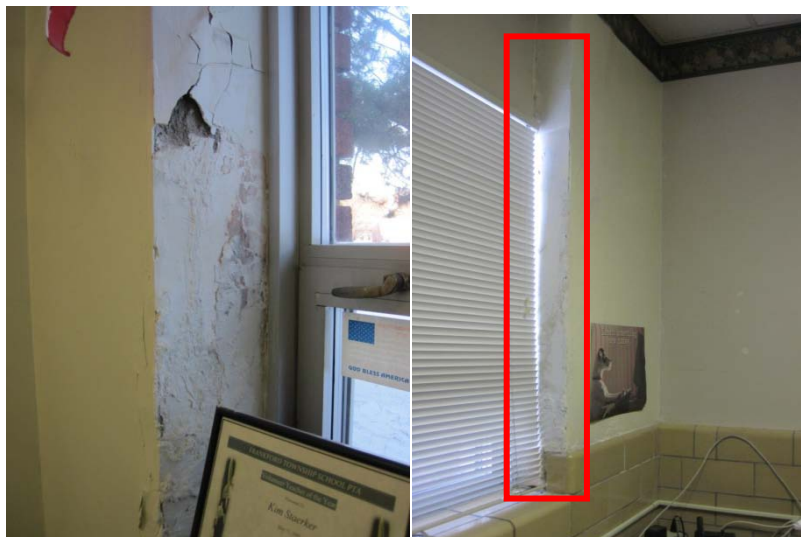
*Interior wall finish – lath and plaster wall damage*

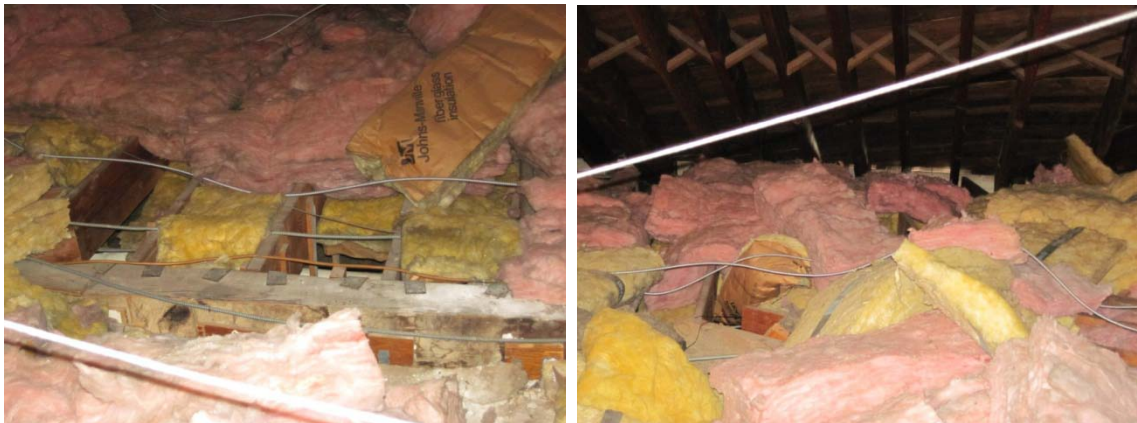
*Fiberglass insulation haphazardly displaced*

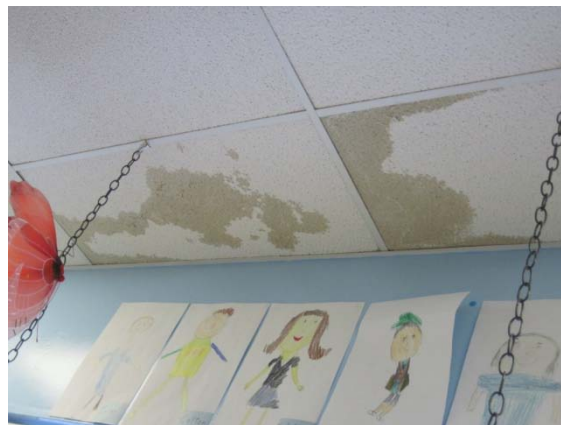
*Image showing damaged ceiling tiles in classroom*

At the time of the audit, SWA was told there are no roof leaks or roof maintenance issues. Damaged ceiling tiles should be checked and replaced in concern for indoor air quality. Regular maintenance should be performed to prevent potential damage to the integrity of the roofing system. When it is time for roof replacement (considering the 1972 roof section), SWA recommends an Energy Star certified roof membrane and rigid insulation (3") assembly.

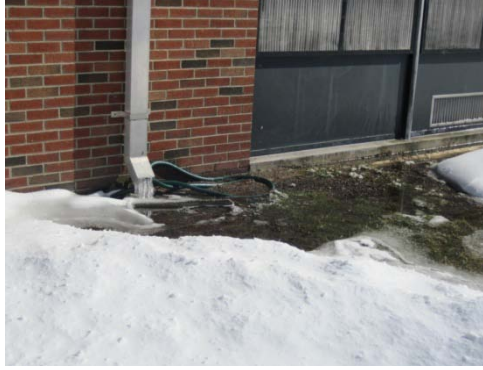
There is a CMU walled tunnel under the Elementary School portion of the building with uninsulated walls (under the A wing of the building). According to building staff the purpose of the design was for under-floor hot air flow, but it is no longer used. The rest of the building's base is an uninsulated 4" concrete slab-on grade with a perimeter footing and concrete block stem walls. At the time of the audit snow was melting off the roof and water was pooling in certain areas due to either insufficient grading and/or the downspouts not extending far enough from the base of the building. SWA recommends extending downspouts, installing french drains, or connecting downspouts underground storm water system. No water seepage through the slab or other issues related to thermal performance was detected.

*Water pooling at base of building due to extreme weather condition*

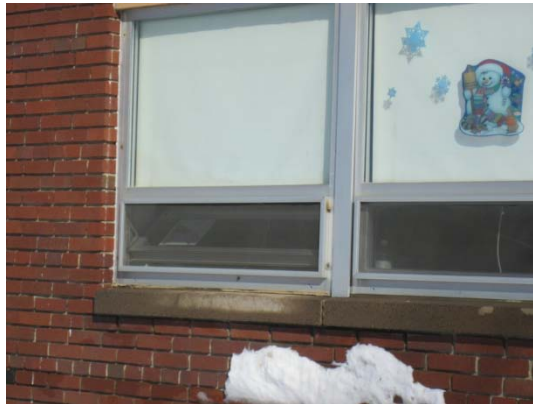
The windows of the school building are single pane, aluminum framed windows and appear to be in fair condition. The seals of the windows are ineffective and do not provide an air tight seal from exterior conditions, increasing the loss of expensive conditioned air. The windows are non-thermal break single glazed with un-insulated panels above them and are energy inefficient. SWA recommends replacement of the single pane windows as part of capital improvement and suggests replacing the existing windows with double-glazed thermal break low-E aluminum framed units. Regular maintenance should be performed, re-caulking around the perimeter of windows (exterior and interior) to ensure a tight seal.

*Open window on day of audit, approximately 28°F*

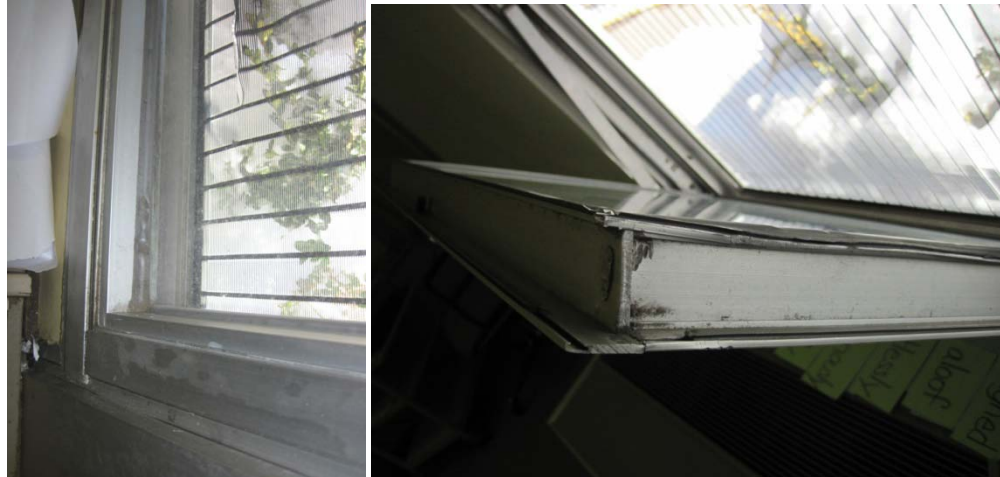
*Single pane aluminum framed windows*

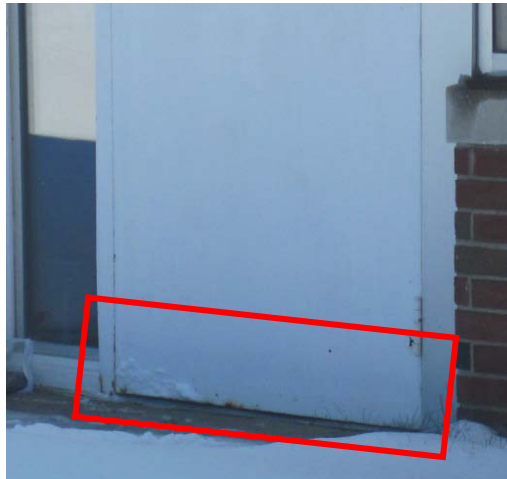
At the time of the audit SWA was told all main exterior doors were replaced in 2000. The FRP exterior doors were inspected and observed to be in very good condition. The exterior wood doors found in various classrooms are in need of replacement. Bubbling of paint (seen in the image below) may lead to rot or warping of the door.

*Older exterior wood door (serving as exit from classroom)*

SWA recommends checking the weather-stripping of each door on a regular basis and replacing any broken seals. Tight seals around doors will help ensure the building to be is kept continuously insulated. When exterior doors or garage doors warrant replacement SWA recommends upgrading existing doors with doors containing a higher R-value with effective seals.

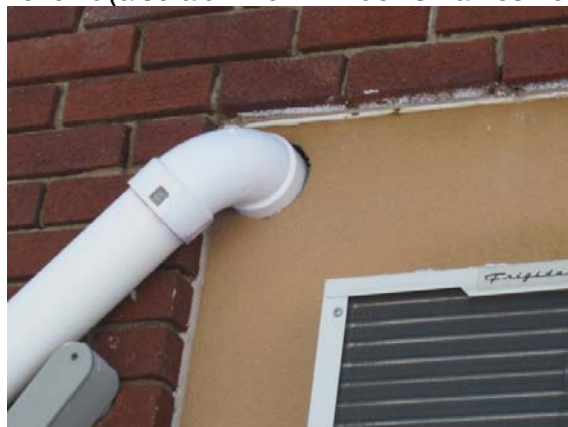
*PVC pipe entering building should be sealed with foam or caulk*

In addition to the above mentioned recommendations SWA suggests air sealing, caulking and / or insulating around all plumbing, electrical, HVAC and structural envelope penetrations. This should include bottom and top plates, recessed light fixtures, electrical boxes, chimney walls and window, or sleeve air conditioner units. If units cannot be removed SWA recommends Chill Stop-R or similar tight sealing gasketed cover to prevent loss of expensive conditioned air.

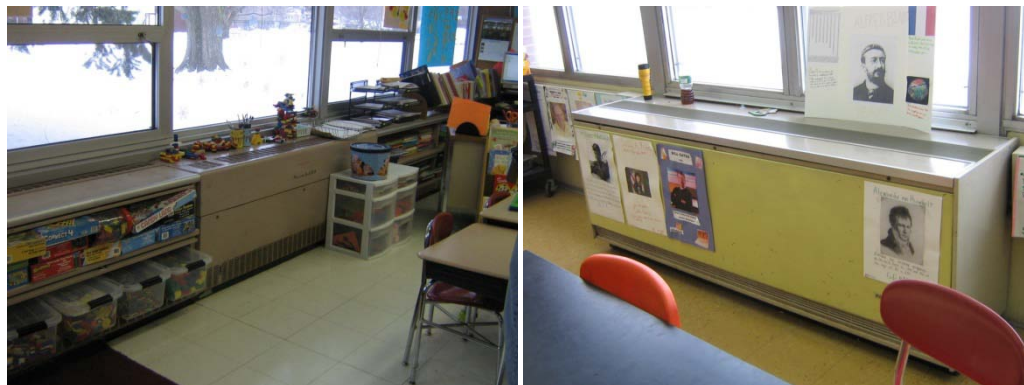
The classrooms in the remaining wings contain wall mounted unit ventilators. It appears that all of the original unit ventilators from the 1958, 1968 and 1974 construction of these wings are still present in the building. This equipment is in fair to poor condition. In total, the school contains approximately sixty (60) Nesbitt unit ventilators of varying ages.

*Unit Ventilators in B Wing (Left) and C Wing (Right)*

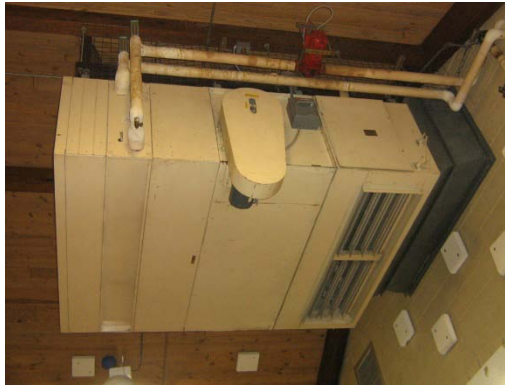
The Large Gymnasium, which also serves as the Cafeteria and Multipurpose Room, is heated by two (2) heating and ventilating (H&V) units, with fresh air provided via rooftop vents. There is one vertical unit located in a small room adjacent to the kitchen. The second unit is horizontal type and is mounted above the Stage. The Small Gym is heated by a large H&V unit suspended from the roof with fresh air provided through a wall louver.

*H&V Unit Suspended From Roof in Small Gym*

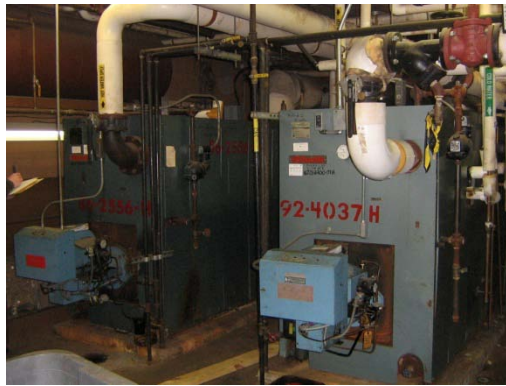
The boilers have a capacity of 2,247 MBH and 2,403 MBH respectively. The boilers are cast iron sectional type. One boiler was installed in 1986 and the other boiler was installed in 1992. According to their age, the boilers have about 6 years and 11 years respectively remaining on their expected service life of 30 years, as published in the 2007 ASHRAE HVAC Applications Handbook. The burners were installed in 1986 and 1992 respectively, and are fed from a 10,000 gallon underground oil storage tank that is adjacent to the B Wing. The first burner is beyond its expected service life and the second burner is approaching its expected service life of 21 years, as published in the 2007 ASHRAE HVAC Applications Handbook.

*A/B wing boilers*

Energy savings could be achieved by replacing these boilers with higher efficiency packaged oil-fired boilers with burner modulation, but this upgrade cannot be justified by energy savings alone.

It is assumed that the circulating pumps were installed in 1986 and 1992 when each boiler was replaced. SWA recommends that the pump motors are replaced with premium efficiency motors.

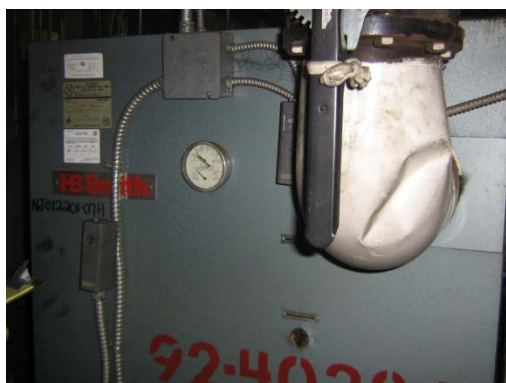
The boiler has a capacity of 3,330 MBH. The boiler was reportedly installed in 1992. According to its age, the boiler has about 12 years remaining on their expected service life of 30 years, as published in the 2007 ASHRAE HVAC Applications Handbook. The burner is approaching its expected service life of 21 years, as published in the 2007 ASHRAE HVAC Applications Handbook.

*C/D wing boiler*

Energy savings could be achieved by replacing this boiler with a higher efficiency packaged oil-fired boiler with burner modulation, but this upgrade cannot be justified by energy savings alone.

It is assumed that the circulating pumps were installed in 1992 when the boiler was replaced. SWA recommends that the pump motors are replaced with premium efficiency motors.

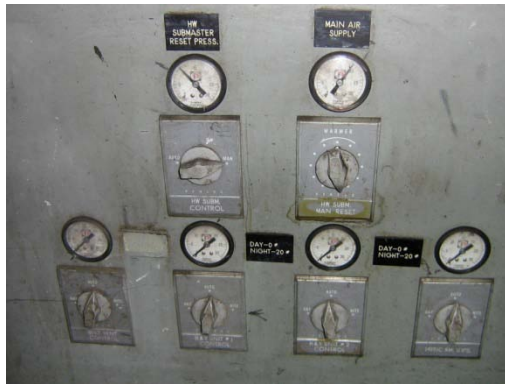
*Pneumatic Control System Panel in C/D Wing Boiler Room*

The building contains two (2) pneumatic controls systems to control the equipment in each pair of wings. The air compressors were noted to run often and in several instances, the thermostats were observed to make a hissing noise indicative of leaking compressed air.

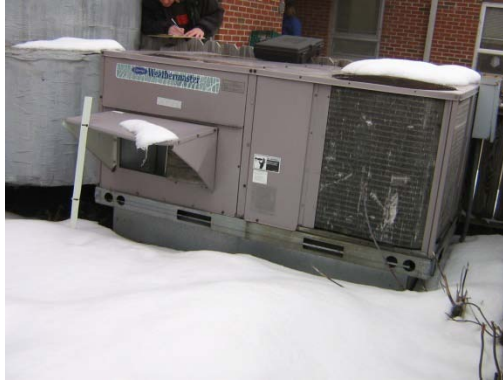
*Packaged HVAC Unit on Grade Serving TV Studio*

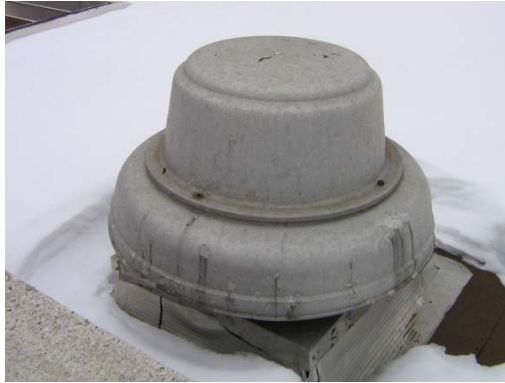
*Typical Rooftop Exhaust Fan*

2007 ASHRAE HVAC Applications Handbook. SWA recommends that this equipment is replaced as part of a capital improvement project, and that it is designed to provide code minimum ventilation rates.

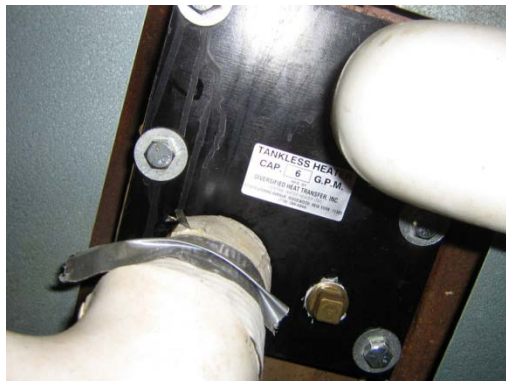
*Typical Tankless Boiler Immersion Domestic Water Heater in A/B Boiler*

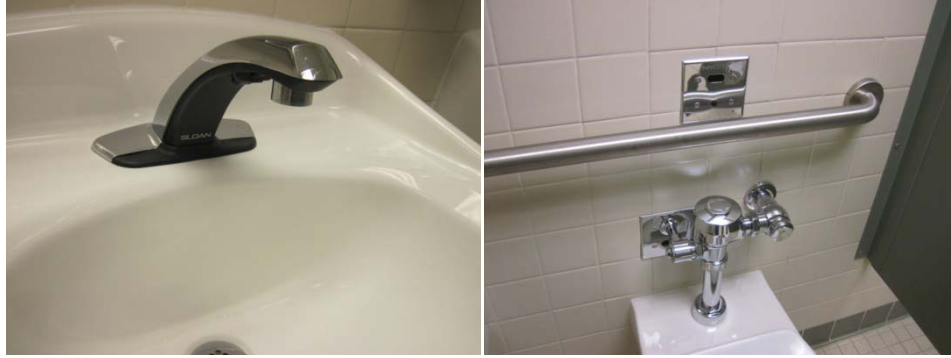
*Updated bathrooms with sensors for toilets and sinks (with 0.5gpm aerators)*

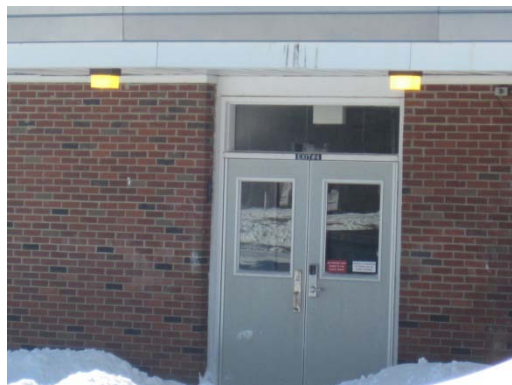
*Exterior lights left on during daylight hours*

*Exterior Lighting* - The exterior lighting surveyed during the building audit was found to be a mix of CFLs and Metal Halide fixtures. Some of the exterior lighting is controlled by photocell sensors. SWA is recommending photocell sensors for all exterior lighting or timers.

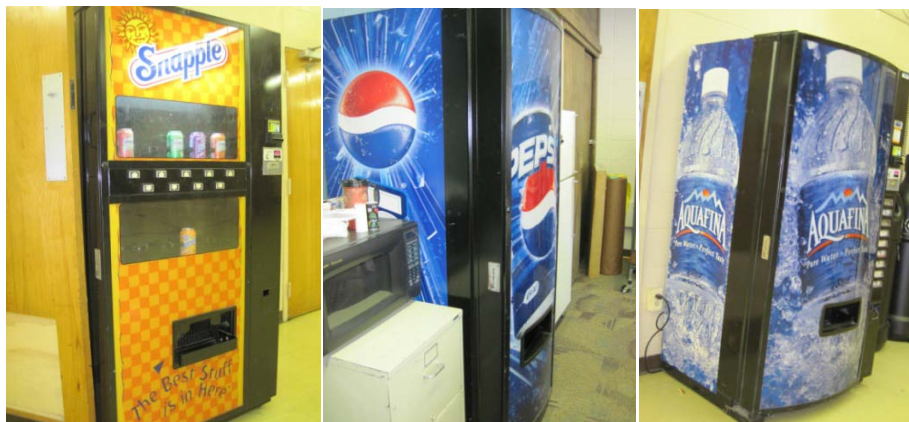
*Two vending machines in Cafeteria, one vending machine in faculty lounge*

Appliances, such as refrigerators, that are over 10 years of age should be replaced with newer efficient models with the Energy Star label. For example, Energy Star refrigerators use as little as 315 kWh / yr. When compared to the average electrical consumption of older equipment, Energy Star equipment results in a large savings. Building management should select Energy Star label appliances and equipment when replacing: refrigerators, printers, computers, copy machines, etc. More information can be found in the "Products" section of the Energy Star website at: <http://www.energystar.gov>. SWA recommends consulting with the vendor that supplies all vending machines, requesting Energy Star models when the contract is due for renewal. Also, energy vending miser devices are now available for conserving energy usage by Drinks and Snacks vending machines. When equipped with the vending miser devices, vending machines use less energy and are comparable in daily energy performance to new ENERGY STAR qualified machines.

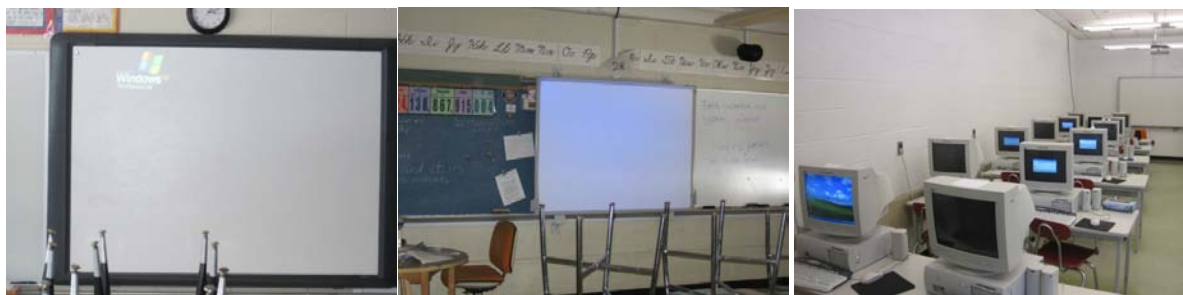
Computers left on in the building consume a lot of energy. A typical desk top computer uses 65 to 250 watts and uses the same amount of energy when the screen saver is left on. Televisions in meeting areas use approximately 3-5 watts of electricity when turned off. SWA recommends all computers and all appliances (i.e. coffee makers, televisions, etc) be plugged in to power strips and turned off each evening just as the lights are turned off.

*Smartboards & Computers left on in vacant classrooms*
