# CORVETTE

## Lieblweb's C5 Rocking Seat Fix

**Vehicle Information:** 2001 Corvette Coupe. We've only had the Corvette for a little over a month at the time of this write-up but have learned so much from other members of the Corvette online community that this is our way of giving back. We read several write-ups before attempting this fix, and pictures sure would have been a big help. Hopefully those of you with the rocking seat problem that have been putting off the repair will see that it really isn't too bad, and will give it a try. Let us know what you think via the email link, or on [www.corvetteforum.com](http://www.corvetteforum.com). Our user names on there are 'Sliebl' and 'Janster'.

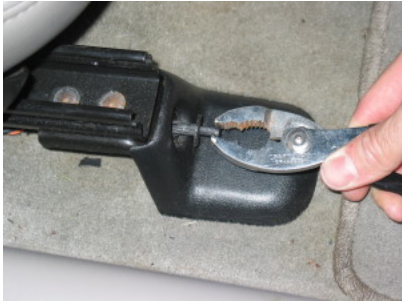
### Step 1: Remove Plastic Trim Fastener

You need to remove the two trim pieces that cover the mounting nuts at the front of the seat. We did the passenger side first, and almost all of the photos are of that seat for your reference.

Pull the center part of the fastener towards the front of the vehicle. The fastener will pop right out.

You may need to get it started with a small screwdriver, and finish it with the pair of pliers.

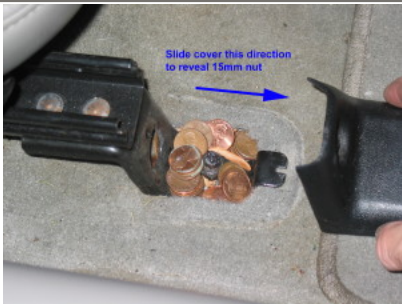
### Step 2: Remove Plastic Trim

Slide the trim pieces forward to reveal the 15mm nuts that need to be removed.

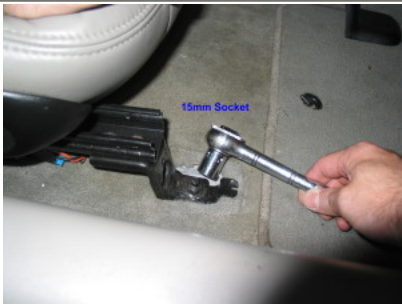
### Step 3: Remove Two Front Seat Mounting Nuts

There are two 15mm nuts that need removed. Slide the seat backwards if you don't have enough room to remove them.

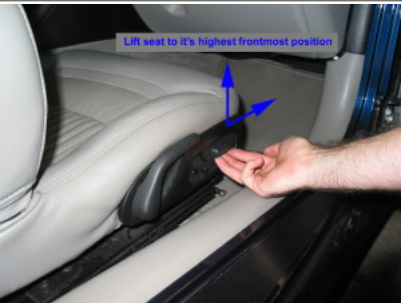
### Step 4: Slide Seat Forward and Raise to Highest Setting

This step is VERY important. Make sure the seat is as far forward as it will go, and raised as high as it will go. Not performing this step may cause the seat to bind when you reinstall the lead screw later.

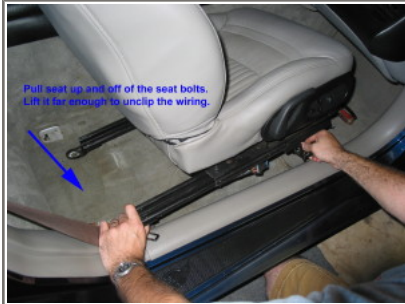
#### Step 6: Lift Seat Off of Mounting Studs

Lift the seat up and off of the mounting nuts. Pull it towards the door sill and tilt it towards the center console. This is to expose the wiring harness that you need to unplug. Please make sure you cover your door sill with a towel to avoid scratching the paint or the plastic trim.

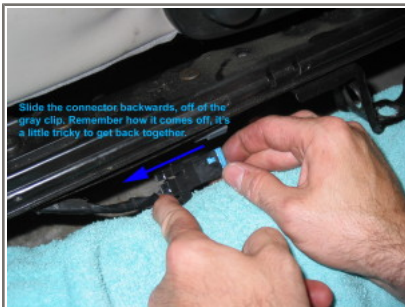
#### Step 8: Remove Connector From Seat Track

After separating the two halves of the connector, you need to slide the one half off of a small gray clip that attaches it to the seat track. Slide the connector half towards the back of the seat and it will slide off of the gray clip. The clip remains attached to the seat track. It's tricky to reassemble the connector onto the connector housing, but just look carefully while you are taking it apart, or study this picture and you can easily see how it goes back together.

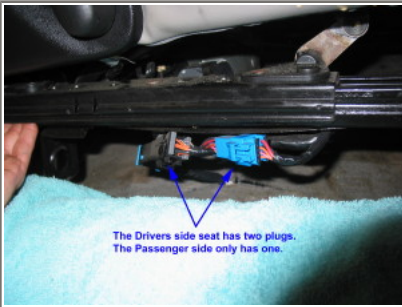
### Step 9: Drivers Side Harness Detail (for when you get to this side)

As mentioned in step 7 above, the drivers seat has two harnesses, and the passenger side only has one. Remove the second harness just like the first one once you get to the drivers side.

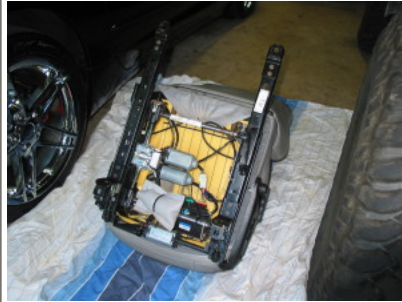
### Step 10: Remove the Seat

Congratulations. You are ready to remove the first seat. Get a friend to help you with this step. Please be careful not to scratch your door sills, or trim panels with the seat tracks. Carefully lift the seat up and out of the vehicle. It's easiest if you have the top removed on a coupe, or top down on a convertible. Sorry FRC/Z06 guys, you'll have to deal with the roof. Once the seat is out, place it on a clean towel or sheet to protect the leather. Now is also a great time to clean the carpets and do a full detail to the seat with leather cleaner/protectant.

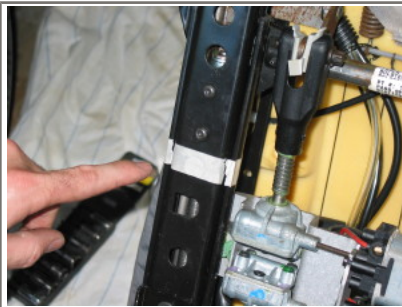
### Step 11: Use Masking Tape to Mark the Tracks

By wrapping masking tape around the seat tracks, you can verify that you have the Lead Screw adjusted correctly during re-assembly. Don't forget to slit the masking tape so the seat tracks can slide. If you have followed the early steps regarding the seat being placed at the full forward position, you won't need this, but it can't hurt to do it just for piece of mind. This first track was the only one of the four we used the masking tape on.

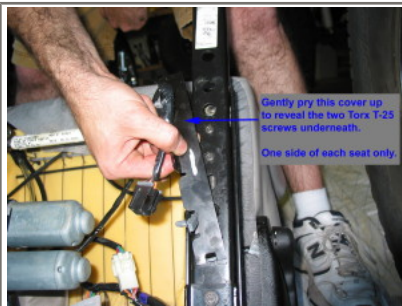
### Step 12a: Remove Cover on Seat Track

If you are working on the outside seat track, you will need to remove the cover that hides the two Torx T-25 screws. Gently pry up one end of the cover and it will slide out of the way.

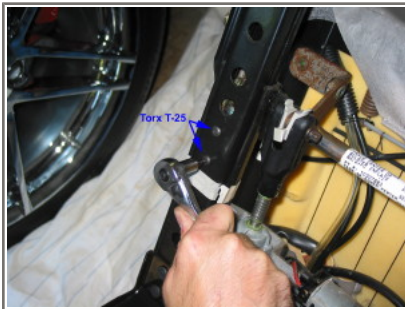
#### Step 12: Remove Two Torx T-25 Screws Securing the Aluminum Block

Remove these two screws in the middle of the seat track and set them aside.

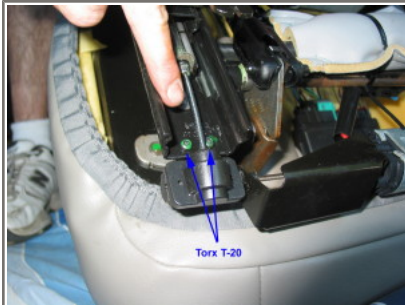
#### Step 14: Remove Two Torx T-20 Screws Near the Front of the Seat Track

These two screws affix the 90 degree drive mechanism to the seat track. Remove the two screws and sit them aside.

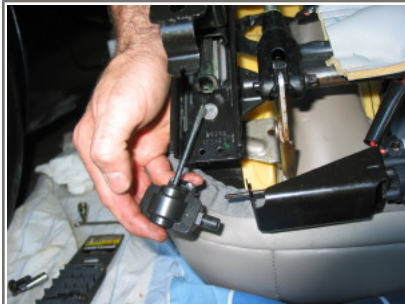
#### Step 15: Remove Drive Mechanism

Once the two T-20 screws are removed, the drive mechanism will basically fall out. Leave the square drive shaft that drives the Lead Screw in the mechanism. Sit it aside.

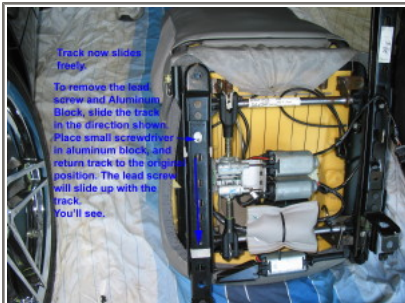
### Step 17: Trick for Removing Lead Screw Assembly

Slide the track towards the front of the seat. Once lowered, place a small screwdriver in one of the T-25 screw holes in the Aluminum Block. Lift the track back to it's original position and the Lead Screw assembly will be lifted up towards the rear of the seat track. It can now be removed. See Step 18.

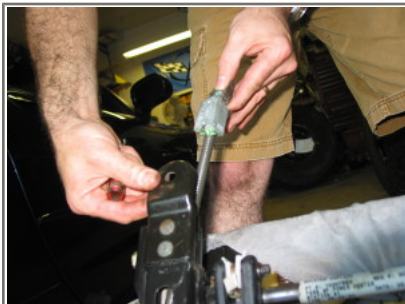
### Step 18: Slide Lead Screw Assembly Out from the Rear of the Track

Slide the track out and take it to a clean work area. Work on cardboard or paper towels, this is a little greasy!

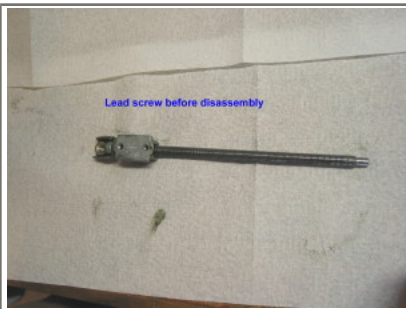
### Step 20: Lead Screw Before Disassembly

Again, it's a good idea to do these steps on some cardboard or paper towels. Wash your hands before handling the leather seats.

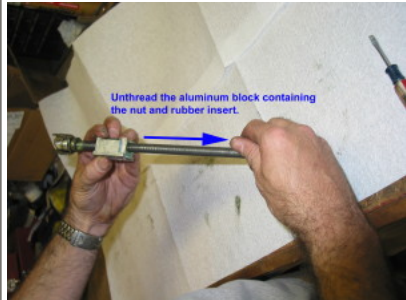
### Step 21: Unthread Aluminum Block From Lead Screw

Unthread the Aluminum Block all the way off the Lead Screw. No need to count turns or anything, as running the seat all the way forward before disassembly will make reassembly a breeze.

**WARNING:** If you decided to tear both seat tracks apart at the same time, please be aware that one of the blocks is reverse threaded. If you get the two sides switched during reassembly, the seat will move forward when you tell it to go backward, and vice versa.

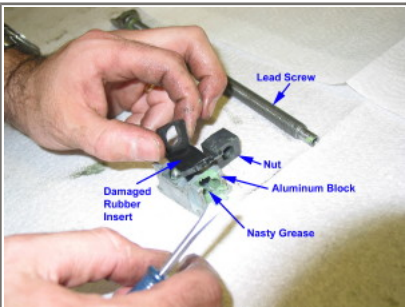
### Step 22: Remove the damaged Rubber Isolators From the Aluminum Block

It is now time to get to the offending Rubber Isolators that have caused the Rocking Seat problem! Remove the Nut and Rubber insert from the Aluminum Block. You will not need the Rubber insert for reassembly, as it will be replaced by the Nylon washers that you purchased. Clean all of the parts of the old nasty grease, or at least most of it.

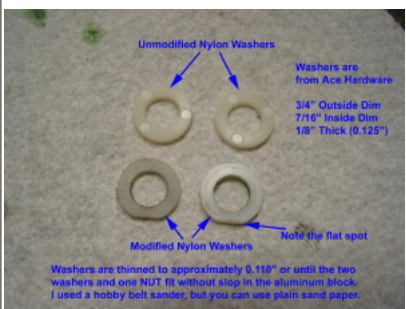
### Step 23: Modify the Nylon Washers

The washers you have purchased are 1/8" (0.125") thick. This is too thick to get two of them in the Aluminum Block with the Nut. You will need to sand down the thickness to about 0.110" each. I used a small belt sander, but you can use plain old sand paper to do the job. Sand the washers a little at a time while trial fitting them in the Aluminum Block between sandings. You want a slop free, zero clearance fit when done. Take your time with this step.

When you are able to get two washers and the nut together in the Aluminum Block, sand or file a flat spot on one end of each washer. This will allow the Lead Screw to pass through the center of the Nylon Washers.

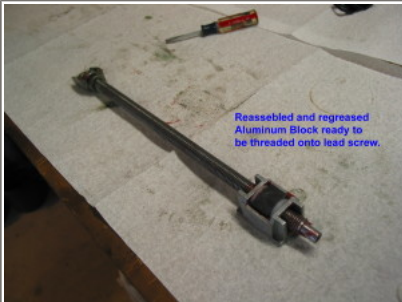
#### Step 25: Reinstall Aluminum Block Onto Lead Screw

Wipe excess grease off of the Lead Screw, and relube with new grease before threading on the Aluminum Block assembly.

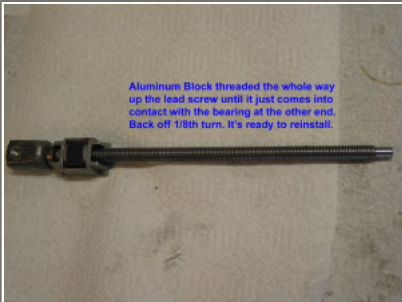
#### Step 26: Thread Aluminum Block Assembly All The Way Up The Lead Screw

Turn the Aluminum Block all the way up the lead screw until it contacts the bearing at the other end. Back it off ever so slightly. It's should look just like the picture on the left. Note the orientation of the block to the flat mounting area on the end of the lead screw. Adjust the Lead Screw until it looks like this.
