## Makita DXT 12" Miter Saw Parts Manual LS1219L 01-18

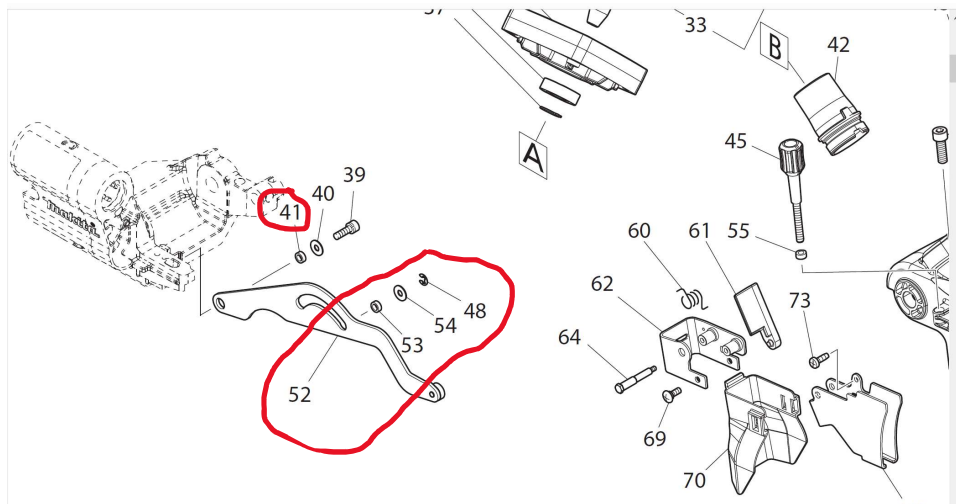
When the saw was dissassembled, it was found that the guide bushing assembly was missing parts and also included an additional washer that is not on the parts diagram. It is suspected the e-clip was lost some time ago and the incorrect parts were used to make the guide functional.

### Missing Parts:

- 048 – PN 961018-5 Stop Ring E-5, looks like a common e-clip
- 053 – PN 257163-5 Ring 6, looks like a bushing, might be able to match it from existing item 041 as it has the same PM and description.

Flat washer (part 54) was installed on the wrong side link plate (part 52)
