# National Register of Historic Places Registration Form

historic name Tuzigoot Museum

other names/site number Tuzigoot National Monument Museum and Visitor Center

city or town Clarkdale  vicinity

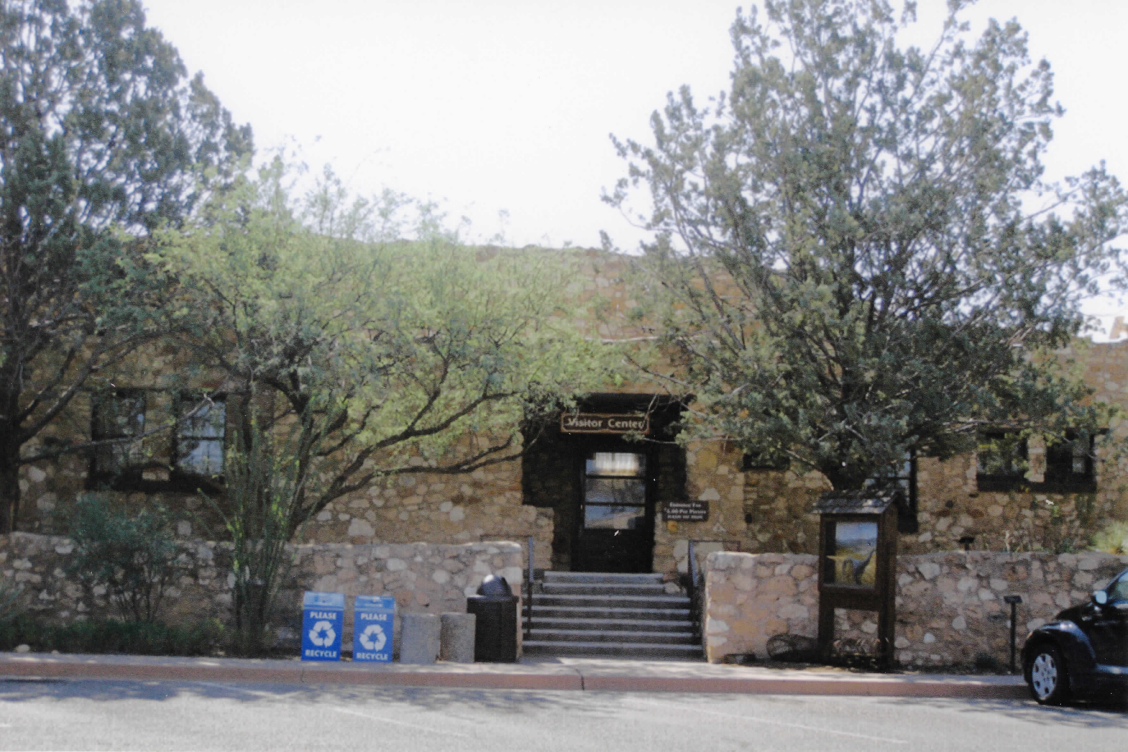
1/19

West facade looking east

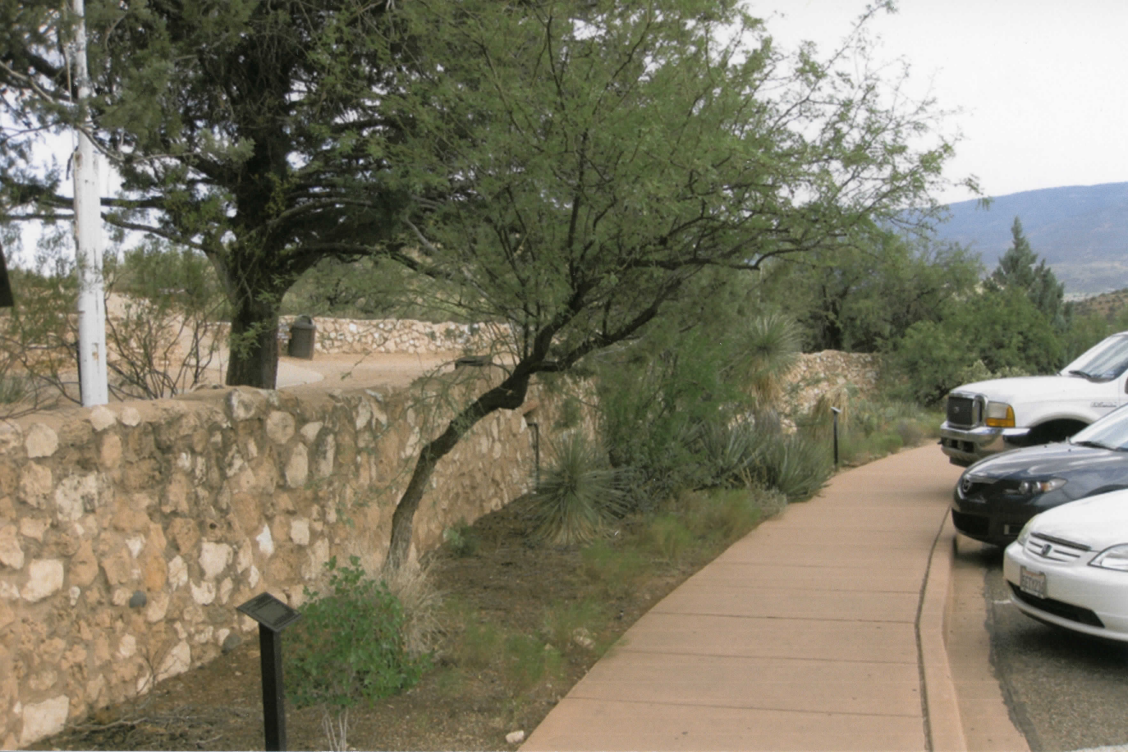
photo 2

SW view of the west wall

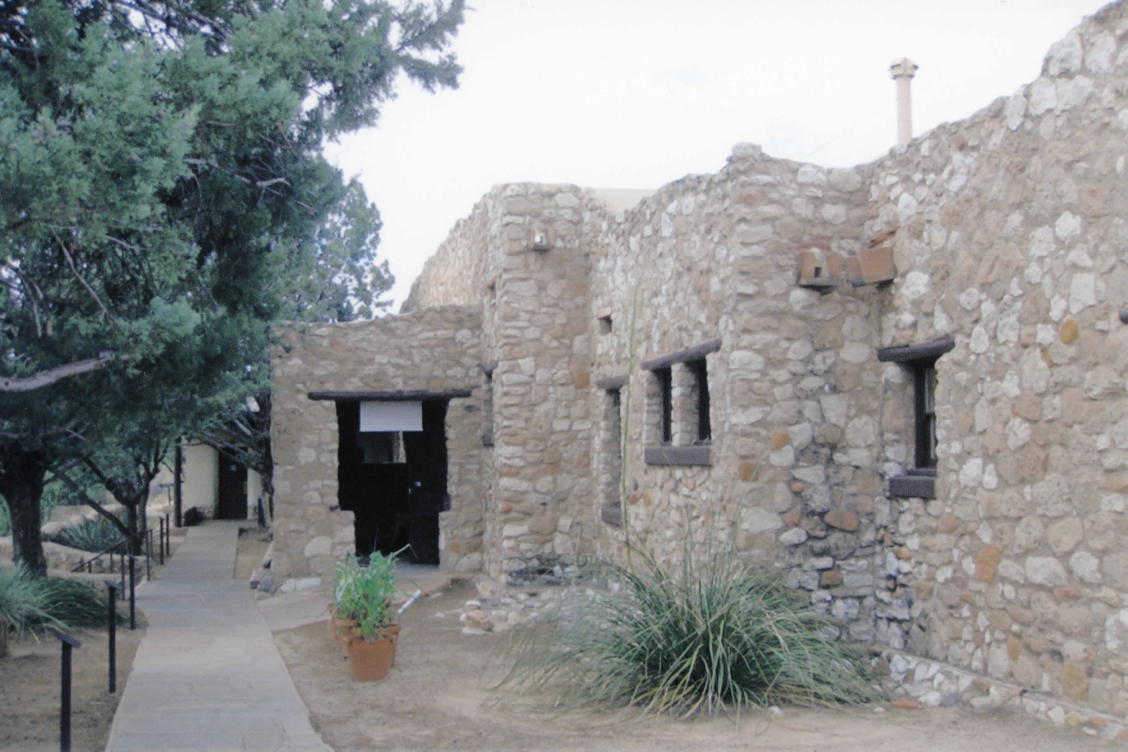
Photo 3

West facade looking North

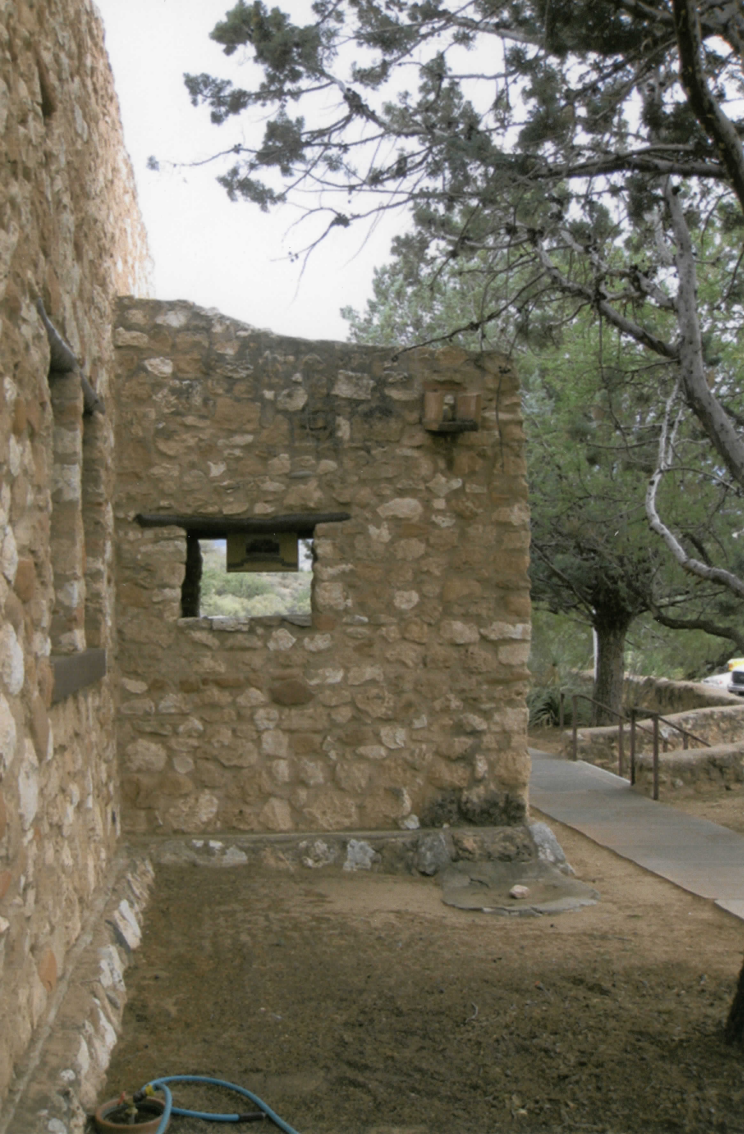
Photo 4

N. elevation of West Porch looking  
South.

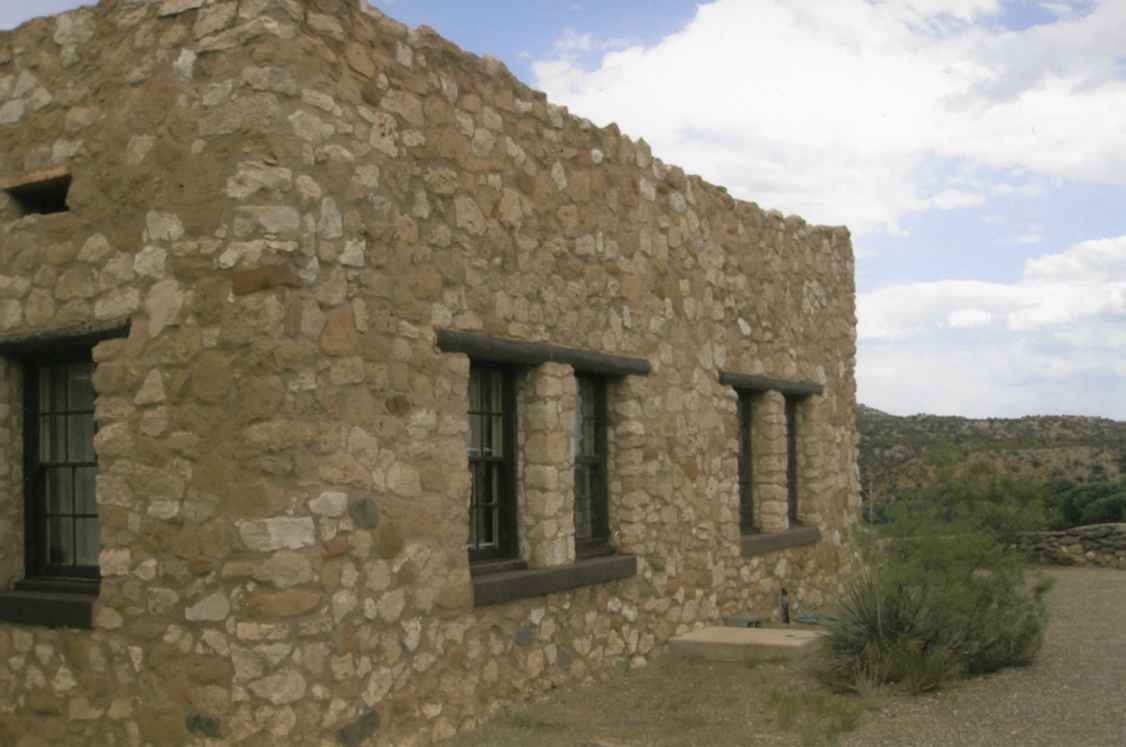
Photo 5

5. elevation of the residential  
wing looking E

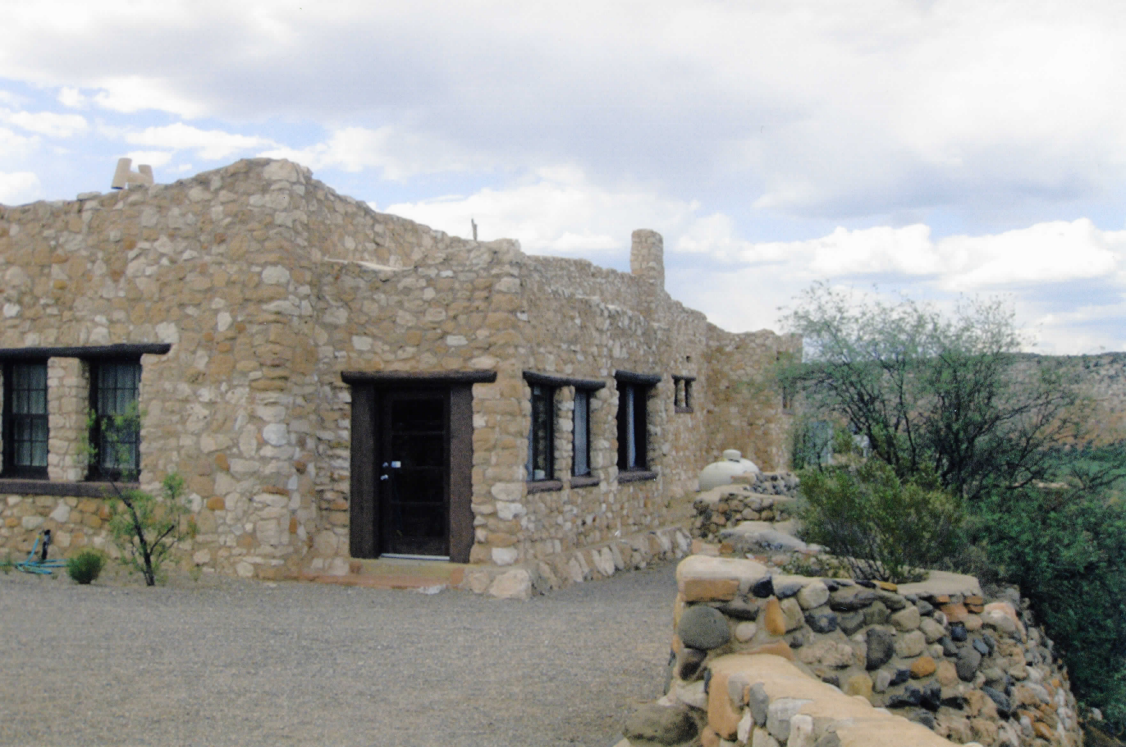
Photo 6

E porch of residential wing  
looking SW

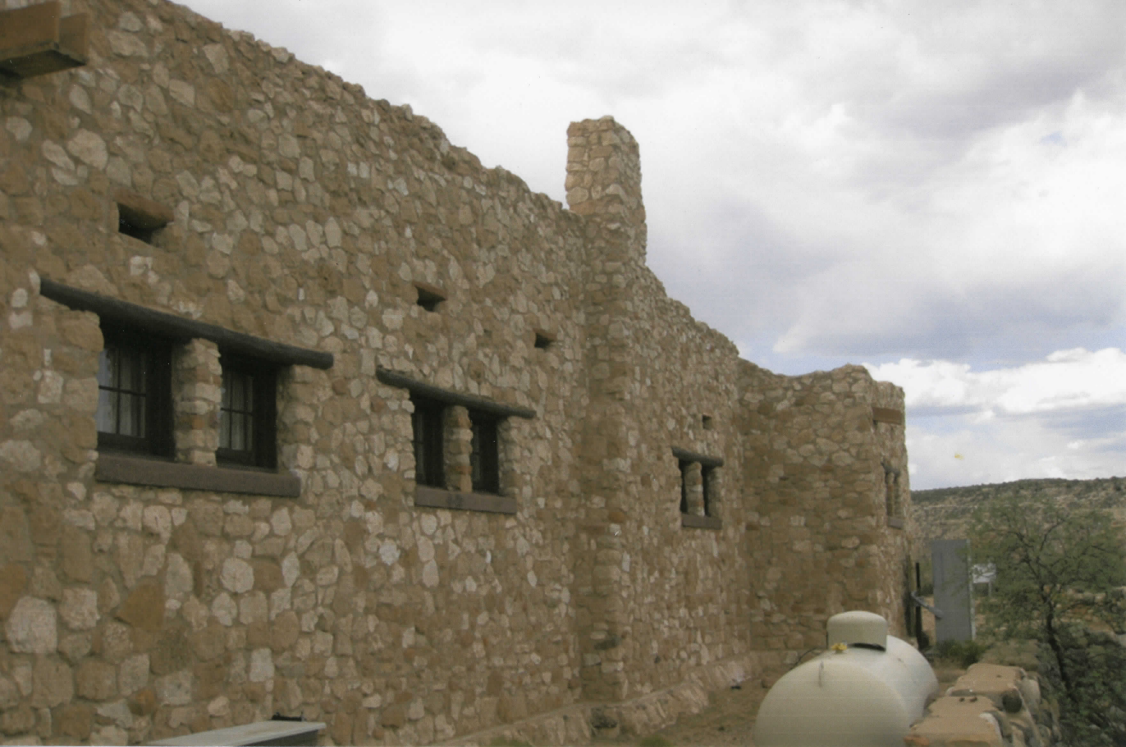
Photo 7.

E elevation of museum block  
looking NW

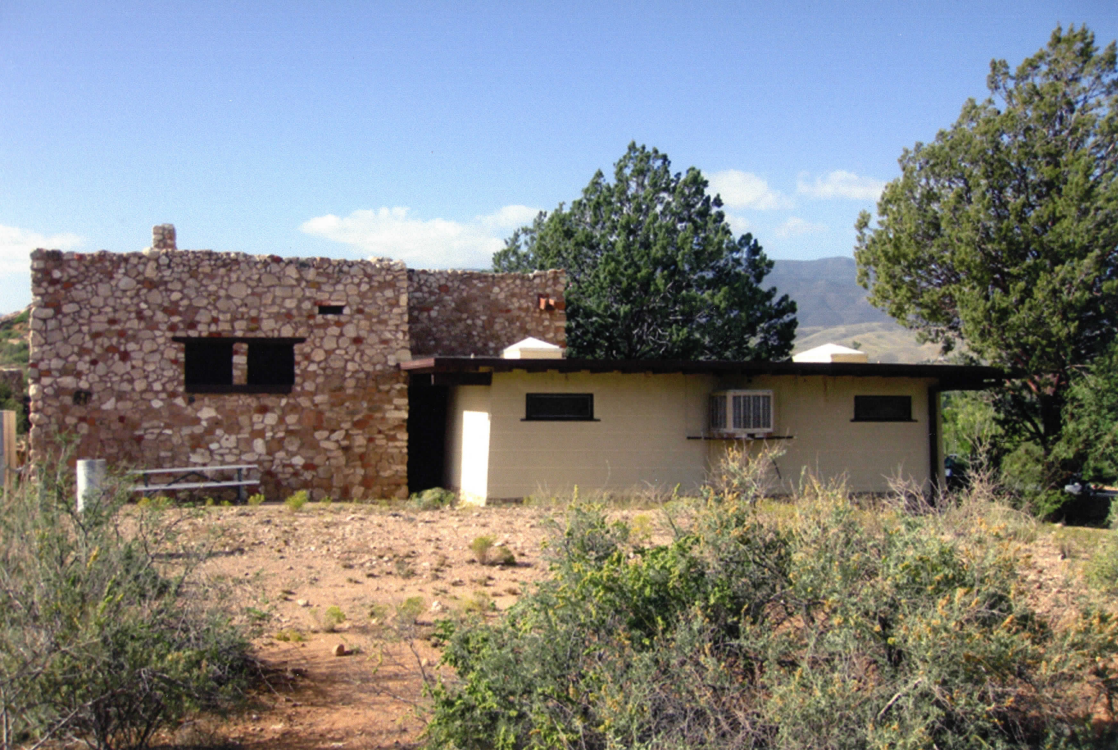
Photo 8.

N elevation of museum block  
and 1968 comfort station  
looking S.

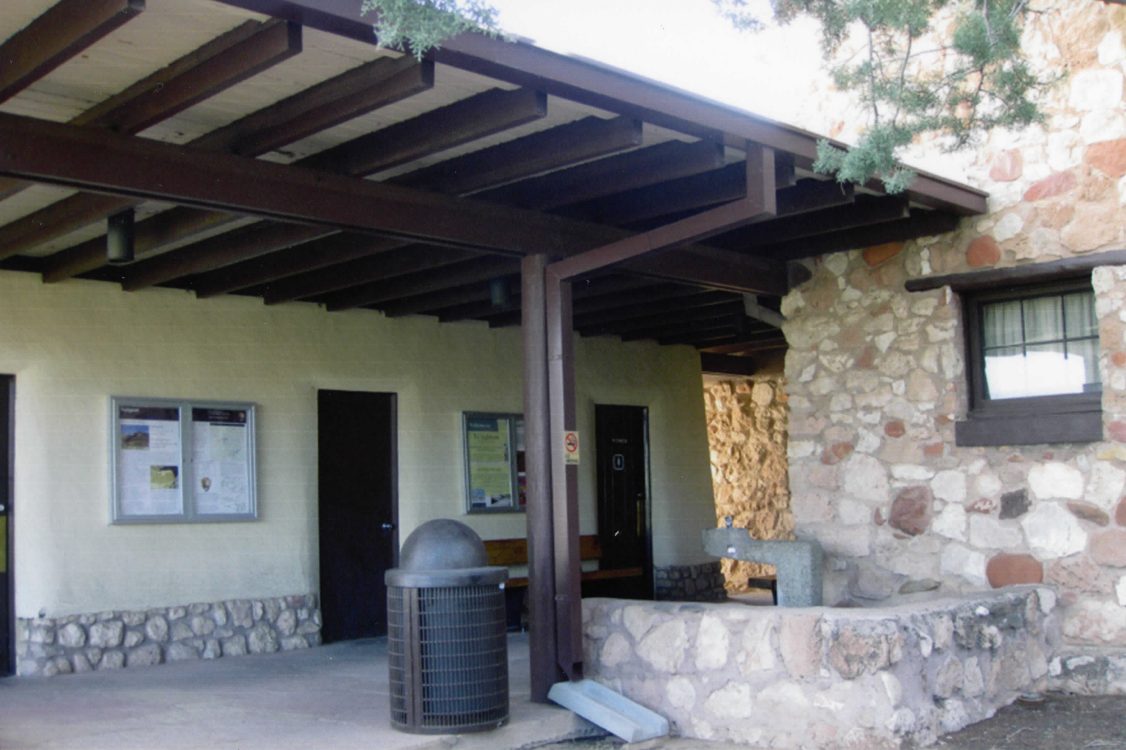
Photo 9.

S elevation of 1968 comfort  
station loggia looking NE

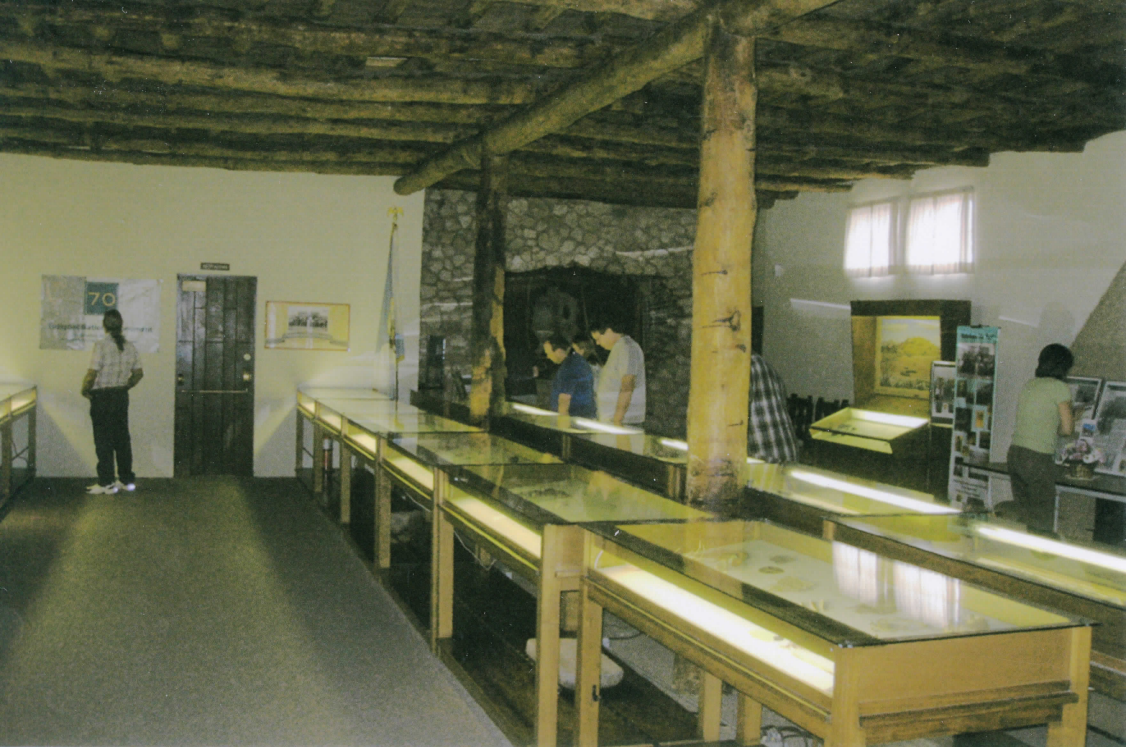
Photo 10.

Interior of museum looking  
NE

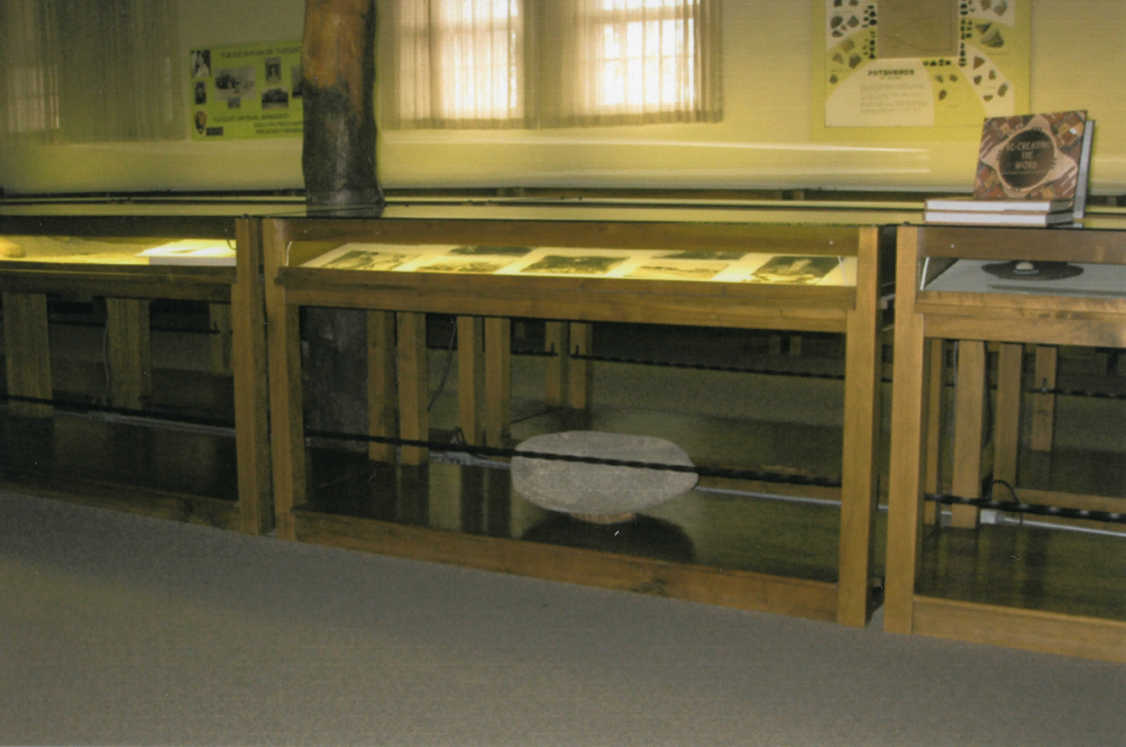
Photo 11.

Detail of original museum  
cabinet

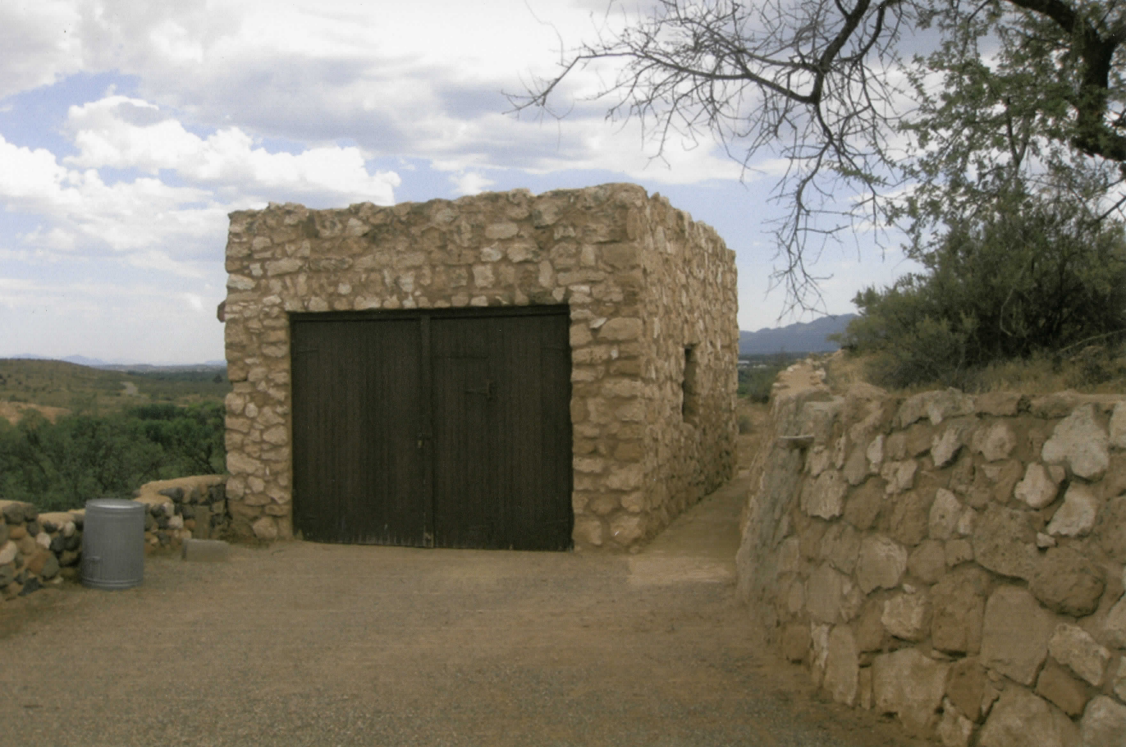
Photo 14.

N. elevation of garage looking S.

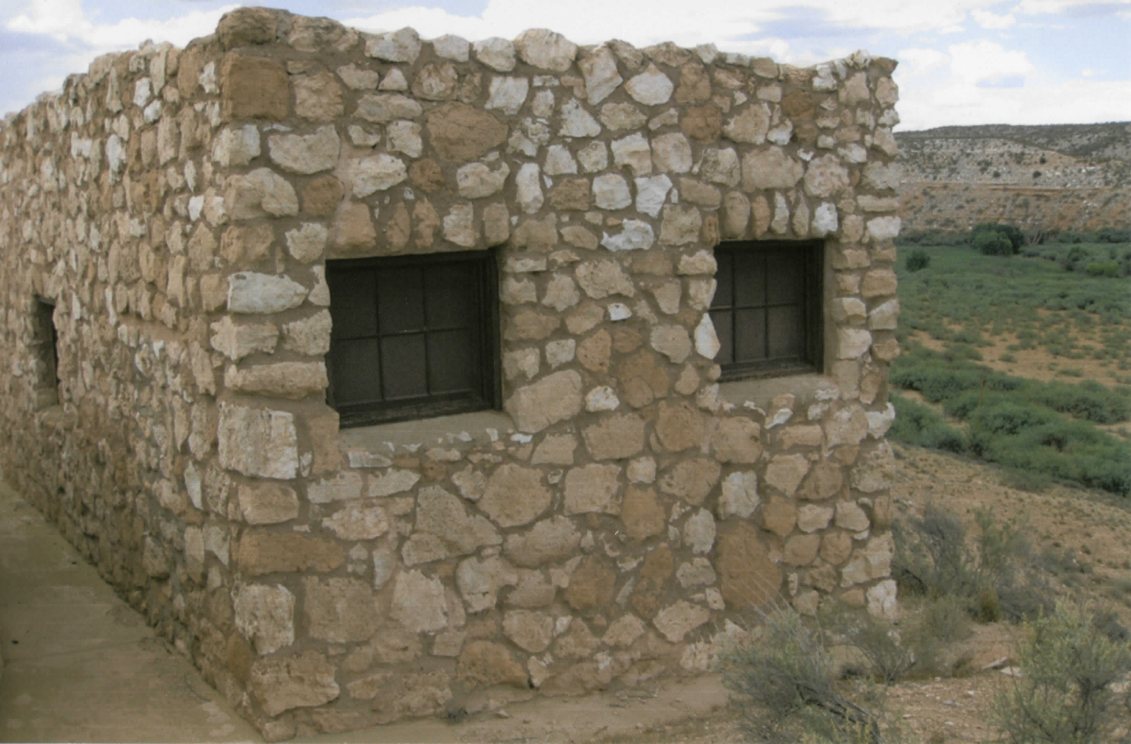
Photo 15.

S. elevation of garage looking  
NE.

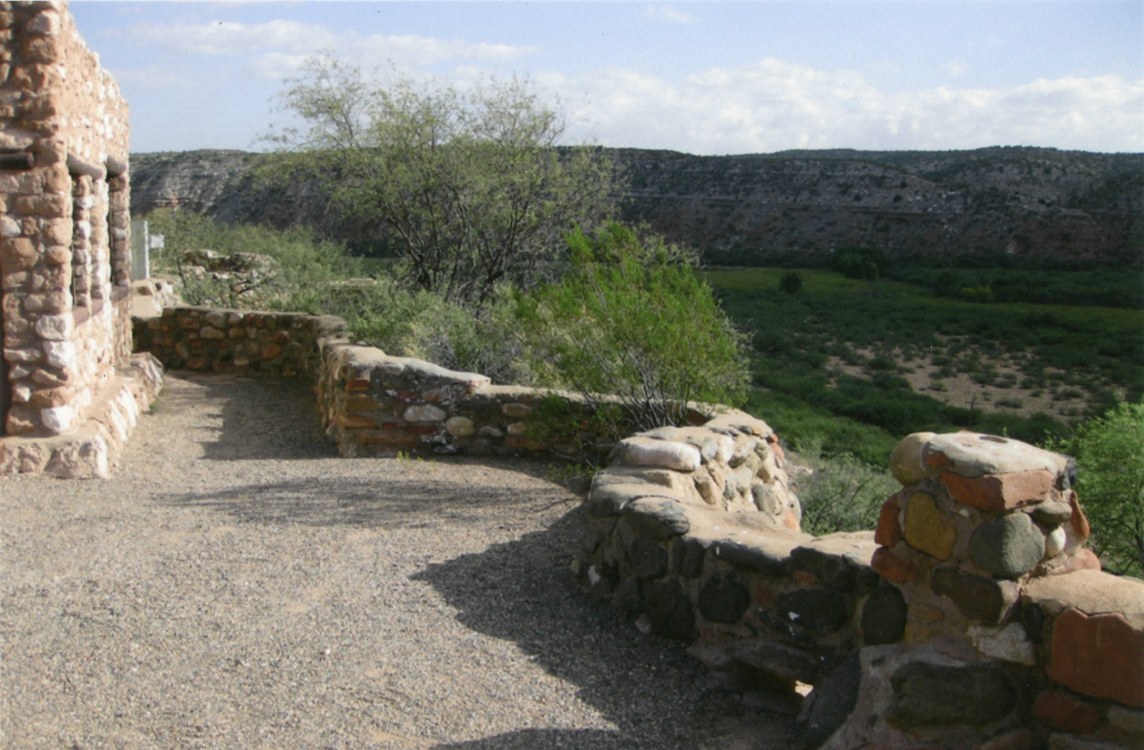
Photo 16.

E. retaining wall near garage  
looking N.

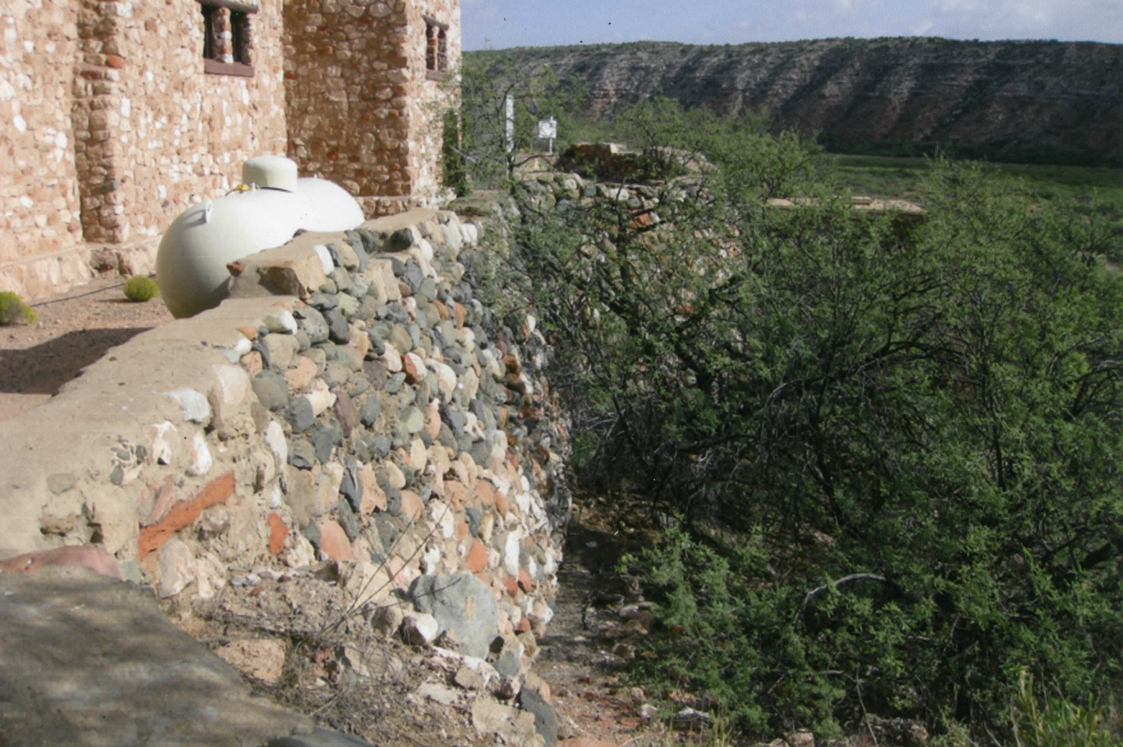
Photo 17.

E. retaining wall looking N

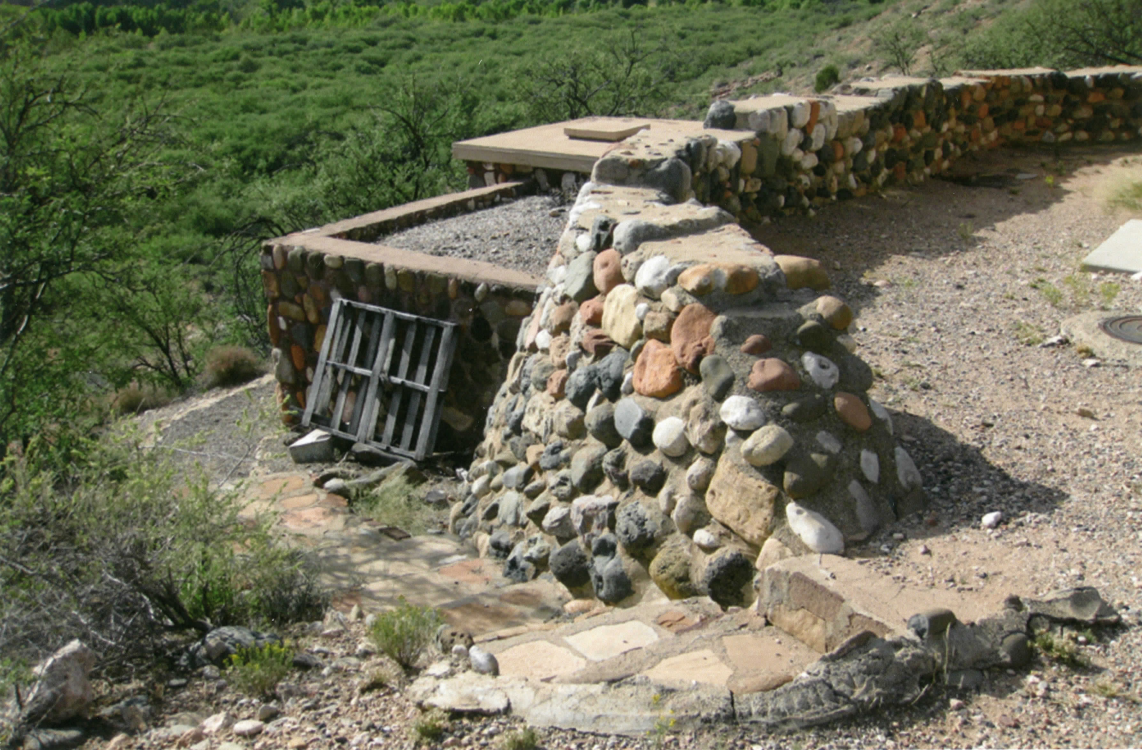
Photo 18.

E. retaining wall, N. end looking  
SE and showing Pump House

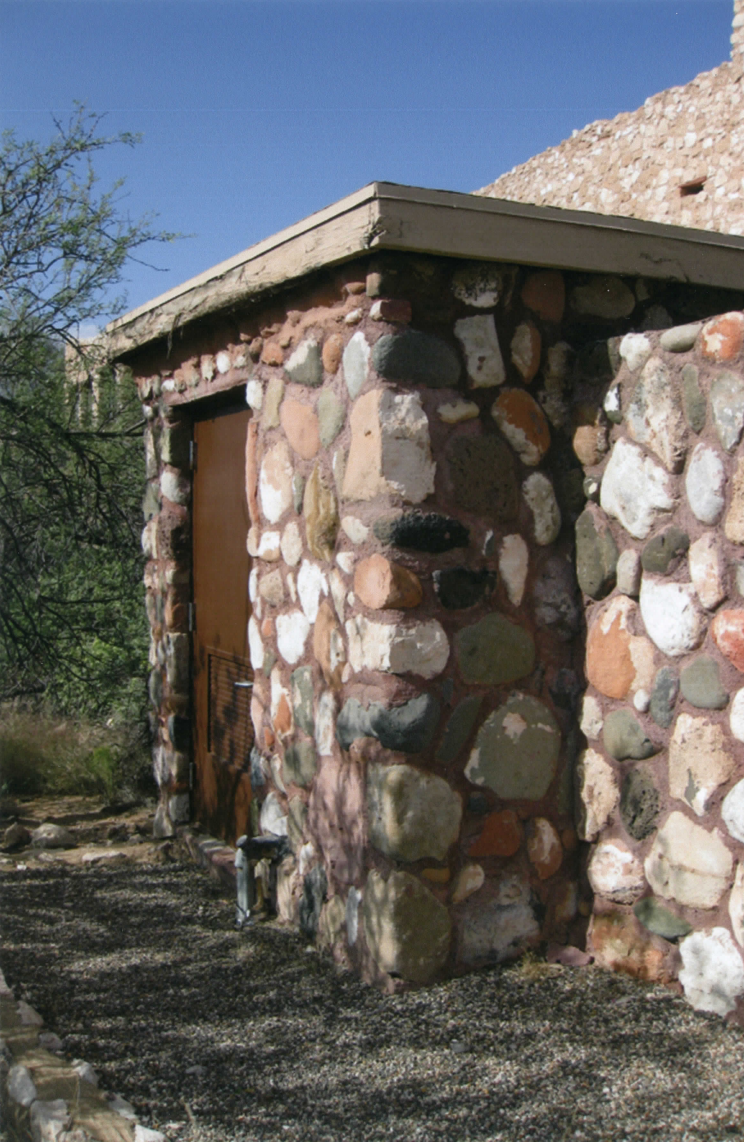
Photo 19.

N. elevation of Pump House  
Looking SW showing entrance

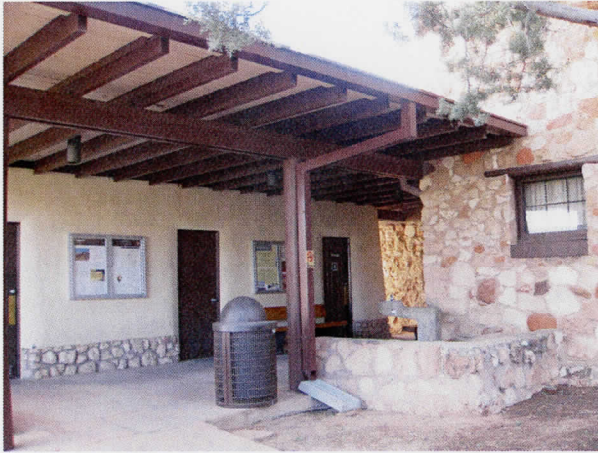
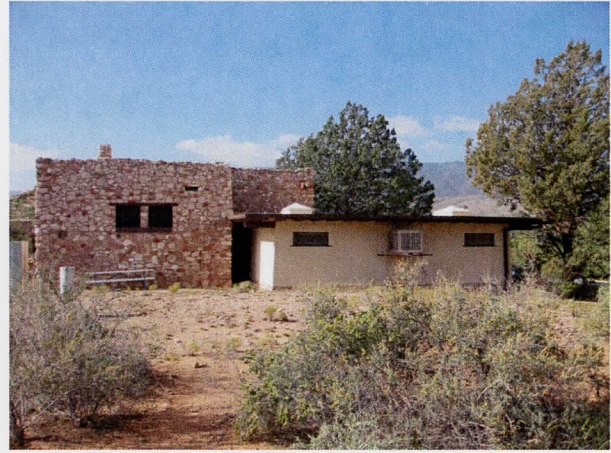
IMG 2248, 2453 accompanying the draft nomination

However the accompanying photographs of the comfort station, depicting it's introduction of an entirely different scale with it's cantilevered eaves as opposed to the parapets and considerable mass of the original building - belie the characterization of this addition as "designed in a compatible style"; which, apparently, is based solely on a low wainscot of veneered stone.

With the exception of that cosmetic gesture and the battered wall, this addition could hardly have been conceived with more indifference to the existing architectural qualities of the museum building; moreover this new building has more in common with standard stand-alone comfort facilities throughout the park system.

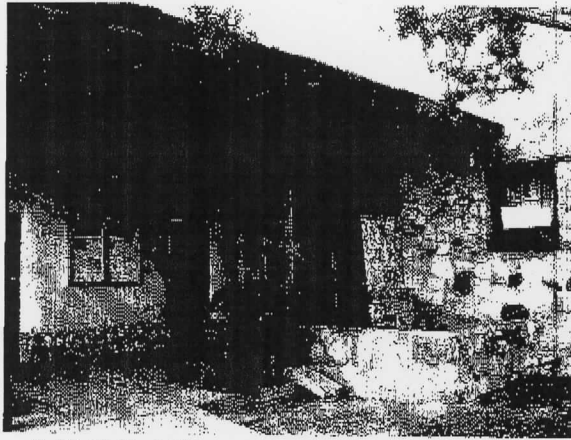
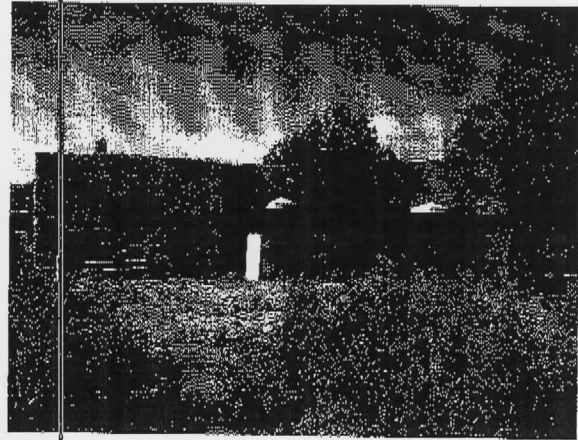
IMG 2248, 2453 accompanying the draft nomination

However the accompanying photographs of the comfort station, depicting it's introduction of an entirely different scale with it's cantilevered eaves as opposed to the parapets and considerable mass of the original building - belie the characterization of this addition as "designed in a compatible style"; which, apparently, is based solely on a low wainscot of veneered stone.

With the exception of that cosmetic gesture and the battered wall, this addition could hardly have been conceived with more indifference to the existing architectural qualities of the museum building; moreover this new building has more in common with standard stand-alone comfort facilities throughout the park system.
