National Register of Historic Places
Registration Form

historic name Overland Cotton Mill

street & number 1314 West Evans Ave. [N/A] not for publication

city or town Denver [N/A] vicinity

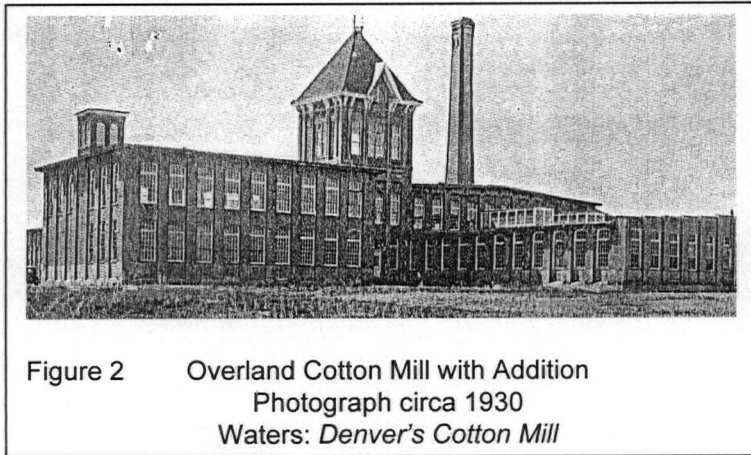
On its completion in 1881, the Overland Cotton Mill contained six boilers to run the 850-1,000 horsepower tandem, compound Corliss engine which powered the mill equipment by means of belts and shafts. The manufacturing machinery included 184 cards and spinning apparatus consisting of slubbers, fly frames and mules, and 16,200 spindles with all the necessary drawing frames and railway heads, 2 slashers, 480 looms and 10 breakers, openers and pickers.

The 1893 Sanborn-Perris insurance map identifies the activities which occurred in the various sections of the mill. The map shows that the main section and the east wing (picker house) interiors consisted of two continuous wood framed floors. The 1904 Sanborn insurance map shows the north addition in place labeled as the cloth room. Other evidence indicates that the addition was constructed by 1900. The picker house remained the same.

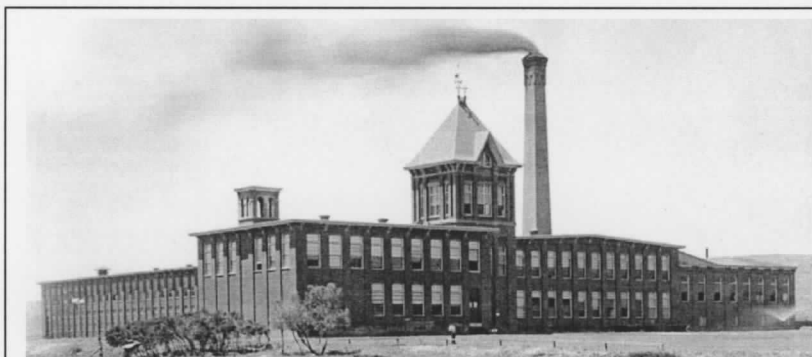
Figure 11 Overland Cotton Mill
William Henry Jackson photographer, circa 1890
Collection of the Western History Dept., Denver Public Library

The 1890 Overland Cotton Mill utilized all these design characteristics (*Fig. 11*). Though designed for utilitarian purposes, the mill afforded an attractive and commanding presence typical of late nineteenth and early twentieth century Denver.

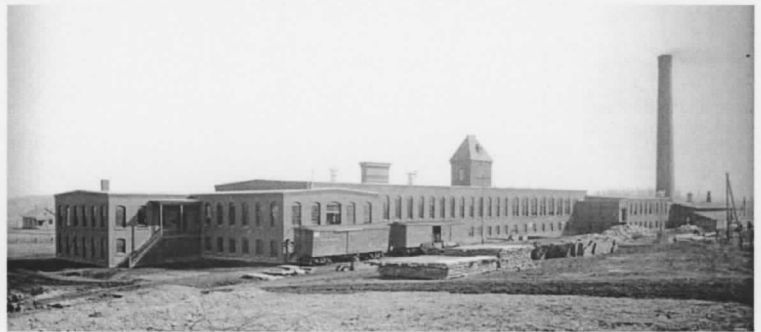
Figure 12 Denver Paper Mill
William Henry Jackson photographer, circa 1890-1900
Collection of the Colorado Historical Society

Company complex. The mill was located on Manchester Avenue (now S. Kalamath St.) between Gray (W. Louisiana Ave) and Agnes (W. Arkansas Ave.). Also built about 1890, the mill bears a strong resemblance to the Overland (*Fig. 12*). The paper mill utilized brick load-bearing walls for its long, rectangular plan, two-story buildings. The fenestration consisted of regular bays of tall multi-light windows with segmental arches. The mill contained a three-story tower with hipped roof and a tall brick smokestack.

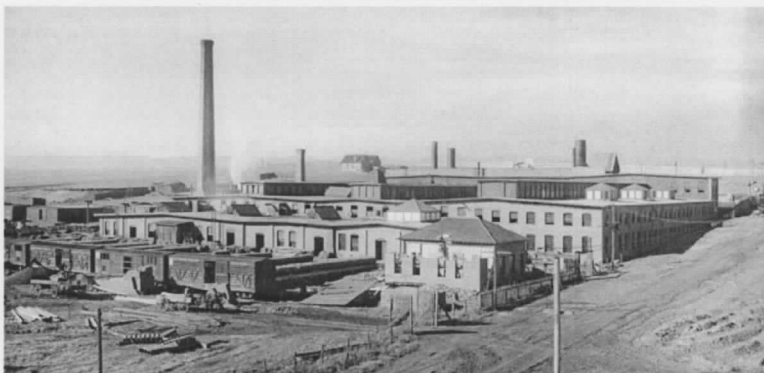
Figure 13 Griffin Wheel Company Plant
Louis Charles McClure photographer, circa 1900-1915
Collection of the Western History Dept., Denver Public Library

The Griffin Wheel Company plant was another nearby industrial facility. From 1895 on, this major complex occupied a site just across the railroad tracks northwest of the Overland Mill (*Fig. 13*). The wheel works utilized similar brick load-bearing walls for its long, rectangular plan, one- and two-story buildings. The fenestration again consisted of regular bays of tall multi-light windows with segmental arches. The wheel works also utilized a tall brick smokestack but failed to include a tower in its basic design.
