National Register of Historic Places Registration Form

historic name Veta Pass
other names/site number La Veta Pass, Old La Veta Pass, Uptop, 5HF.2410

Veta Pass-Uptop Historic District
Name of Property

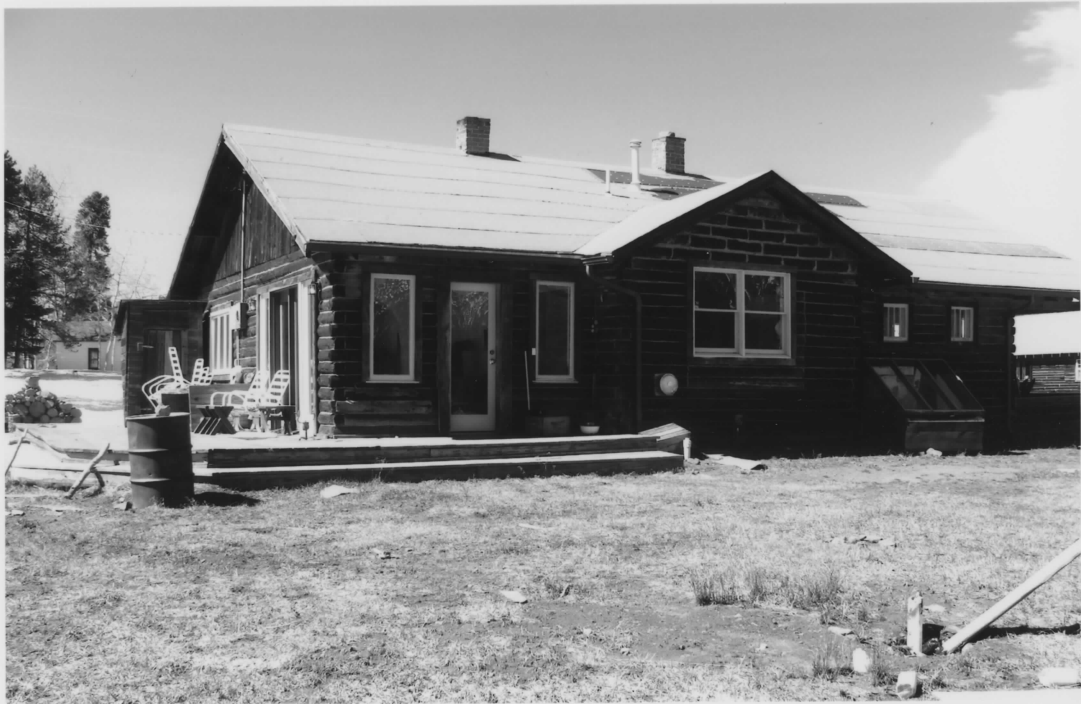
04

Head Quarters (HQ) is a large, rectangular chinked log building (28' x 40' including the portico) on a concrete foundation, running northwest to southeast (Photos 4, 5, 6). This building originally served as the headquarters for operations at this property when it was a stop for automobile tourists in the mid-twentieth century. The chinking was reapplied in 2003. The front-gable roof has a projecting side-gable on the east, and its original wood shake roof was replaced with rolled roofing in 2003. The building retains its original large front entry room with a brick chimney for a coal furnace and three smaller rooms in the back with a common brick chimney for wood stoves in each room. Original wood floors remain throughout the building.

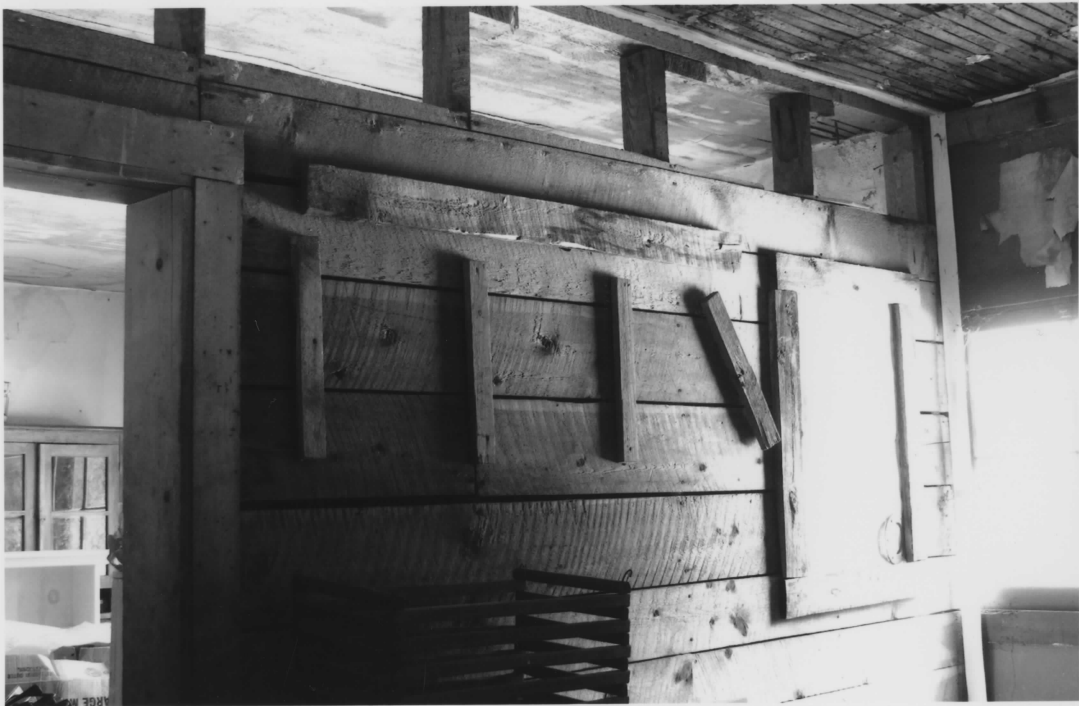
26

The tavern and dancehall is a large T-shaped log building that sits on a concrete foundation, located about 20' to the north of County Road 443 (Photos 26, 27, 28). The front portion of the building (the 94' x 24' tavern section) was created

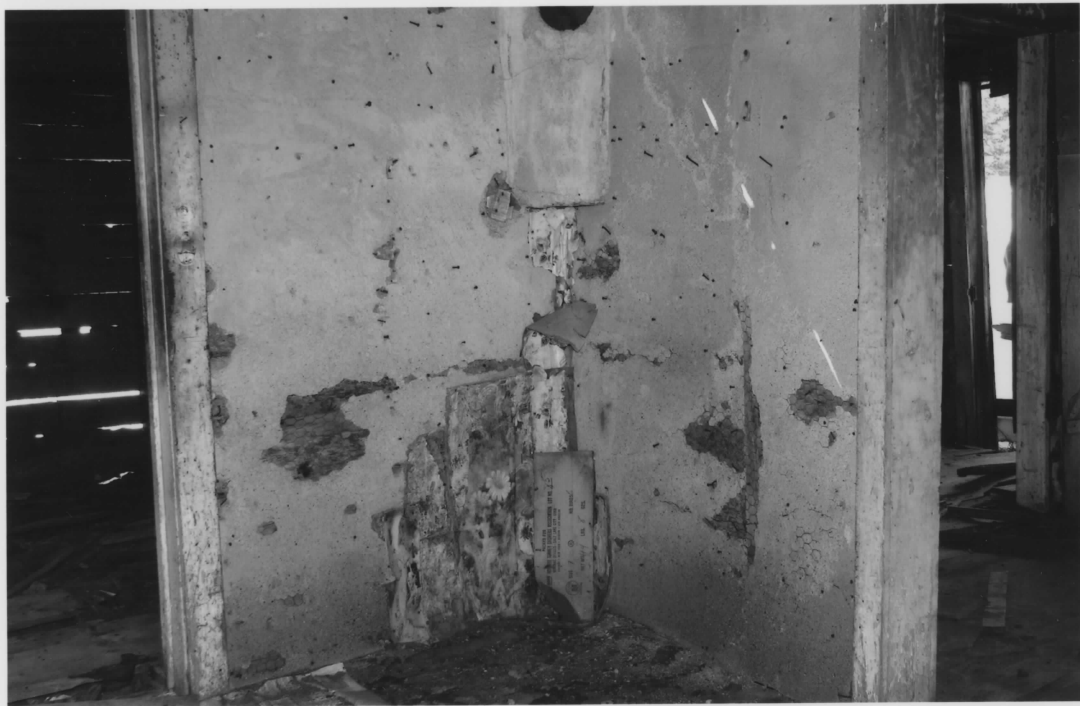
Veta Pass - Uptop Historic District 29
Huerfano County, Colorado

around 1940 by moving together two smaller log cabins extant on the property that dated from the 1920s, adding onto the east end of one and putting them under a common hipped roof of asphalt shingles, which remains intact (Photo H007). In this process the existing roofs of the cabins were never removed, producing an odd combination of interior roof lines in the attic. At the same time a 40' x 33' extension for a dancehall was built on the center of the north side of the building and covered with a continuous, adjoining gabled roof. Externally, the tavern looks all of a piece; internally, a 3' gap exists where the two cabins come together (Photo 29).

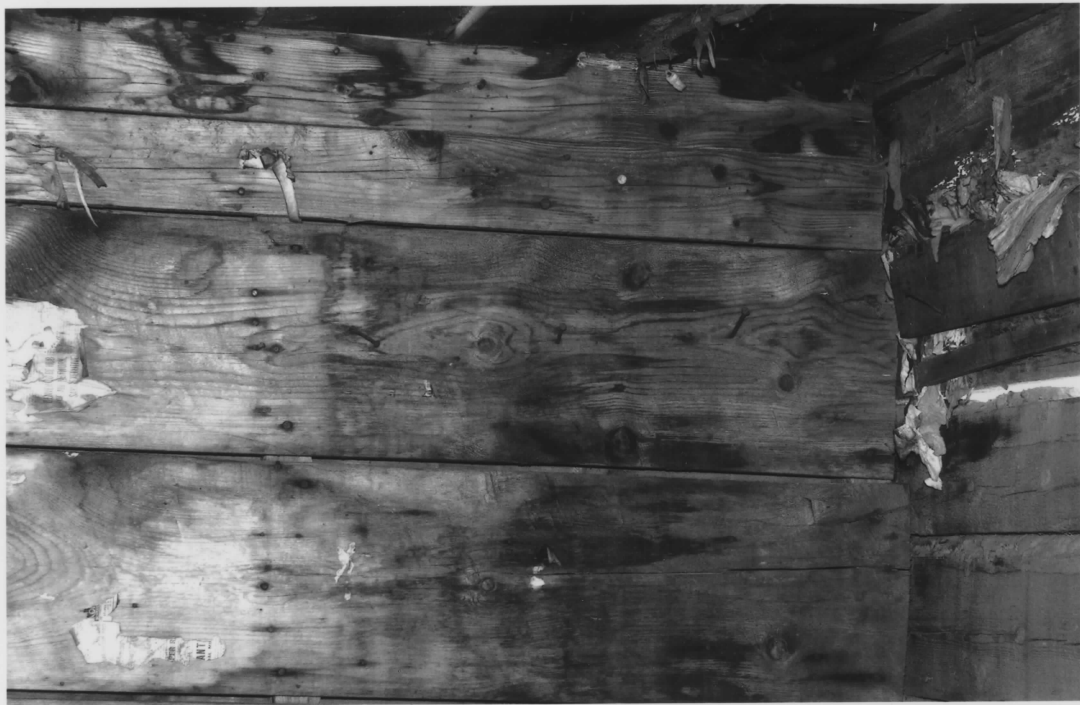
Veta Pass - Uptop Historic District 30
Huerfano County, Colorado

A 40' x 33' dance hall extends from the back of the tavern. Seven original wood windows are located on the dancehall's east, north, and west sides. Each window is a two-sectioned, three-over-three sliding window (Photo 30). A wood double door that opens out is also on the east side, close to where the extension joins the tavern. The building has a single brick chimney that served a coal furnace in the dancehall. The floor of the dancehall is made of maple, imported from Missouri, to provide a quality dancing surface. The rest of the building has pine floors. The foundation is concrete with a negligible crawl space underneath. Sometime in the 1970s, squatters pulled down the smoke-stained ceiling panels, exposing the rafters. A small raised stage is located in the northeast corner of the dancehall (Photo 31).

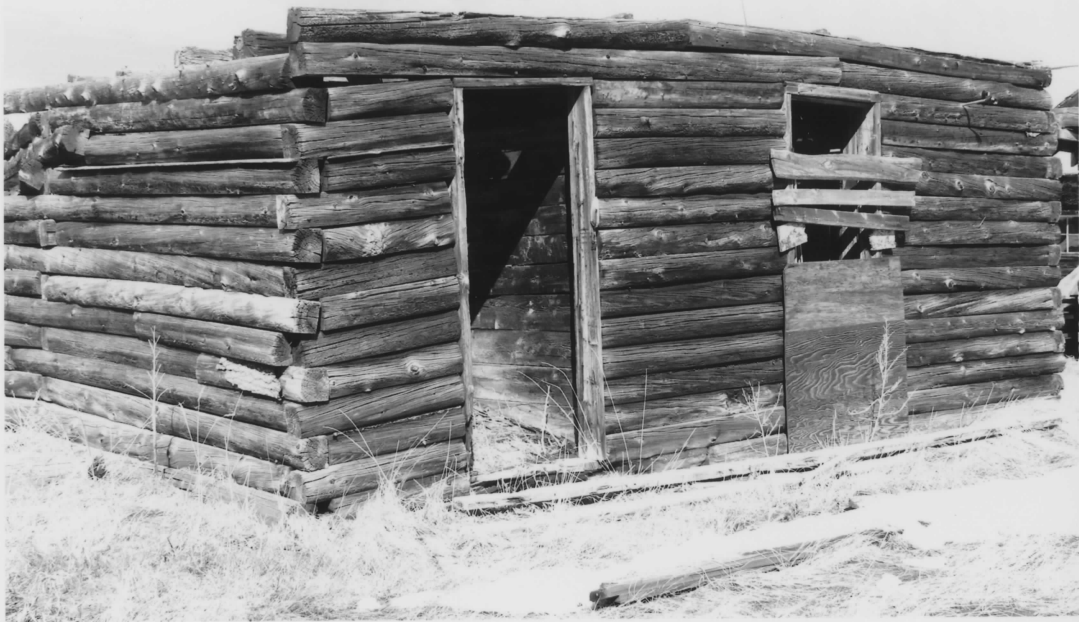
Veter Pass - Uptop Historic District 33
Huerfano County, Colorado

The bunk house is a square log cabin (24' x 25') with no foundation (Photos 33, 34). It has a front-gable roof on which only a few wood shakes remain, pierced by a central brick chimney, which opened into four rooms, each one a separate living quarters (Photo 35). All four sides have windows that are badly deteriorated, as are the three exterior wood doors (south, east, north), and the flooring. Inside, the rooms have patches of period wallpaper that was often put over old newspapers. Newspapers were also used as chinking throughout (Photo 36). The southeast room has an interior access to a root cellar in its southeast corner. No changes have been made to this building, allowing it to retain a "ghost town" feel.

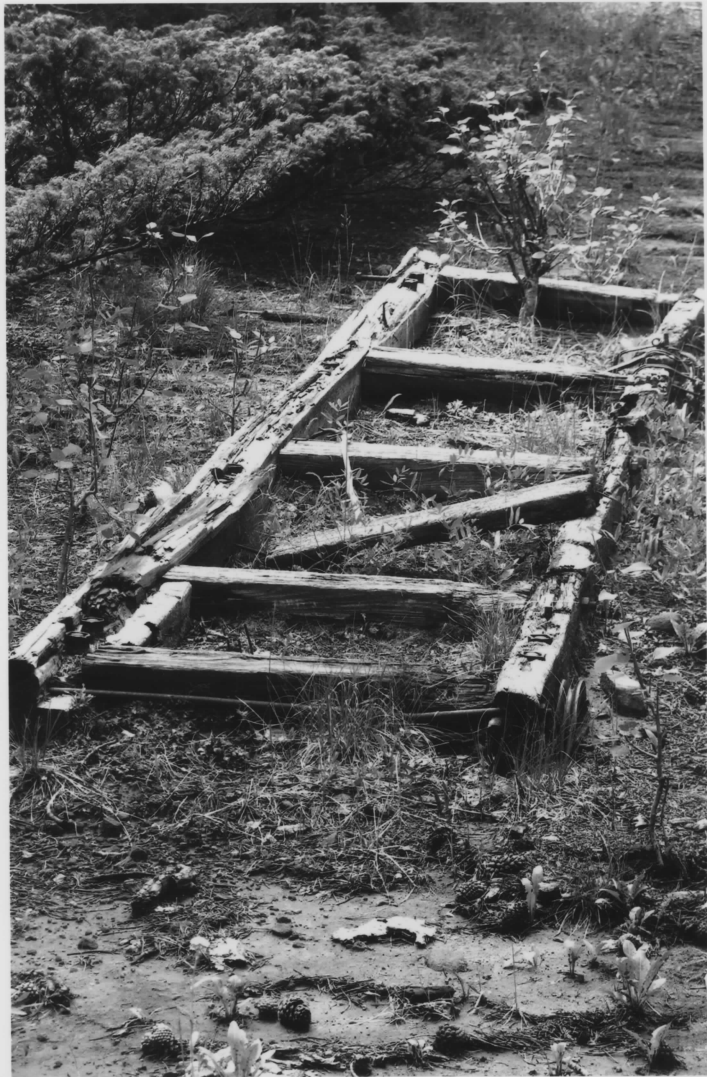
Ueta Pass - Uptop Historic District 40
Huerfano County, Colorado

This small log rectangular building (10' x 20') located to the west of the tavern once housed the generators that provided electricity to the mountain top (Photos 40, 41). There are two door openings on the south and one opening on the east. The roof has fallen in and what was once a garage has collapsed. The building had no foundation and no windows.
