National Register of Historic Places
Registration Form

historic name Beckwith Ranch

other names/site number 5CR26

BECKWITH RANCH
CUSTER COUNTY, CO

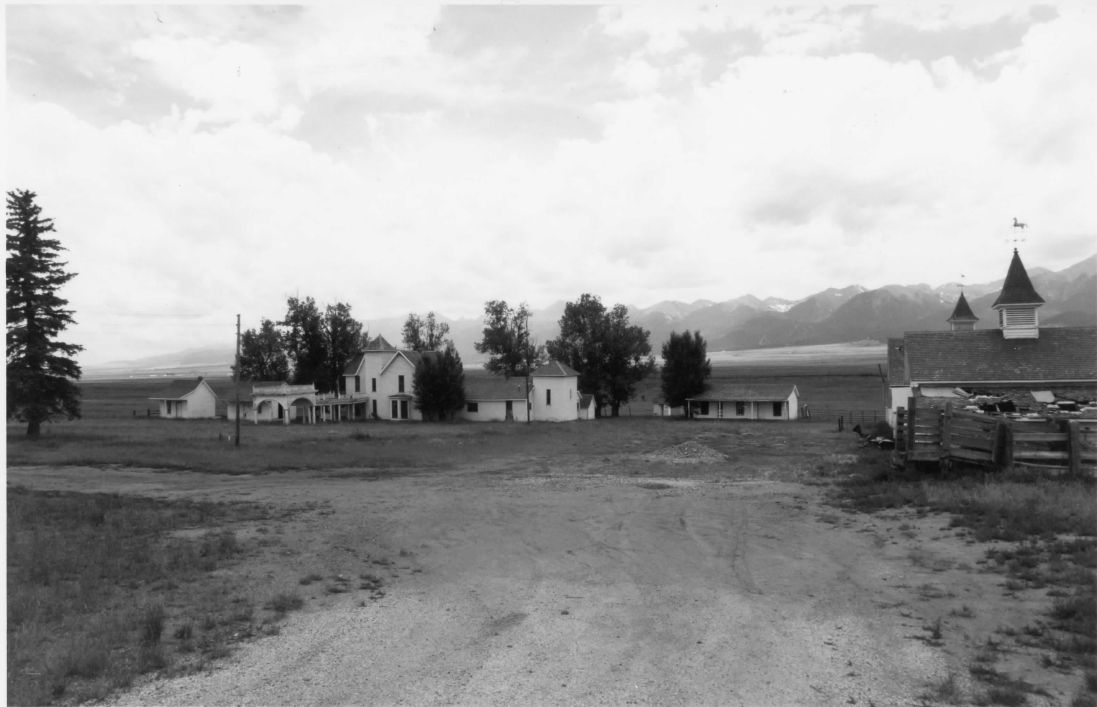
#1

The privy [no separate photo, but can be seen in photos 1 and 2] is a rectangular, one-story building measuring 5 feet x 8 feet. It has a side gable roof covered with red painted wood shingles and enclosed eaves. Its date of construction is unknown, but it appears to be part of the major construction episode of the 1890s. The balloon frame structure has a finished interior. It is a two-seater. The exterior is covered with clapboard siding with corner boards. The foundation is sill timbers on grade. The door is 4-panel wood.

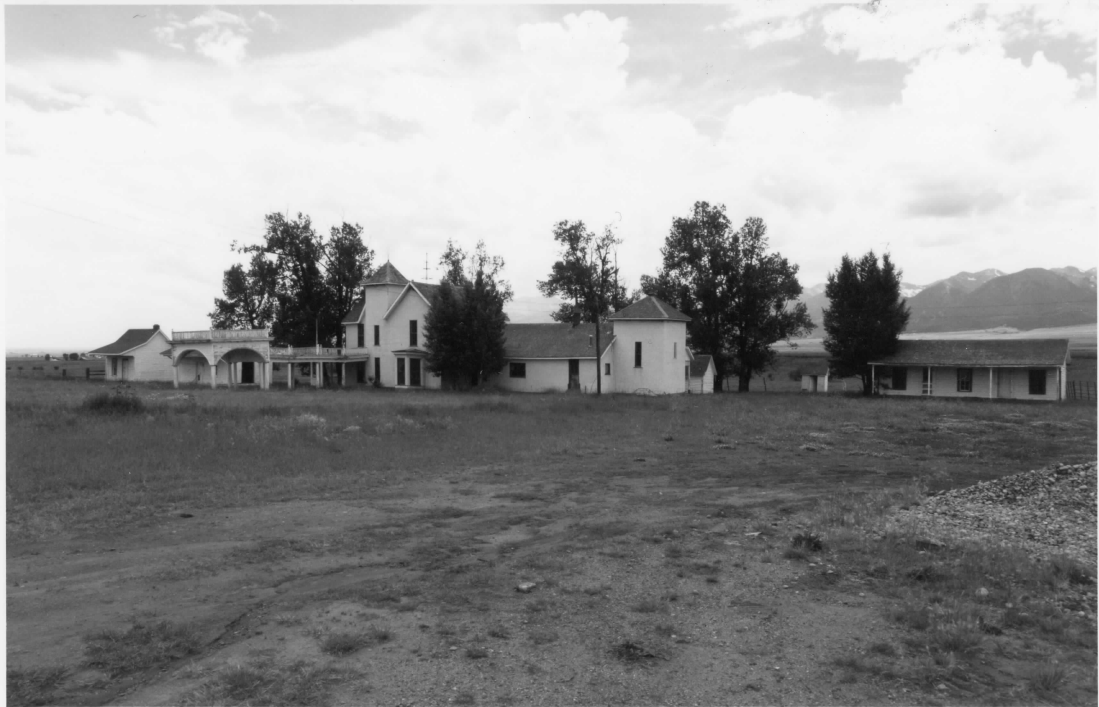
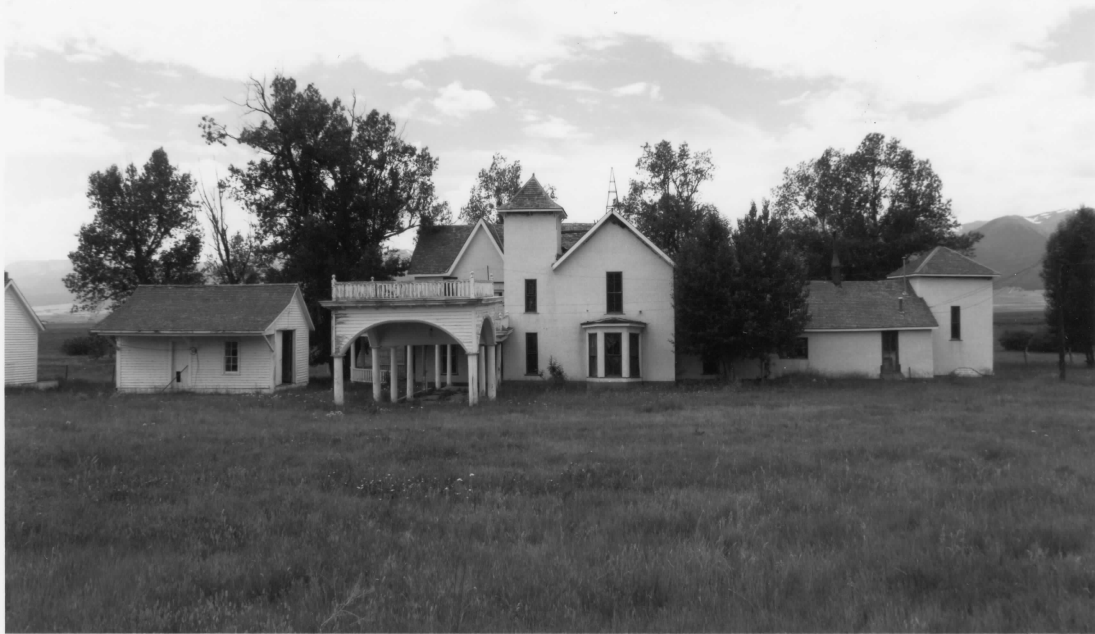
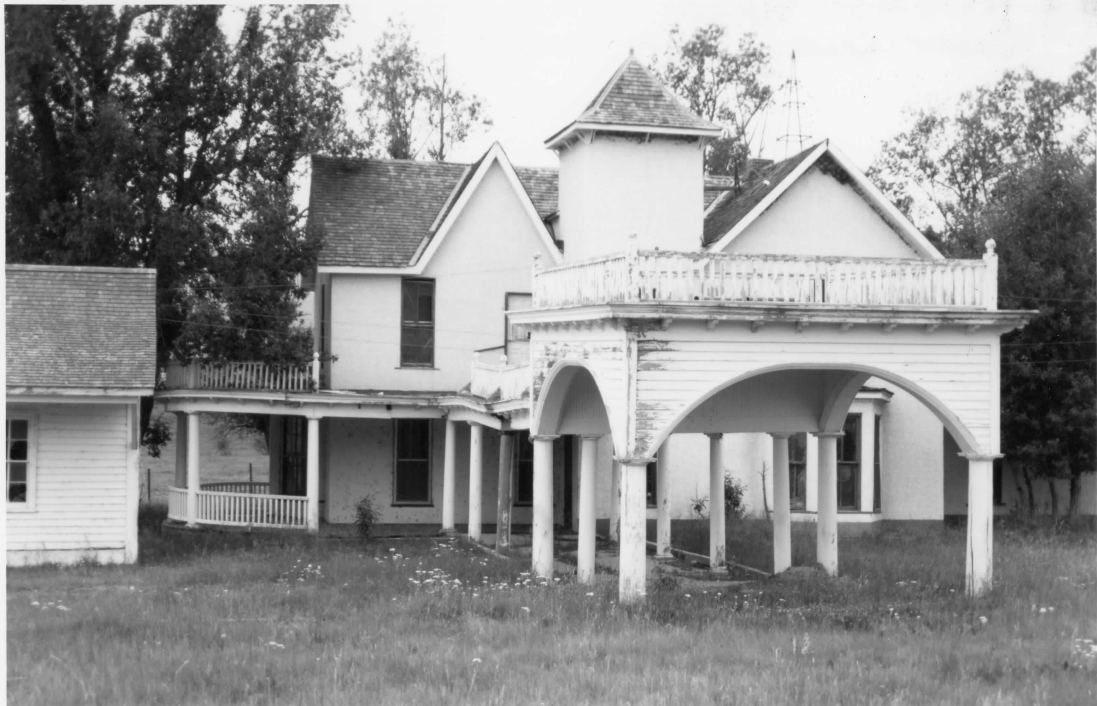
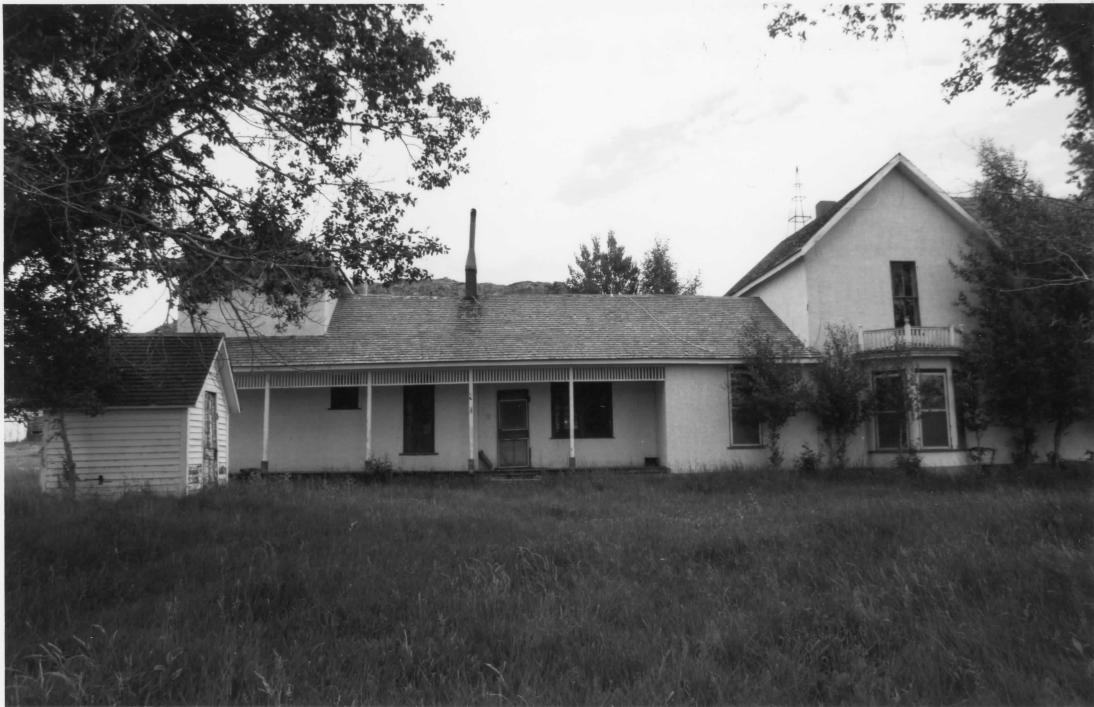
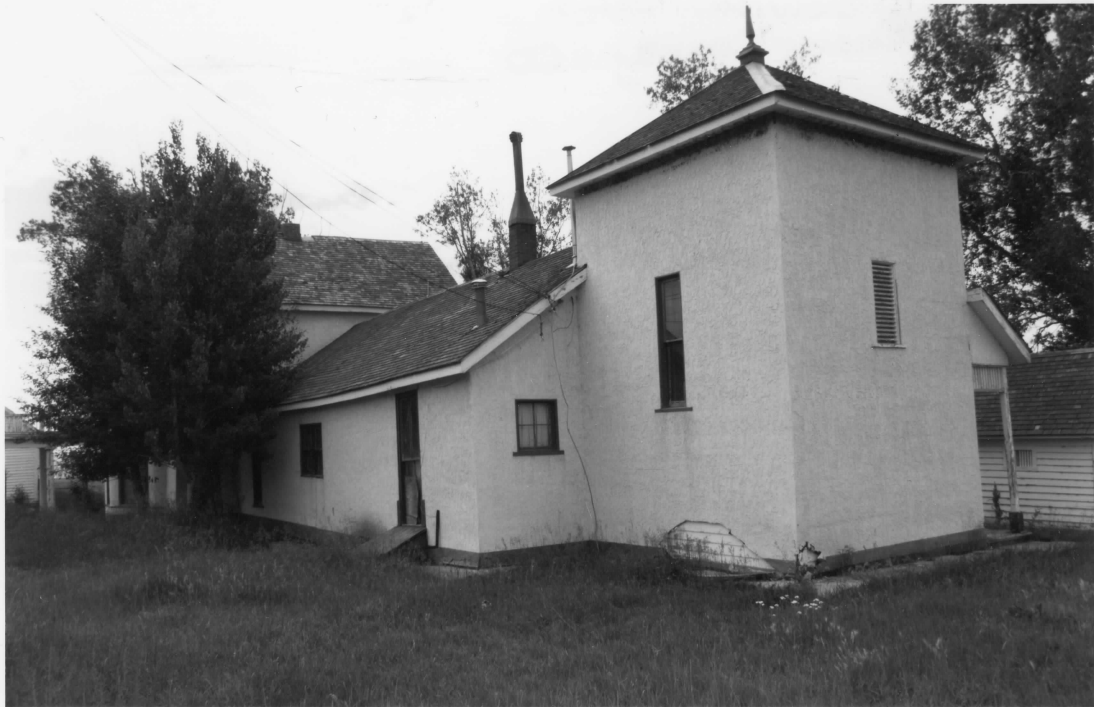
#2

The main house [photos #2-6], the most striking building within the complex, is a combination 1-and 2-story late Victorian eclectic style with an irregular footprint resulting from numerous additions. (See floor plan.) A porte cochère dominates the front of the house. The house's roofs reflect the additions and are a combination of intersecting gables, a hipped roof, and a bellcast hipped roof with a flat roof on the bay windows and porte cochère. The exterior is clad with clapboard siding over coated with stucco.

The combination roof is made of wood rafters covered with planks and wood shingles painted red. There are now flat capped brick chimneys on the roof ridges. Metal stove pipes are located at various points on the roof as well. There is a small framework made of metal bars located on one of the main gables. All eaves are enclosed with bracket decorations on the central towers.

The walls are a combination of hewn log from the original cabin and balloon framing. The weatherboard siding is coated with stucco. The stucco was added after 1954, based on a photograph published in the *Pueblo Chieftain*. While the stucco is not the original wall material and has cost the house some of its integrity, the key characteristics (such as the unique foot print, the roof shape, and the placement of doors and windows) remain. The house retains enough integrity to be considered a contributing element of the district. The windows are predominately 2-over-2 light, double hung with some 1-over-1 light, double hung. Some of the 1-over-1 light windows contain stained glass. All the windows are wooden sash. The doors are 1 light over 1 panel with milled trim and stained glass, 1 light over 4 panel, 4 panel wood and 1 light over 3 panel wood.

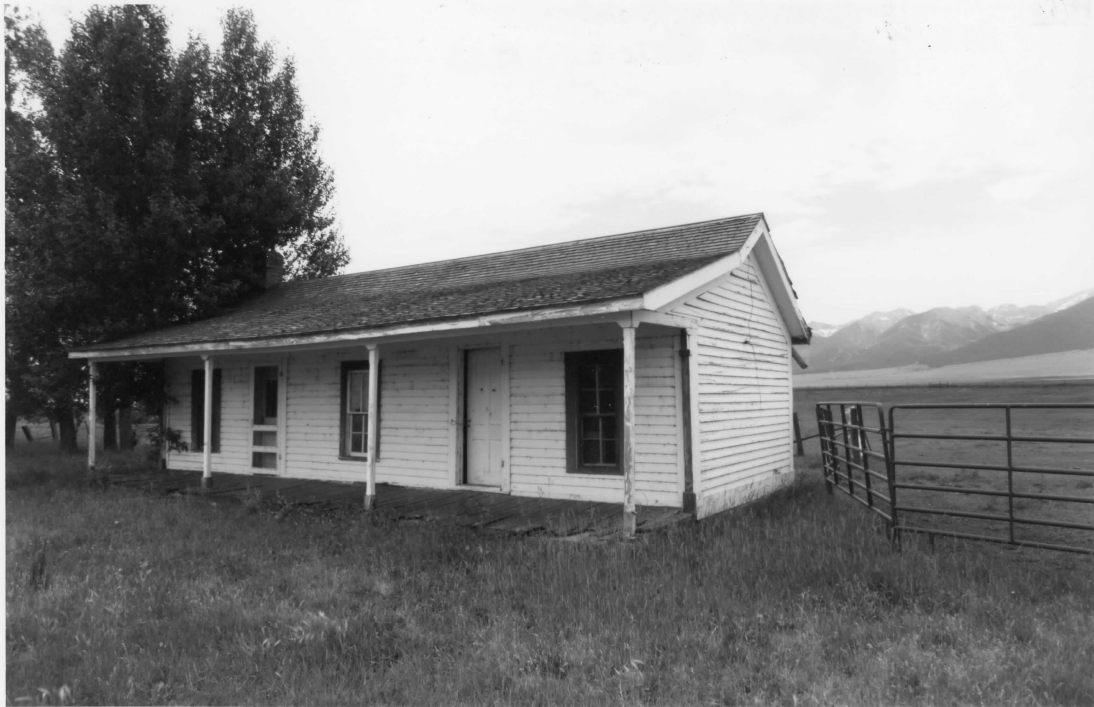
#7

The bunk house [photo 7] is a one story building with a rectangular footprint, measuring 20 feet x 32 feet. Construction was completed in 1899. The building has a modified side gabled roof clad with wood shingles that are painted red. The eaves are enclosed. The roof extends out along the front to cover a full length veranda style porch. The porch roof is supported by four wood posts with decorative engaged posts on the front wall of the building. The wood plank flooring of the porch is supported by a concrete pad. The frame structure is on a concrete foundation. The building is covered with clapboard siding with corner boards. A brick chimney with tapered metal cap sits on the ridge at the east end of the roof. The interior contains three rooms. There are two front doors, a glazed and paneled wood and a four-panel wood door facing north toward the interior of the complex. The back, south-facing door is a four-panel wood door. The windows are 4-over-4 light, double hung, wooden sash. The interior is in fair condition and little of its historic fabric remains.

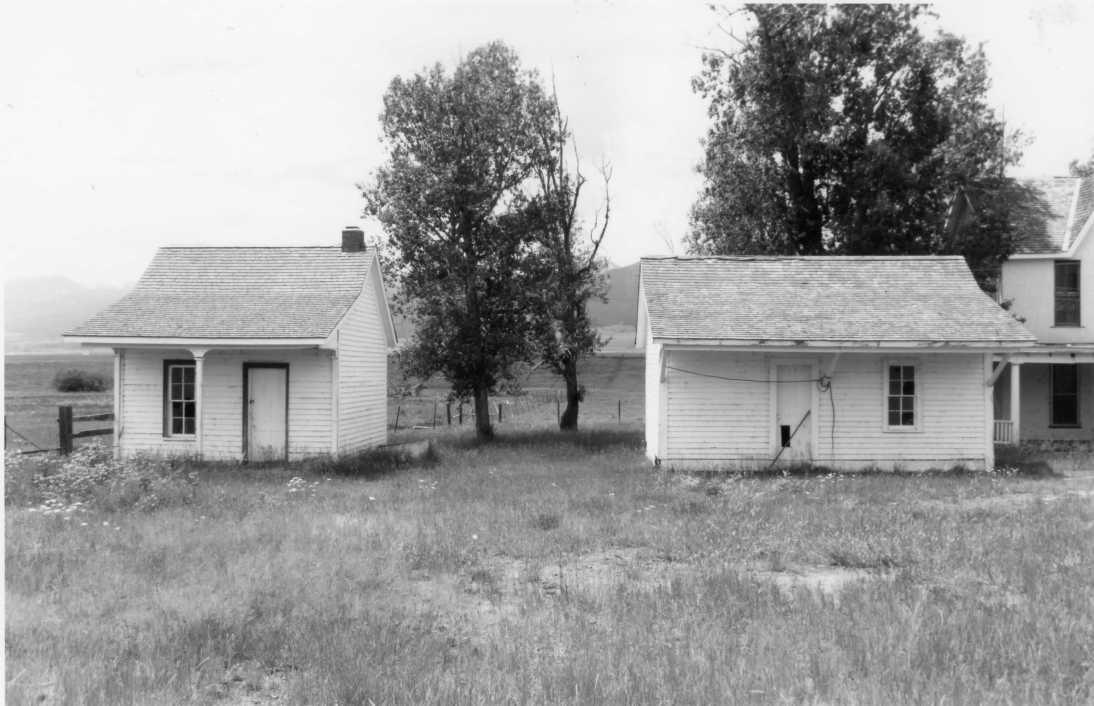
#8

The Servant's Quarters [photo 8] is a one-story building with a nearly square footprint, measuring 12 feet x 15 feet. This building dates to the 1890s. The building has a modified side gable roof, like the bunkhouse. The roof is covered with wood shingles painted red. There is a brick chimney with a metal

The Carriage House [photo 8] is a one-story building with a rectangular footprint, measuring 20 feet x 12 feet. It is similar to the servant's quarters in many ways and appears to have been built at approximately the same time, during the late 1890s. The building has a modified side gable roof covered with wood shingles painted red. The eaves are enclosed. The walls are balloon frame. Clapboard siding with corner boards covers the outside. There is a 4-panel wood door and 4-over-4 double hung wooden sash windows. The foundation is poured concrete. The veranda style porch has square wood brackets holding up the porch roof which is an extension of the main roof. The house has a vertical plank hinged double doors on the west face. The carriage house appears to be a functional conversion, probably of servant's quarters. The interior is in poor condition and retains almost none of its historic fabric.

cap protruding from the ridge line. The wood frame walls are sheathed with clapboard siding and have corner boards. The building has a 4-panel wood door and 4-over-4 double hung wooden sash windows. The foundation is of poured concrete. The veranda style porch is on the north side. At one time the porch roof, an extension of the main roof, had three simple, square wood columns. Engaged columns remain attached to the front wall of the building. The interior has been nearly gutted, resulting in a loss of historic fabric.

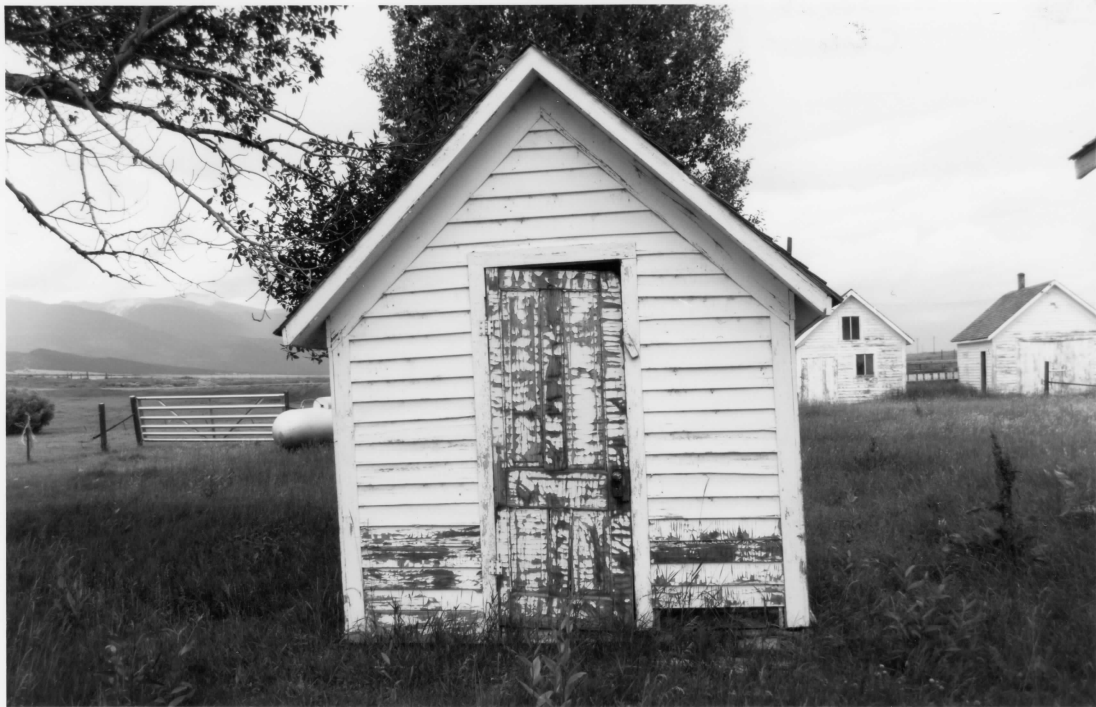
#9

The ice house [photo 9] is a small, square (8 feet x 8 feet), one story building. Its date of construction is unknown, but it appears to be part of the major construction episode of the 1890s. The front gabled roof has red painted wood shingles. The eaves are enclosed. The frame structure is sheathed with clapboard siding and vertical corner boards. There is one wooden window on the northeast side that is covered. The building sits on a poured concrete foundation. The single door is 4 panel wood. The interior is one open space.

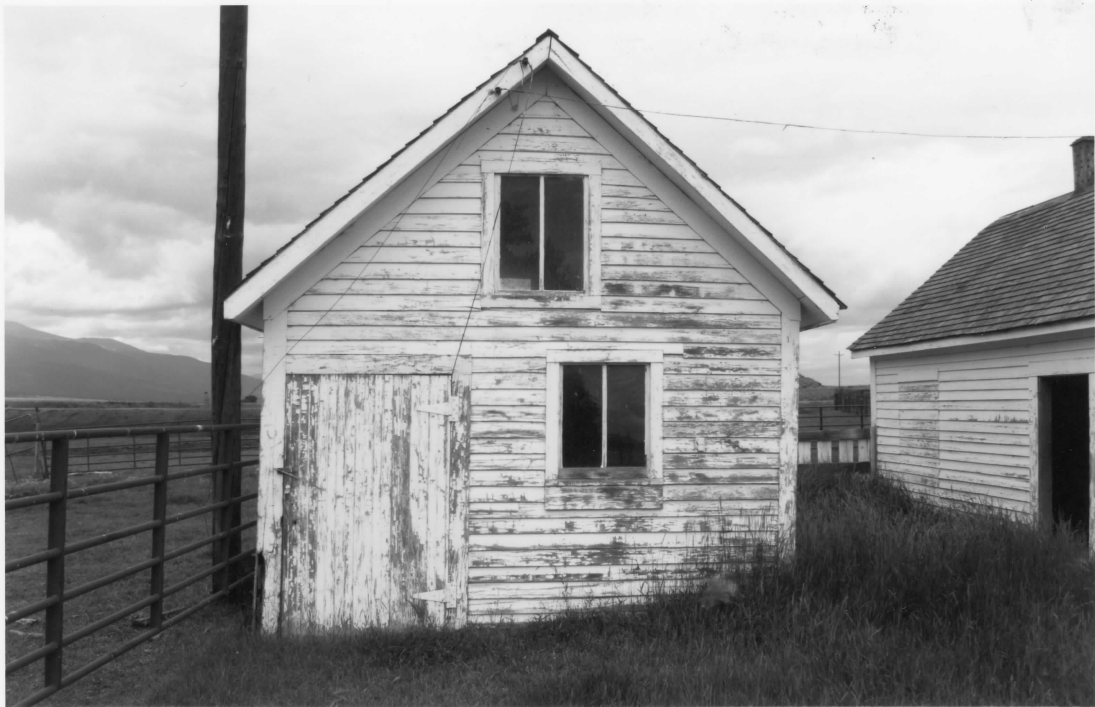
#10 Beckwith Ranch
Custer County, CO

The rectangular (12 feet x 20 feet) shop [photo 10] is a 1-1/2 story building with a front gabled roof covered with wood shingles painted red. It was built during the late 1890s. The eaves are enclosed. The frame building is covered with shiplap siding and corner boards. The foundation is poured concrete. The two wood windows are 2-light fixed and are on the front facade. There is one large, vertical plank door on the southeast corner of the front facade, facing east toward the center of the complex. The interior is unfinished.

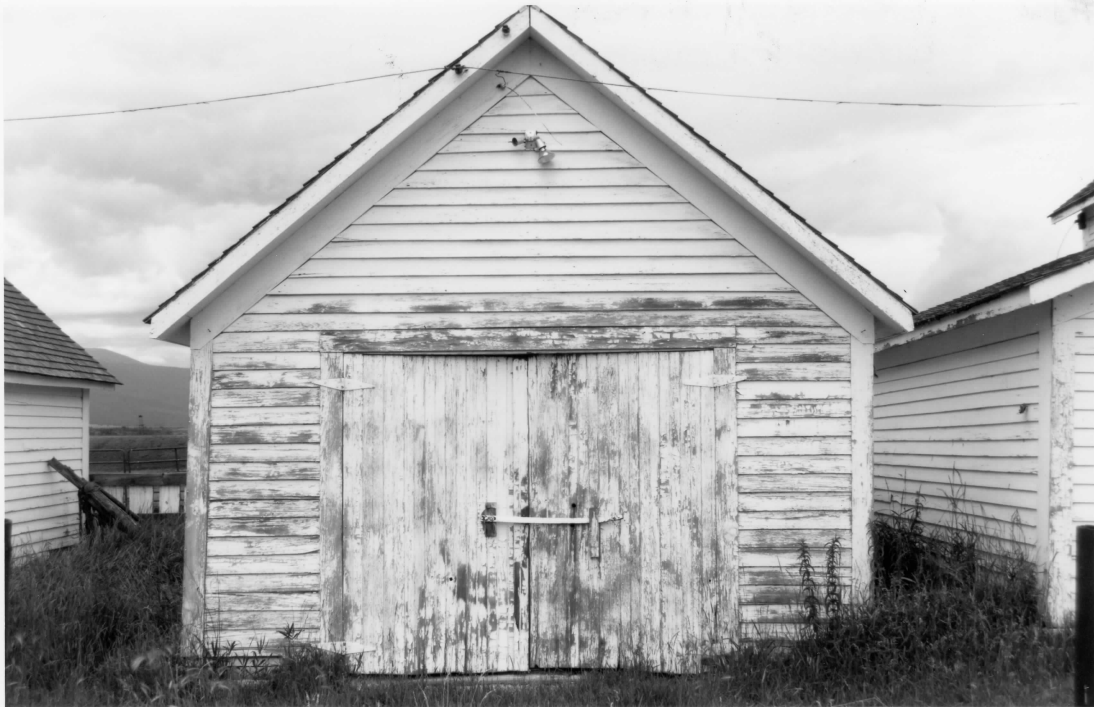
Beckwith Ranch
Custer County, CO

The garage [photo 11] is a one-story, nearly square building, measuring 15 feet x 15 feet 6 inches. It has a front gabled roof covered by red painted wood shingles and enclosed eaves. There is a flat capped brick chimney straddling the ridge. The balloon frame structure has an unfinished interior. The walls are sheathed with shiplap siding and have corner boards. The foundation is timbers on grade. There is one door opening on the south side and a pair of hinged vertical plank doors on the east side. There is one covered window (wooden). The building appears to have served as a carriage house or similar function prior to its use as a garage, thus it has generally functioned for vehicle storage throughout its life. It dates to the 1890s.

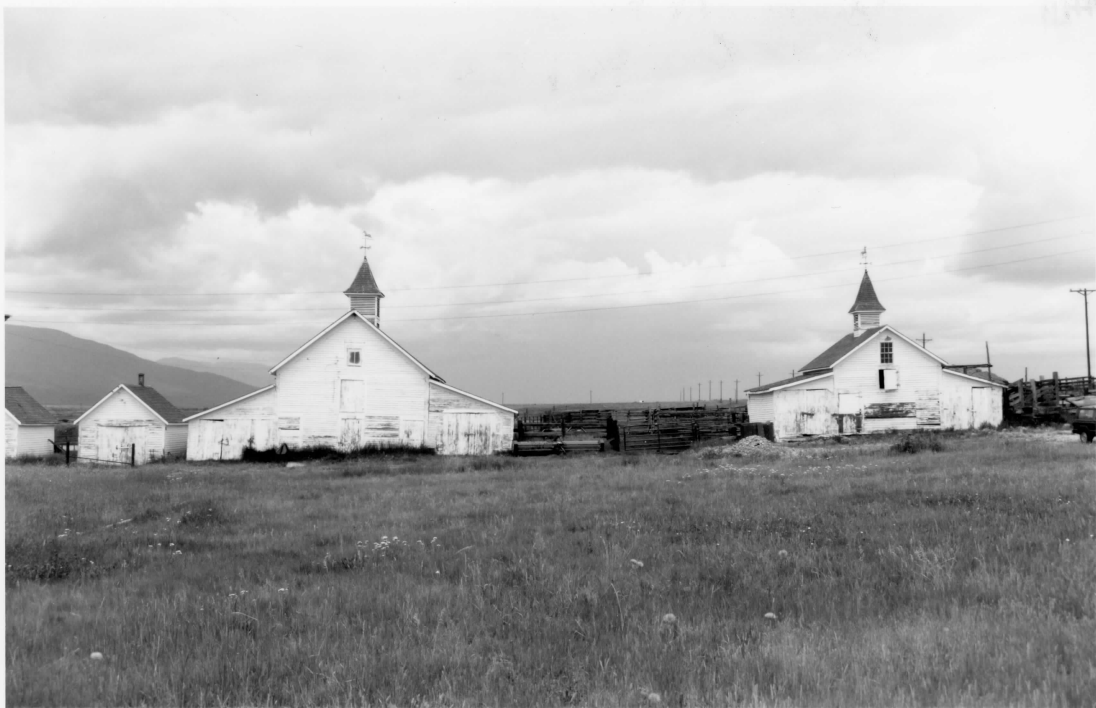
Beckwith Ranch
Custer County, CO

This 2-1/2 story rectangular barn [photo 12] dates to the 1890s. It measures 28 feet x 50 feet and is comprised of a steeply pitched gable roof with shed roof extensions on each side. The roofs are covered with wood shingles painted red. Straddling the ridge line of the gabled roof is a wooden cupola with louvered sides. Its bell cast, pyramidal roof is covered with red wood shingles and topped with a horse weather vane. The walls are wood framed and covered with clapboard siding and cornerboards. The doors are vertical plank with hinges and are hung individually and in pairs, including the loft doors. The foundation is of stone and sill timbers. There are two-light fixed wooden windows. The interiors are unfinished but divided into areas for animal shelter (stalls) and work areas. There is a hay loft.

This is a 1-1/2 story rectangular (22 feet x 36 feet) barn [photo 12] with a moderately pitched gable roof and shed roof extensions on each side. It is very similar to the cattle barn (#9), only smaller. This barn appears to date to the 1890s. The roofs are all covered with wood shingles painted red. Straddling the ridge line of the gabled roof is a wooden cupola with louvered sides. Its bell cast, pyramidal roof is covered with red wood shingles and topped with a horse weather vane. The walls are wood framed and covered with clapboard siding and corner boards. The doors of vertical plank with hinges are hung individually and in pairs, including the loft doors. The foundation is of stone and

sill timbers. There is a six-over-six light, double hung, wooden sash window. The interiors are unfinished but divided into areas for animal shelter (stalls) and work areas. There is a hay loft.
