**NATIONAL REGISTER OF HISTORIC PLACES
REGISTRATION FORM**

historic name Orendorff, John, Farm

other names/site number CARR-1425

CARR-1425
Orendorff, John, Farm
Carroll County, MD

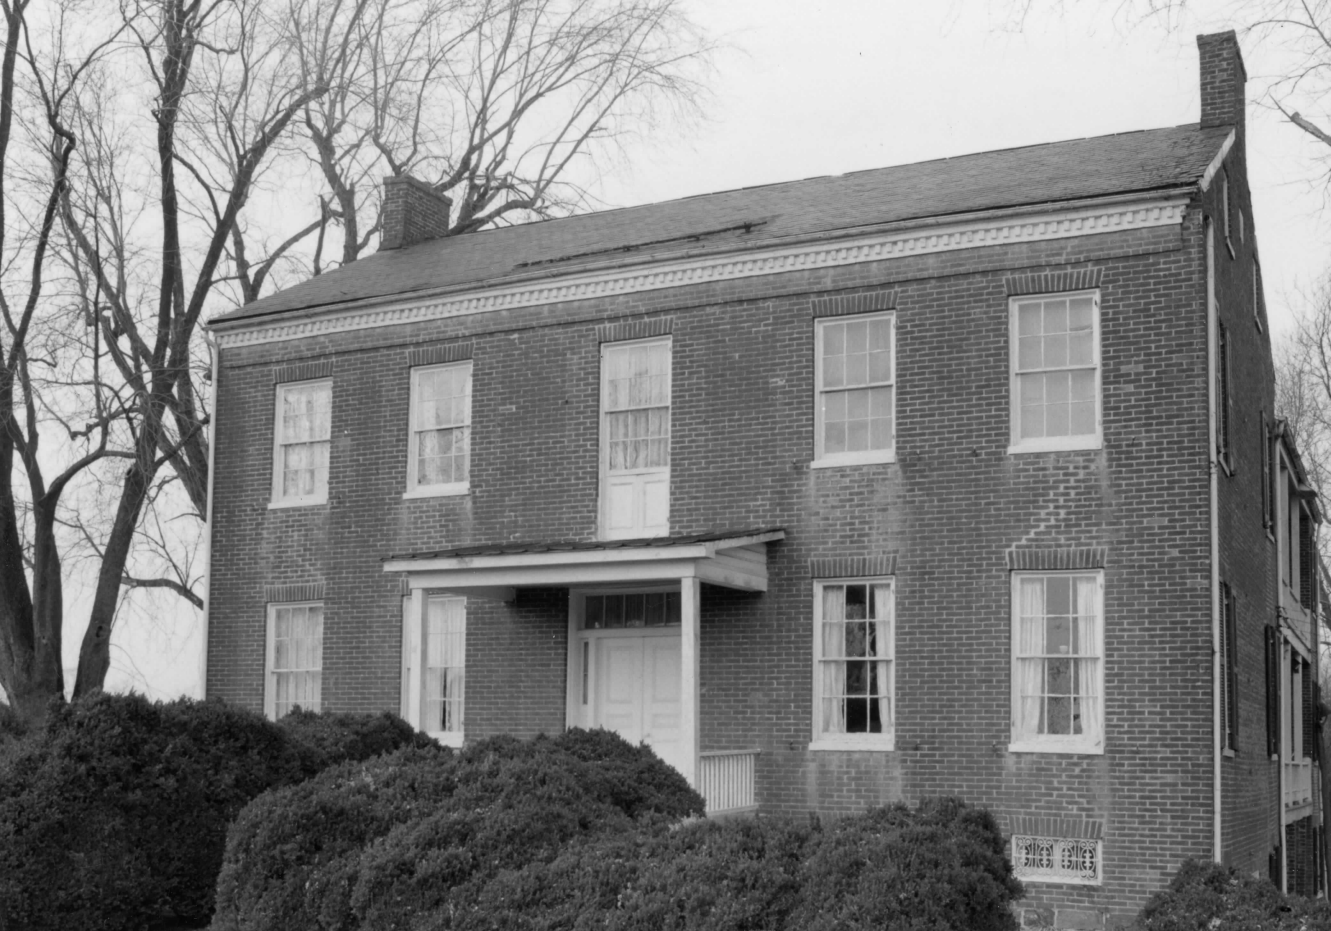
1/18

House - south elevation

=====
iron grill with a fleur de lis in the four end bays. The center bay has a brick porch foundation that is not tied into the house. The first and second stories have running bond. The first story has a center entrance with paired doors. Each half has three panels, with a lying panel in the center and a square panel at the bottom. There are sidelights with two lights over two panels. These panels line up with the door panels. There is also a six-light transom. The transom bar is fluted, as are the sidelight stiles. There is a marble sill and a bullnose frame. There is a one-story, one-bay porch with two square posts that have square-in-plan balusters on each side of the porch. The porch has a wood box cornice and an inverted-V-seam metal shed roof. There are two 6/6 double-hung sash on each side of the door. They each have a wood sill, a splayed brick jack arch, and a bullnose frame. They had blinds with cast iron shell-pattern shutter holdfasts. The sash are pegged. The second story has four shorter 6/6 sash. The center bay has a typical 6/6 sash with a jib window that has two one-panel doors below the sash. The brick cornice has a projecting brick frieze and brick dentils with three corbelled courses above. There is an interior brick chimney on each end, centered on the gable ridge.

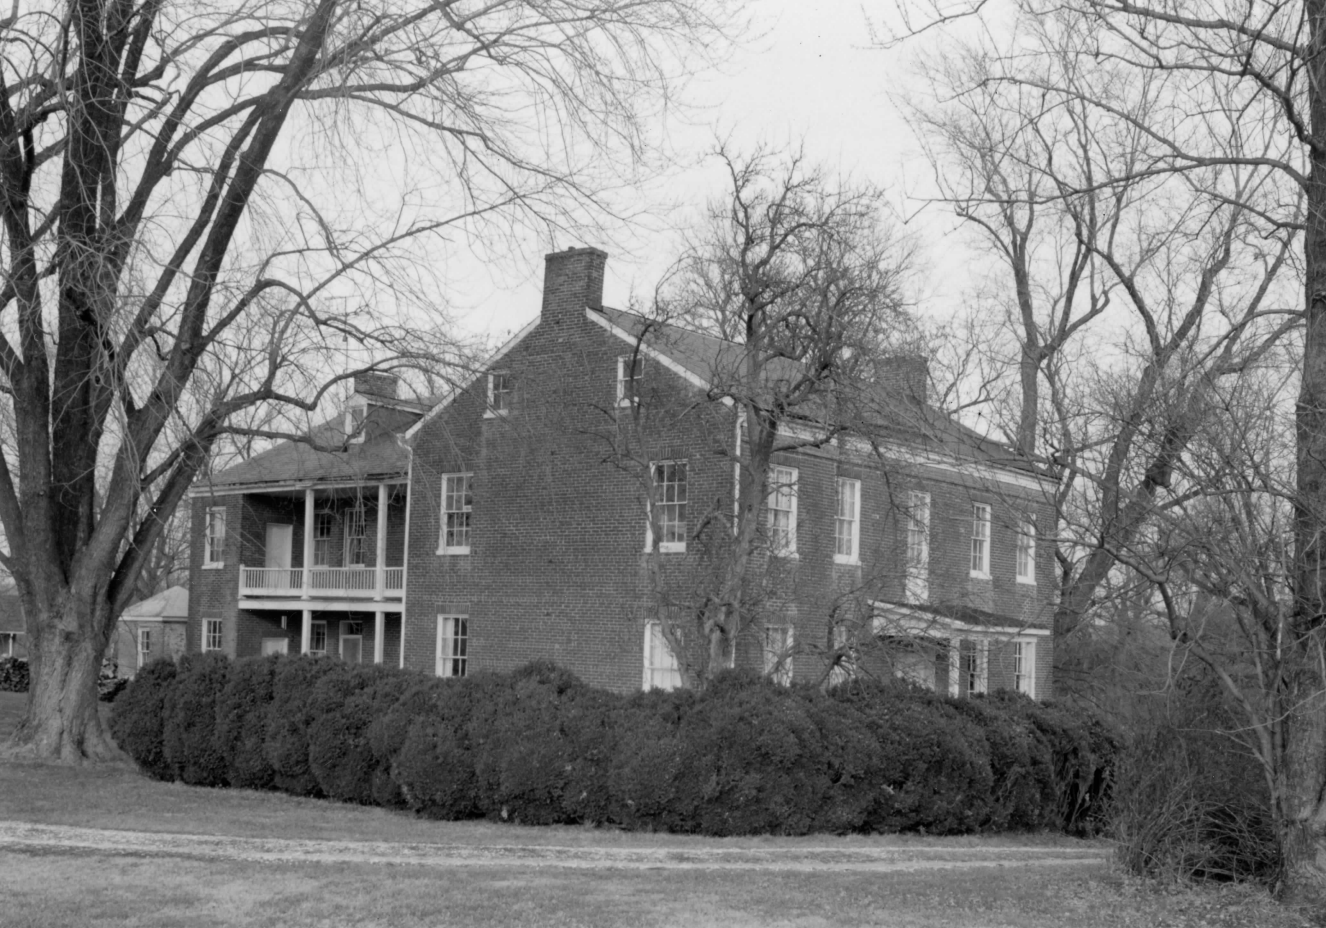
2/18

Neg. loc.: Maryland Historical Trust
House - west & south elevations

The west elevation of the main block has 5-to-1 common bond brick. The foundation has two paired one-light casements like those on the south elevation, but without grills. The first and second stories have two 6/6 sash each. The gable end has two 2/2 sash in a bullnose frame with a wood sill and a straight brick jack arch. There are insulators for a lightning rod down the center of this elevation. The rakeboards have been altered.

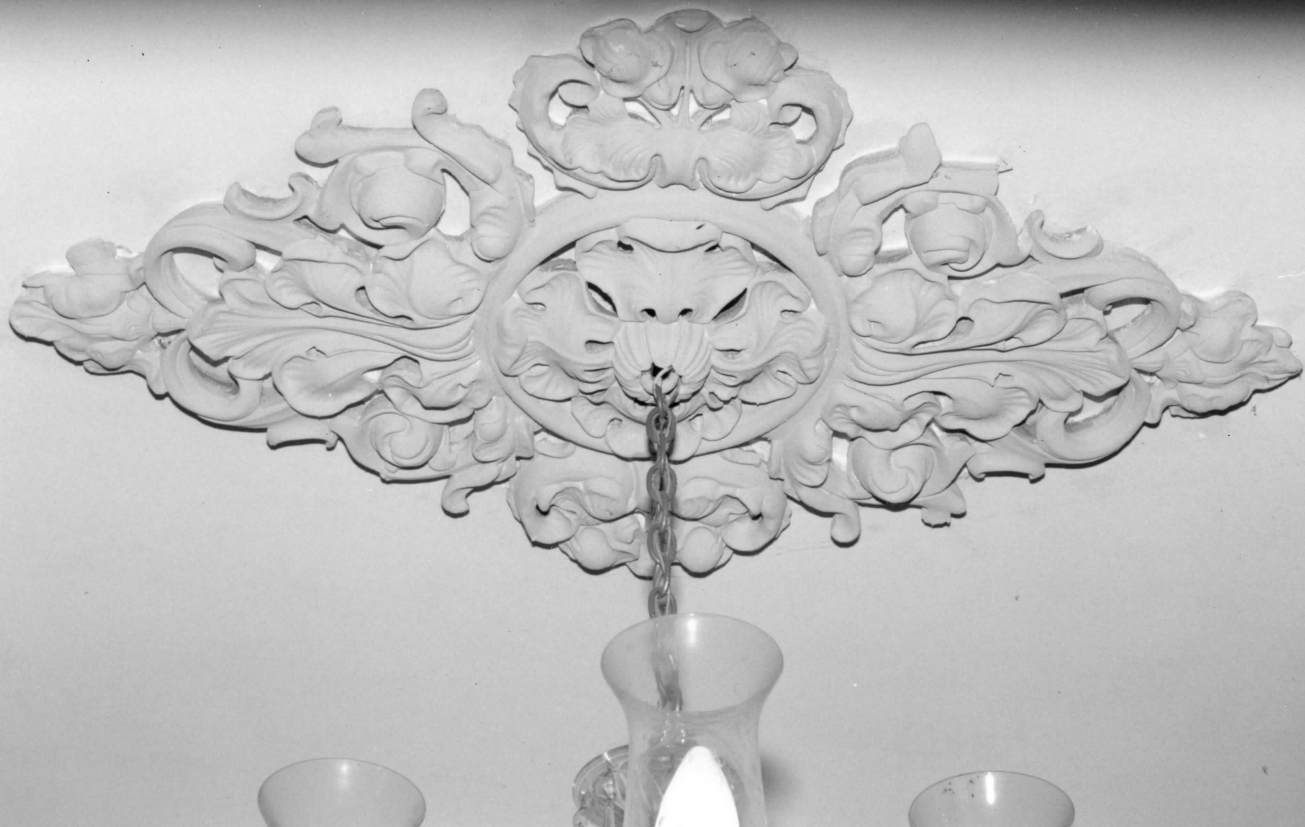
6/18

Neg. loc.: Maryland Historical Trust
center passage - ceiling

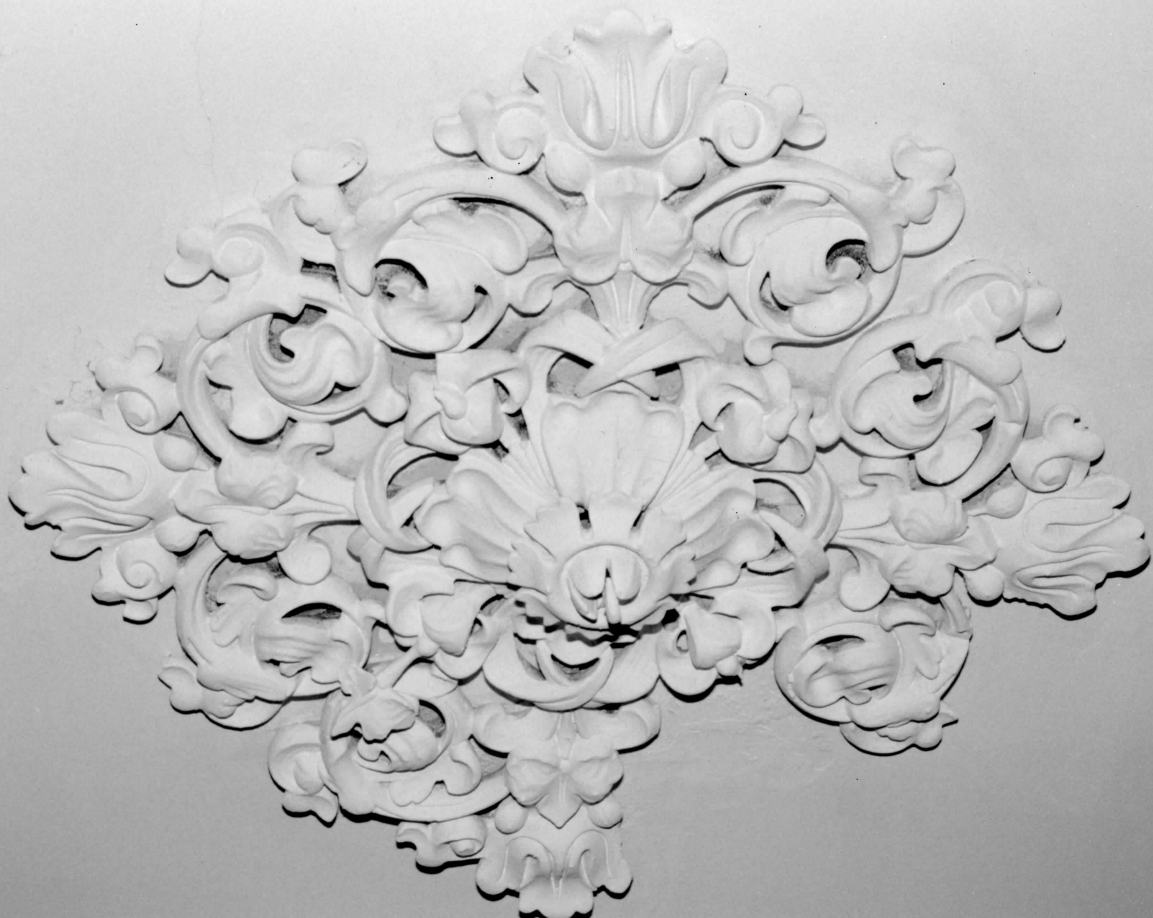
8/18

Neg. Loc.: Maryland Historical Trust
center passage - ceiling

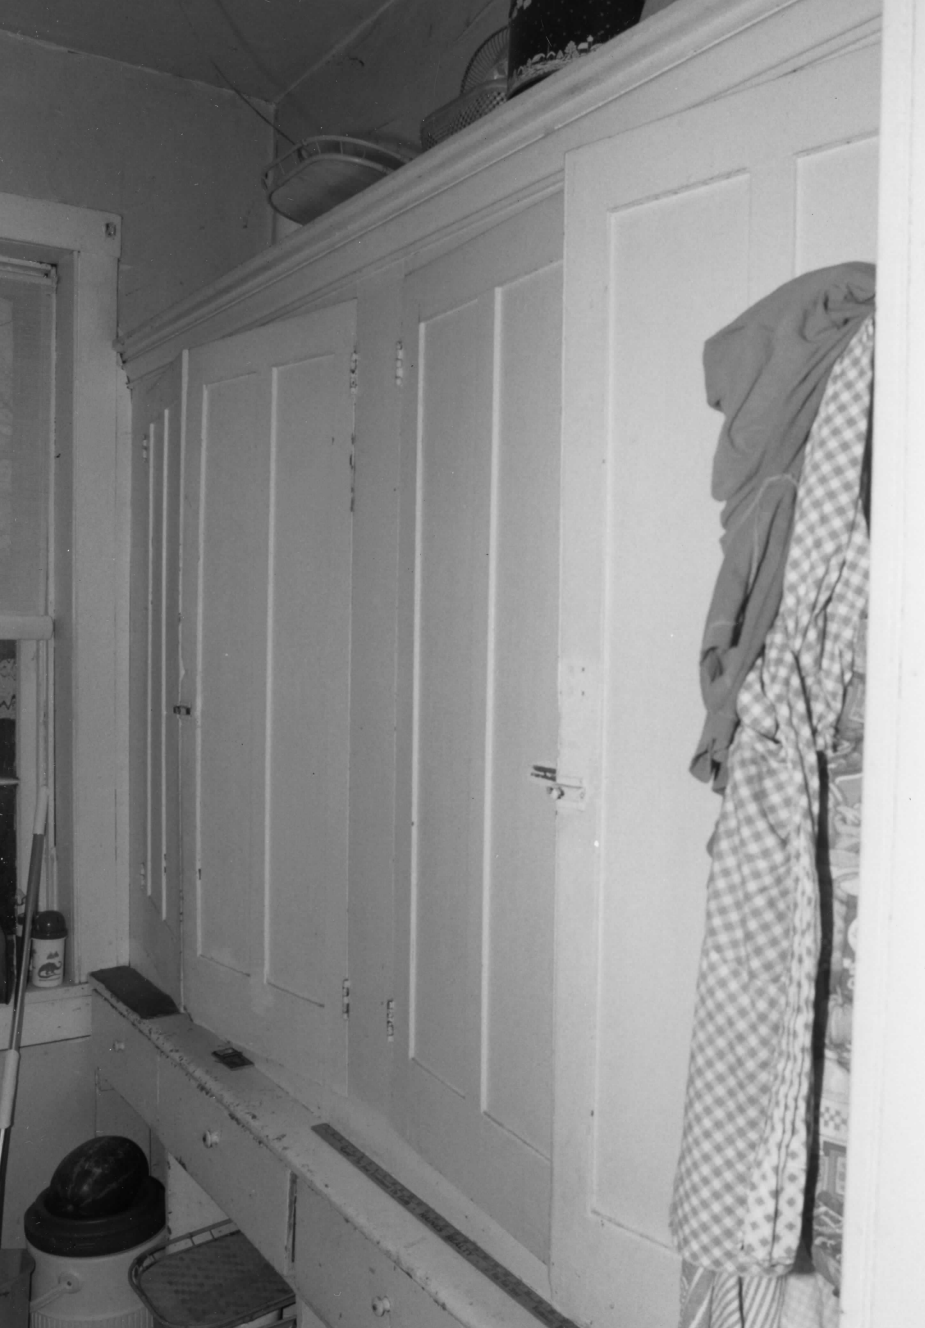
9/18

Neg. loc.: Maryland Historical Trust
Pantry

The south elevation of the projecting pantry on the first story has a typical six-panel door with no panel moulds, and a splayed brick jack arch. The second story of this pantry has a typical six-panel door with no panel moulds, as well.

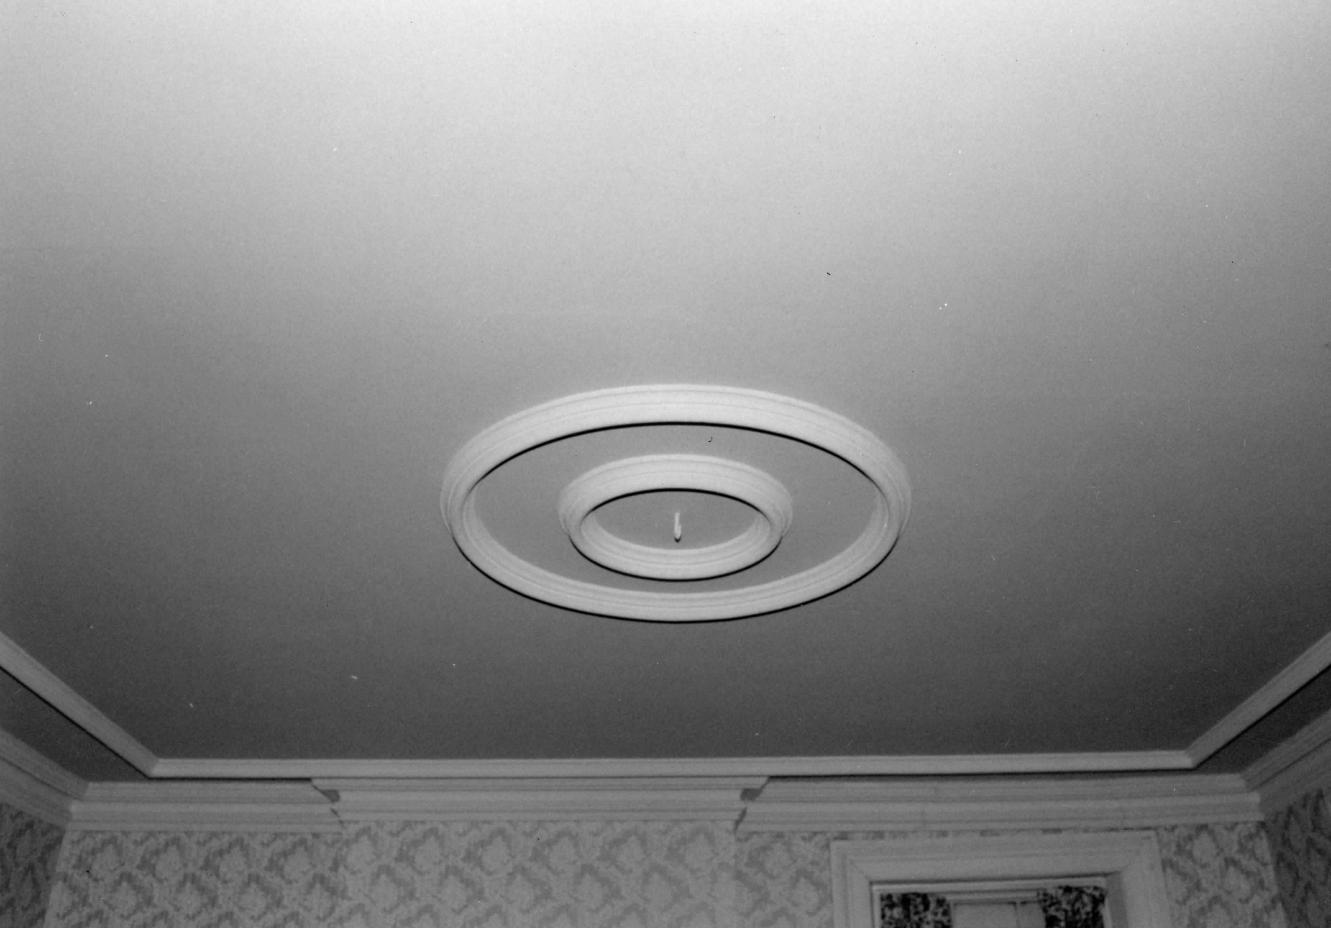
10/18

Neg. loc.: Maryland Historical Trust
South east room ceiling

The southeast room has an identical floor, baseboard, architrave, windows with panels beneath them, cornice, and ceiling band as is found in the west room. In the center of the ceiling is a circular medallion with the same profile as the bands in the ceiling. It is a smaller circle within a larger circle. The fireplace on the east elevation has a plastered surround and firebox that has been painted red and striped to look like brick. There is a brick hearth. The wood mantel has plain pilasters and frieze and a cavetto bed mould. The shelf is plain. The doors have plain cast iron rim locks.

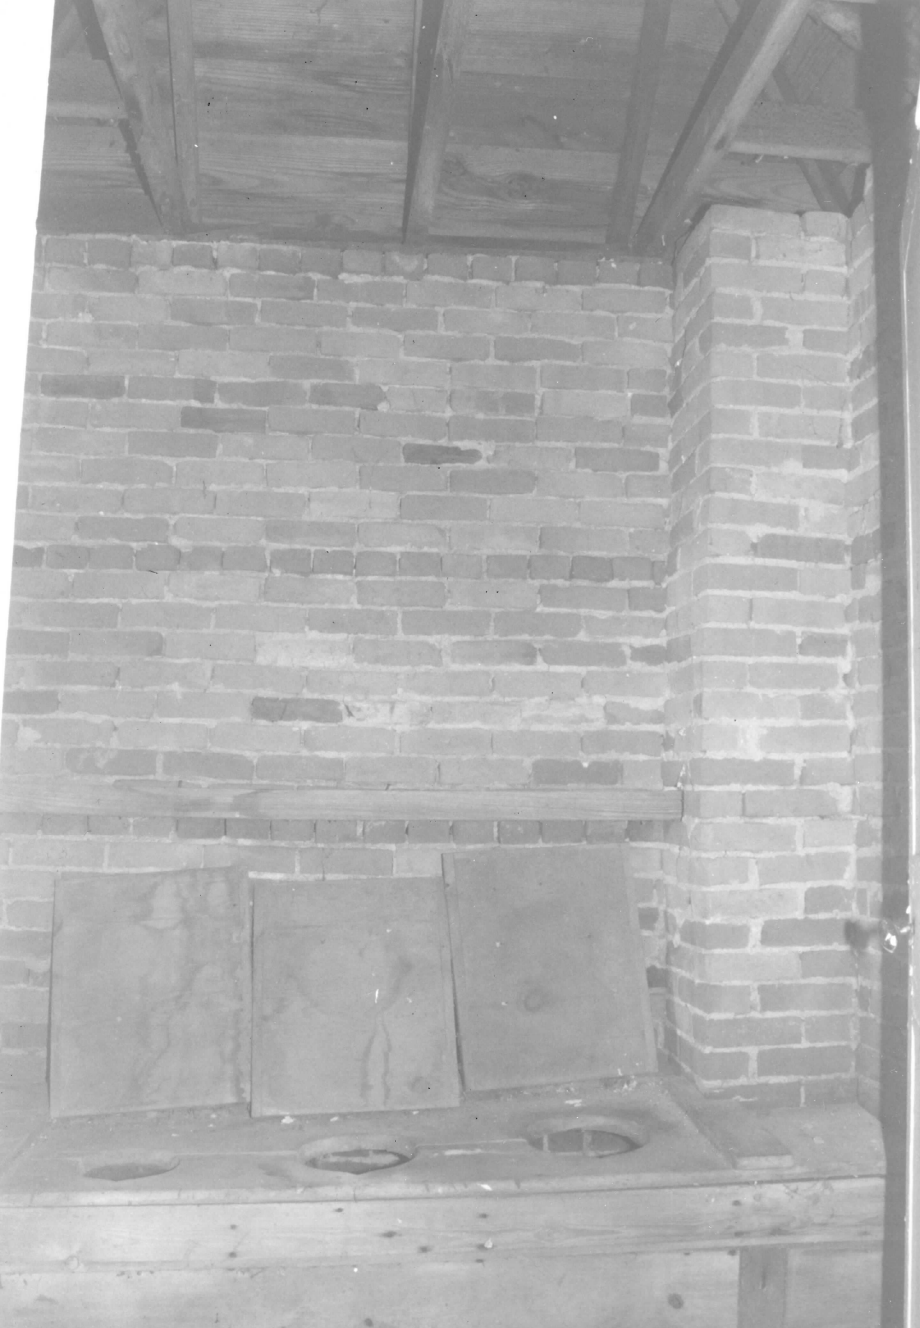
14/18

Privy interior

=====
panel door with recessed fields and no panel moulds. The frame has a chamfered inner edge and is mitered at the corners. There is a boarded-up transom. The building has a wood box cornice on all four sides. The west elevation has one 4/4 sash. The top sash is fixed in place by the outer stop. There is a wood sill and headers on the lintel. The frame, which is mill sawn, is identical to the door frame. The window has shutter hardware. The east elevation is identical to the west elevation. The north elevation has a small hole in the wall where a brick was left missing near the top of the east corner. This is apparently for ventilation. On the interior, the floor is covered with linoleum. The walls were never plastered, but were always exposed brick. Along the north wall is a wood box with three different-sized holes. There are wood lids on leather hinges that are probably not the original because they are wire nailed. The lids apparently originally had cast iron butt hinges that were broken. There is a brick vent stack in the northeast corner. It has a hole on the west side of the stack, at the base, which is down below the level of the seats, and another on the west side of the stack about 3 feet 6 inches above the floor. The floor joists run north-south. The joists overhead also run north-south. On the east and west ends of the building are short sections of joists that run east-west and are tenoned into mortises in the easternmost and westernmost joists. These tenons are nailed from below with a cut nail. The rafters are about 1½ inches by 2½ inches. In the peak of the hip is a hollow wood box, and the rafters appear to be toenailed to it.

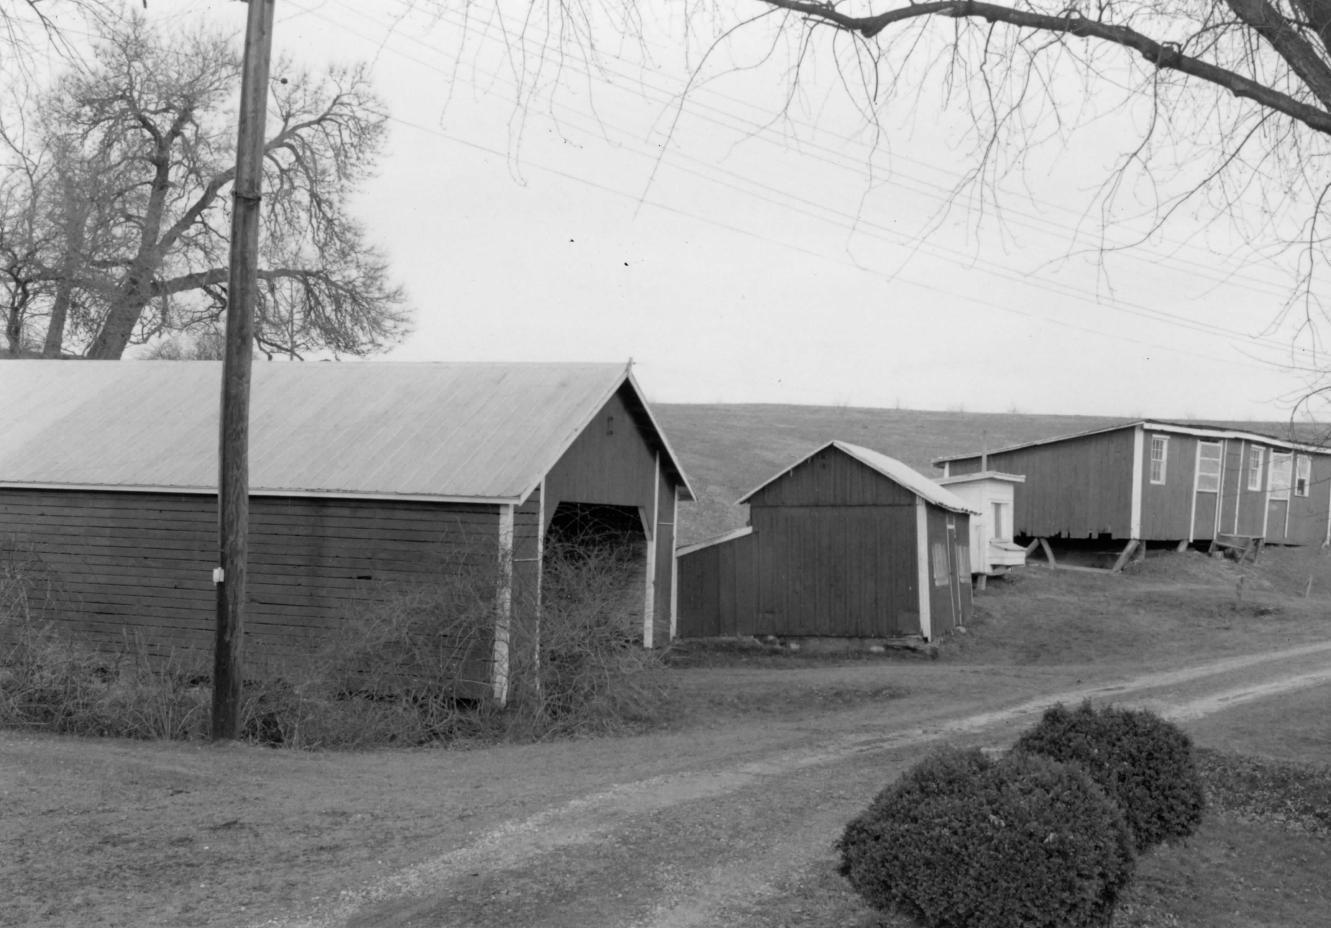
15/18

Neg. Loc.: Maryland Historical Trust
wagon shed, peep house, poultry house,
south elevations

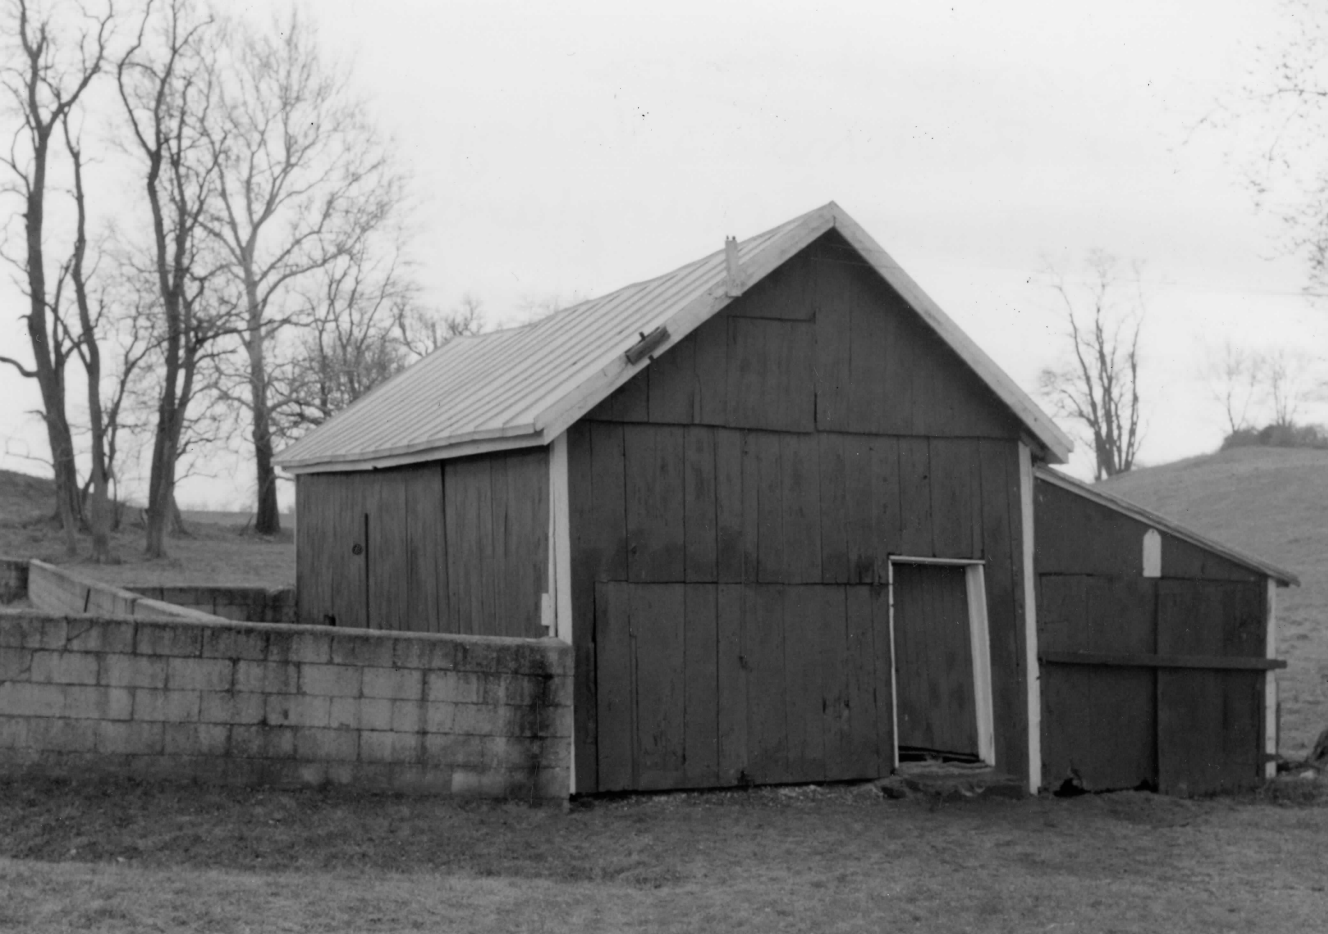
Neg. Loc.: Maryland Historical Trust
hog pen - east & north elevations
16/18

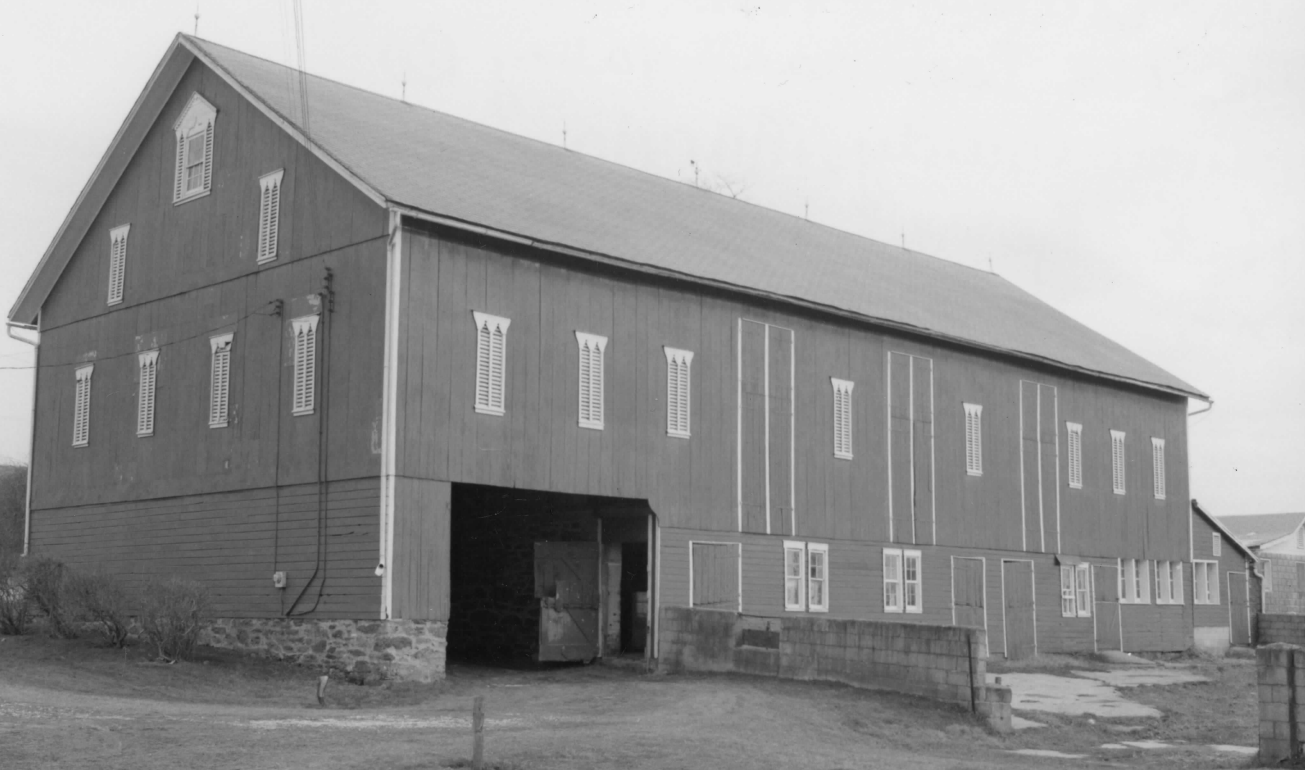
17/18

Neg. Loc.: Maryland Historical Trust
Barn-north; west elevations

About 50 feet east of the hog pen is a bank barn that was rebuilt on an earlier bank barn foundation. The foundation was extended so that there is no longer a cantilevered forebay. The original forebay faced west. The barn has a rubble stone lower story and vertical board upper story, with a gable roof of asphalt shingles that has a north-south ridge. On the west elevation, the lower story has a wagon shed to the north, then a beaded-edge-and-center, vertical-board dutch door on strap hinges with round ends, then a paired 4/4 sash, another paired 4/4 sash, a typical dutch door, another typical dutch door, paired 4/4 sash, a typical door, paired 4/4 sash in a different opening, and paired 4/4 sash in a different opening in the south bay. This bay has German siding. The upper story has three vents at the north end, with double doors over double doors hung on strap hinges like those on the lower story. To the south of this is a vent, double doors over double doors, another vent, more double doors over double doors, and three vents to the south. There is a shed-roof addition to the south, then a CMU milk room attached to the south of this addition. The south elevation upper story has four vents with two vents above in the gable end. The gable peak has a 6/6 sash, with a vent on each side, and pedimented trim. The north elevation has horizontal boards on the lower story, and the upper story is the same as the south elevation. The east elevation has two concrete silos to the south. The silos were installed about 1950. There are three pair of vertical-board wagon doors on rollers in the center, with two vents that have four-light sash at the bottom, set to the south, and two plain vents set to the north. The lower-story north bay is now closed off, but was originally open to gain access to the wagon
