United States Department of the Interior  
National Park Service

National Register of Historic Places  
Registration Form

historic name Jacobson, Pehr J., House  
other names/site number Jacobson Hill Farm

JACOBSON, PEHR J., HOUSE

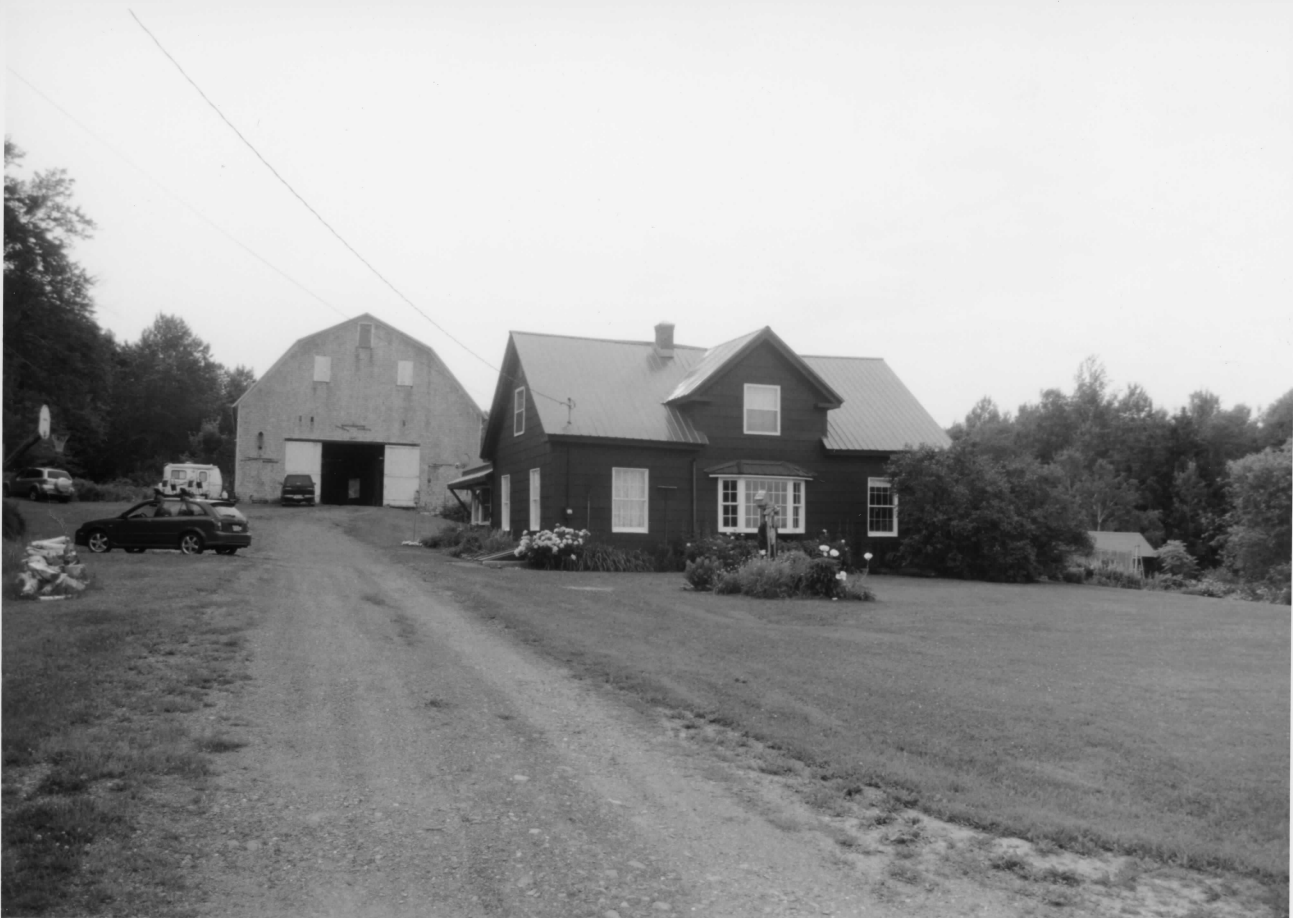
JACOBSON, PEHR J., HOUSE; AROOSTOOK CO., MAINE

Photograph 1 of 2  
Christi A. Mitchell  
Maine Historic Preservation Commission  
26 June 2006  
East facade of house and barn, facing west.

As was the custom among the Swedish immigrants to northern Aroostook County the home that Pehr J. Jacobson erected was of log construction. Presently covered by textured Masonite siding, it is a one-and-a-half story side-gable cape measuring 36 x 24 feet with a frame addition measuring 24 x 24 feet attached to the southwest corner. The primary elevation of the house faces east and contains two window bays with replacement six-over-six light sash flanking a central bow window. Directly over the center bay a gable roof dormer breaks through the eaves and rises flush with the plane of the facade. The dormer contains one six-over-six window. To the south of the intersection of the dormer ridge and the ridge line of the main house is a short brick chimney. The house is supported by a full concrete foundation and is roofed with painted metal. The side elevations each feature a pair of six-over-six windows on the first floor and a single window under the gable peak. The south elevation also contains a metal bulkhead cellar entrance. Narrow corner boards and minimal cornice returns mark the corners of the structure.

The addition is almost flush with the south side wall and contains one window and the main entry to the house. Another chimney rises through the west end of the east to west running gable roof, and the north wall contains several modern windows. On the west side of the log house is a single door.

Barn, 1936. Non-contributing.

The barn on the Jacobson Farm is a large, three-story gambrel roof structure that faces south with a ridge that runs north to south. It is set on concrete pads, sided with wood shingles and features a metal roof over asphalt and cedar shingles. The primary facade is in the south wall and contains a large pair of exterior sliding wood batten doors and a single six light window on the first floor. Two windows covered with plywood and a louvered window are located high on the end wall. The structure features a center aisle between post and beam construction and a common rafter-major purlin roof. Although most of the original structural beams are intact many have been augmented with sistered dimensional lumber and cables and turnbuckles have been added for extra strength and stability.

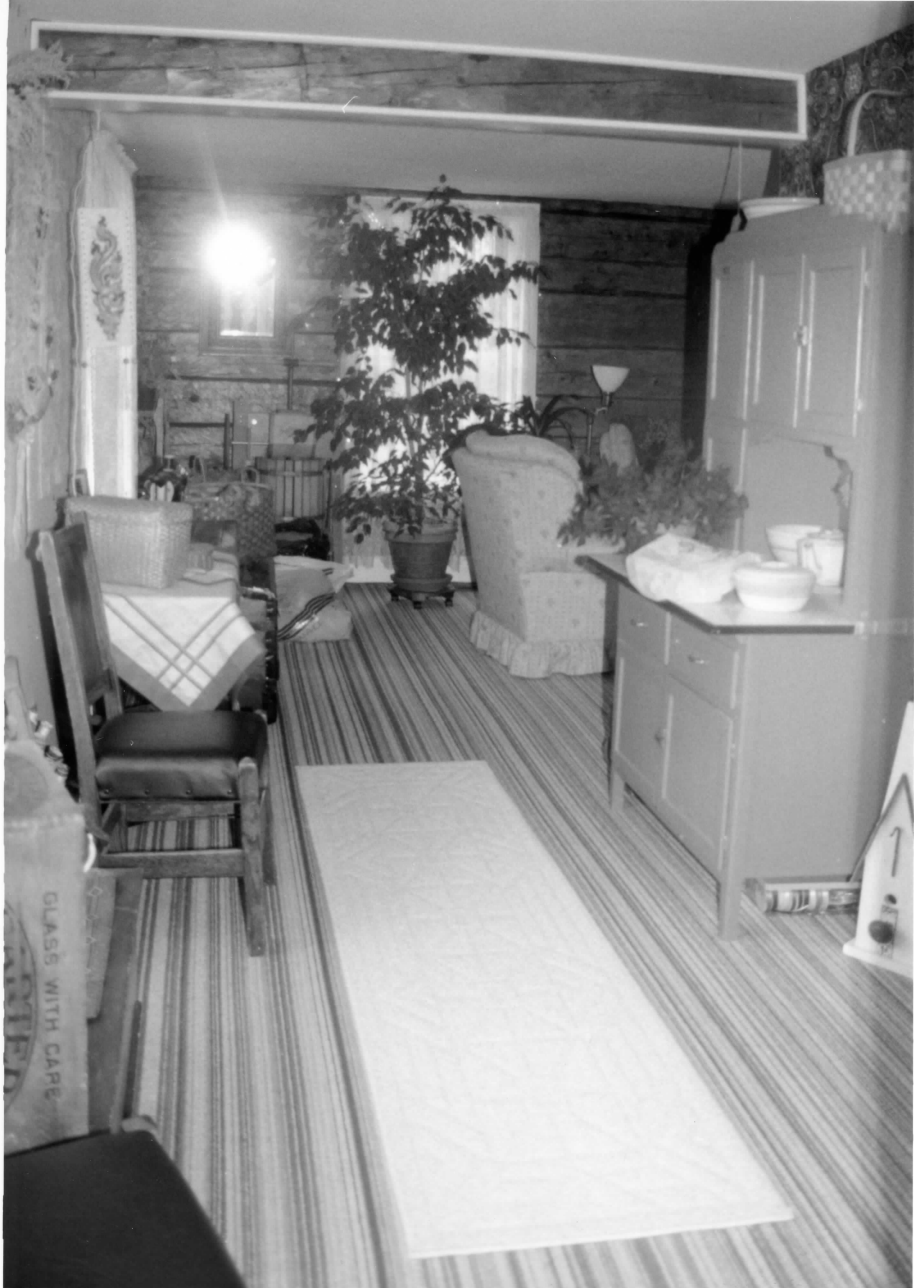
JACOBSON, PEHR J. HOUSE; ABBOTSTOOK CO., ME

Photograph 2 of 2  
Christi A. Mitchell  
Maine Historic Preservation Commission  
26 June 2006  
Interior, entry way, facing south. Note remainder of log partition wall in ceiling and interior of log walls in background.

northern bay. It is important to note that all but the uppermost two courses of logs have been removed between the front middle room and the larger southern room. A newer frame partition running west to east has also been placed in the northwest corner room to create a hallway and bathroom, and another was installed in the northeast room to enclose a cellar staircase added in 1977. The front staircase is located in the northwest corner of the front middle room and runs along the northern long log partition wall. The second floor features three large bedrooms, one each over the north and south bays and the third in the front behind the dormer. All of these partition walls are of stud construction.

Several of the interior log walls are exposed including those in the south and west walls of the southern bay, and the south, east and west walls of the west center room. This room served originally as the kitchen. A door is cut through the partition walls on each side of this room with the western wall providing access into the new addition. The ceiling and north walls of the kitchen are covered with patterned tin panels and decorative tin mouldings. The remaining chimney is located in the southeast corner of the room, while the northeast corner ceiling shows a patch associated with a now removed second chimney. Along the north wall are built-in bead board cupboards and counters. The remaining interior finishes consist of carpeted floors (except for the northeast corner room, which has pine floors) and sheet rocked walls and ceilings. The exposed log walls are coated with a clear sealant, and in spots moss chinking is visible. The logs in the southwest corner of the kitchen retain sequential letters and numbers marked with a wax pencil marking the order of the logs.
