## NEW JERSEY TRANSIT RAILROAD STATION SURVEY

A. Name: Common  Mountain Avenue <sup>station</sup> Line: Hoboken Division - Boonton  
Historic (Erie)

451 Upper Mountain Avenue  
 Upper Montclair, N. J. 07043

FACILITY NAME: Mountain Avenue

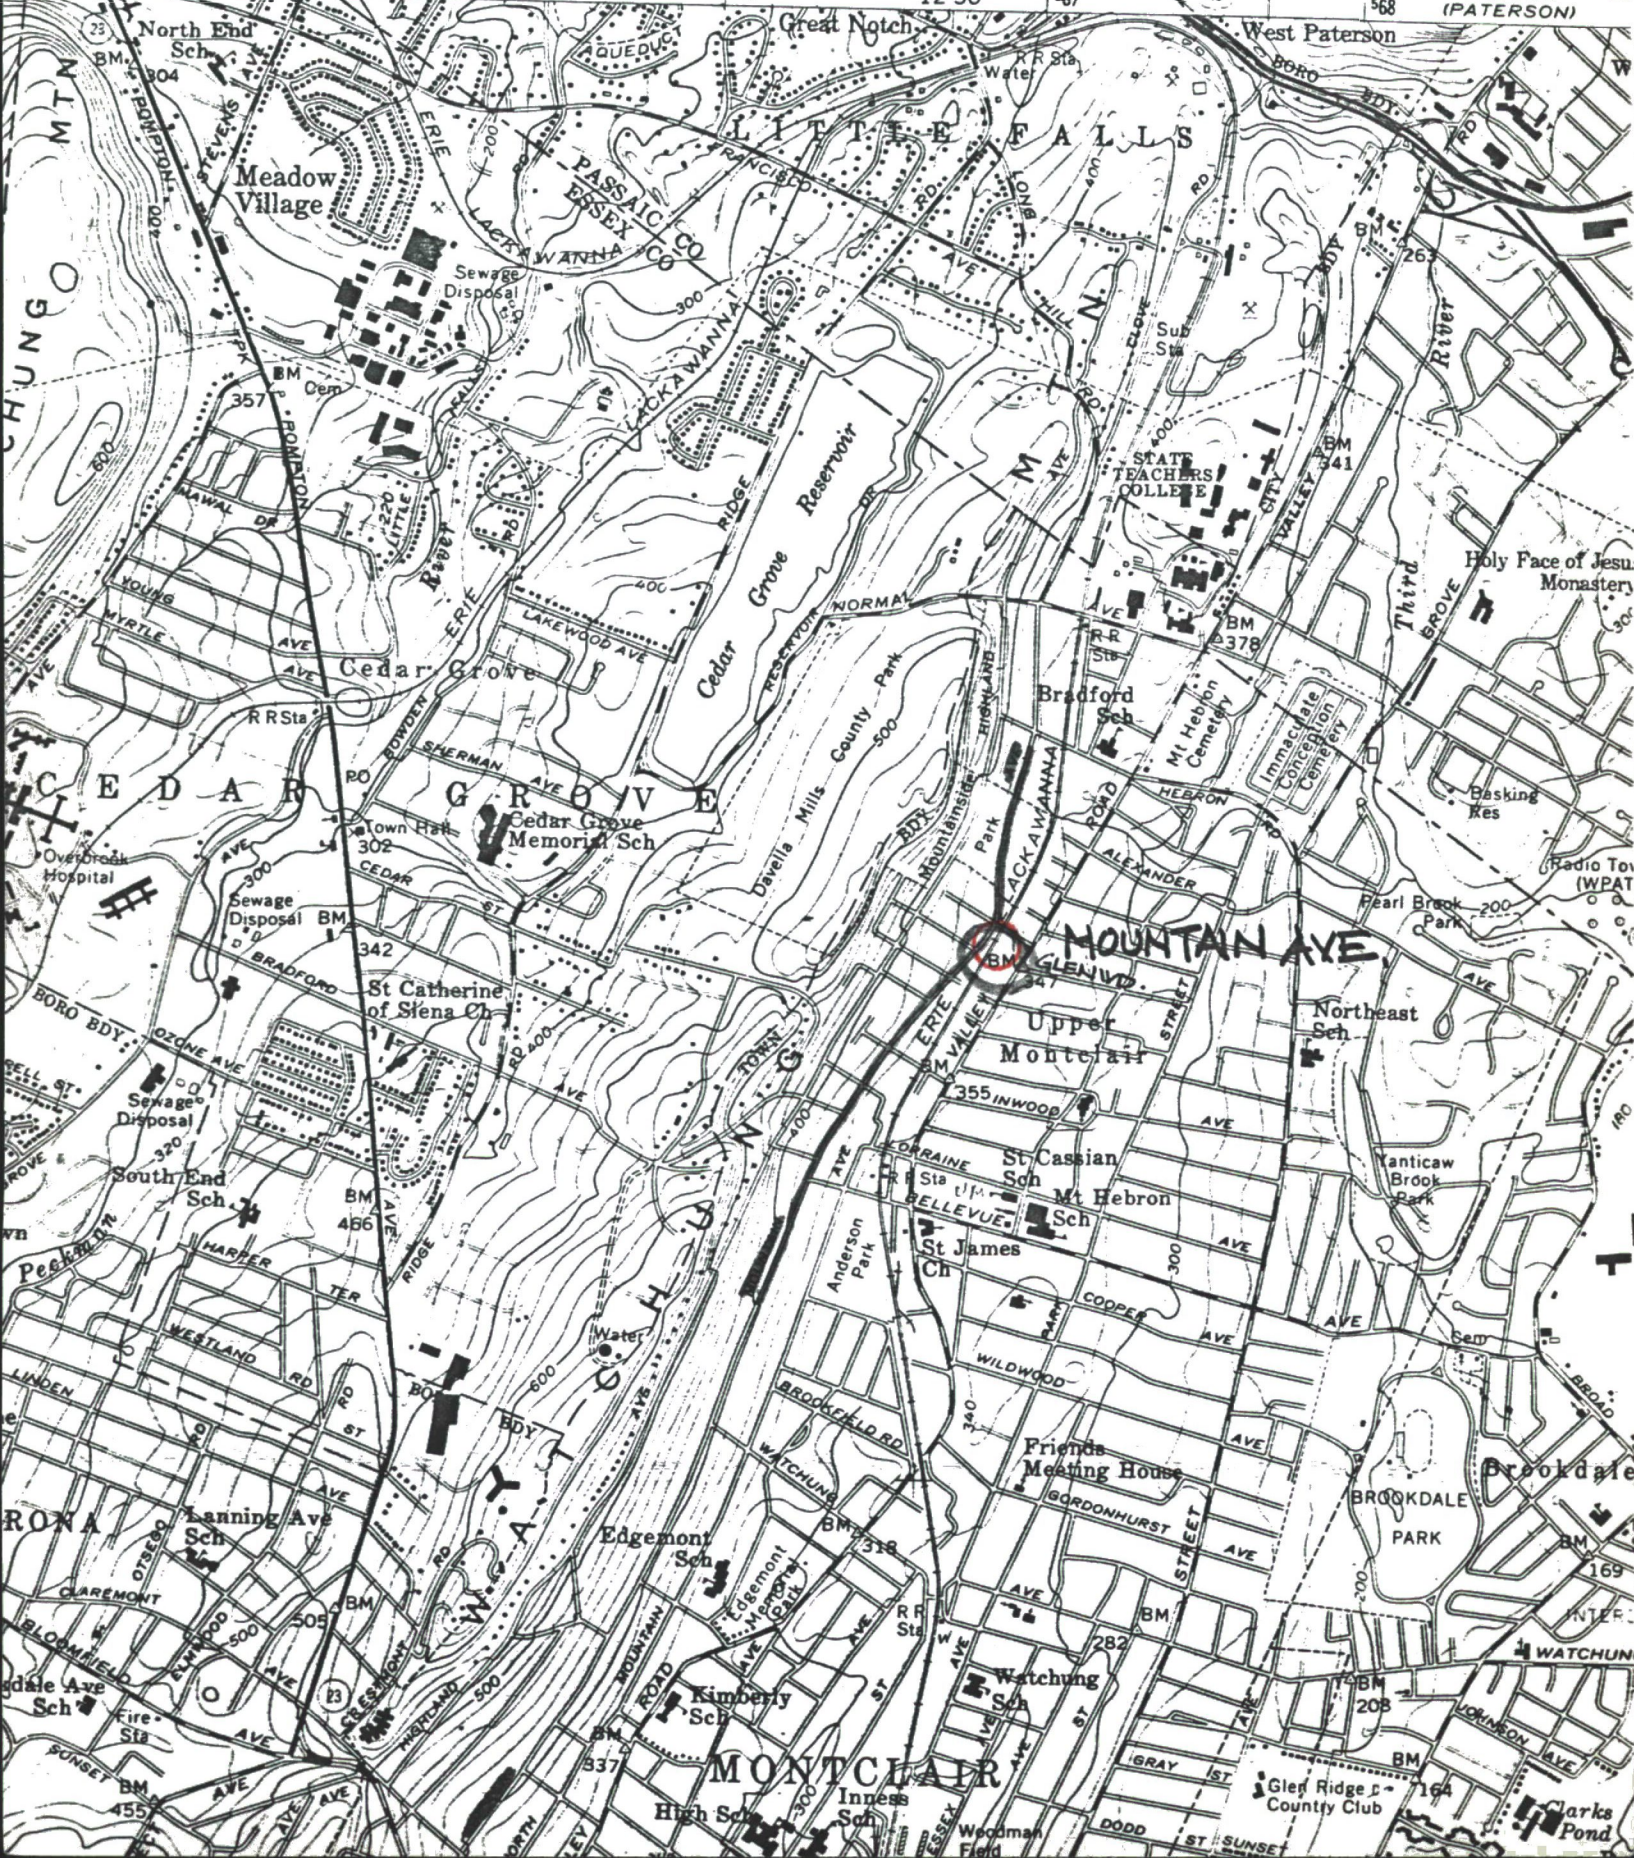
OUTBOUND PLATFORM  
568' x 8'-7"

INBOUND PLATFORM  
466' x 8'-2"

PARKING LOT 1  
CAPACITY: 24

ON GRADE CROSSING

STATION BUILDING

SCALE: 1"=100'

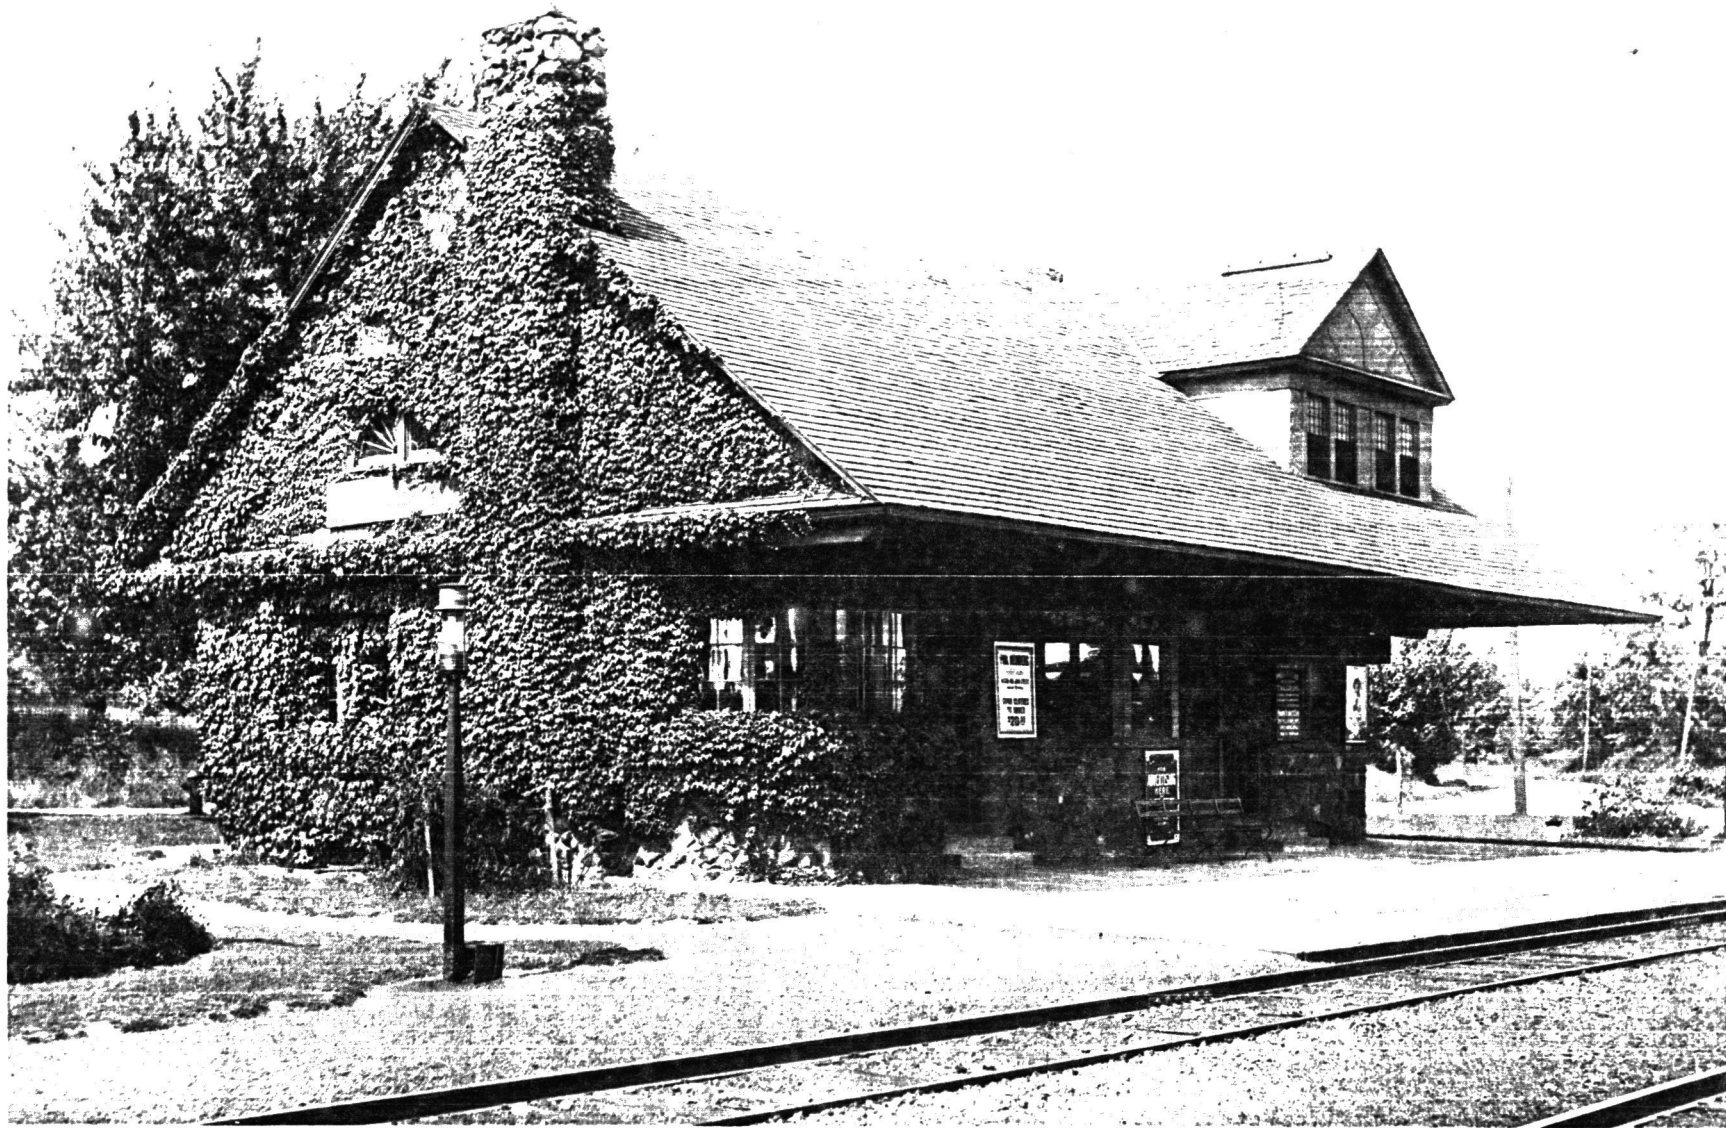
M.P.-15.2

This attractive, homelike station at MOUNTAIN AVE. in Upper Montclair was originally constructed with three living rooms. In 1935, the agent, Mr. Chet Volski, remodeled half of the building into a five-room, duplex apartment, and moved in with his family. They lived there for over twenty years.
