National Register of Historic Places  
Registration Form

historic name Randall Farm

street & town 3713 Page Green Road  not for publication

city or town Cortland  vicinity

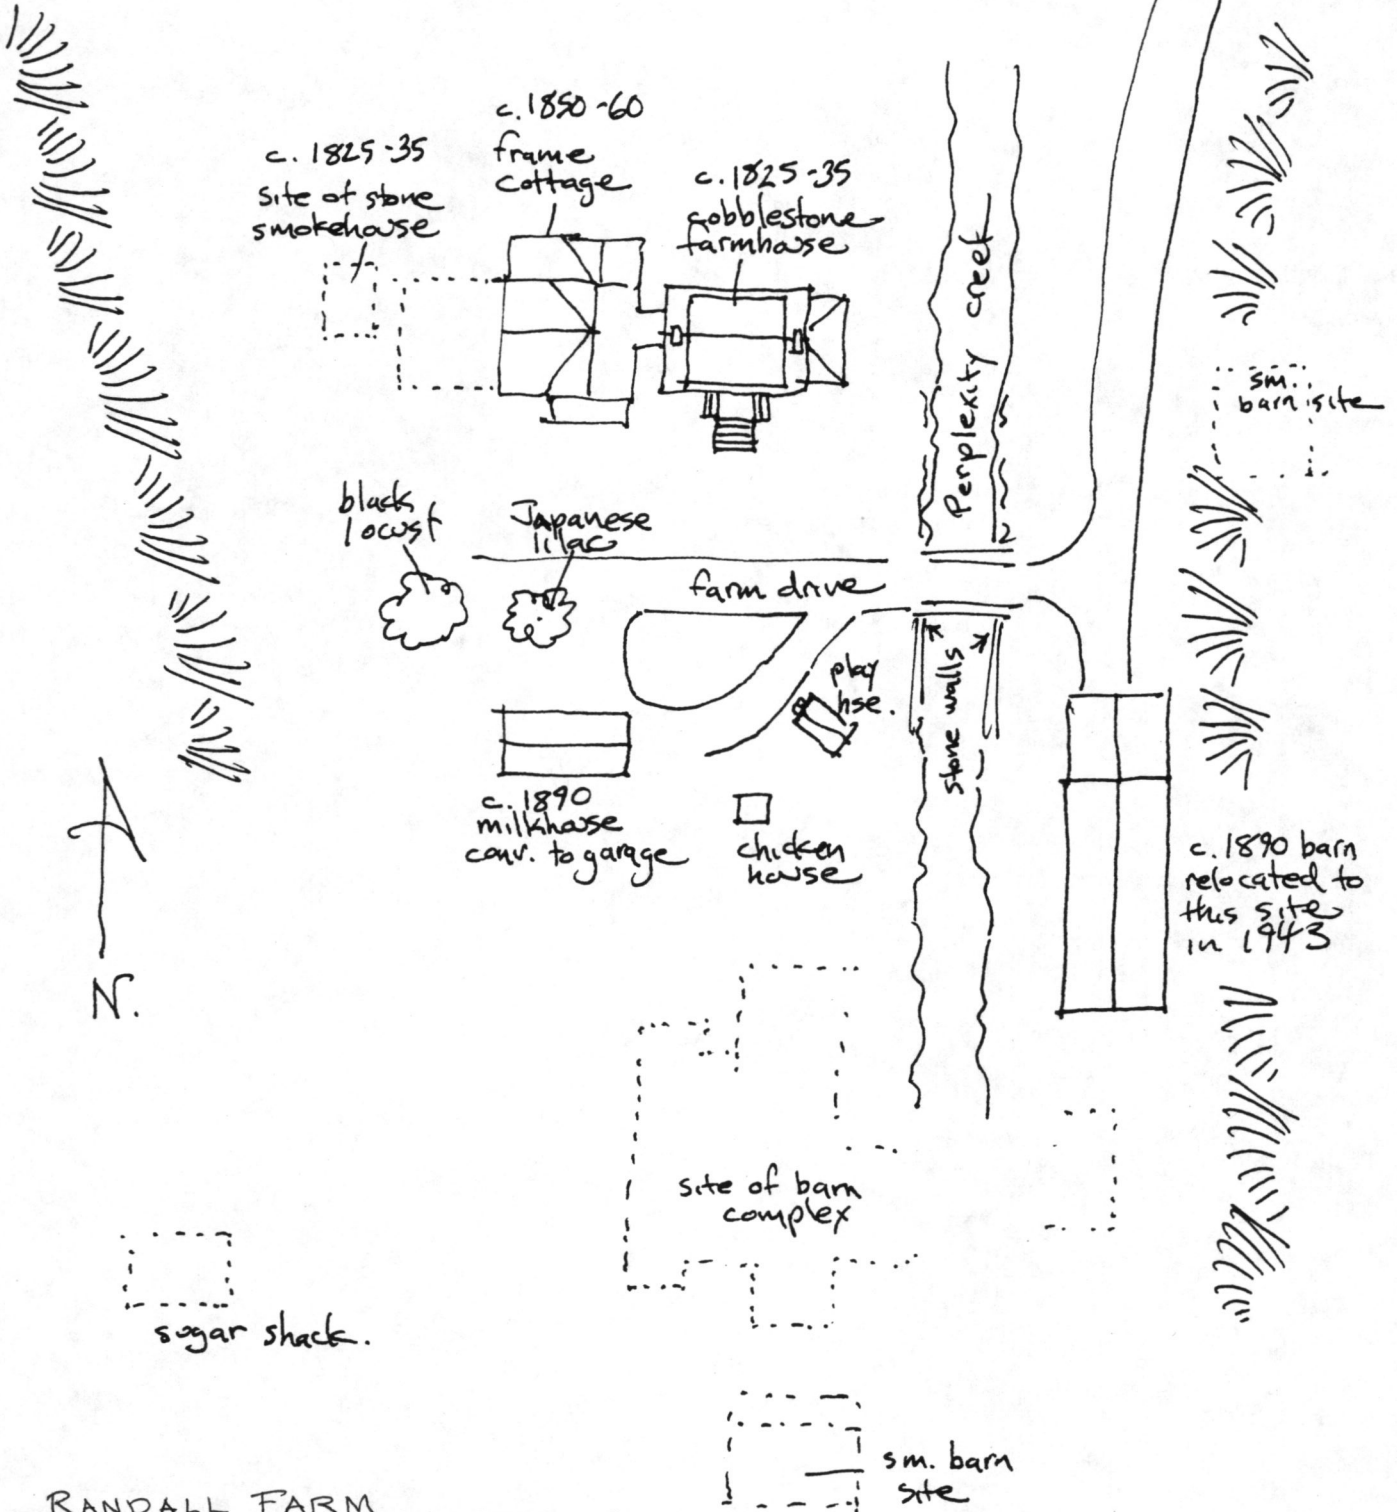
RANDALL FARM  
 Cortland vic. Cortland Co., New York  
 Sketch site plan  
 (not drawn to scale)

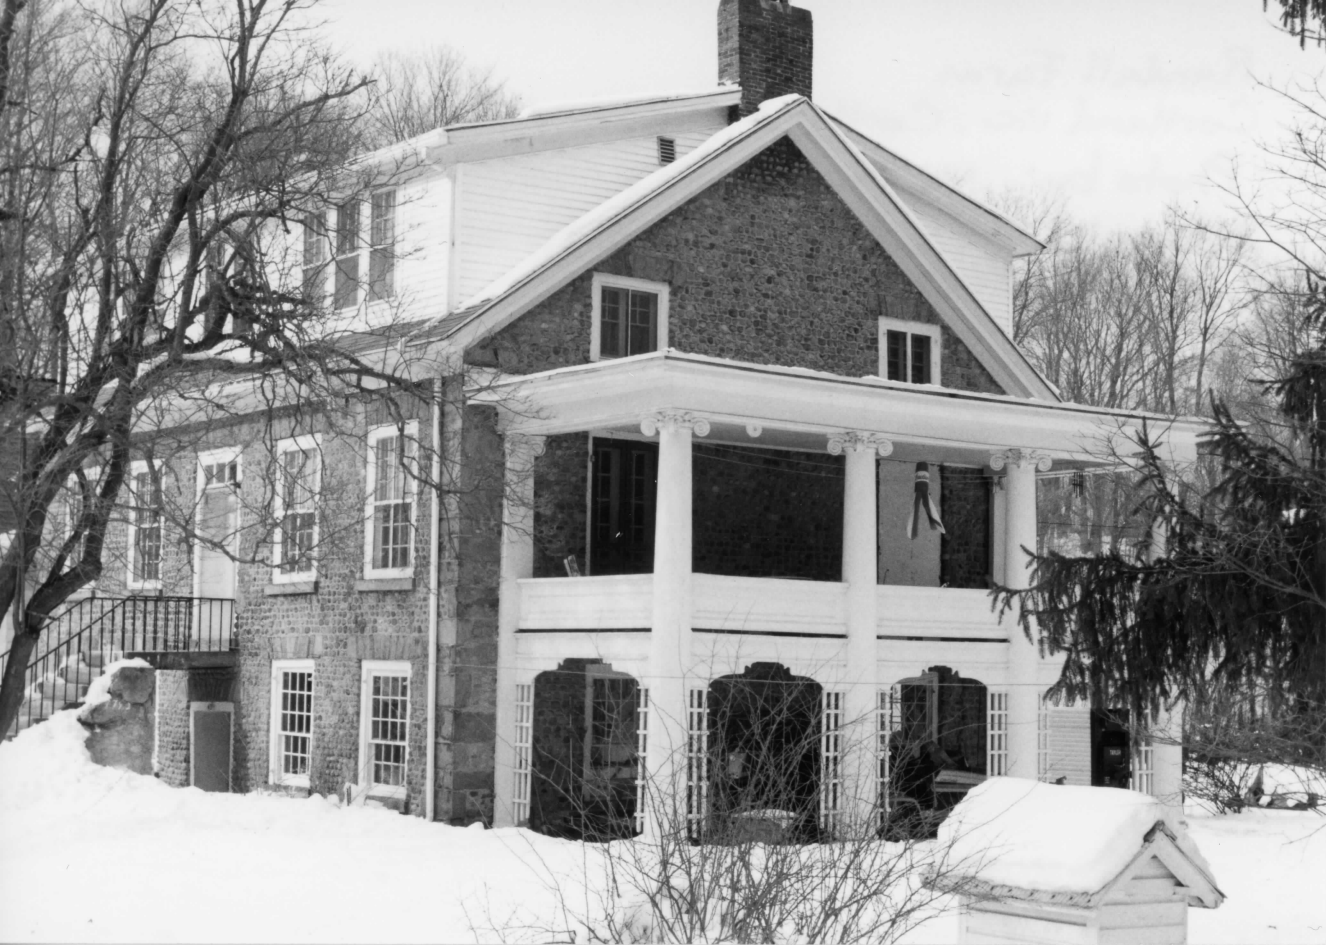
Photo 1 : South and east elevations of  
farmhouse.

The principal architectural component of the farm is the cobblestone farmhouse. Built between 1825 and 1840, the house consists of a raised basement level, a center hall first story and a half story attic enlarged circa 1920 to a full story with the addition of shed roof dormers. It features a five-bay center entrance façade. A distinctive two-story Colonial Revival style porch was added to the east gable end of the house circa 1920. The walls of the house are built of even courses of round grey cobblestones, trimmed with sandstone quoins, sills and unusual flat-arched headers stylistically consistent with the Federal style. The relatively large size of the wall cobbles and their simple placement are generally consistent with what has been identified as the Early Period in the development of cobblestone architecture in New York State, i.e. 1825-1835 (Cobblestone Architecture in New York State, National Register Multiple Property Context, 19992). The house is entered at the raised first floor level via a stone stairs and a landing which lead to a central doorway containing a paneled wood door and a three-light transom. The basement level contains a corresponding doorway beneath the landing, accessed by steps at each side. Fenestration at the basement and first floor levels includes original twelve-over-twelve light sash windows and several later, two-over-two light sash windows probably installed circa 1900. Fenestration in the shed roofed dormers, added circa 1920, consists of six-over-one light sash windows arranged in pairs at the ends and tripled in the center. The Colonial Revival style porch at the east end features four finely detailed Composite order columns with a molded cornice. Scrolled brackets support the intermediate level floor, which is encircled by a paneled wooden balustrade. French doors open out on this level from the first floor interior. Arbors are attached to the columns at the ground floor level. Two original brick chimneys are centered above each of the two gable ends.

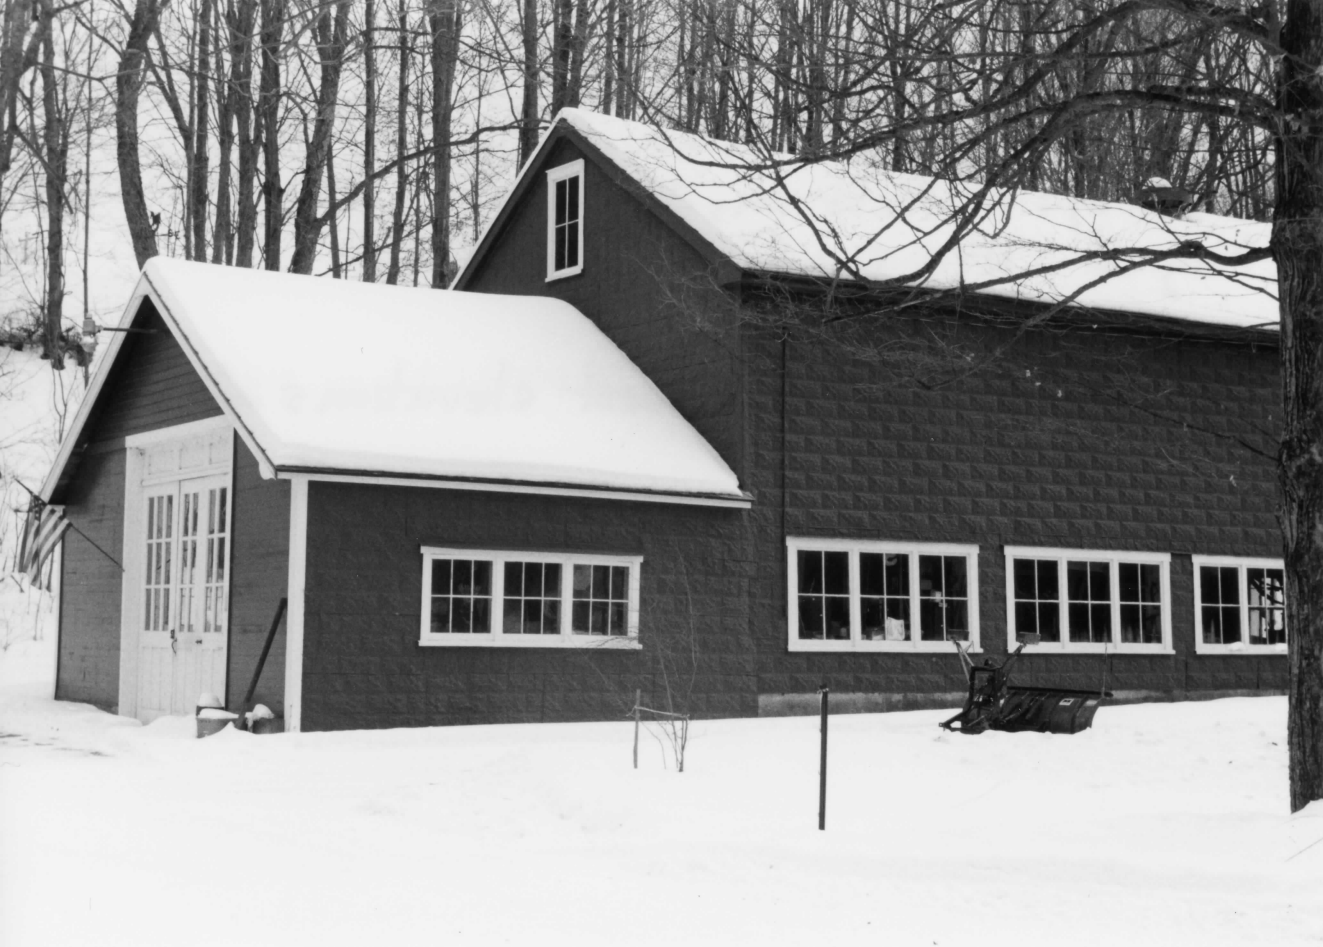
Photo 2: North and west elevations of barn.

The Randall Farm incorporates four contributing dependencies. The largest of these, a circa 1890 dairy barn, was relocated to its present location southeast of the farmhouse in 1943. The barn is rectangular in plan and constructed of a timber frame, wood sheathing and a pressed tin exterior mimicking rock-faced block masonry. An addition at the north end, built in 1943, contains a large double-leaf garage door. Fenestration consists primarily of tripled two-over-two sash windows along the sides. A one-story frame garage, built as a milk house circa 1890, is located south of the house. It features a concrete foundation, clapboard siding, a standing

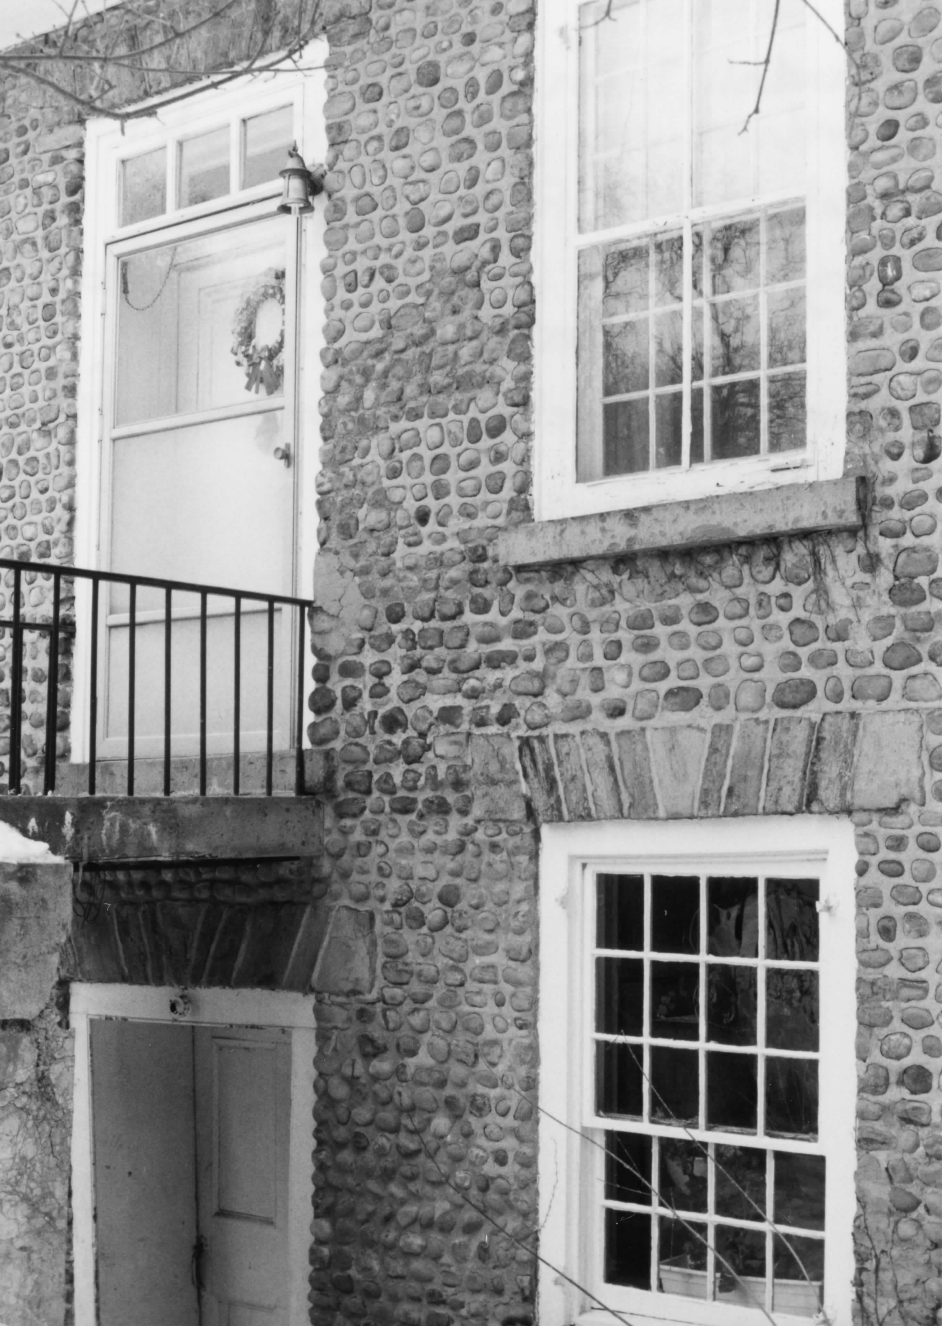
Photo 3: Detail, farmhouse facade.

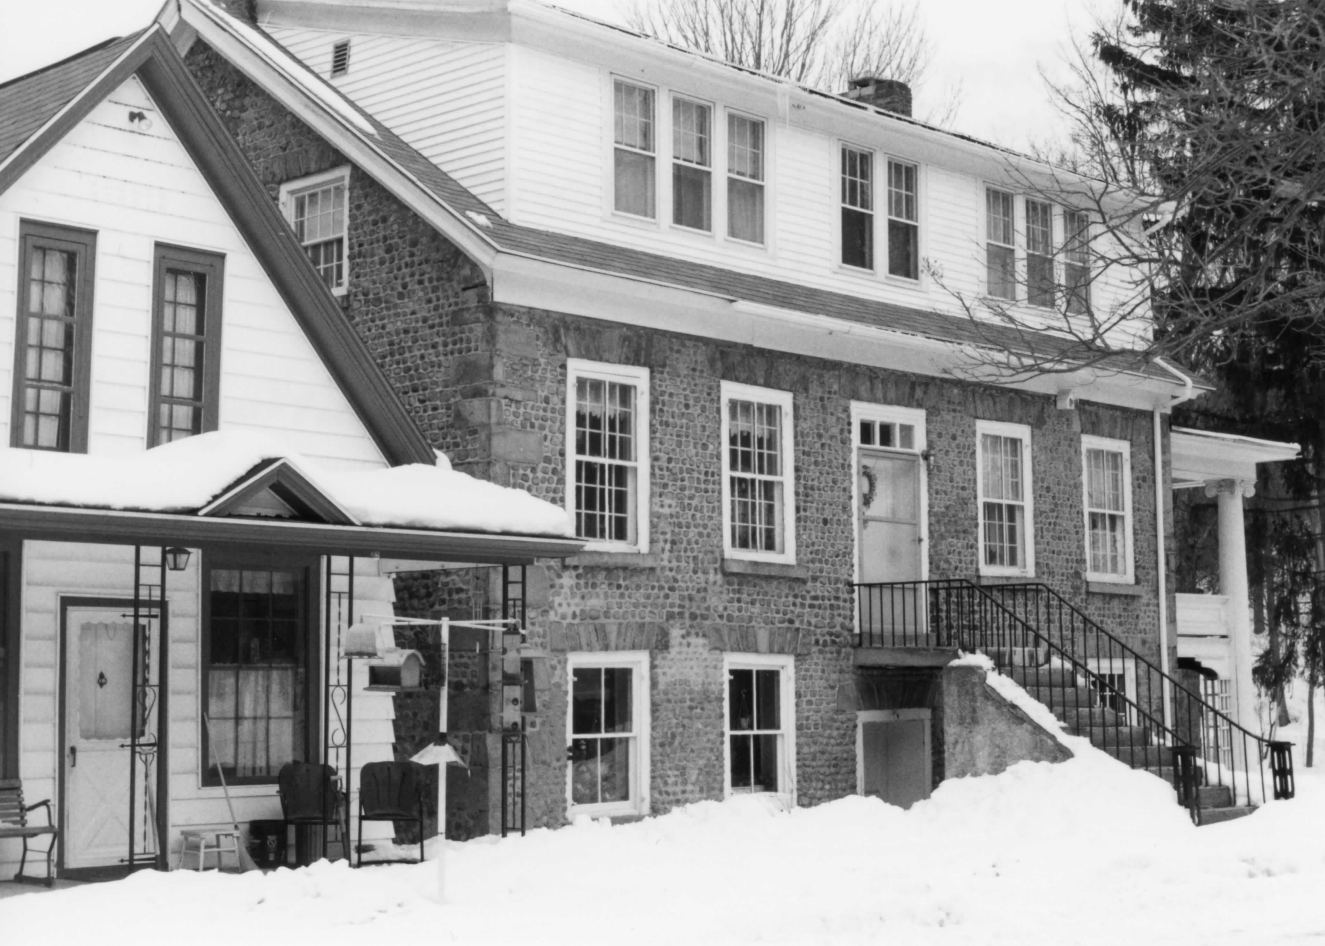
Photo 4 : Farmhouse facade, Cottage at  
left.

A second residence built of frame construction is situated several feet west of the cobblestone house. The gabled one-and-one-half story façade and steeply pitched roofs suggest the influence of the Gothic Revival style although there is no evidence that the house was detailed with bargeboards, finials or other typical manifestations of the style. The cottage appears to date in construction from the 1850s or 1860s and is connected at the basement level by a partially below grade hyphen. The roof ridge of the house is oriented north-south with an intersecting ridge extending west. Fenestration consists of six-over-six and two-over-two light window sash at the first floor and elongated casement windows at the attic story. The house is currently sheathed with vinyl siding. Early twentieth century photos indicate that the house was originally covered by wood clapboard siding. The interior of this house has been extensively remodeled and retains little visible evidence of its original plan or finish. Taken together, the two houses are counted as two contributing buildings.

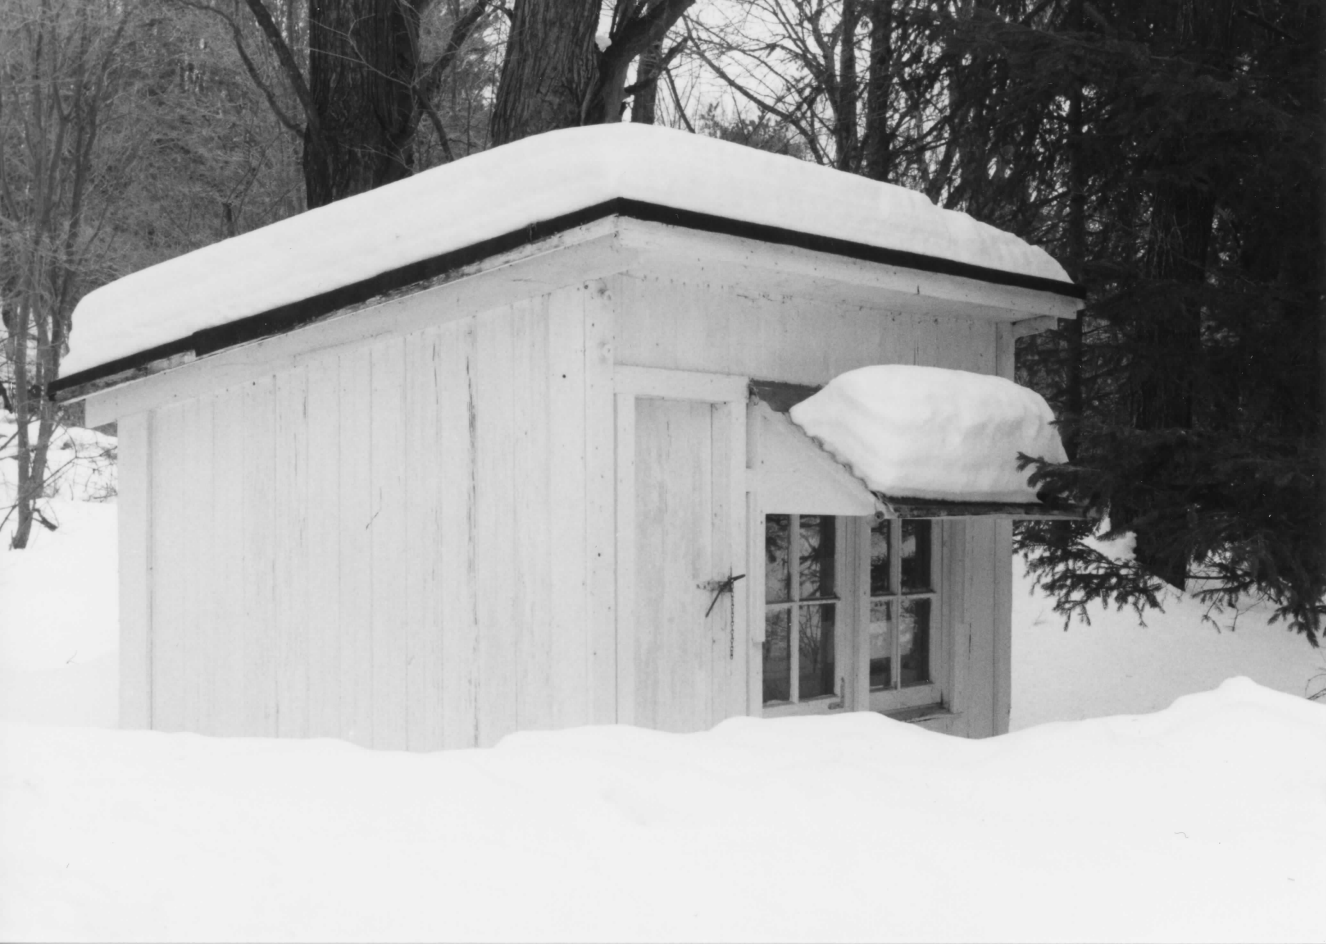
Photo 5 : Chicken House.

seam metal roof, reused windows and doors and an overhead door. To its east stands a small frame playhouse. Also built circa 1920, the playhouse features a concrete foundation, clapboard siding, an asphalt-shingled gable roof and Mission style door and windows. A small frame chicken shed is located south of the playhouse and appears to date from circa 1920 or earlier. Other dependencies historically associated with the farm included a carriage barn attached to the frame cottage, a stone smokehouse west of the carriage barn, various wings and additions connected to the large barn but not moved with it, a small, saltbox-shaped barn at the south side of the large barn complex, a small gabled barn on the hillside east of the cobblestone house, and a sugar shack southwest of the milk house. None of these buildings remain, however, archaeological evidence of their location, construction and usage is believed to remain on the nominated property. The sites have not, however, been investigated to date and are not included in the property's resource count.

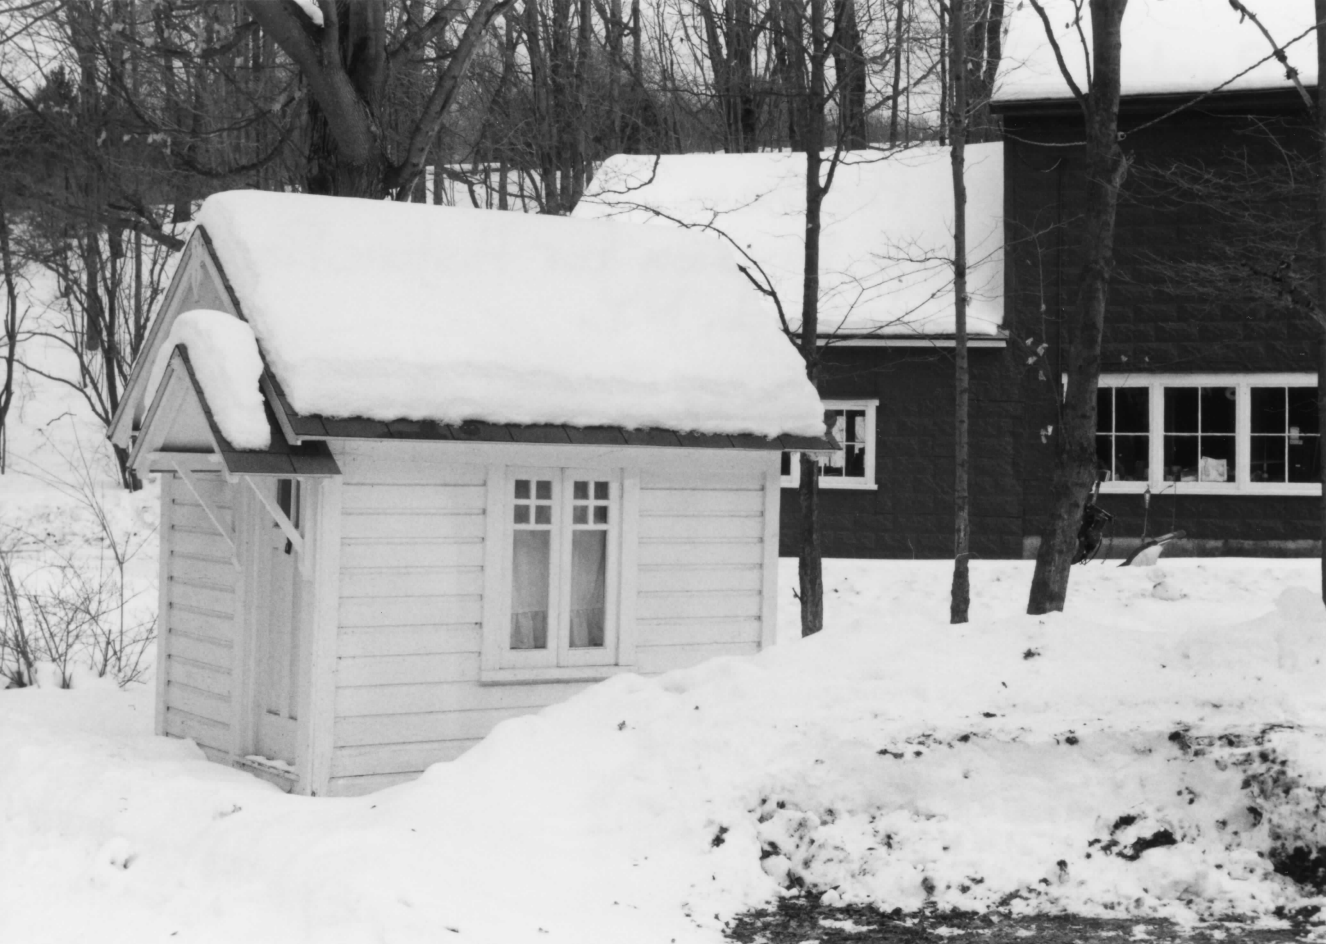
Photo 6: Play house.

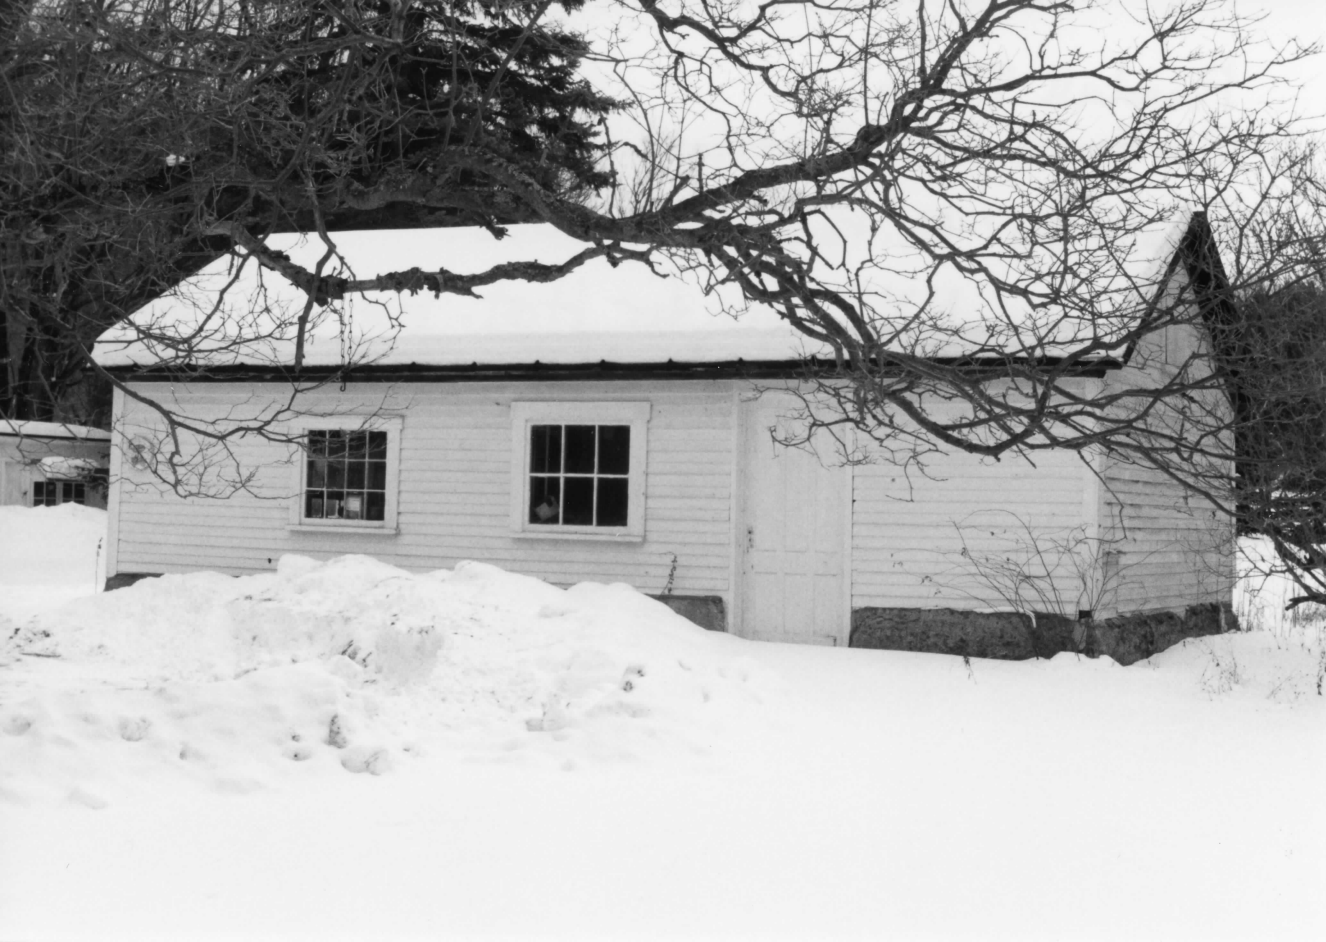
Photo 7: Milkhouse/garage
