National Register of Historic Places
Registration Form

historic name Kenyon Residences

street & number 60 and 62 Main Street not for publication

Kenyon Residences
Mt. Vision, Otsego County, New York

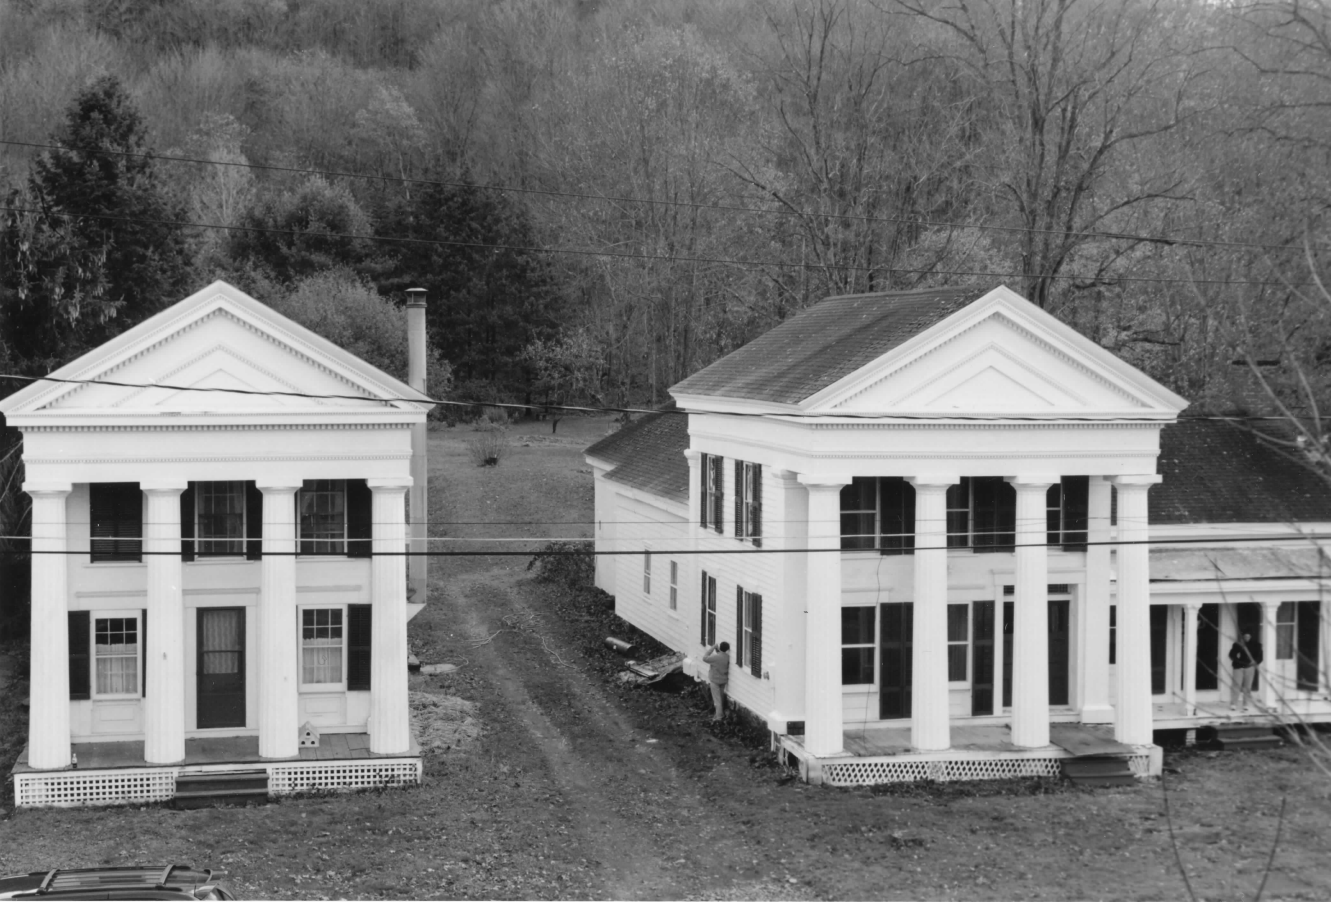
#1

view: 62 + 60 Main Street
looking southeast

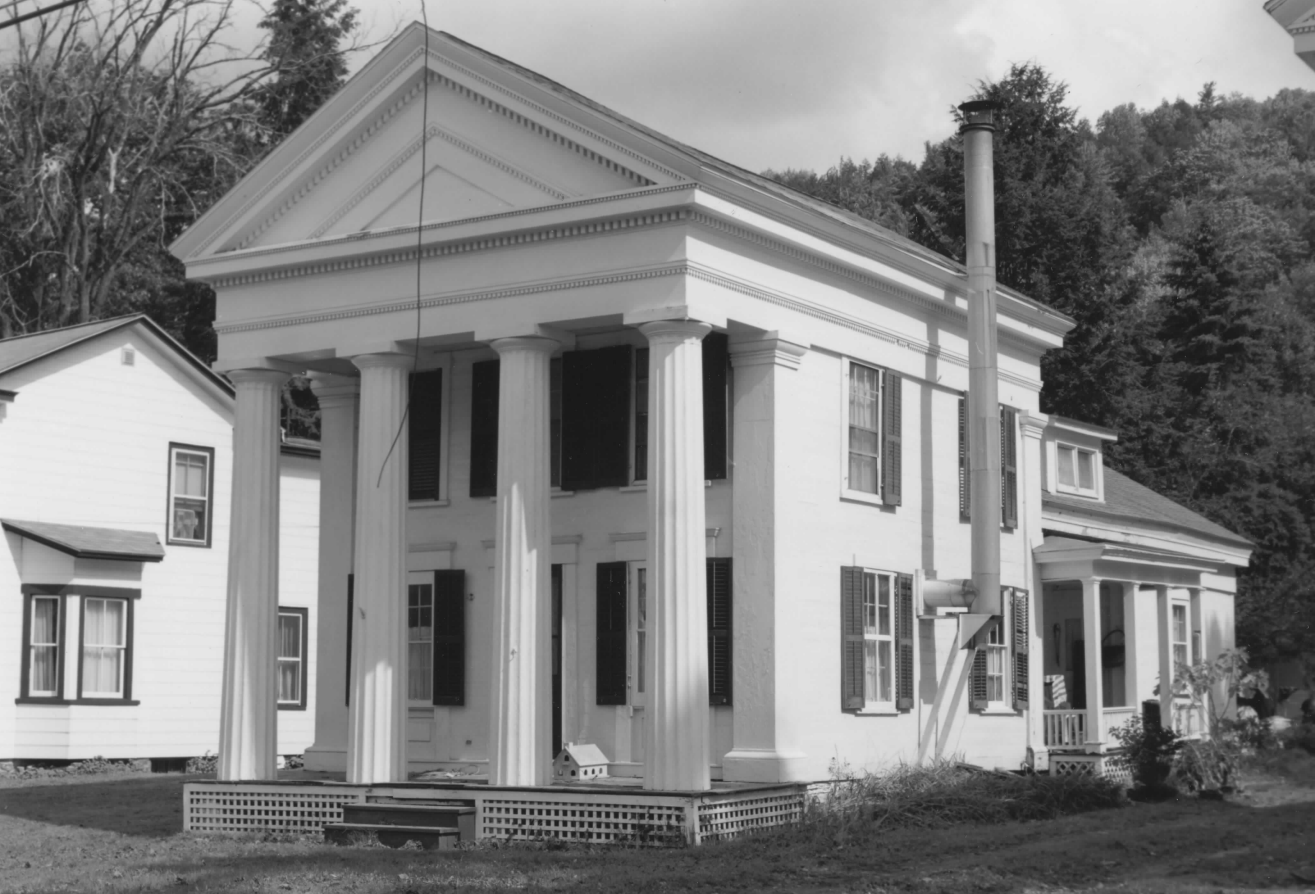
#2

facade + south
elevation

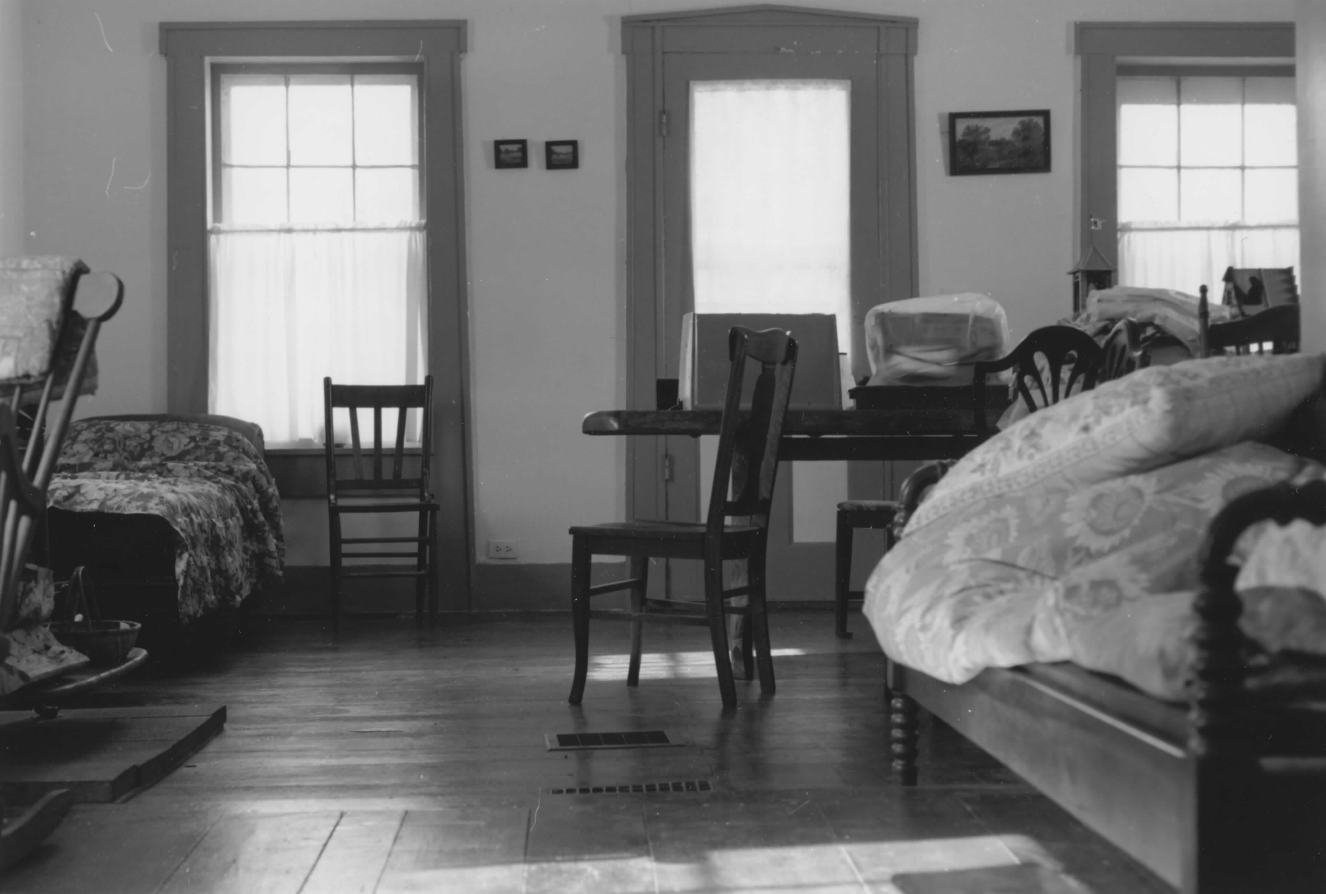
#4

main entrance

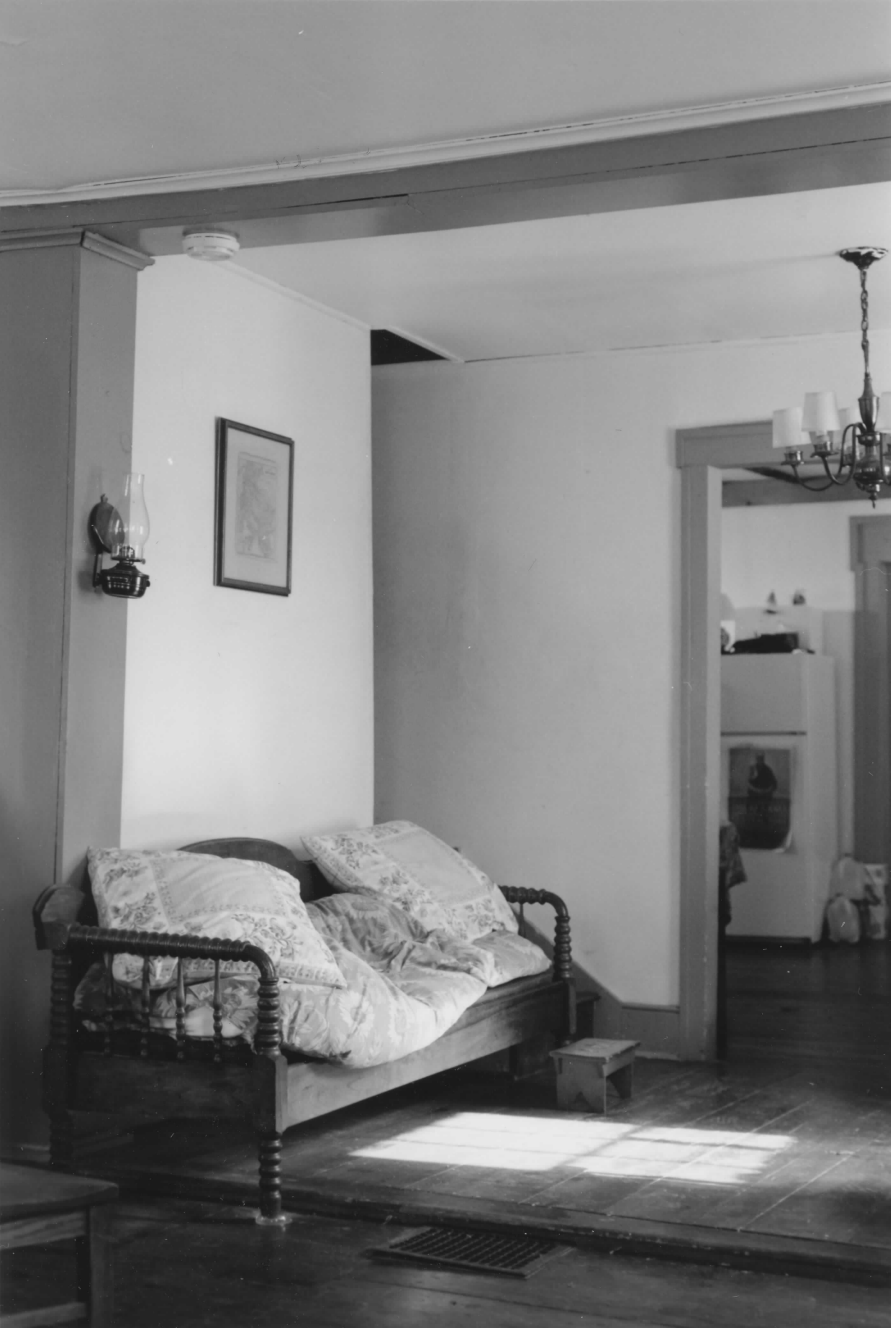
#5

view: 62 Main
interior, rear parlor
w/ enclosed stair
on the left

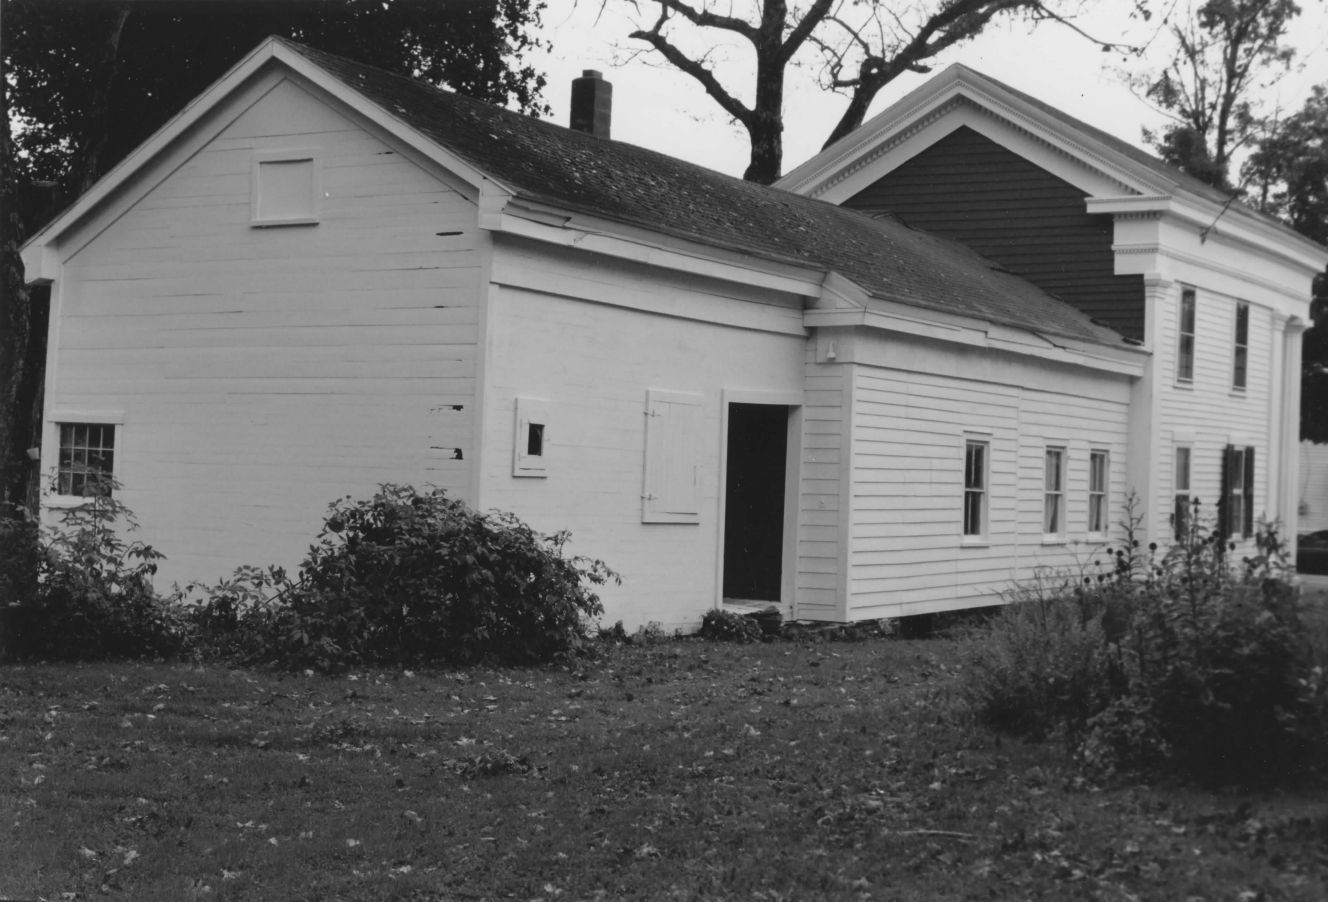
#7

view: 60 Main
west + north
elevations

The northern elevation of the house has four sections, three of which are identical to those at 62 Main Street: the main house at the western end, the middle section (most likely the original dining room—Room 105 on enclosed plan), and what was the original kitchen and pantry. A fourth section on the far eastern (rear) end of the northern elevation consists of a shed added to the rear of the house. According to Otsego County maps, the shed was built between 1858 and 1903. A small, inset, covered porch separates the eastern end of the original house from the shed. The porch includes a door into the building and a window on its western wall.

On the northern elevation, the western (front) end of the house is located between two pilasters, one at the northwestern corner of the building and one approximately twenty-five feet from the façade. Two windows on the first floor and two windows on the second floor of the western section are one-over-one. Both the middle section and the storage area have windows on the first floor only. The two first-floor windows in the middle section and the one first-floor window in the pantry are two-over-two.

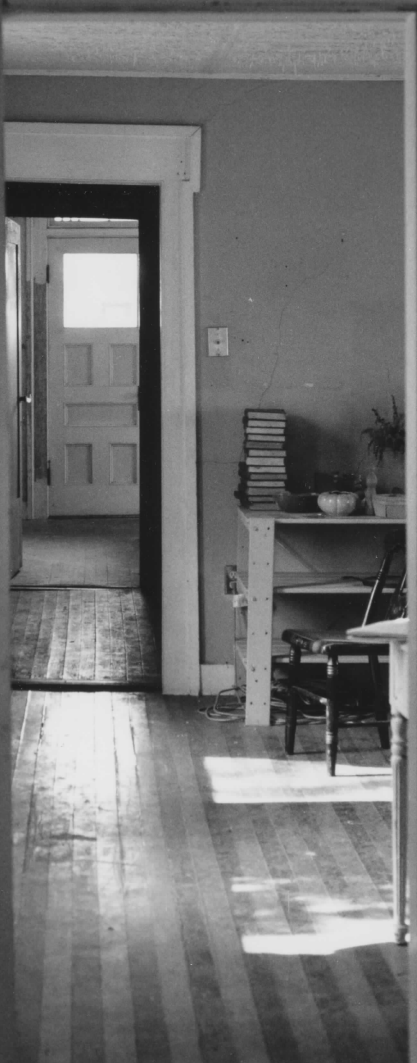
9

View: 60 Main
interior, 1st floor
looking at side
hall + main entrance
from the rear
