National Register of Historic Places  
Registration Form

historic name John Smith Farm

other names/site number Slate Creek Farm

state New York code NY county Montgomery code 057 zip code 13339

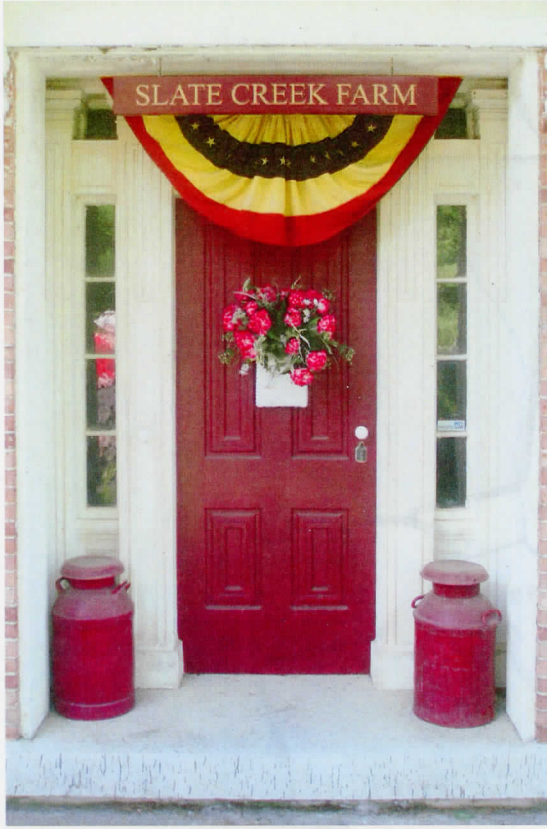
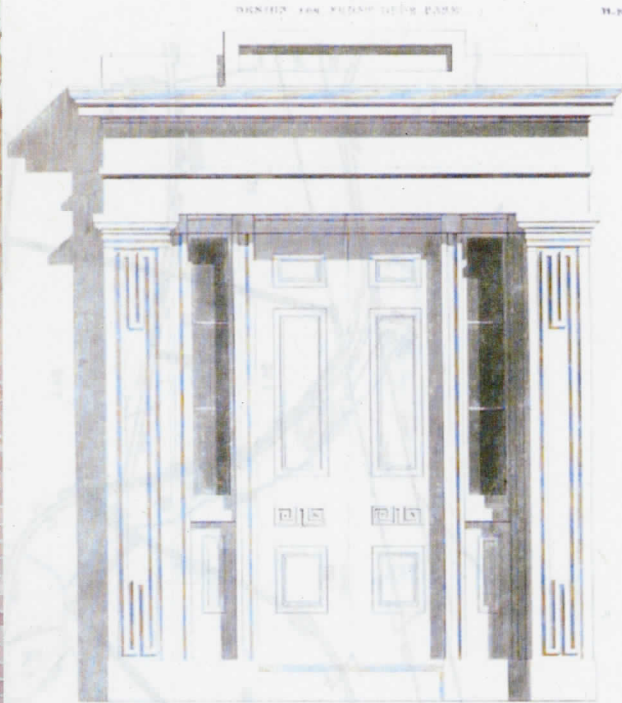
Front door casing of nominated house, and PLATE 28 of Asher Benjamin's *The Architect or Practical House Carpenter* (1830)

Fenestration on the main façade is regular and maintains symmetry around a center entrance and two flanking bays. The main elevation has a clear emphasis on the front door which is fully trabeated and robustly treated. The door itself is a four paneled wooden door flanked by  $\frac{3}{4}$  length sidelights. The surrounding enclosure features a deep recess with moulded pilasters with ogee-profiled capitals, a moulded projecting cornice in wood, and a sawn-stone lintel in the masonry wall; the whole surround is surmounted by a hipped-roofed hood supported by elaborate scroll-sawn brackets. All nine main window openings on the elevation (four lighting the lower and five lighting the upper) hold double-hung, 2/2 wood-sash windows with projecting cut-stone sills and large cut-stone lintels. Other ornamentation includes a wide frieze band adorned with three-light frieze windows, decorative wooden panels and elaborate ornamental scroll-sawn brackets supporting the roof overhang. Surmounting the foundation is a cut-stone water table that incorporates the jog between the two blocks.

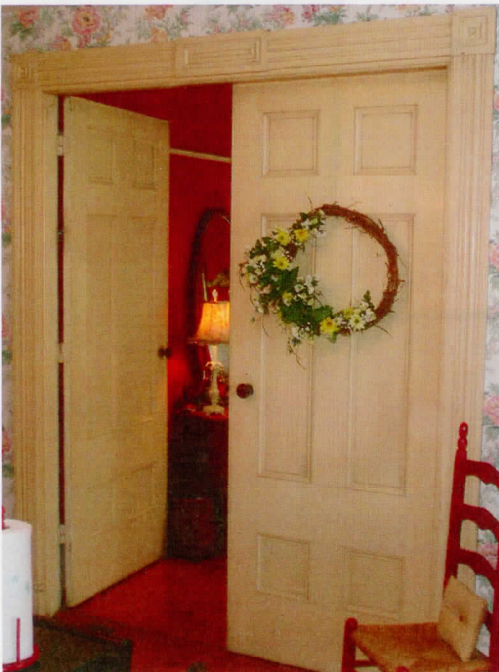
Clockwise from left: Parlor architrave of nominated house; "Diamond Plate" detail from PLATE 25 of Asher Benjamin's *Practice of architecture: Containing the five orders of architecture* (1833); detail of an architrave PLATE 48, Benjamin's *The Architect or Practical House Carpenter* (1830)

On the interior of the first story, the house presents a double-pile plan of four unequally-sized rooms arranged around a central stair hall/entry foyer. The three-bay block contains a parlor and dining room; the two-bay wing has a second parlor and a small chamber and includes a hall connected to the east entrance. Finishes vary by block. In the three-bay, brick main block, they consist of wide wood floors, lath and plaster walls and ceilings, and moulded window and door surrounds. As is customary, the mouldings in the public rooms are particularly fine with moulded architraves and ogee-profiled baseboard. The large double doors between the dining room and parlor features a center rectangular-shaped beveled panel, or "diamond panel."<sup>1</sup>

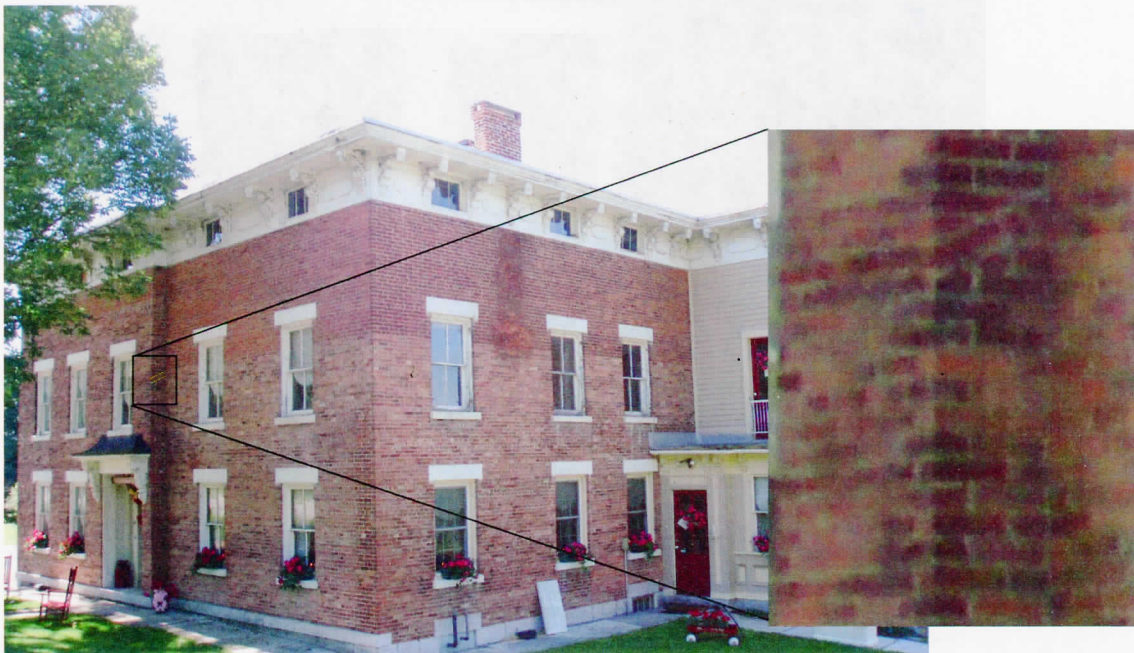
Detail of west elevation with arrow showing remnants of wooden frieze band (above)  
View of main elevation and wing with detail of angled bricks showing former roofline.

Fenestration on the west elevation is asymmetrical, with two window openings lighting the rear bay at the main floor, the second story and the upper-half-story frieze windows. This lighting configuration does not reflect an interior arrangement on the first floor, which is double pile, but does light a hall on the upper full-story and a small hall in the attic half-story. Three windows on the upper full-story are the same 2/2 type already described, but the three on the lower story are double-hung, 6/6 wood-sash windows—all six are set into surrounds already described. Despite the fact that the upper half story of the main block and wing appear to be later additions, the stone lintels and sills all visibly match in terms of size, material and saw marks.

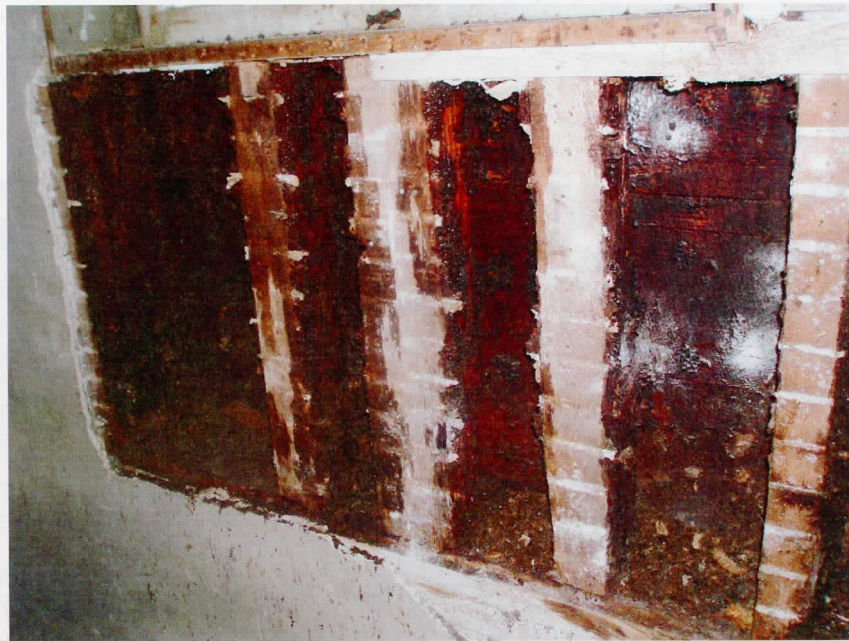
Detail of interior framing and cladding under brick veneer. Image from upper-half story of wing block.

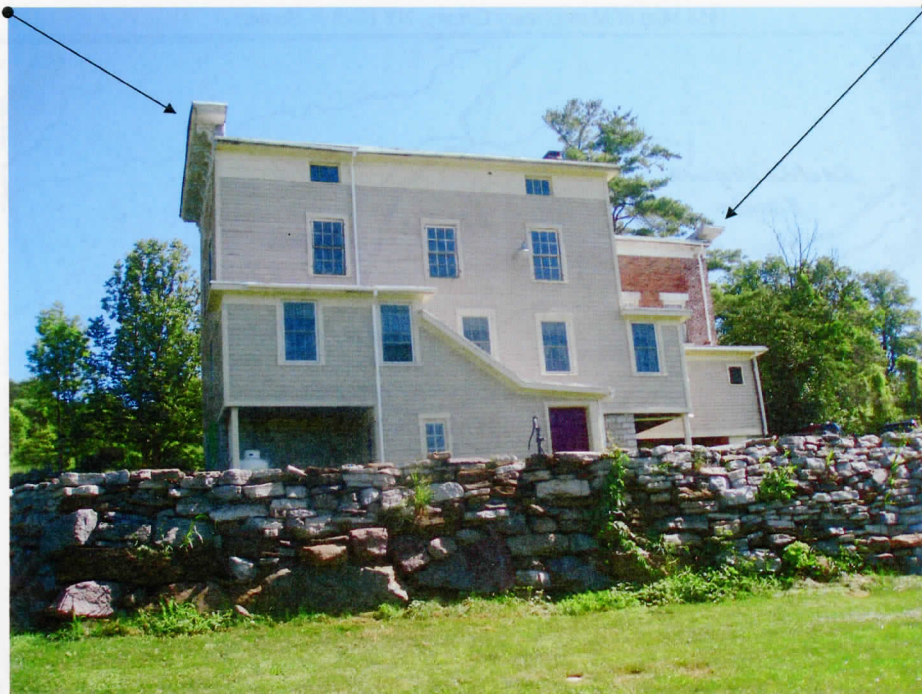
Rear elevation with details showing parapet and cornice false front

Fenestration, ornamentation and framing in the rear block, along with interior finishes, indicate the block is contemporary with the 1860-70ss modifications to the house. The rear block is two stories in height, three bays wide and two bays deep. Projecting off the block are four step-down blocks, each a single story. The two-story portion has double-hung 6/6 wood sash windows set into moulded wooden surrounds lighting the main floors. Other openings consist of two rectangular wood-framed windows, set just below the frieze band, lighting the attic on the east, two three-light rectangular windows set into the frieze band of the rear elevation and two three-light rectangular windows lighting the attic on west elevation. Ornamentation includes a wide frieze band adorned with decorative wooden panels and elaborate ornamental scroll-sawn brackets supporting the roof overhang on the east elevation and northeast corner only; this matches that described on the main block except it lacks the frieze band windows. The roofline of the rear block has been extended vertically with a non-structural element to include this decorative feature. On the rear is a wide frieze band without roof brackets. The rear and west elevation of the frame block lack the decorative roof overhang. The step downs include an enclosed basement stair hall and three cantilevered blocks.
