NATIONAL REGISTER OF HISTORIC PLACES
INVENTORY -- NOMINATION FORMSEE INSTRUCTIONS IN *HOW TO COMPLETE NATIONAL REGISTER FORMS*
TYPE ALL ENTRIES -- COMPLETE APPLICABLE SECTIONS**1 NAME**

Cornell Farmhouse

Cornell (Creedmoor) Farmhouse Complex

CORNELL (CREEDMORE) FARMHOUSE
CIRCA 1750 AND ADDITIONS

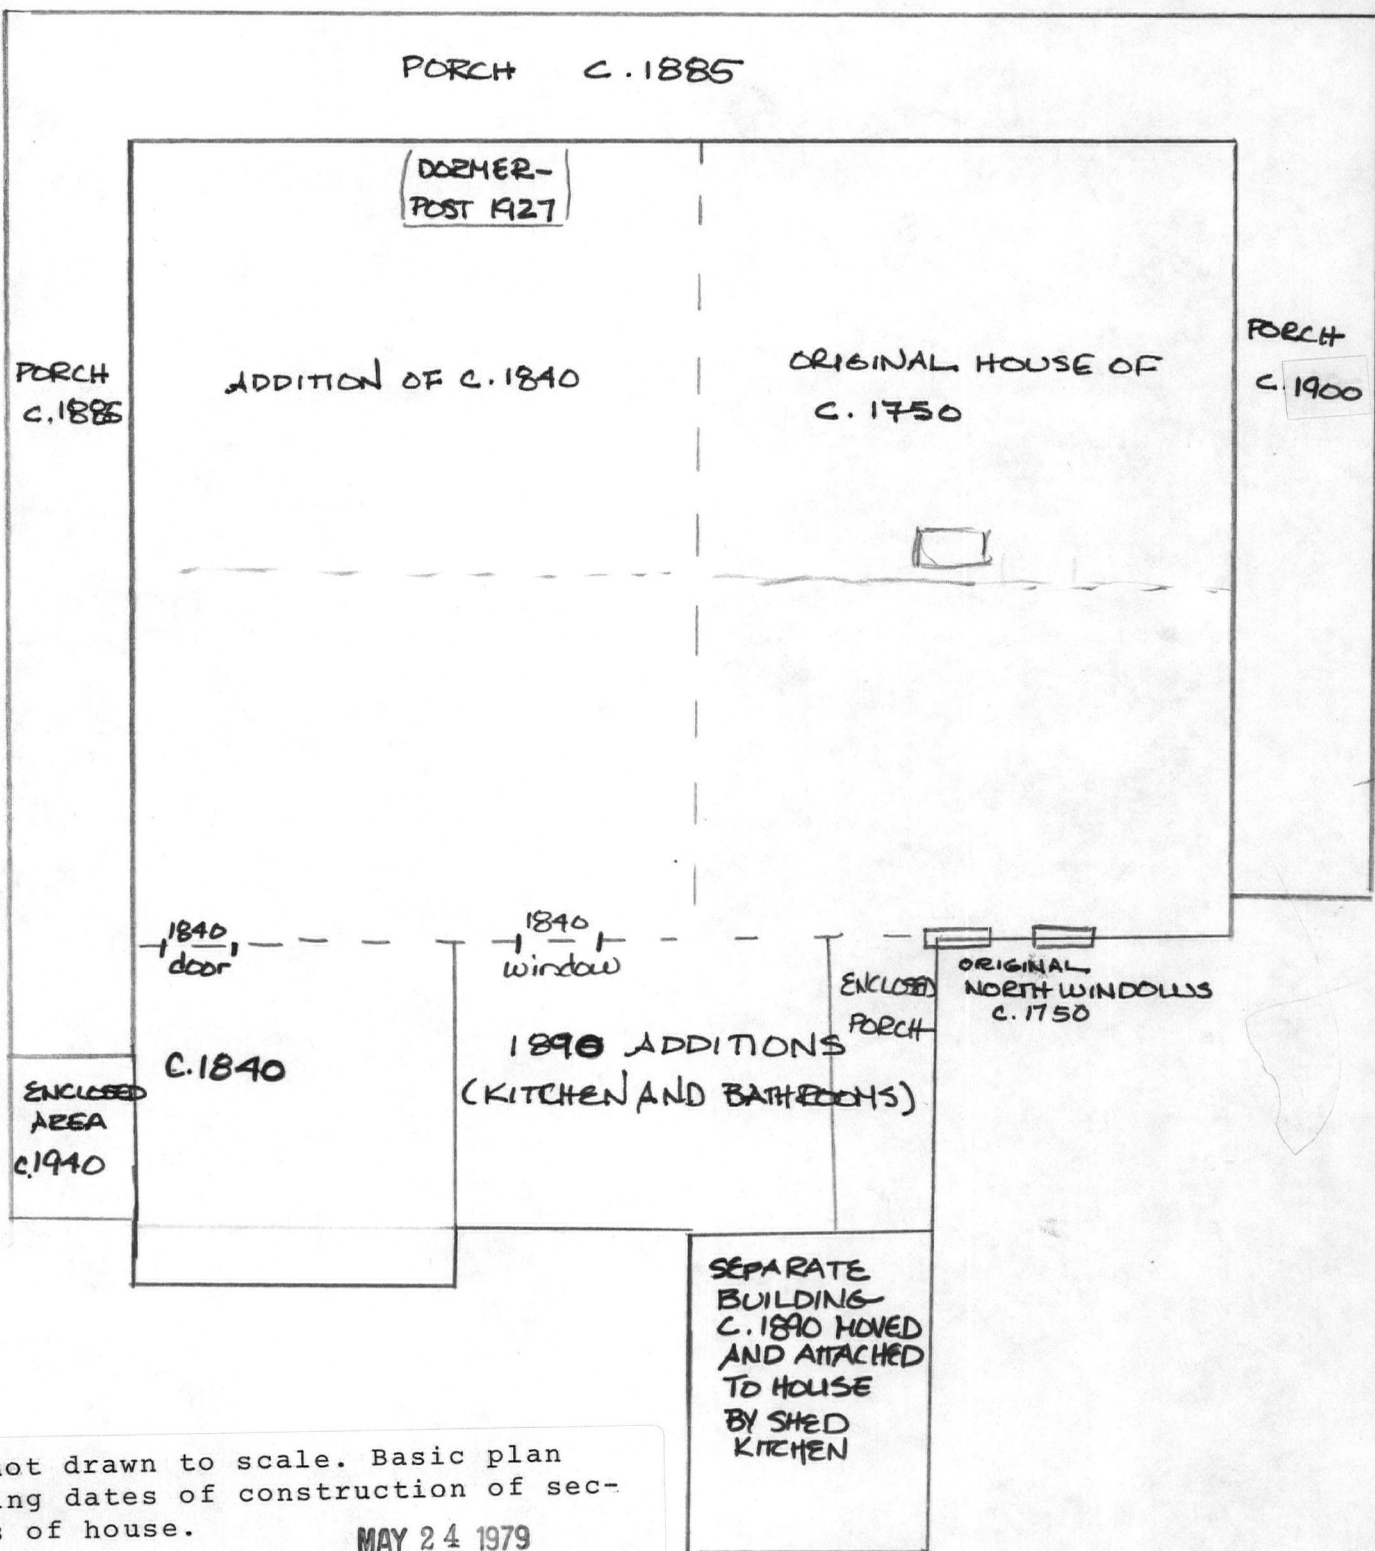
Map not drawn to scale. Basic plan showing dates of construction of sections of house.

The Cornell (Creedmore) Farmhouse as seen today includes a series of additions which were made over a period of years to the Dutch farmhouse of c. 1750 (see floor plan). An eastern portion was added to the original house in about 1840 in a Greek Revival style, identifiable mainly on the interior. In 1890 a wing was added to the north and in about 1885 porches were constructed on the east and south sides with a porch extension along the west side after the turn of the century.

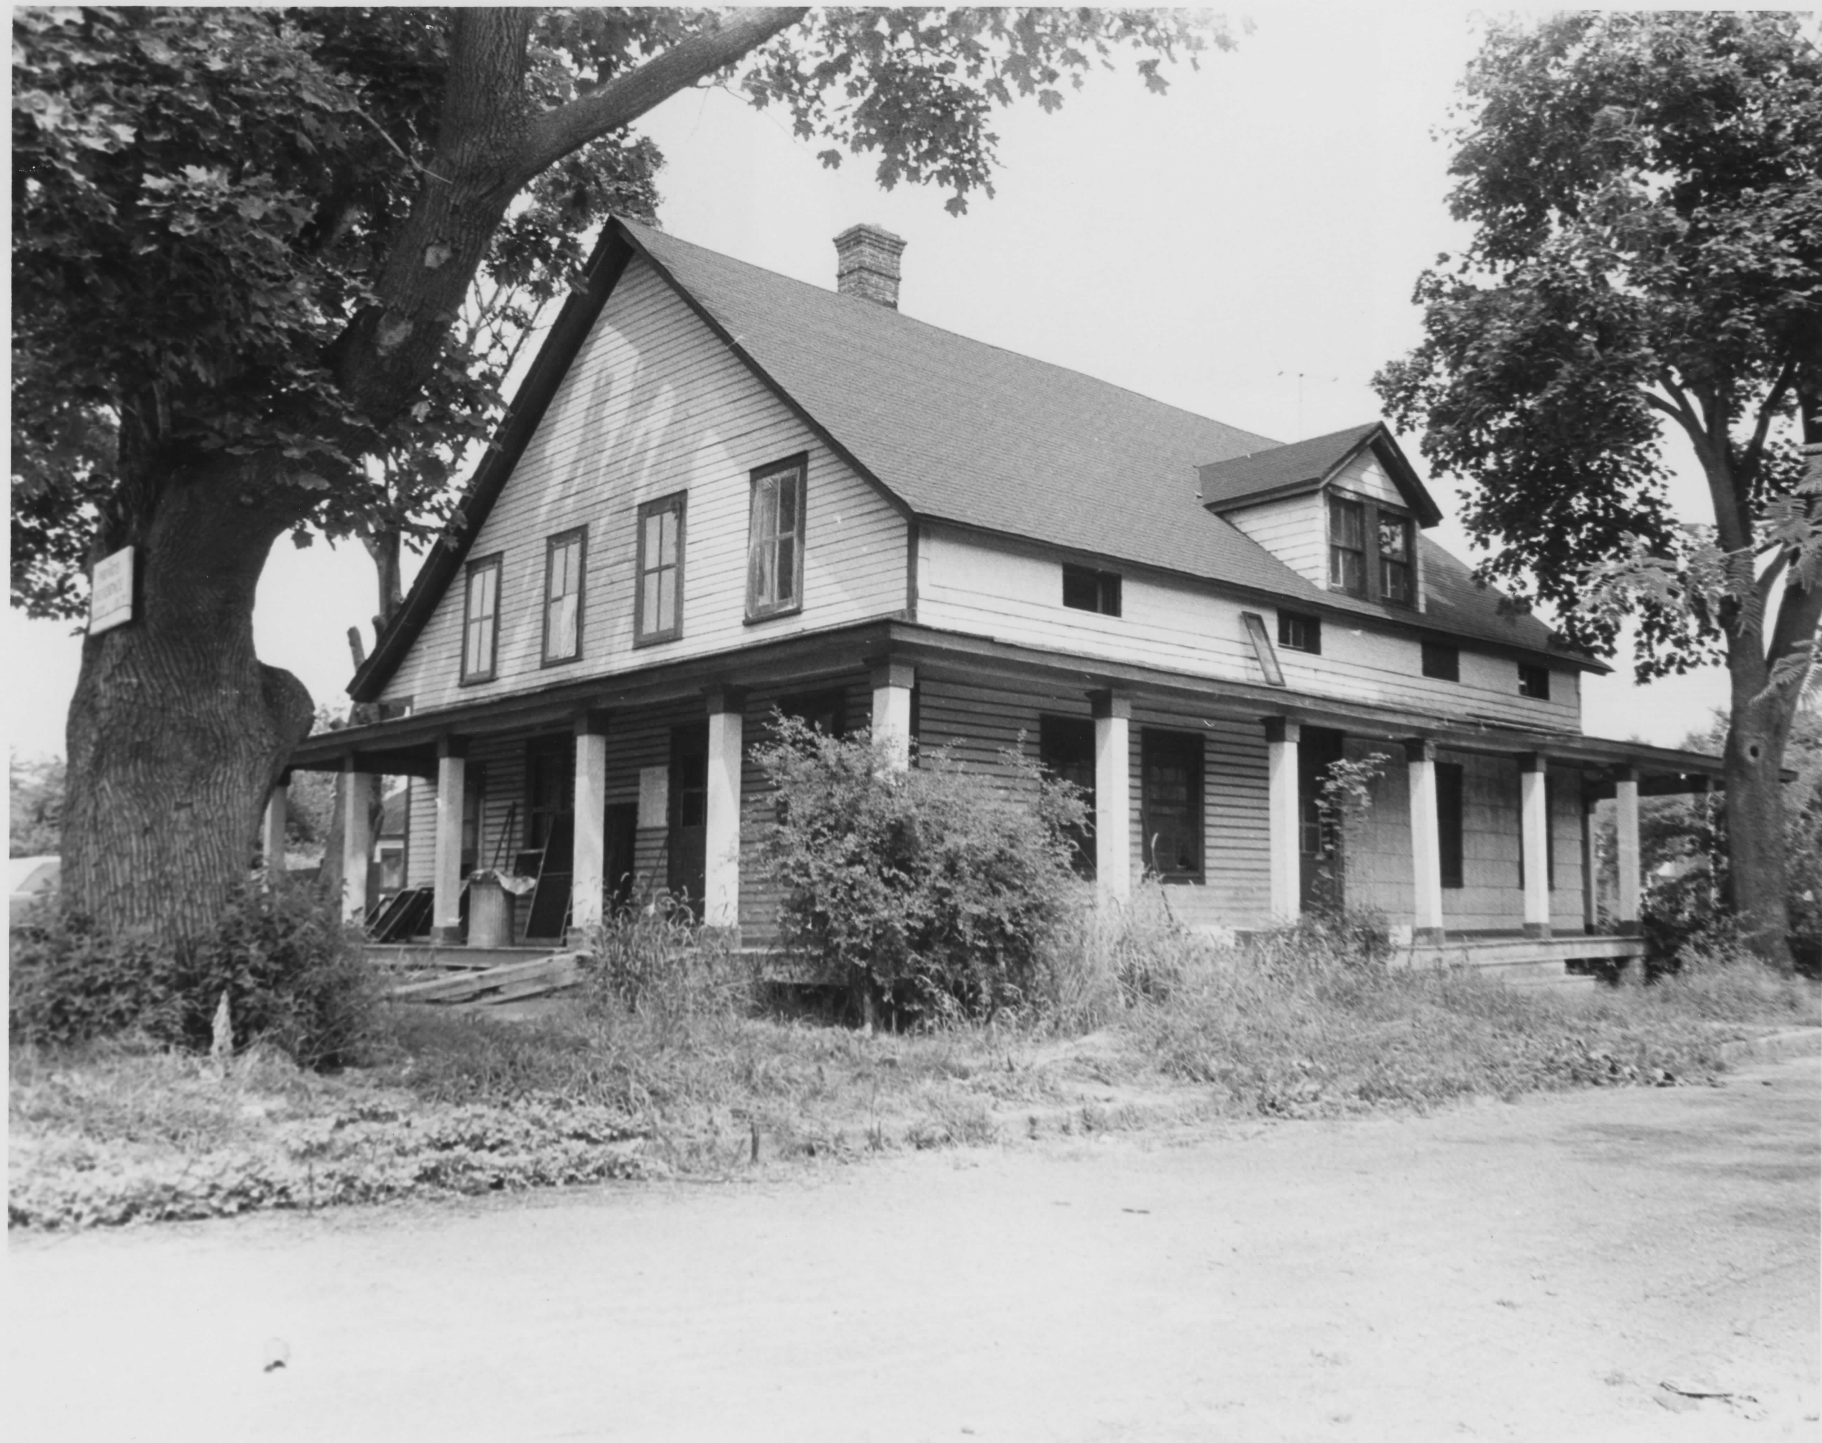
DOE
JUL 24 1979 1.6

EXTERIOR VIEW - This view is looking at the west (left) and south (right) facades. Novelty siding and proches dates from the 1880's. Dormer is post-1927. Some hand split shingles survive to the right of the door on the south facade.

As seen from the south, the most significant element of the house is a wood-columned porch which extends the entire width of the front and along both sides. Above the porch is a series of fascia-type low windows set just below the eave. In the western portion these probably replaced a projected or spring eave which, judging from the north elevation of this portion of the house, must have once been a notable feature on the south side.

The pitched roof with rather high gables at each end maintains a continuous ridge from end to end. The dormer window at the south was a later addition. The porch is the most conspicuous feature at each end of the house; four windows are placed above it at the west.

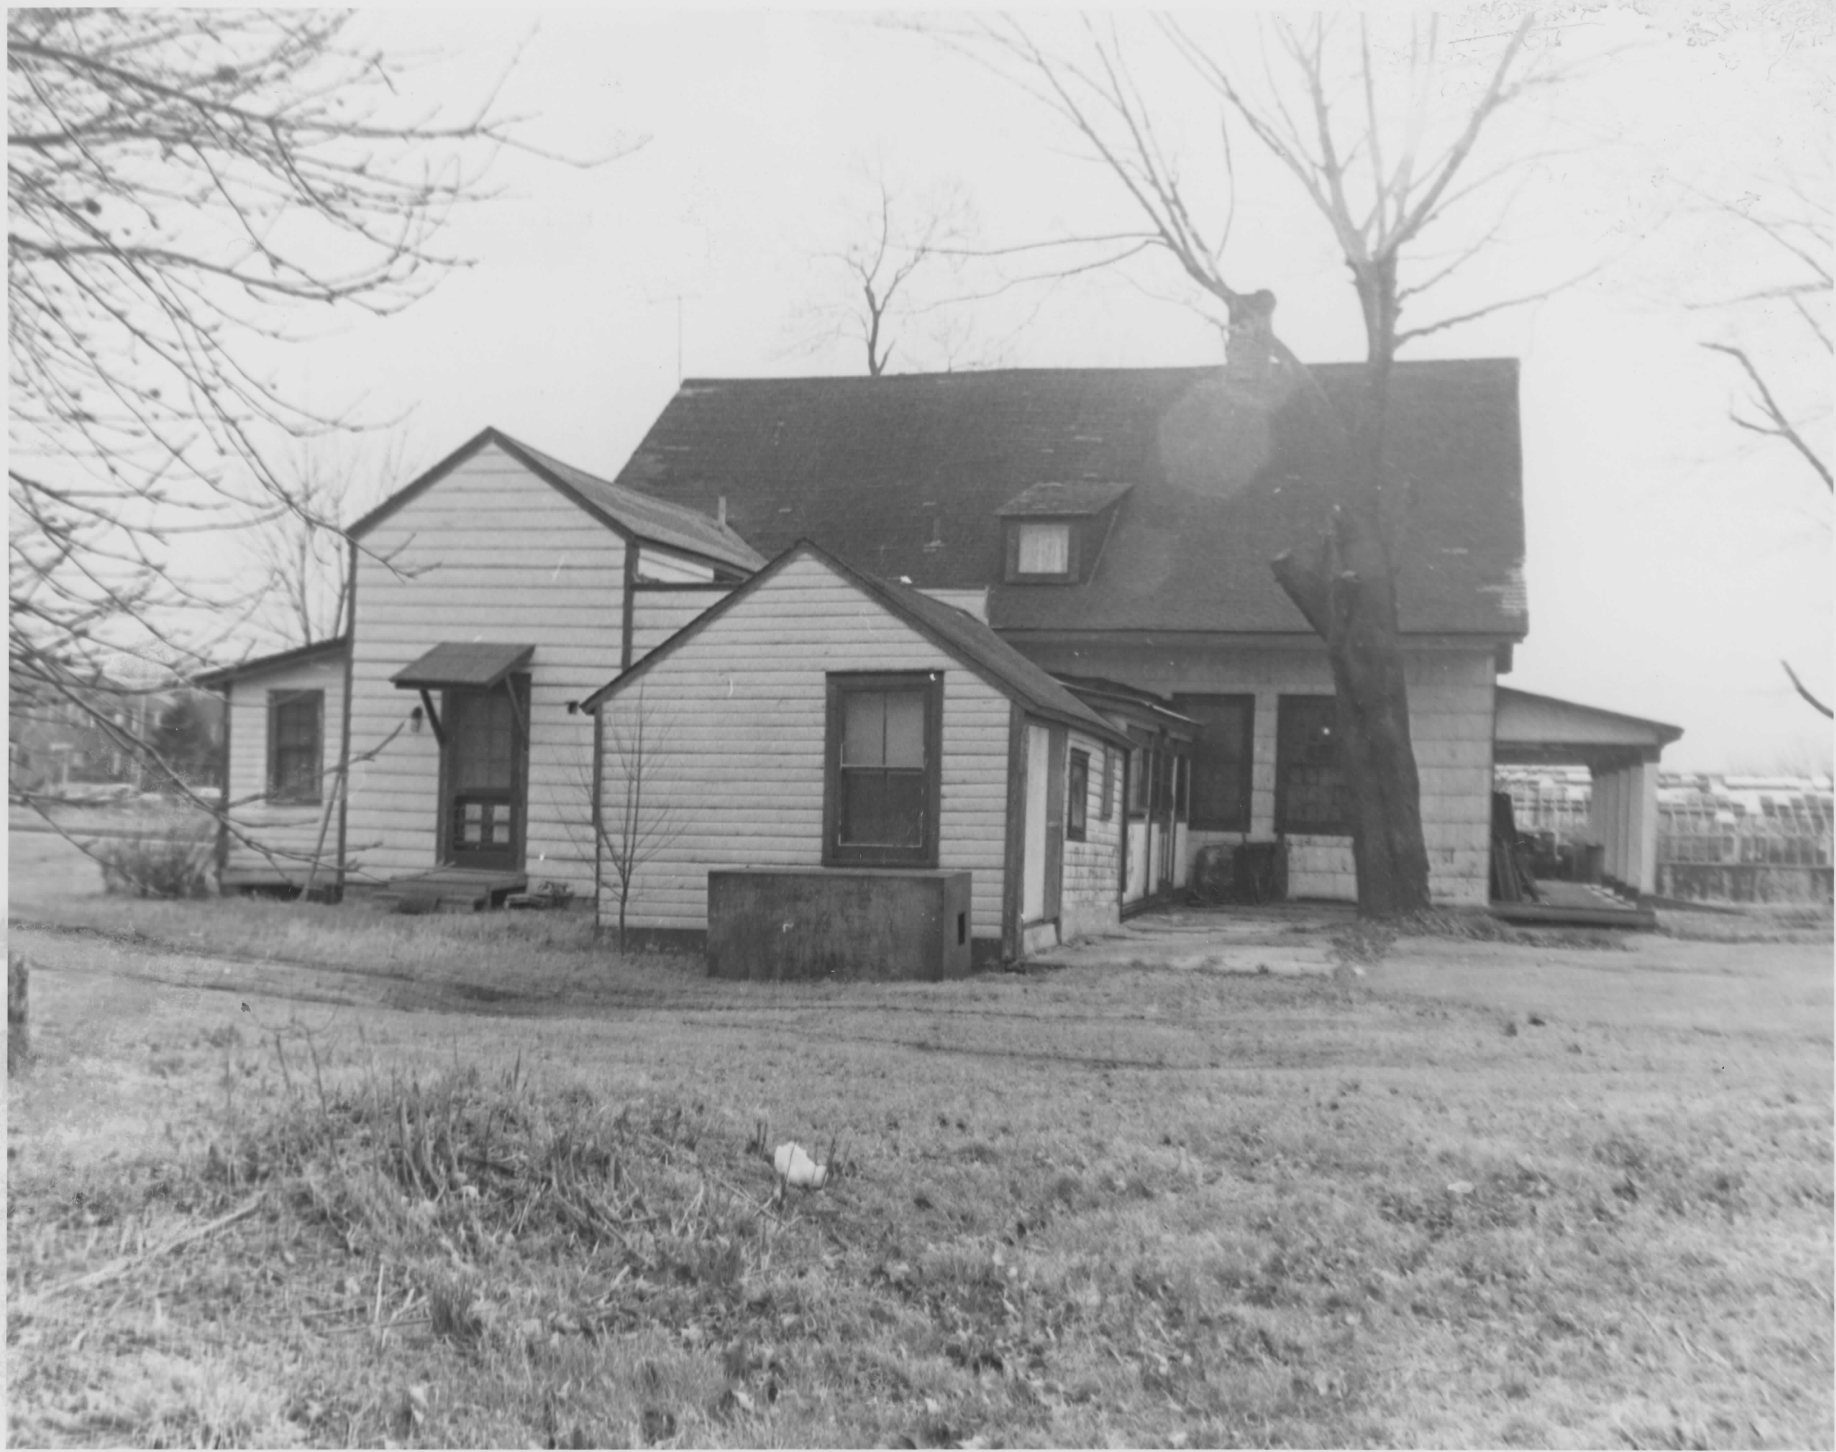
2^{of 6}

NORTH FACADE. This view shows late 19th Century extensions incorporating kitchens and bathrooms.

The north wing is set behind the Greek Revival portion of the house revealing the original spring eave of the old portion of the house to the west of it as well as twelve-over-twelve window sash and original shingles exposed about twelve inches to the weather and secured by hand-wrought nails. A portion of this old shingle facing is also exposed on the south side to the right of the front door. Two original windows in the north wall, complete with heavy muntined sash, follow the Dutch pattern of placing their tops right up against the second story floor boards.

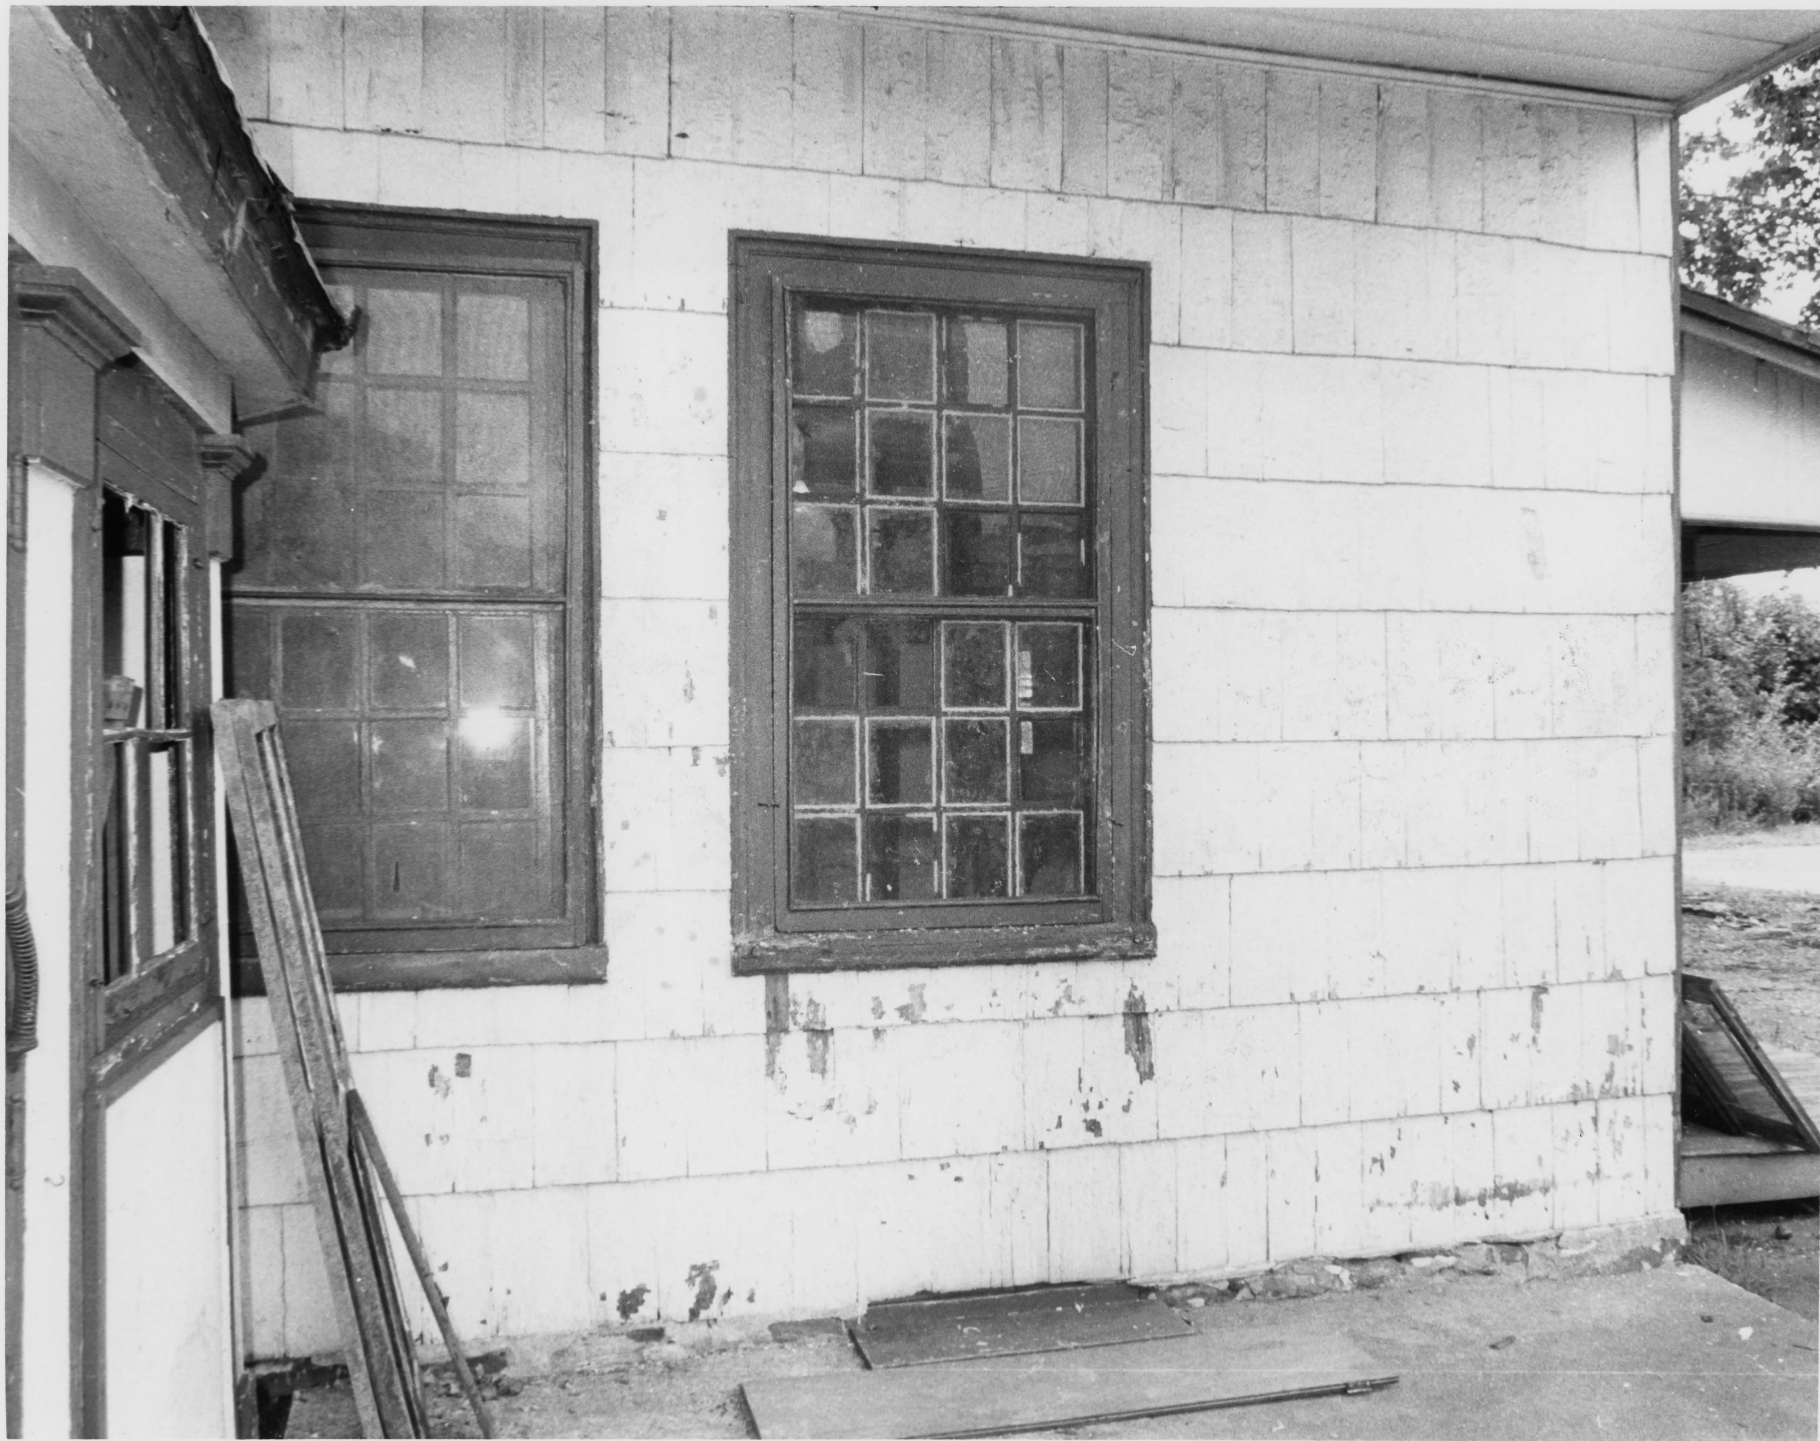
3 of 6

002
EXTERIOR DETAIL: The view of the north wall of the main and original house shows hand split shingles of the 18th century and the original 12 over 12 window sash, among the oldest in New York City.

Except for the western portion of the north wall, the other exterior walls have been re-sided with narrow clapboard. Without this portion of the north wall, it would be almost impossible to determine the real age of the house. The extent of the old portion has been largely deduced from a study of the interiors.

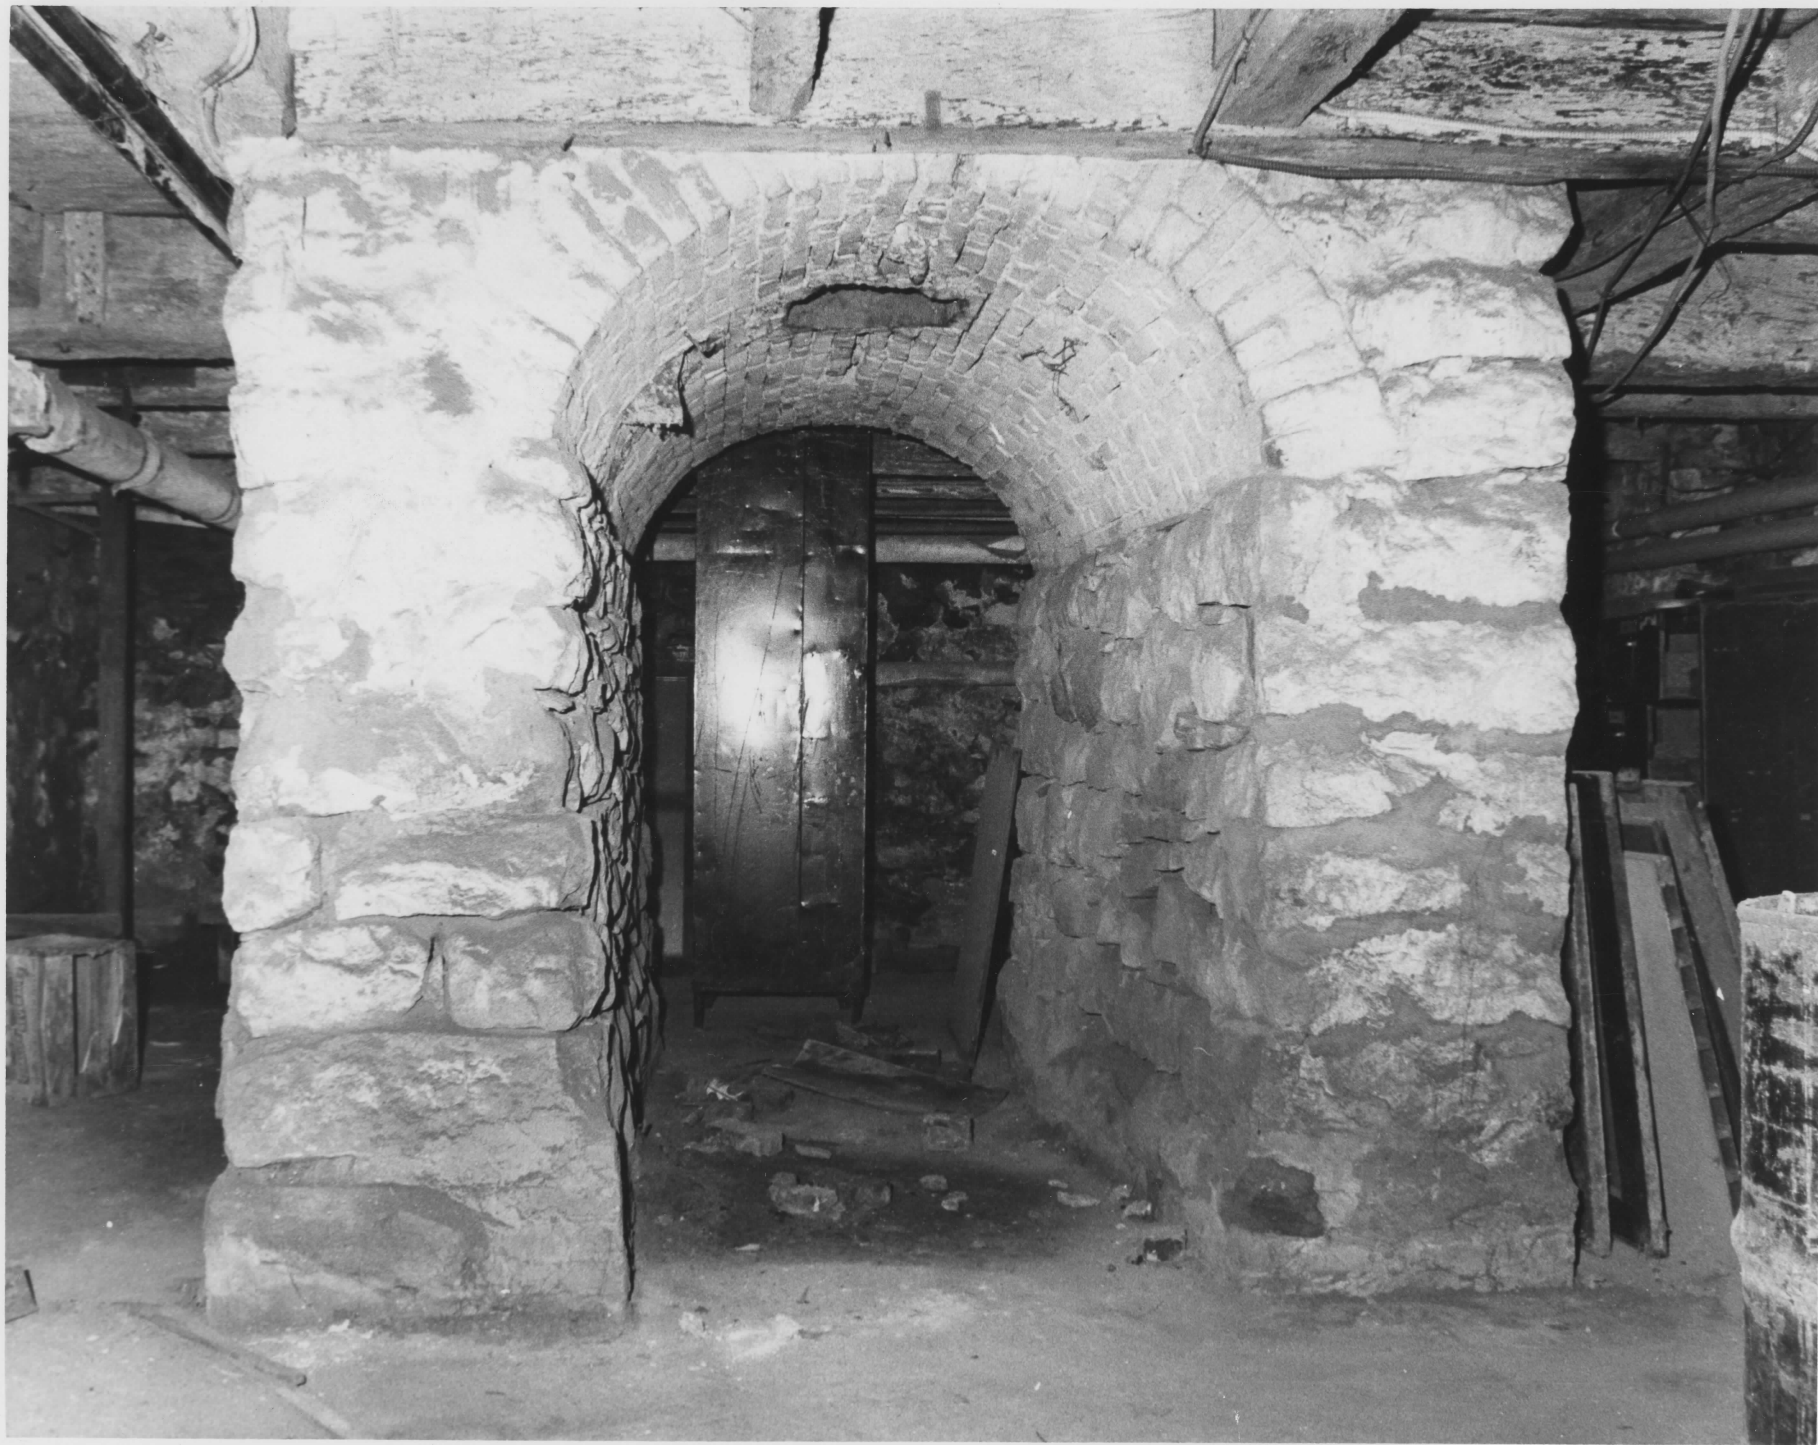
DOE
JUL 24 1979 *D.* *5.6*

Interior View: Cellar under original portion of the house. In center of photo is the chimney support consisting of hewn native stone and a mortared brick arch. Both fireplaces on main floor are supported by this masonry construction. Hole at top of underside of arch is probably late 19th cen-

tury.

The chimney, set just north of the ridgeline, has been rebuilt recently. As seen in the cellar, the base of the chimney is constructed of stone piers with brick arch between them, designed to support back-to-back fireplaces above. This would have resulted in a large square chimney above the roof. The chimney placement is indicative of New England influence. The house rests on a foundation of native fieldstone with mud-packed joints.

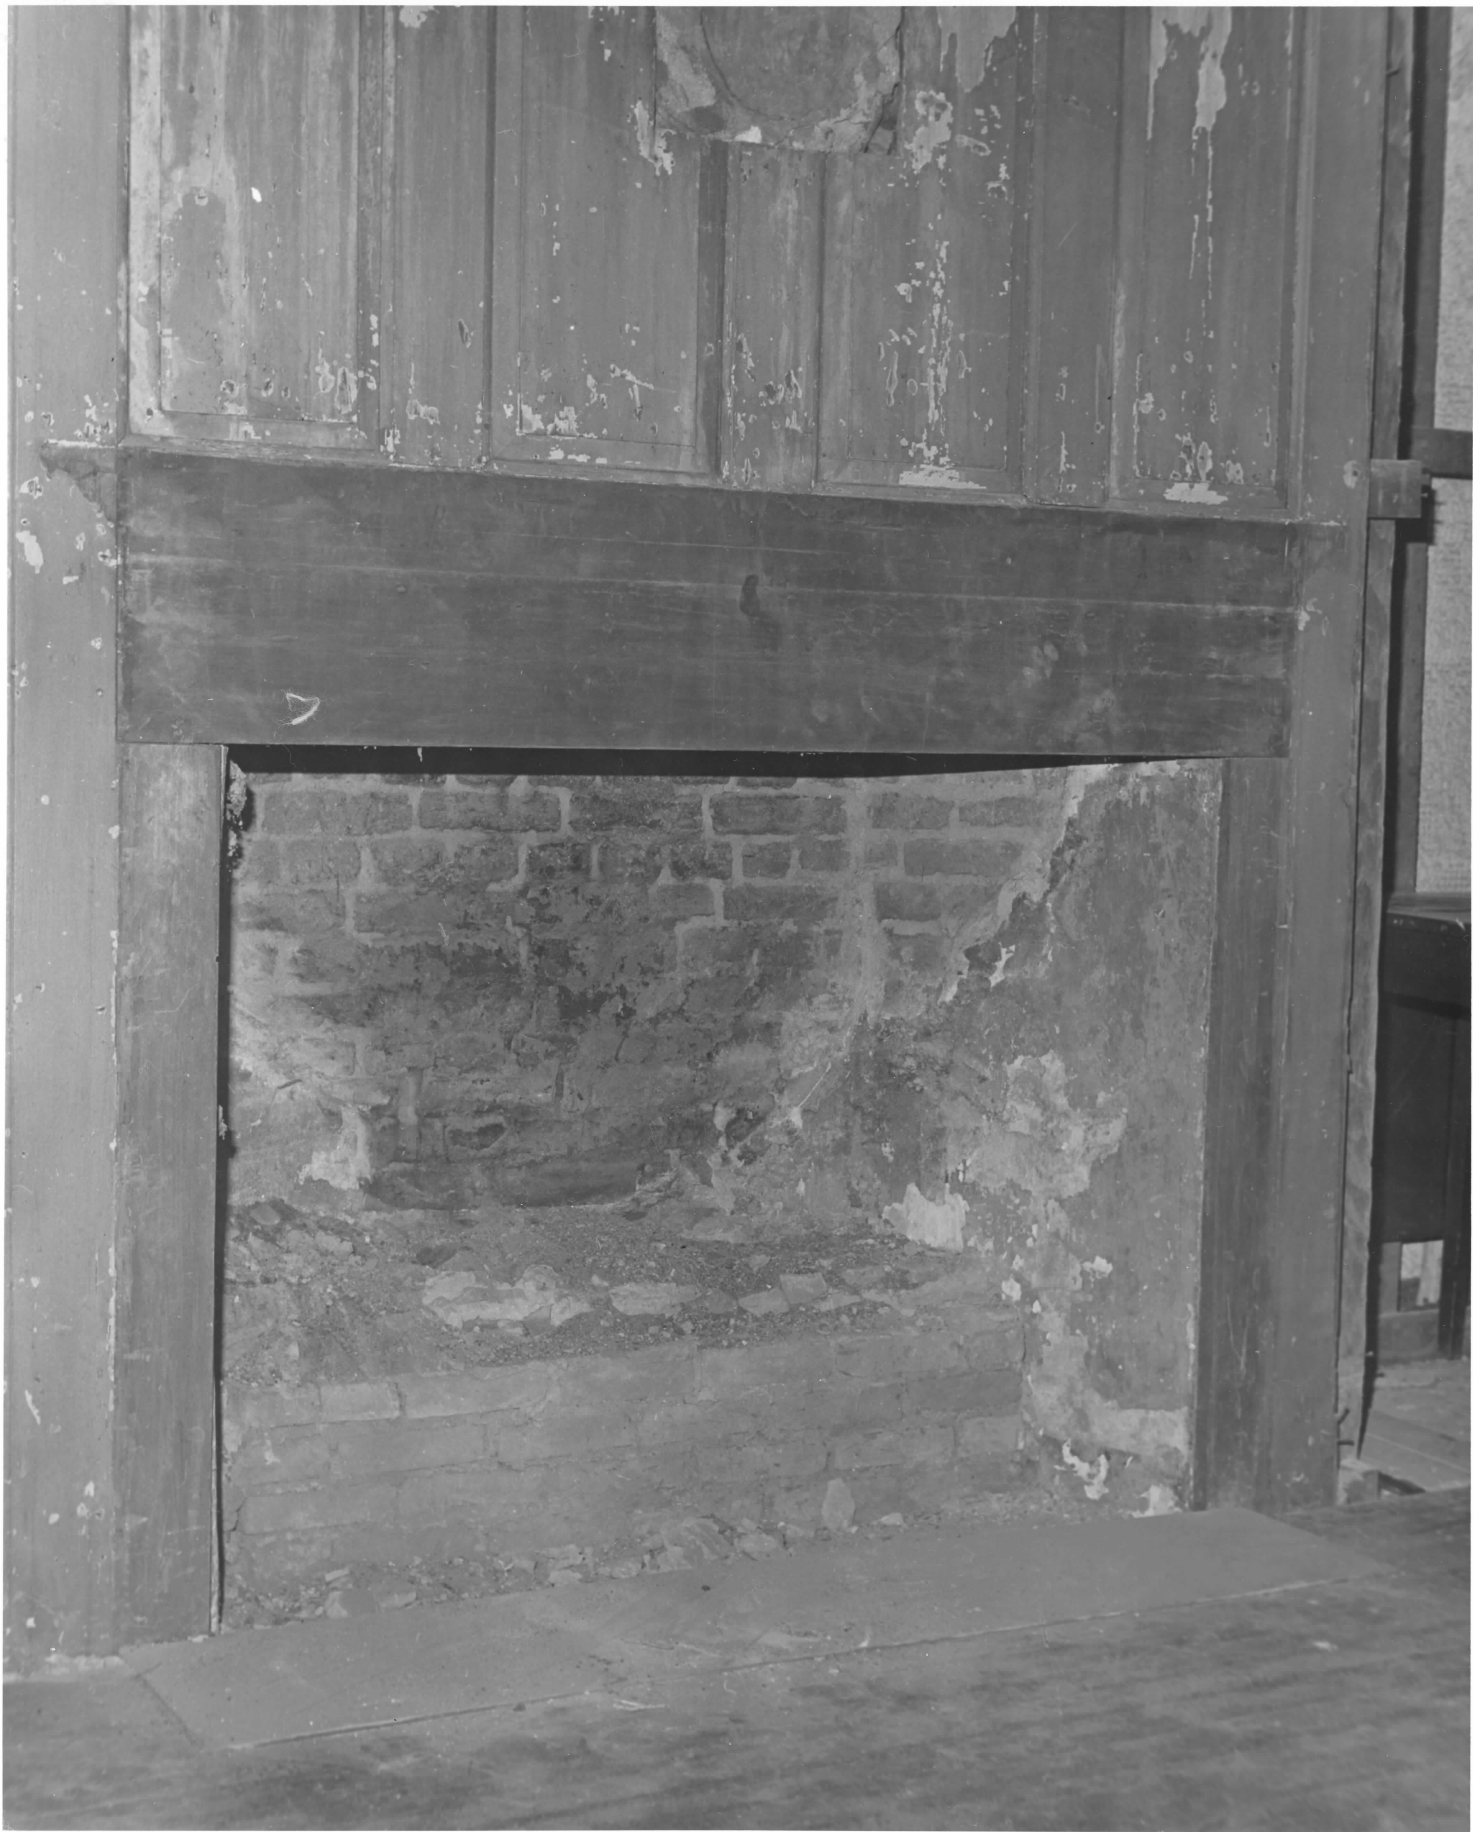
6 of 6.

INTERIOR VIEW- Parlor fireplace with original raised field paneling on chimney breast.
