National Register of Historic Places Inventory—Nomination Form

historic Edgerley

street & number 9303 Creek Road not for publication

state New York code 036 county Livingston code 051

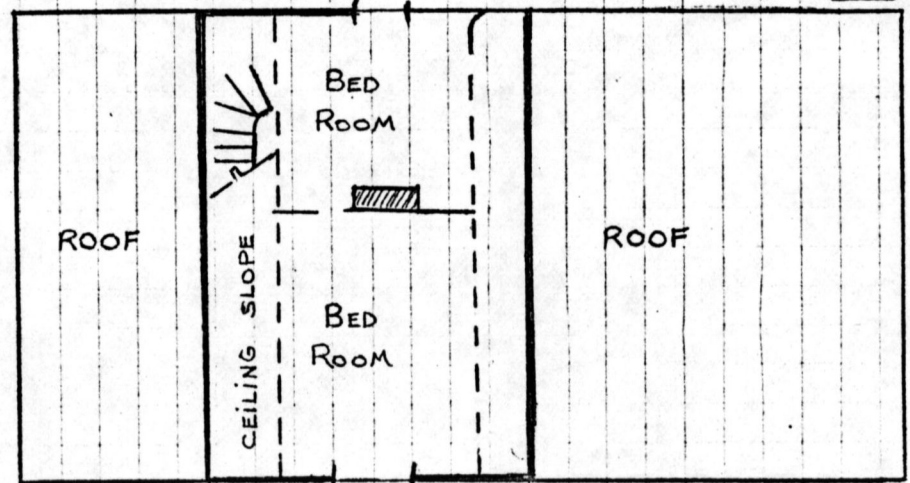
ILLUSTRATION #3

FIRST FLOOR

EDGERLEY
 "Box Hill"
 Town of Portage, *OAKLAND VIC*
 Livingston County
 New York
 Date: 1979

SECOND FLOOR

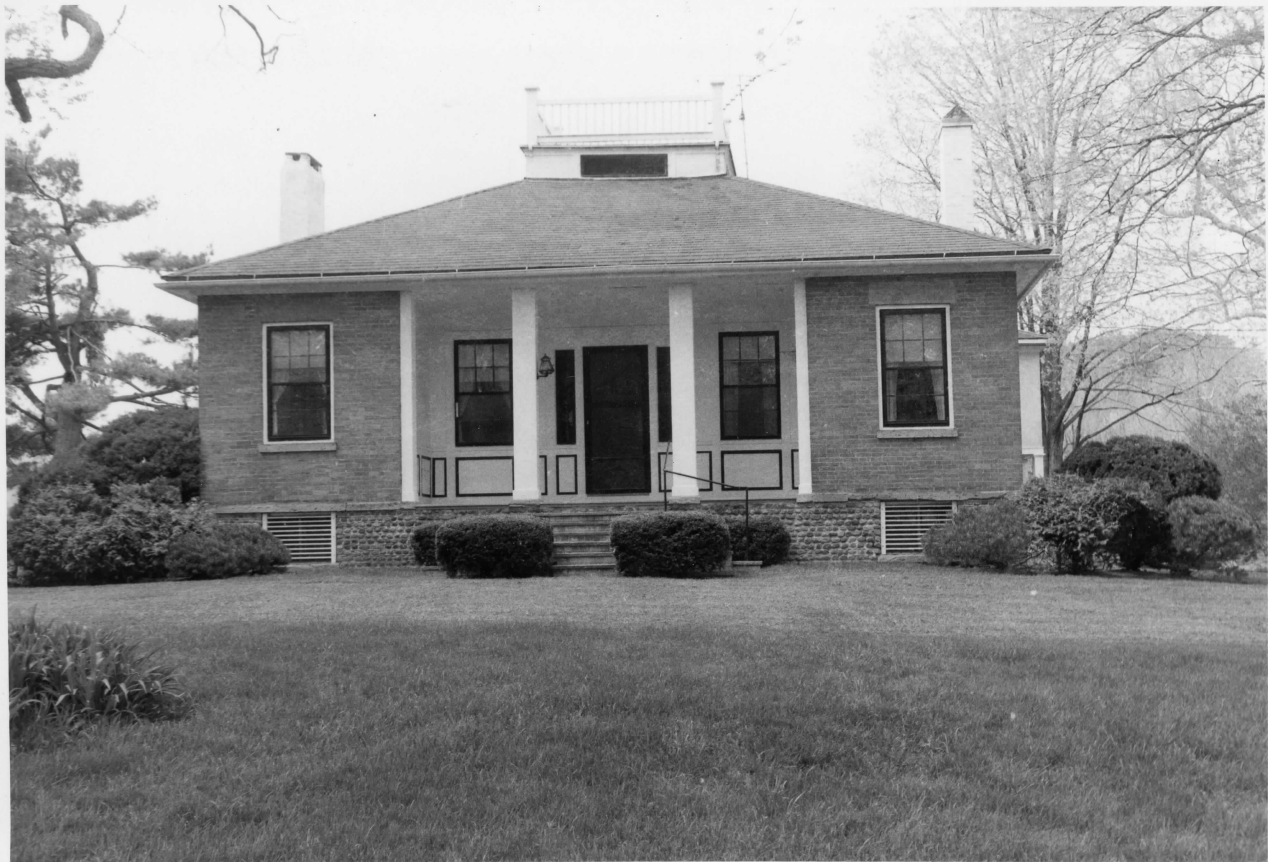
Photograph # 1/20

Description: Main house, original 1828 section: east facade.
(looking west) showing raised foundation, in-antis
porch and belvedere.

The one and one-half story original house has a five-bay facade with a raised basement, an in-antis porch and six over six double-hung windows. The two outer bay windows have stone lintels and sills. A center, three-bay, in-antis porch with square columns and pilasters shelters the main entrance. Square pilasters frame the side-lighted, two-paneled door. A paneled wainscot extends along the porch walls beneath the windows and sidelights. Single chimneys flank the north and south sides of the hipped roof. The south chimney is projected with stepped brickwork at its base (Photo #2). A belvedere with rectangular windows and a wooden balustrade crowns the truncated hip roof of the original house (photo #1).

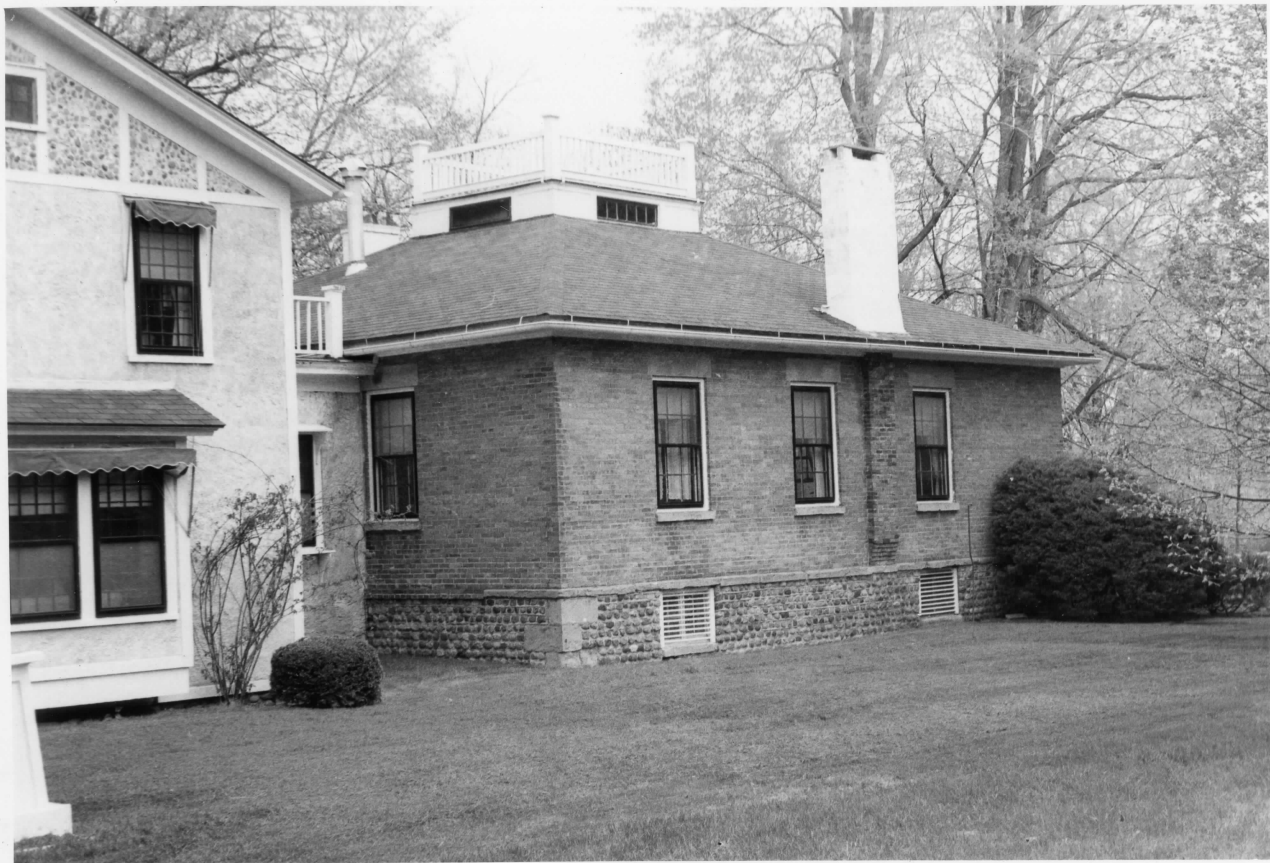
#2/20

Description: Main house, (looking northeast) showing from left to right, 1870 wing and one-story passageway, south elevation; 1828 original house on, south elevation.

Notice: (1870 wing) half-timbered gable

balustrade on passageway roof

chimney with stepped brick work base.

cobblestone foundation

The north and south elevations (sides) are three bays wide and contain double-hung, six over six windows which have stone lintels and sills. The western (rear) elevation is similar to the north and south elevations; however, the 1870 passageway obscures all but one of the original windows. (Photo #2).

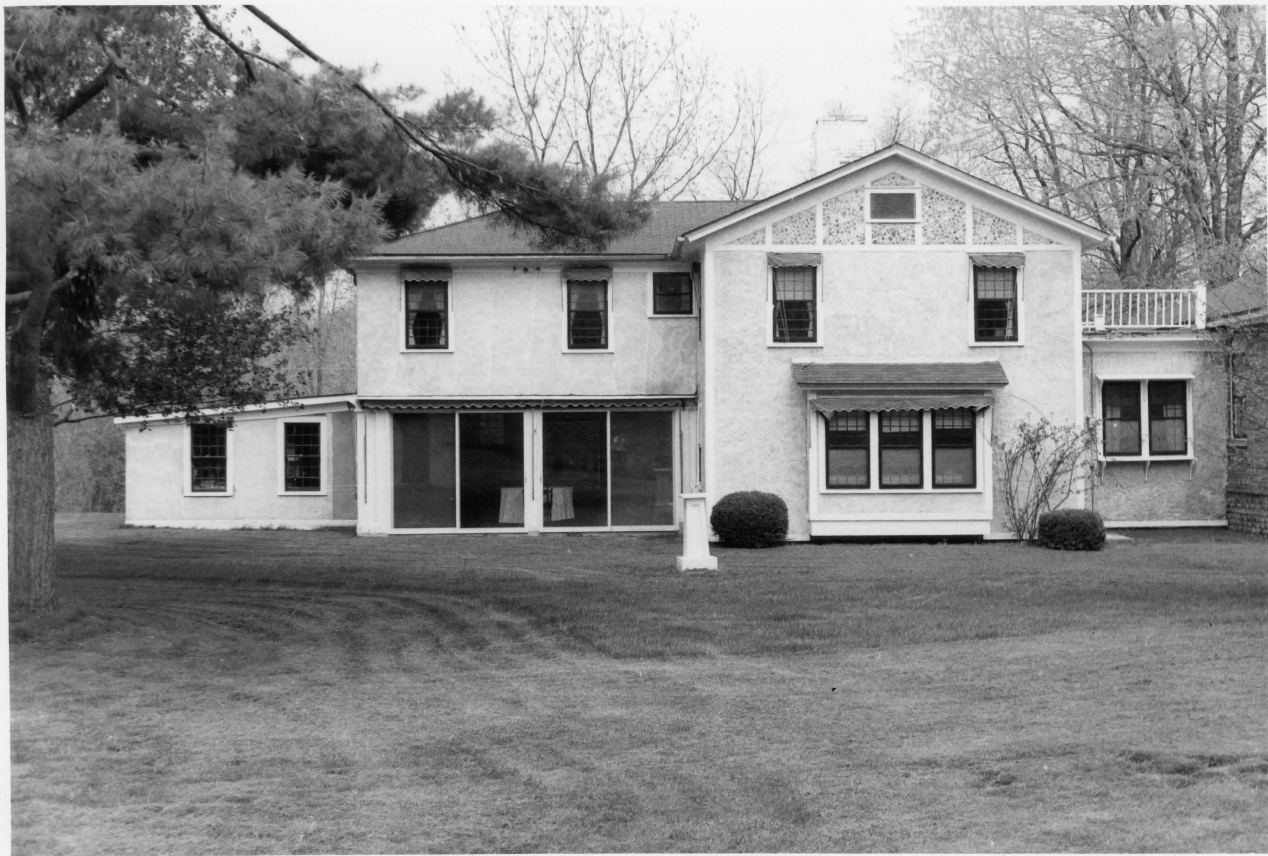
#3/20

Main building (looking north) showing (left to right) one-story garage, 1930 wing (with sliding glass doors), 1870 wing and one-story passageway; original 1828 house.

The middle section consists of a one-story passageway and a two-story wing. (Photo #3) The passageway has a flat roof topped with a wooden balustrade. A north entrance is covered by a small, shed-roofed porch with lattice-work sides (Photo #4). The two-story wing has a gable roof and sixteen over sixteen, double-hung windows. Both north and south elevations have half-timbered gables with small, rectangular windows above first floor, triple-windowed, projecting bays. A brick chimney straddles the ridge line of the roof.

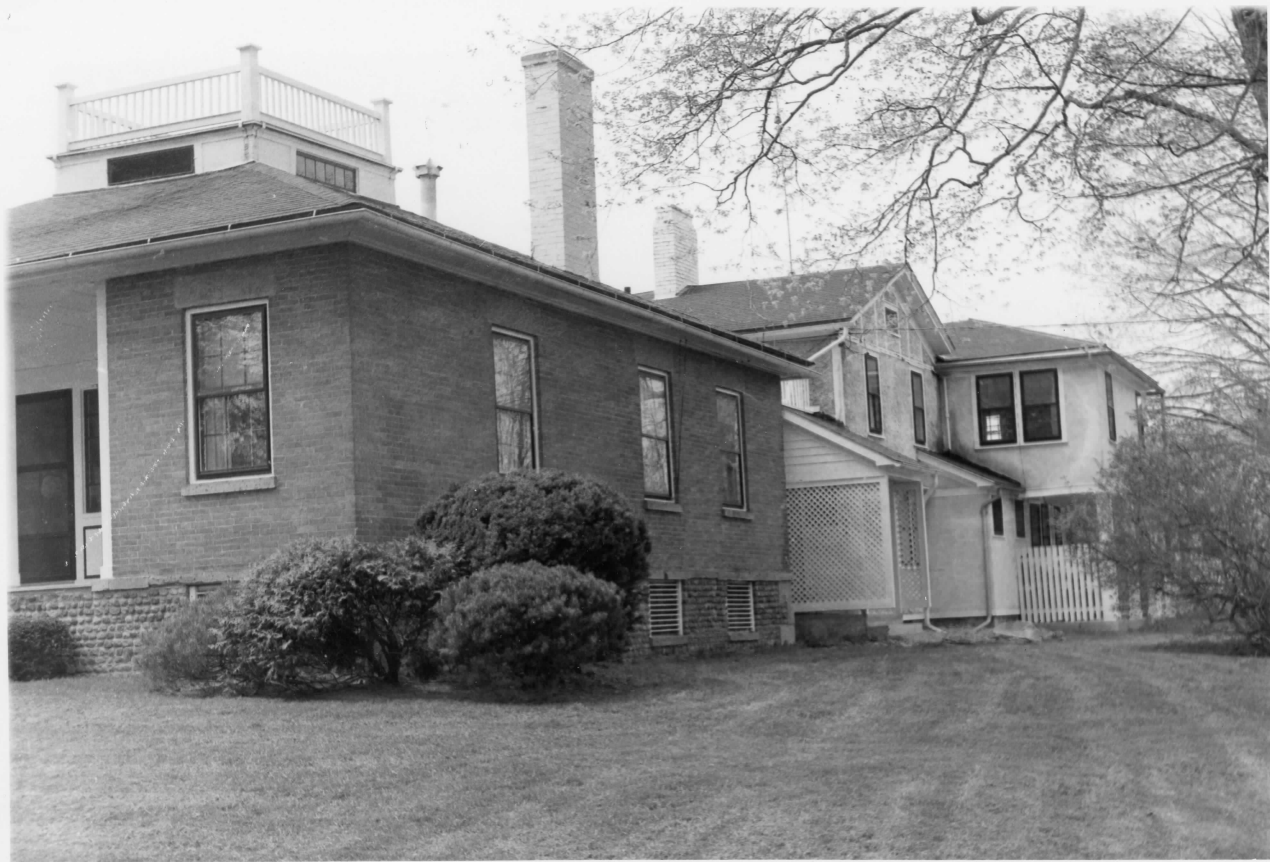
Photograph # 4/20

Main building, (looking south west)
showing (left to right):
1828 house, east facade
north elevation JUL 16 1980
1870 wing, north elevation (lattice-work porch
half-timbered
gable)
1930 wing, north elevation (recessed first
story porch)

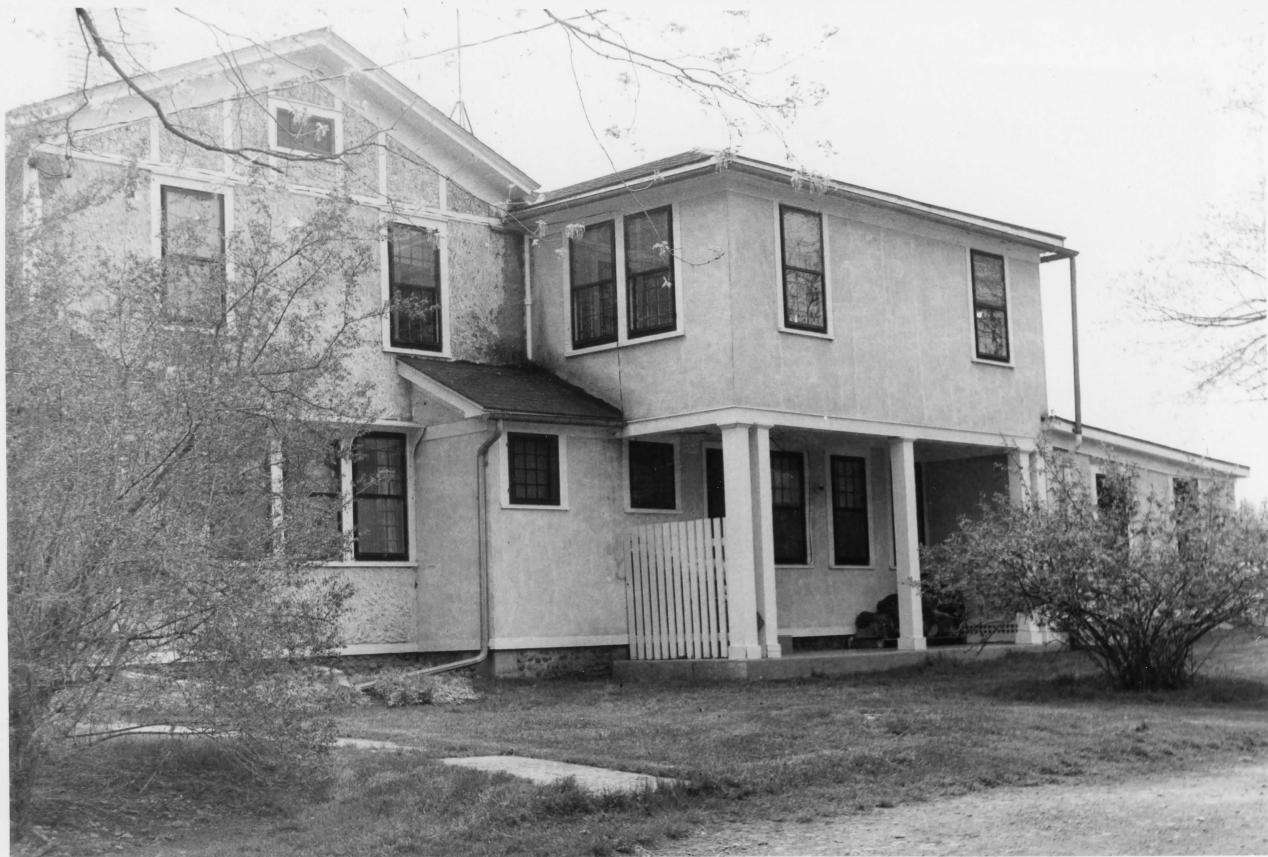
5/20

Main building ,(looking south west) showing left
to right:

1870 wing(half timbered gable)

1930 wing(recessed porch)

attached garage (one-story)

The rear section consists of a two-story wing and a one-story, attached double-car garage (Photos #5 & #6). The two-story wing has a hipped roof with deck on

the west side. The north elevation has sixteen over sixteen, double-hung windows and a first floor, recessed porch with square columns (Photo #5). The west elevation has four, second-floor French windows (Photo #6). The southwest corner of the first floor consists of six sliding-glass doors, which form the southern and western walls of the 1930 dining room (Photo #3 & #6). The one-story garage, attached to the rear of this last wing, has four, sixteen over sixteen, double-hung windows in the style of the additions (Photo #6).

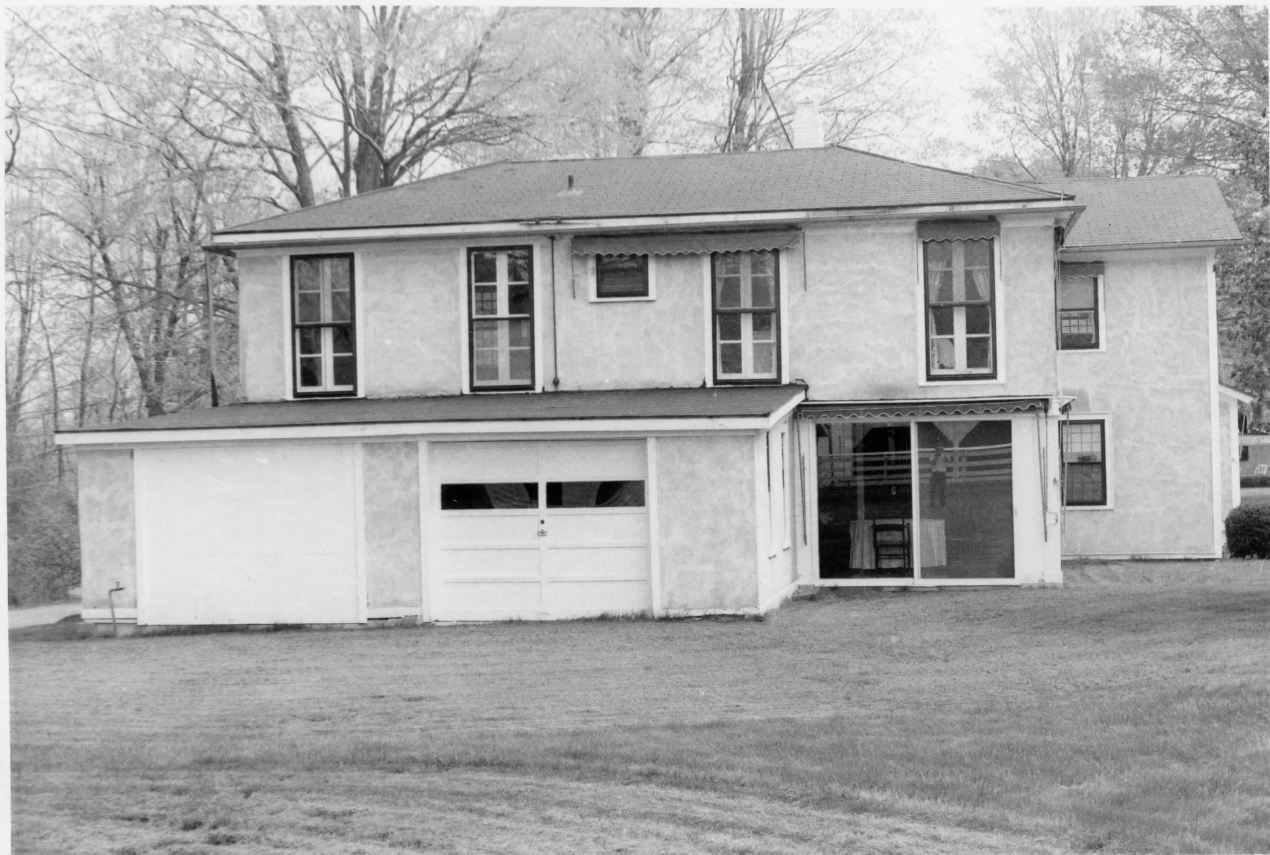
Photograph # 6/20

Main Building, looking east, showing left to
right:

1930 wing(attached garage, sliding glass doors)

1870 wing (gable roof, extending to right)

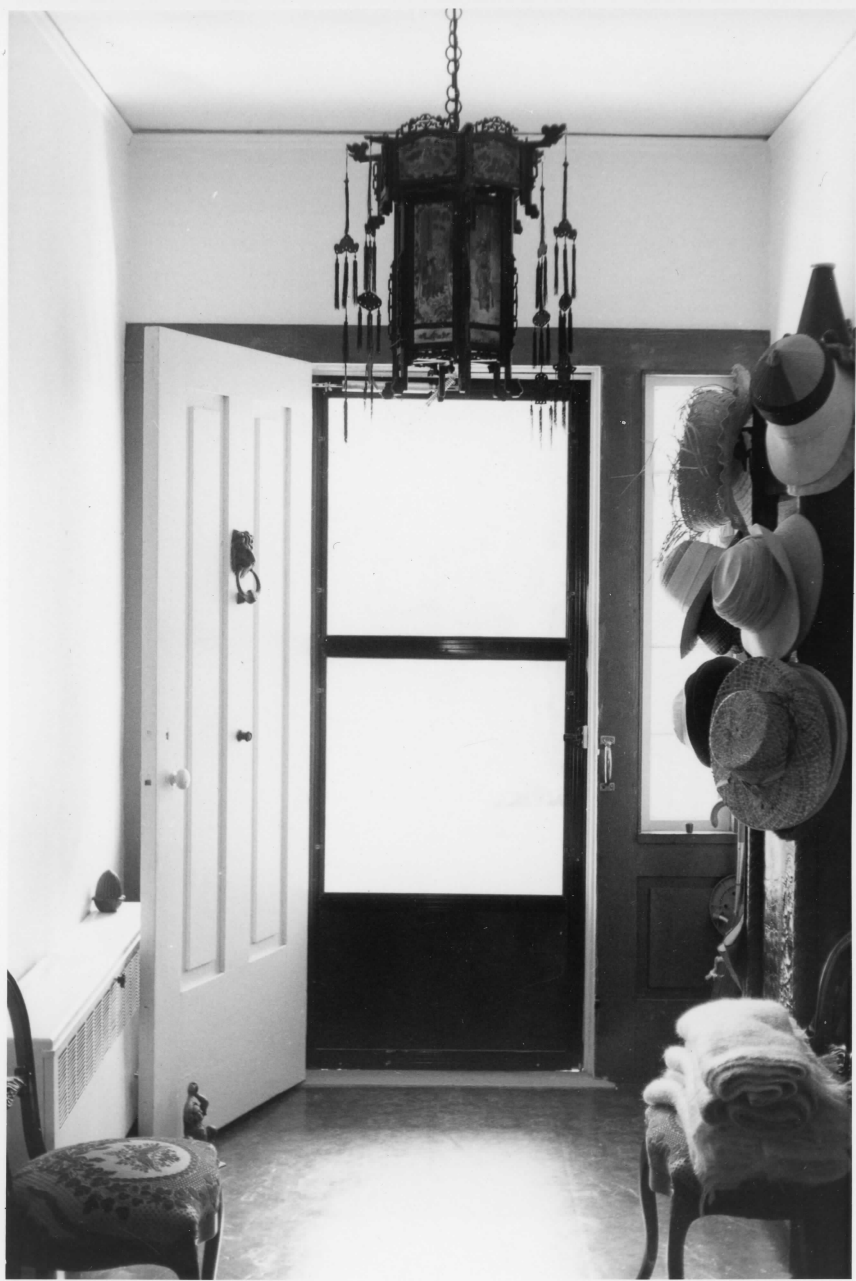
7/20

Main : 1828 section, main entrance, looking east.

Building: Notice two-paneled door, sidelights, paneled
wainscotting under sidelights.

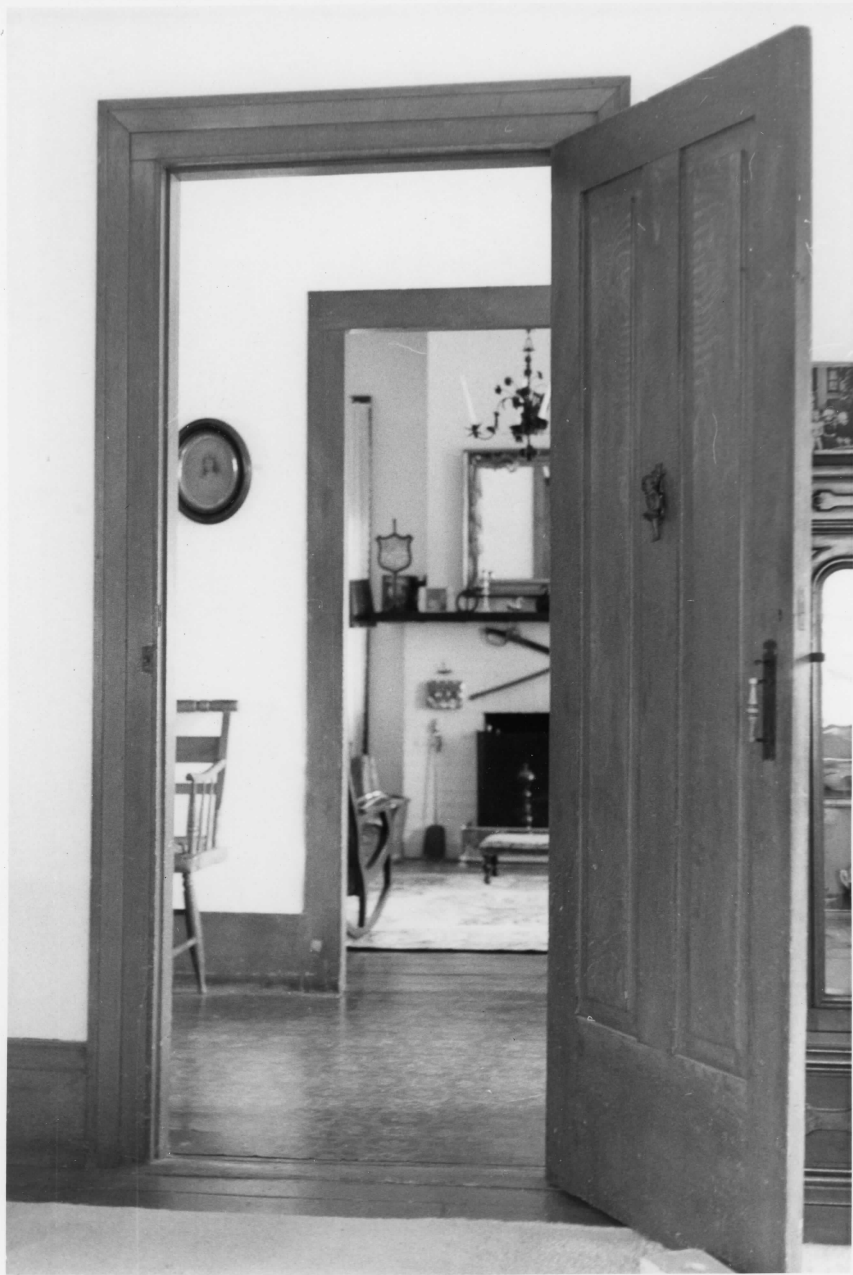
8/20

Main Building, 1828 section looking north
View from Master Bedroom looking across hallway
in Sitting Room. Notice: wood grained door,
fireplace.

The four-room interior of the original house has simple architrave moldings on doors, windows, archways, and baseboards (Photo #8). One-paneled wainscotting extends beneath the two sidelights by the main entrance (Photo #7). All of the interior two-paneled doors are oak with painted wood graining which appears to be original (Photo #8). A painted brick fireplace with a simple wooden mantle is located on the north wall of the sitting room. The floors are constructed of wide pine boards. The walls are plaster finished. In the north wall of the basement, the original brick fireplace with baking oven is set above a brick floor (Photo #9).

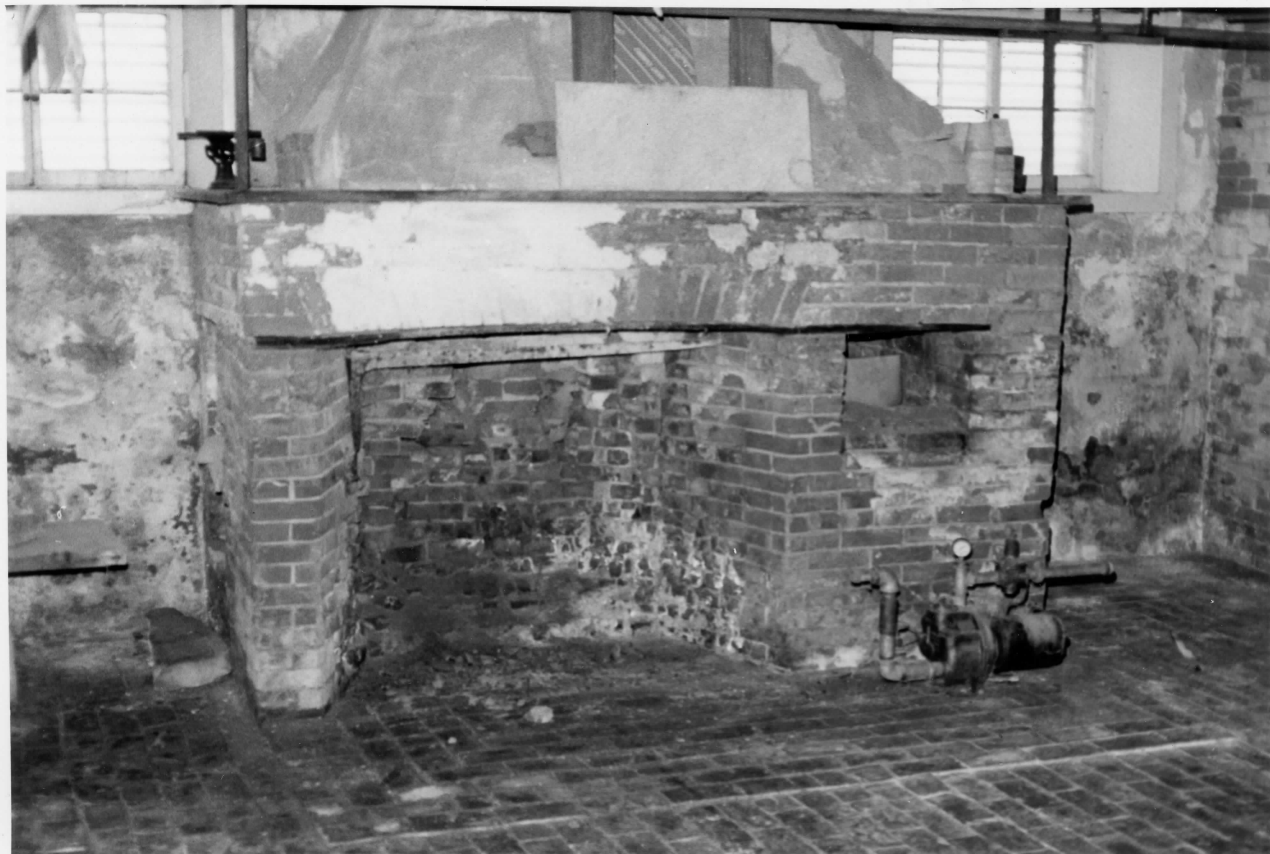
9/20

INTERIOR, Main House, 1828 section
North Wall, basement (looking north
Original fireplace and baking oven.

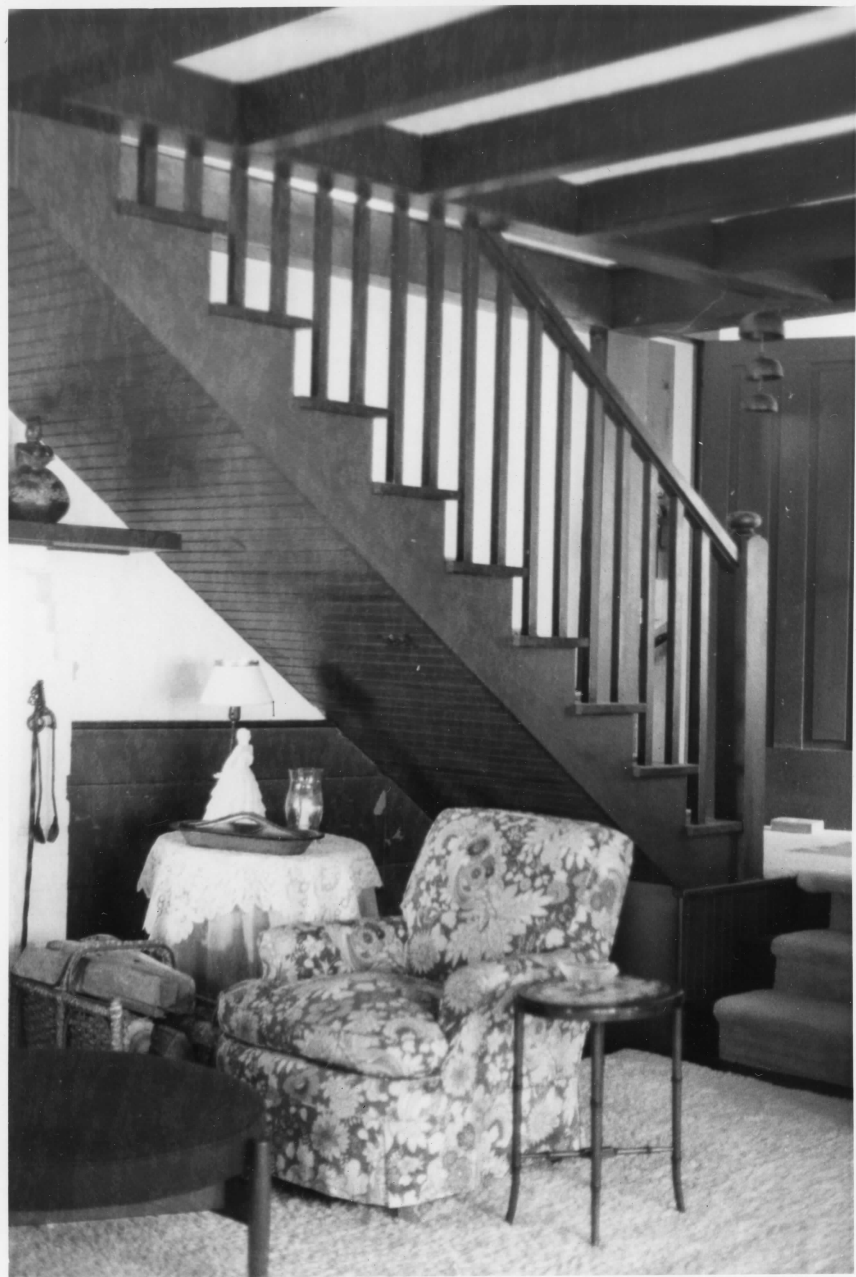
DESCRIPTION: INTERIOR, Main House, 1870 wing (looking north east)
Living Room, main staircase, fireplace

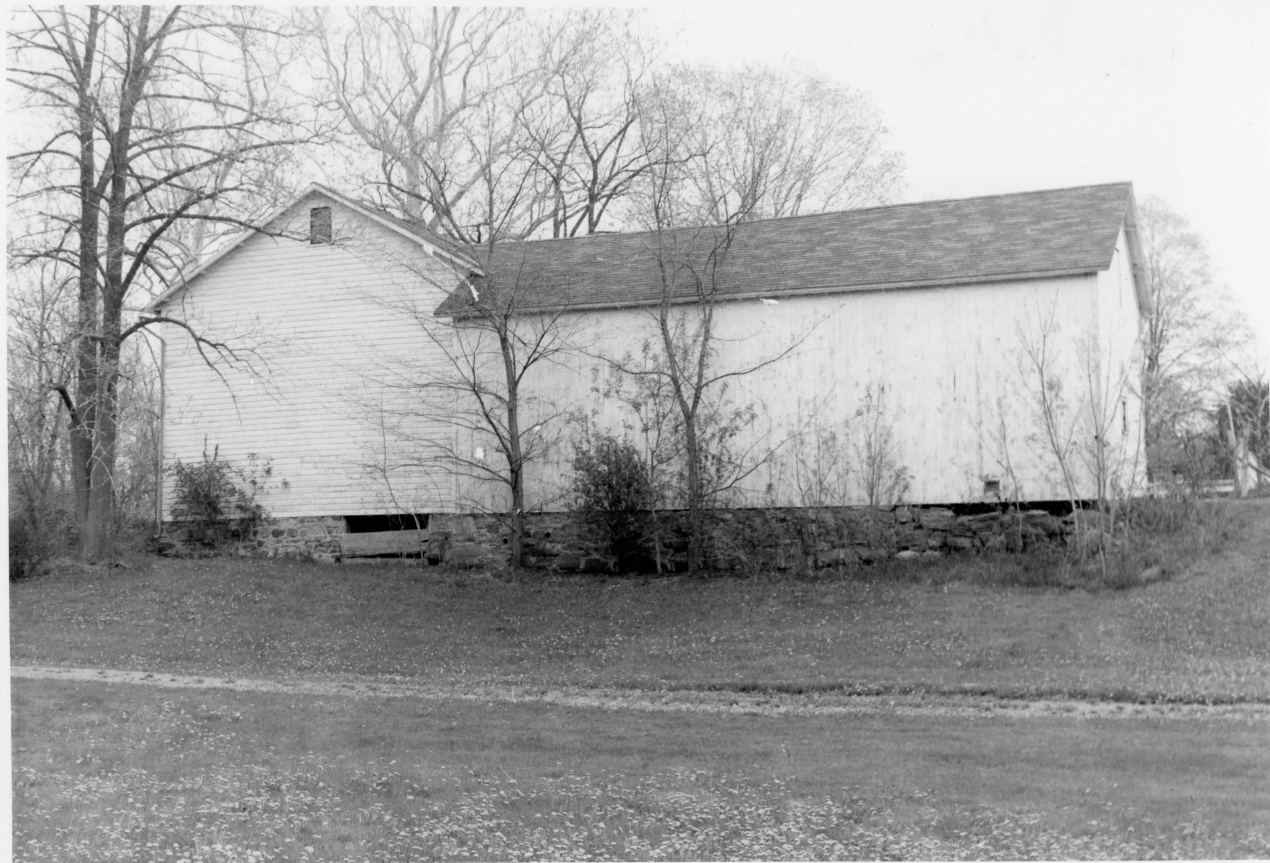
Photo #13/20

DESCRIPTION: 1830 Barn complex, looking east.
west facade.

The large, L-shaped barn and machinery shed complex is located west of the main house (Photos #12 & #13). It was built after 1830 and is constructed of clapboard with a gable roof. The north and south elevations each have two doorways with sliding, double doors. The attached two-story shed is constructed of vertical

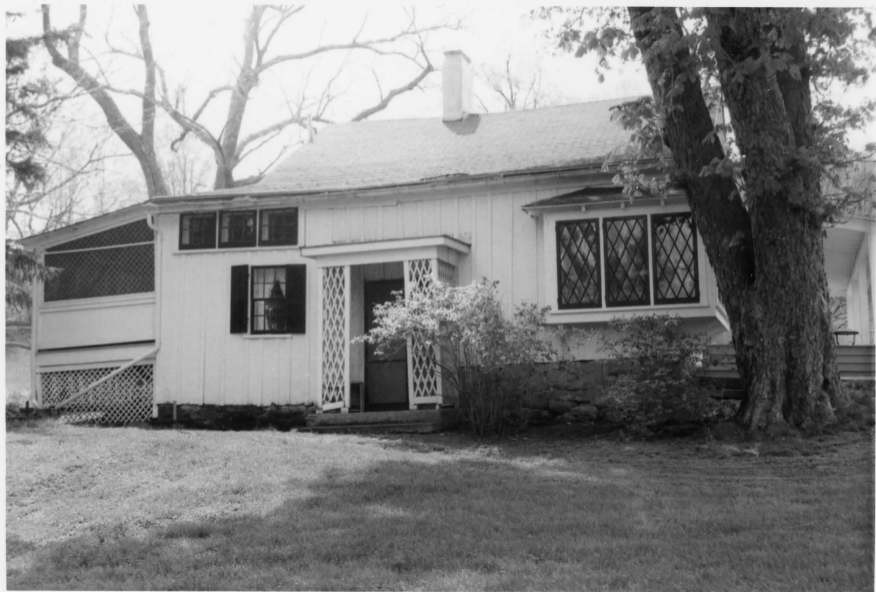
DESCRIPTION: Box Hill (Looking south)

To the east of the main house, at the eastern edge of the front lawn, is "Box Hill," and a small, vertical board, early nineteenth century barn (photo 18), and the swimming pool. The central, one and one-half story section of "Box Hill" is wood frame with a gable roof and rubble stone foundation (Photo #14). A central brick chimney straddles the ridge of the roof. This central section is believed to date from 1815-20, although it has undergone considerable additions and alterations. The facade and west elevation are sided with vertical board and batten, while the east and south elevations are finished with horizontal wood clapboard. The cottage has six over six, double-hung windows with only two exceptions: a casement-windowed bay on the northwest corner of the cottage and a small, three-windowed panel located near the roofline of the facade.

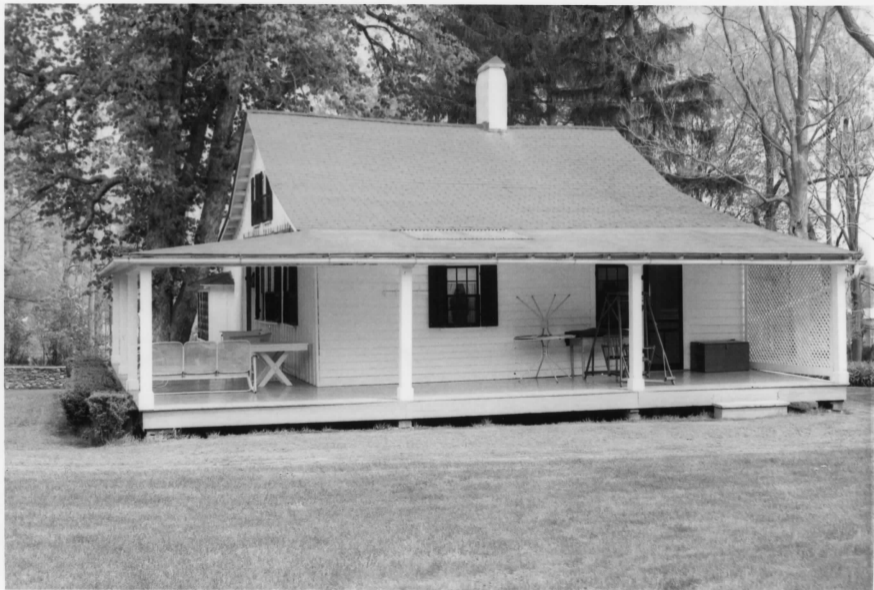
Photo # 16/20

DESCRIPTION: BOX, HILL South Elevation(looking north)

and a lattice-sided, flat-roofed entry porch on the facade (photos 15-17).

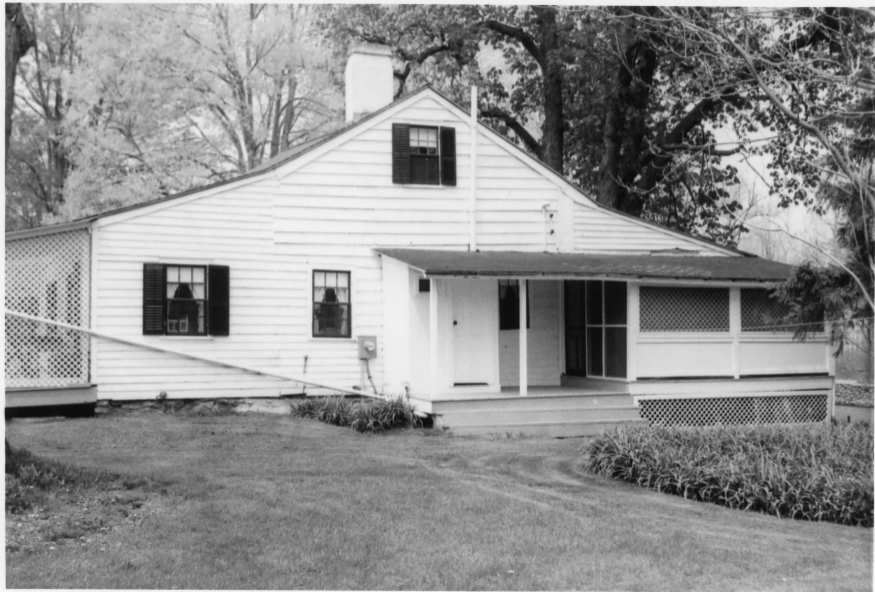
Photo # 17/20

DESCRIPTION: BOX HILL, East Elevation
(looking west)

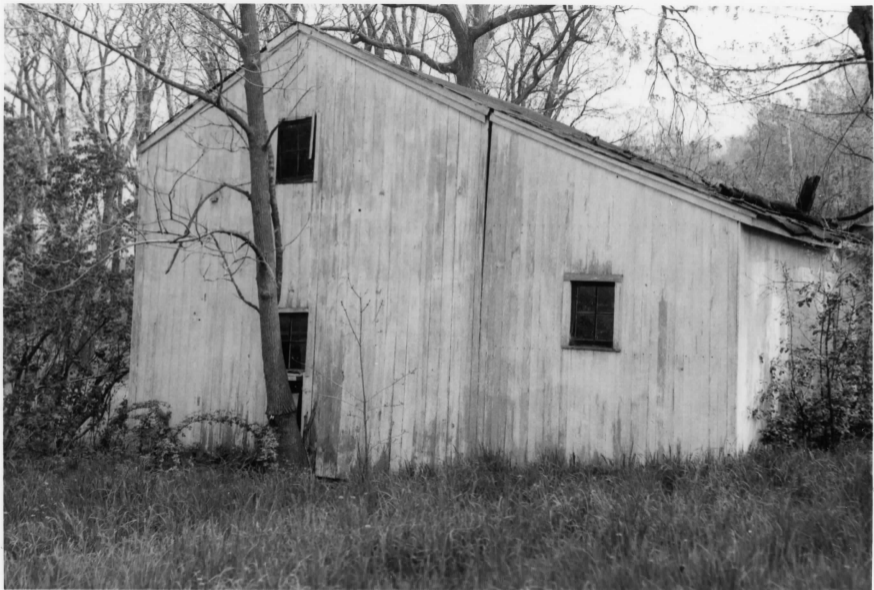
DESCRIPTION: WEST ELEVATION, Old Barn (east of Main
House)
(looking east)

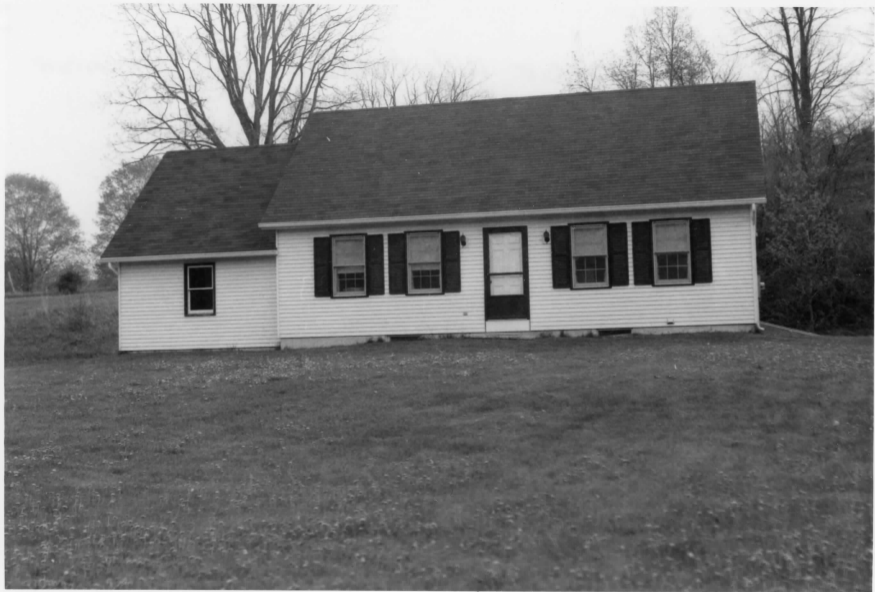
Photo #19/20

DESCRIPTION: Gardener's Cottage
(looking east) west facade

The swimming pool, located northeast of the main house, was first installed in 1919 and completely rebuilt in 1969. In 1964, a one and one-half story, frame gardener's cottage was constructed to the southwest of the main house (photo 19). The pump house, located south of Keshequa Creek, was built in the 1960's, and is a small square shed constructed of vertical board siding.

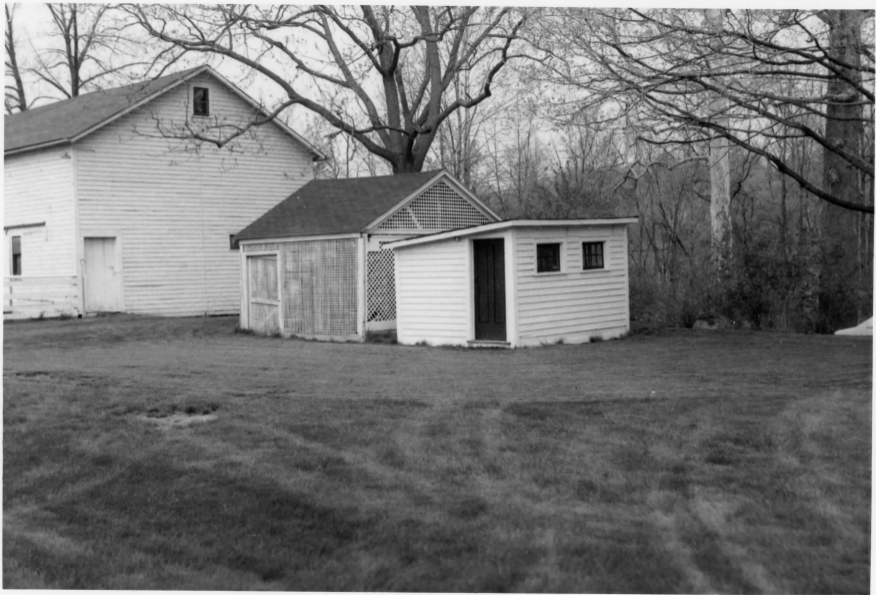
DESCRIPTION: (looking north west)
