National Register of Historic Places Inventory—Nomination Form

Type all entries—	-complete applicable se	ections	April 1		es - Martine Res	400 20
1. Name	9		A service for		erro lettelo - etlanes	768 2 Zi
historic C	Central Savings Ban	k	a roner		8 00 3 000 6	n onto al
and/or common	Apple Bank for Sa	vings		ni in in path	riasi juloš

Central Savings Bank
Continuation sheet New York County, NY

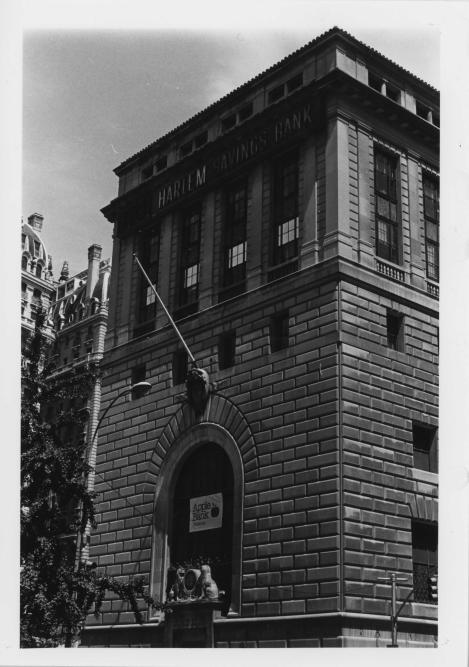
73rd Street facade, view northwest.

The Central Savings Bank is located just north of the triangular Verdi Square in a congested commercial and residential section of Manhattan's upper west side. Built in 1926-28, the structure was designed by Benjamin Moscowitz of York & Sawyer in the manner of a grand Italian Renaissance palace. The tapezoidal building follows the shape of its site, which is located at the intersection of Broadway and Amsterdam Avenue.

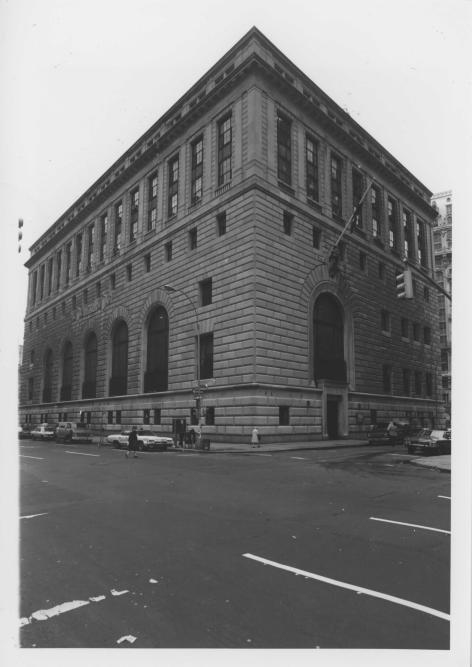
View from the northeast

Although each side of the building shows a different fenestration pattern, a continuity of design is maintained through the clear division of the rusticated walls into a base, two middle sections, and an attic story. A full story high, the base is surmounted by a torus molding and pierced by entrances on the west, south, and north elevations. The entrances are framed by heavy stone architraves with denticulated cornices. The south, 73rd Street, entrance is crowned by two stone lions flanking a clock. The western, Broadway, wall is designed as the principal facade, with three tall, centrally located, arched windows lighting the interior banking room. A row of 14 small, rectangular windows appears above the arched windows. Separated from the lower floors by a molded string course, the fourth and fifth stories are incorporated as one in a loggia-like composition that alternates Doric pilasters with 14 balustraded windows. The vertically paired windows are separated by iron spandrels. This composition is repeated on all elevations and differs only in the number of bays. The lower portion of the southern wall is pierced by a single, massive arched doorway and window. Four bays define the upper portion. The eight-bay, north elevation has a large single arch located on the left side of the wall. Five arched windows pierce the east wall. A modillioned cornice crowns the bank, while a classical attic with paired windows and flanking pilasters rises above. The attic is surmounted by a hipped, tile roof. Exterior ornament includes decorative stone plaques with carved mottos, intricate wrought-iron window grilles capped with gargoyle heads, and lanterns that flank the entrances. All of the ironwork was executed by the studio of Samuel Yellin of Philadelphia.

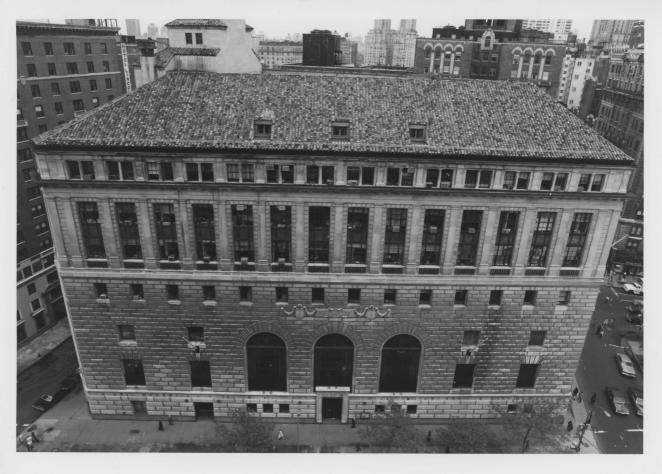
View from the west

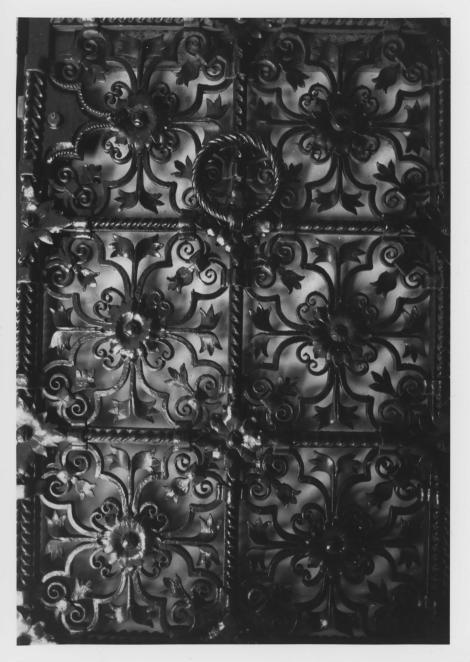
Ironwork detail

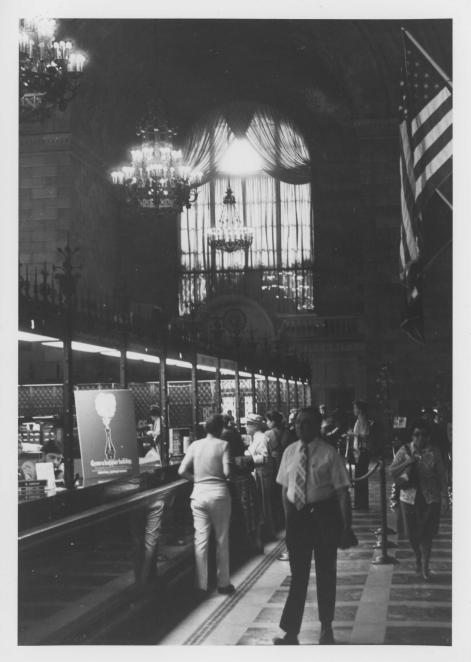
Interior

The bank has elaborate interiors, dominated by a two-story banking room. Here, honey-colored stone piers rise to a soaring, coffered, barrel-vaulted ceiling. Marble mosaic floors, marble wainscot, intricate wrought-iron and bronze grilles, and magnificent chandeliers contribute to the overall effect of splendor, wealth and tradition.
