**National Register of Historic Places
Inventory—Nomination Form**

historic Studio Apartments

street & number 44 West 77th Street _____ not for publication

STUDIO APARTMENTS

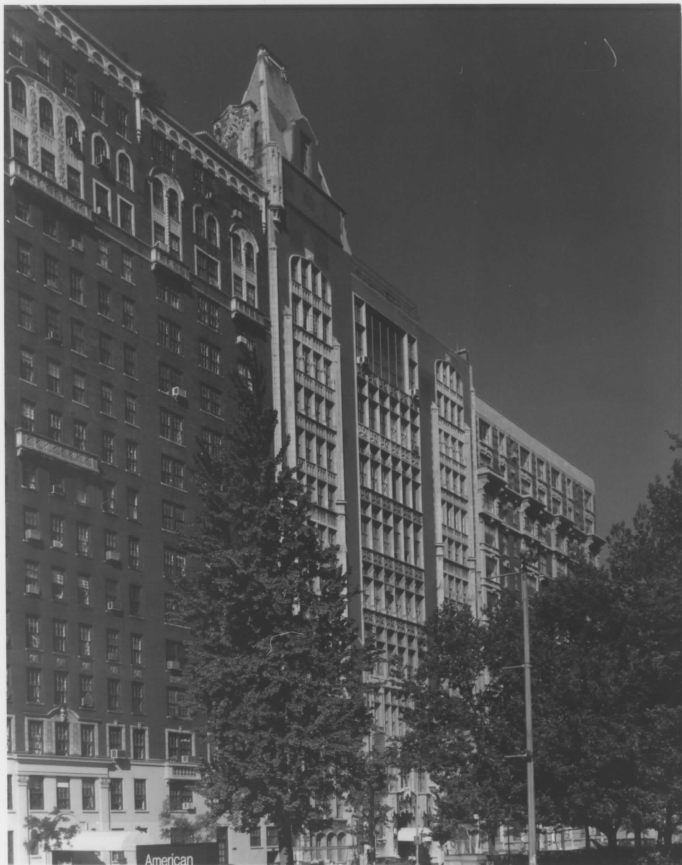
1. Studio Apartments
44 West 77th Street
New York County, *New York*

View from Northeast

The Studio Apartments is located on the south side of West 77th Street between Central Park West and Columbus Avenue on the upper west side of Manhattan. Designed by Harde & Short in 1907, the building is 100 feet wide on West 77th Street and 102 feet deep. It is fourteen stories tall and constructed of red brick with limestone trim. The flat brick wall of the building is enlivened by three sections of many-tiered window bays separated by finely detailed spandrel panels. These double-tiered windows are an expression of the two-story-high artists' studios behind them. Full advantage was taken of the north light provided by the open square in front of the building occupied by the Museum of Natural History. The center section of the facade is flanked by window bays with ribbed enframements, which terminate below the top two stories of the building. A steep roof with domers crowns the left bay.

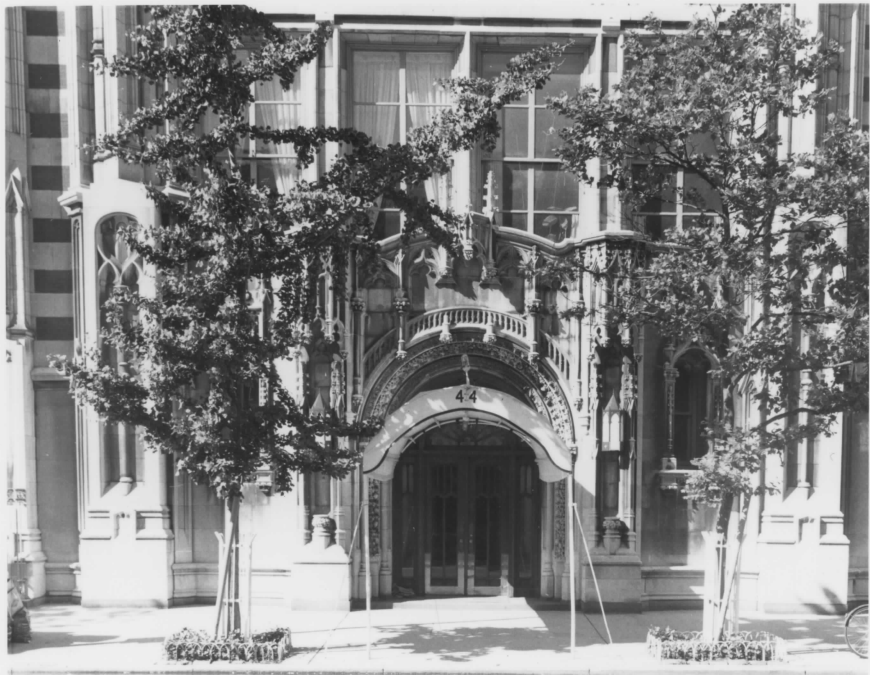
2. Studio Apartments
44 West 77th Street
New York County, *New York*

Detail:entrance

The doorway is set in a richly carved and elaborately framed arch. The windows flanking this entranceway have been treated as recessed niches and are crowned by pinnacled caps. Two buttresses frame the doorway and windows and step in as they rise three stories. The roof of the building originally featured an elaborate Gothic style pediment, crocketed pinnacles, and a turret with a tent roof spire. These elements were removed in the 1940's when it was discovered that the mortar bonding some of the exterior ornaments had begun to deteriorate.

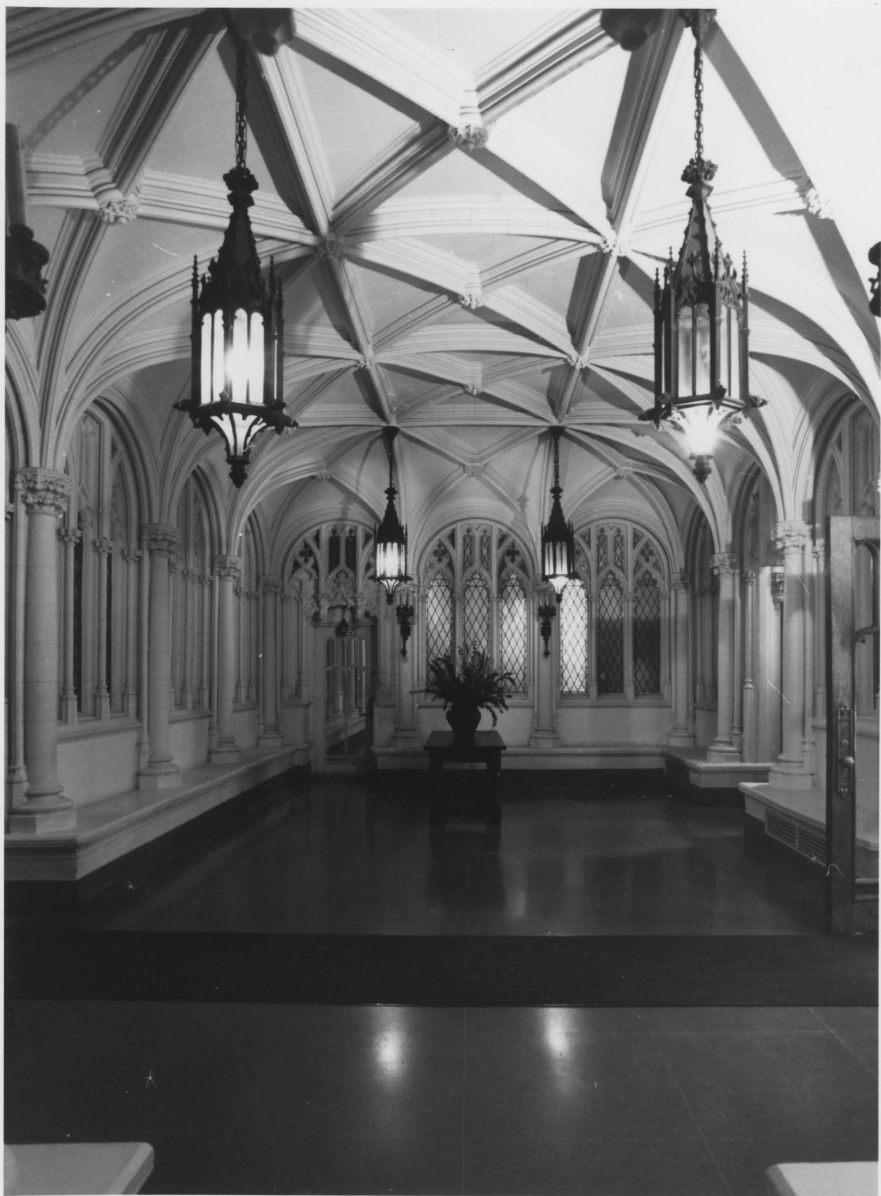
3. Studio Apartments
44 West 77th Street
New York County, *New York*

Lobby

The lobby of the Studio continues the Gothic motifs. It is divided into three rooms featuring groin vaulting which springs from slim engaged columns flanking the interior doorway and windows. The round-arched lobby doors and windows have limestone enframements and the delicate tracery design of the lead-paned windows is repeated in the transom of each doorway.
