**HISTORIC AND NATURAL DISTRICTS
INVENTORY FORM**

1. NAME OF DISTRICT: 14: Cooper Ave.^{n⁴e} Row *Historic District*
2. COUNTY: Queens TOWN/CITY: New York City VILLAGE: _____
3. DESCRIPTION: see attached 6434--6446 Cooper Ave.

Historic Resources of Ridgewood, New York, Queens County

Cooper Avenue Row Historic District
(Ridgewood MRA)
Queens County
NEW YORK

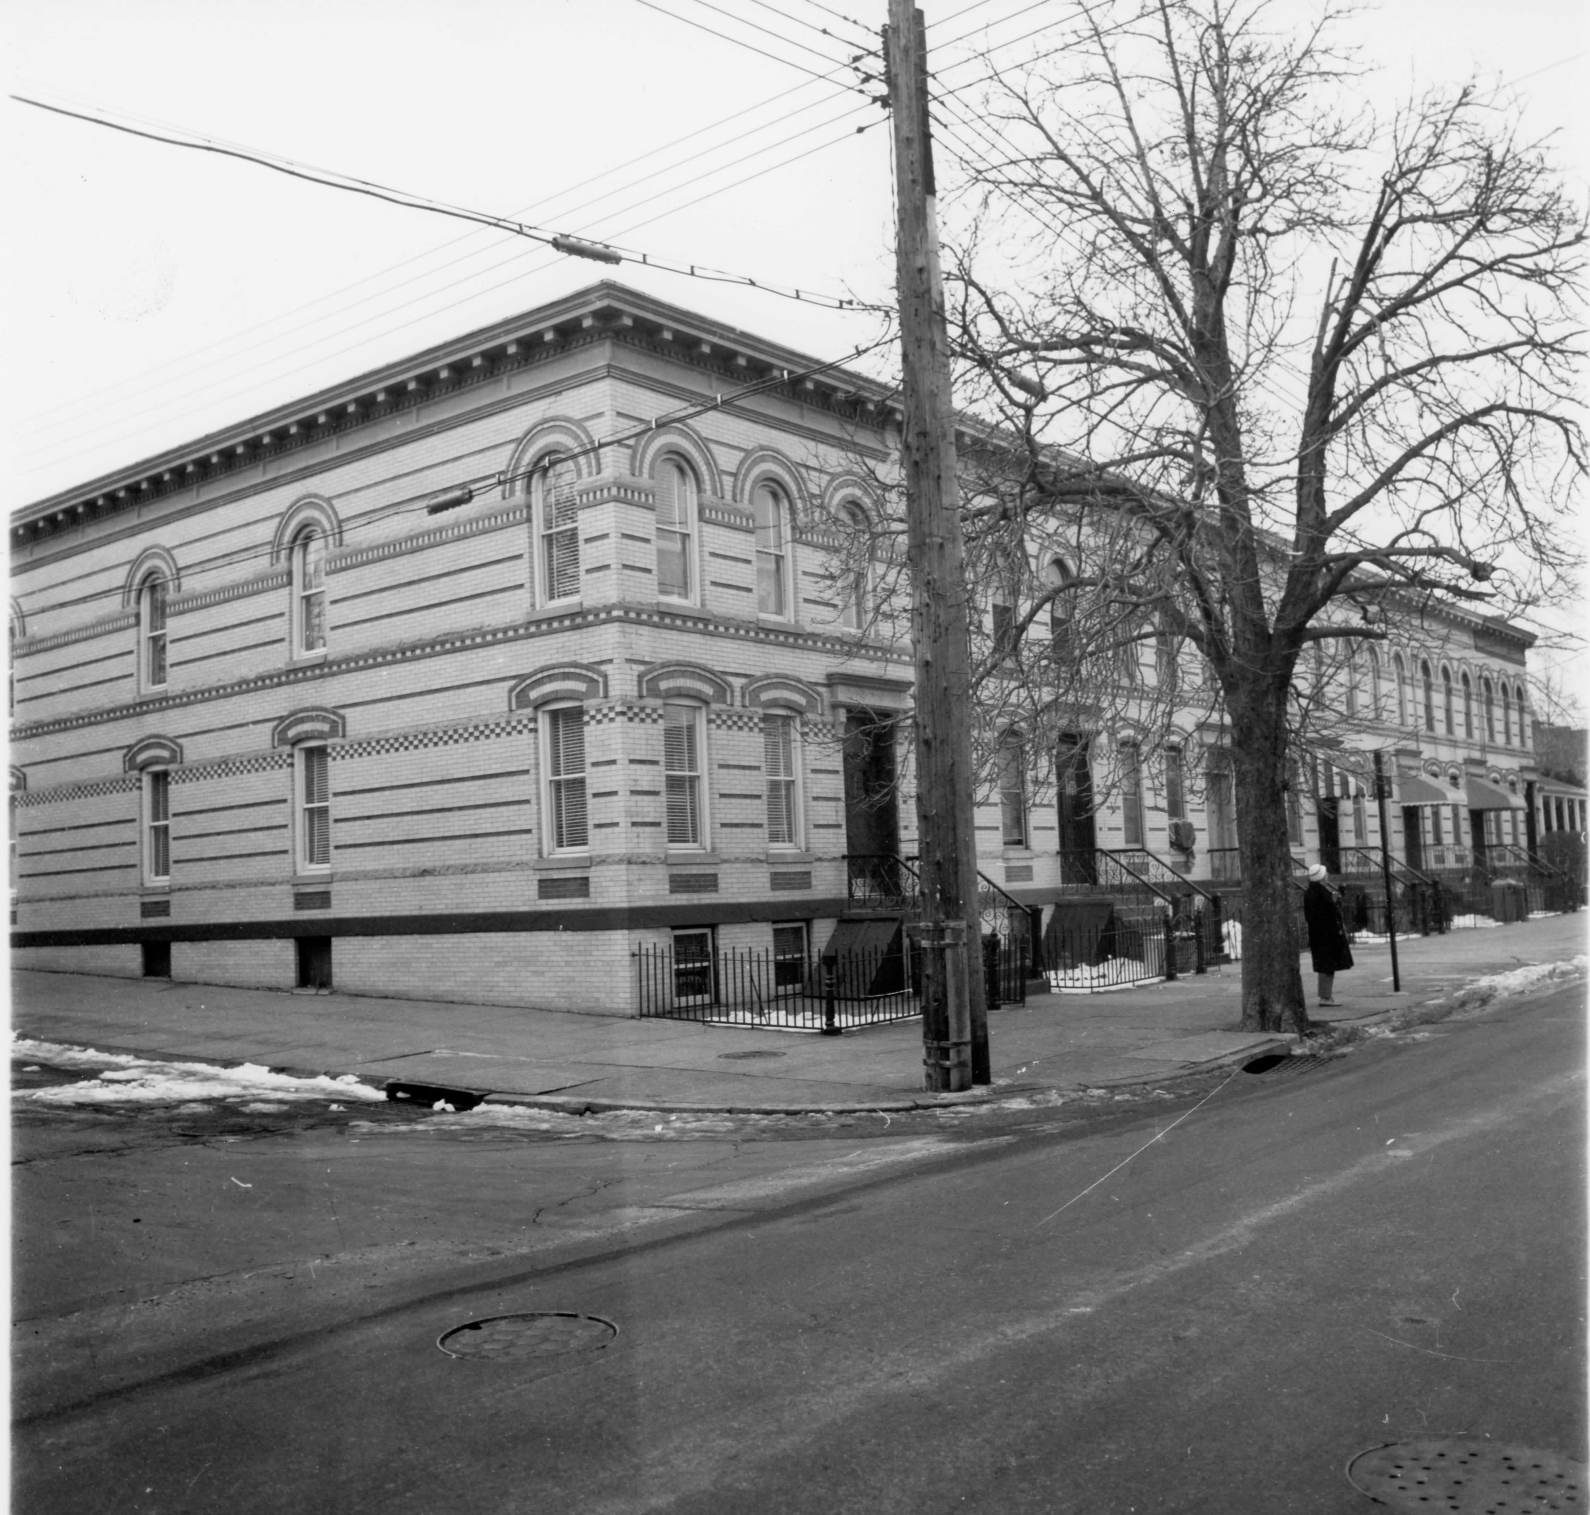
Photo #43

The Cooper Ave. Row (photo 43) consists of seven structures that lie along Cooper Ave., between 64th Pl. and 64th La. The row, which covers approximately $\frac{1}{2}$ -acre, contains two-story row houses, built in 1915, with flat facades and one apartment per floor. The buildings are characterized by simplified Romanesque and Renaissance Revival style detailing. The row's boundaries were drawn to exclude the surrounding frame and detached houses, and other buildings that are not in keeping with the architectural character of the row. The boundaries of the row are those delineated on the accompanying map.

Direction of View: West along Cooper Ave
toward 64th Pl.

The Cooper Ave. Row remains largely intact. Typical alterations include replacement doors and windows, and the addition of metal awnings over the entrances. There are no non-contributing buildings in the district. An annotated list of buildings included in the district follows.

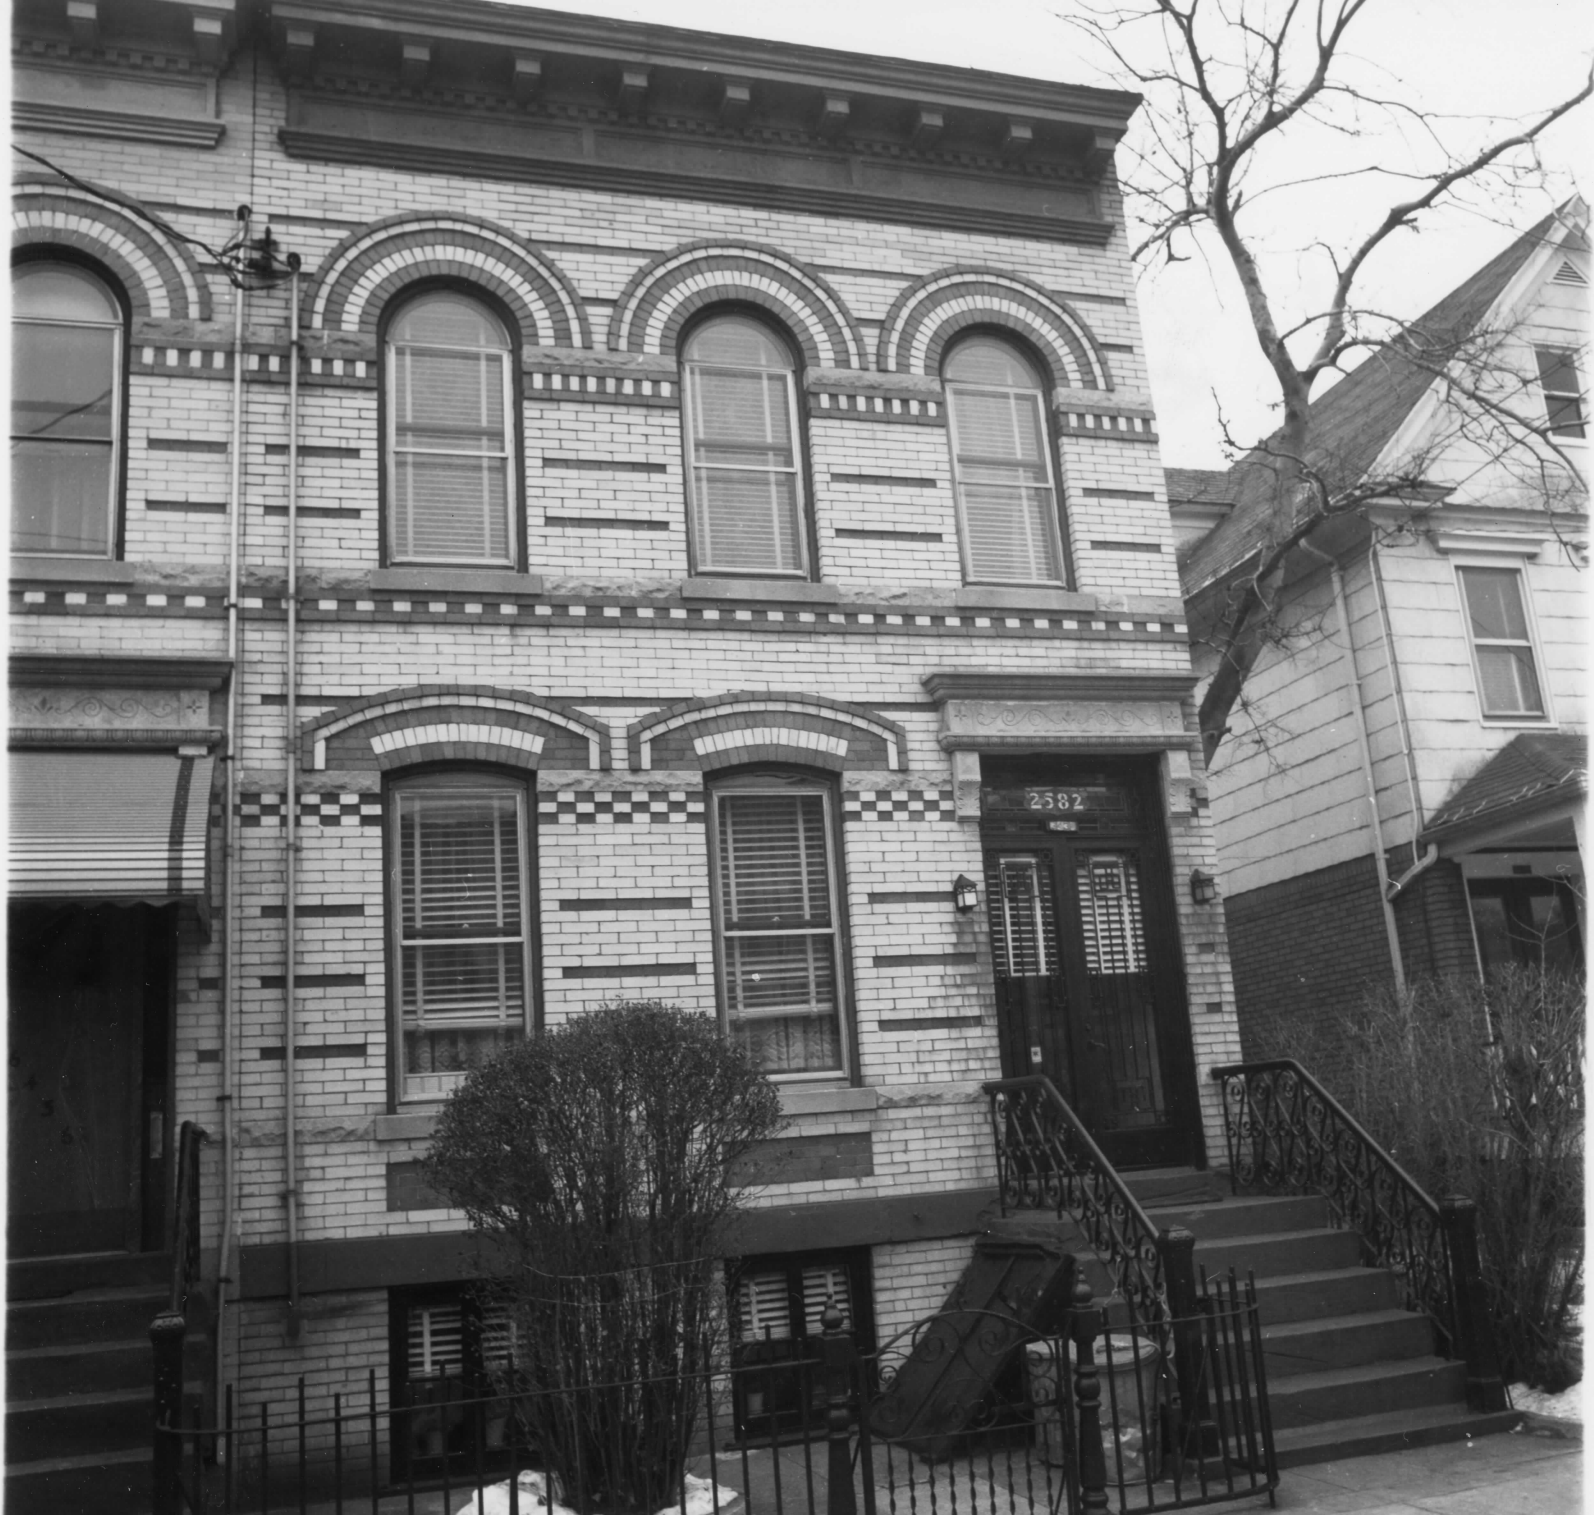
Photo # 44

The buildings, which are all identical, are constructed of yellow brick in stretcher bond with burnt orange brick detail such as panels, band courses, dentils, and arches (64-34 Cooper Ave.; Photo 44). The buildings are further characterized by brownstone stoops and water tables, double doors with glass panels and transom lights, cast-stone sills in a continuous band, segmental window arches on the first story and round window arches on the second story, and incised stone door surrounds with foliated consoles and egg-and-dart moldings. The facades are unified by simple pressed metal entablatures with dentils and blocks, visually supported at ground level by decorative ironwork.

3718/4 | 43/44 | green | attached brick row house, 1915, Romanesque and Renaissance Revival detail, arched lintels, pressed metal cornice; original doors, metal awning |

Direction of View: South

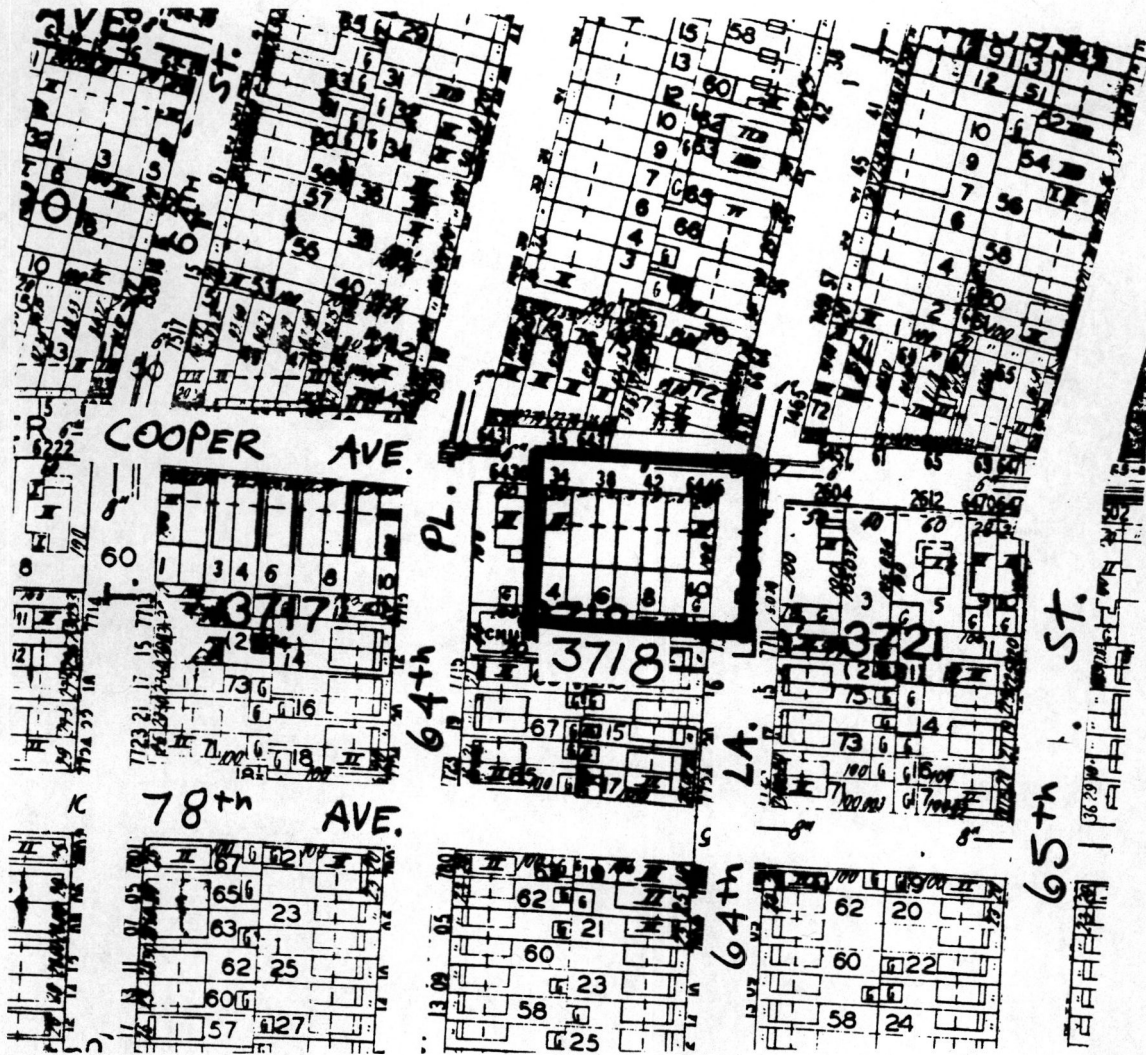
District 14: COOPER AVE. ROW

The Cooper Ave. Row includes the following addresses as delineated on the accompanying tax map.

64-34 to 64-46 Cooper Ave.

*NO MENTION OF REAR YARDS, BUT THEY APPEAR FROM THE MAP TO
BE INCLUDED*
