National Register of Historic Places
Inventory—Nomination Form

historic Riverside Drive West 80th-81st Streets Historic District

The Riverside Drive/West 80th-81st Streets Historic District is a small cohesive district composed of thirty-five contributing buildings (and one intrusion) dating from the period of the Upper West Side's initial architectural development. The thirty-two row houses and three of the four apartment buildings in the district were erected during the 1890s and form a cohesive grouping of low-scale structures now surrounded by high-rise twentieth-century multiple dwellings, an altered apartment building of the 1890s, and a modern school. The district is a compact unit comprising parts of two contiguous blocks; the district includes the north and south sides of West 80th Street between West End Avenue and Riverside Drive, the south side of West 81st Street between these same streets, and almost two complete block fronts on Riverside Drive between West 79th and 81st Streets. Stylistically, the buildings in the district reflect the eclecticism of the period, with designs exhibiting Romanesque Revival, Beaux Arts, Venetian Gothic, Elizabethan, and Flemish forms.

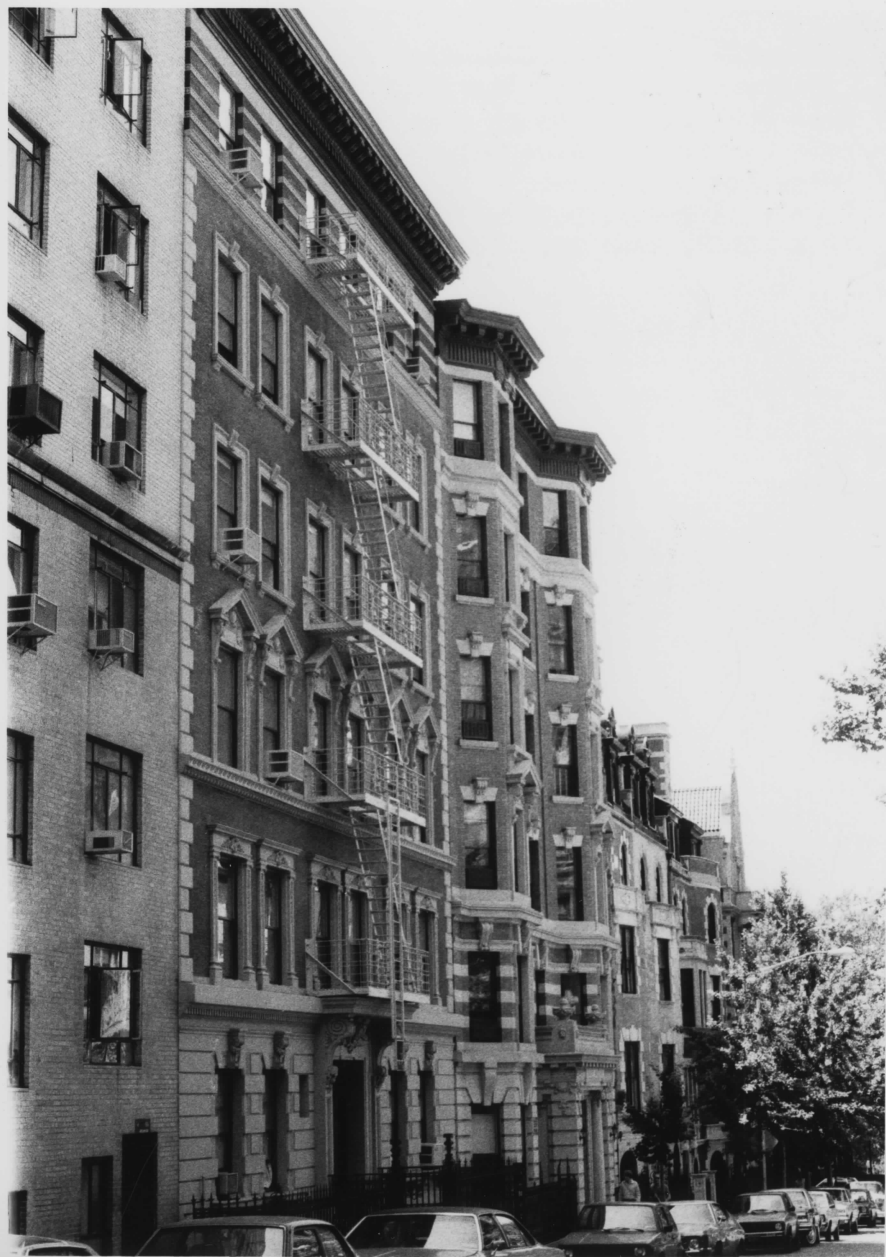
No. 1

Riverside Drive/West80th-81st Streets
Historic District New York County, NY
West 80th Street, south side (Nos. 306-
326 and 77 Riverside Drive side facade)
view from northeast

The three six-story apartment houses in the historic district are contemporary with the row houses built by True. All three are Beaux-Arts style structures designed in 1898 (see photo 1). These buildings have rusticated bases and brick upper stories ornamented with terra cotta. Among the prominent Beaux-Arts style forms prevalent on these structures are cartouches, shields, quoins, frets, urns, wreaths, and lion's heads.

West 80th Street, south side (see photos 1-2)

- No. 306. Janes & Leo, 1898. Six-story, Beaux-Arts style apartment building constructed of Roman brick with limestone base and terra-cotta trim.
- No. 310. James E. Ware & Son and Herbert S. Harde, 1898. Six-story, Beaux-Arts style apartment building constructed of brick with limestone base and limestone and terra-cotta trim.

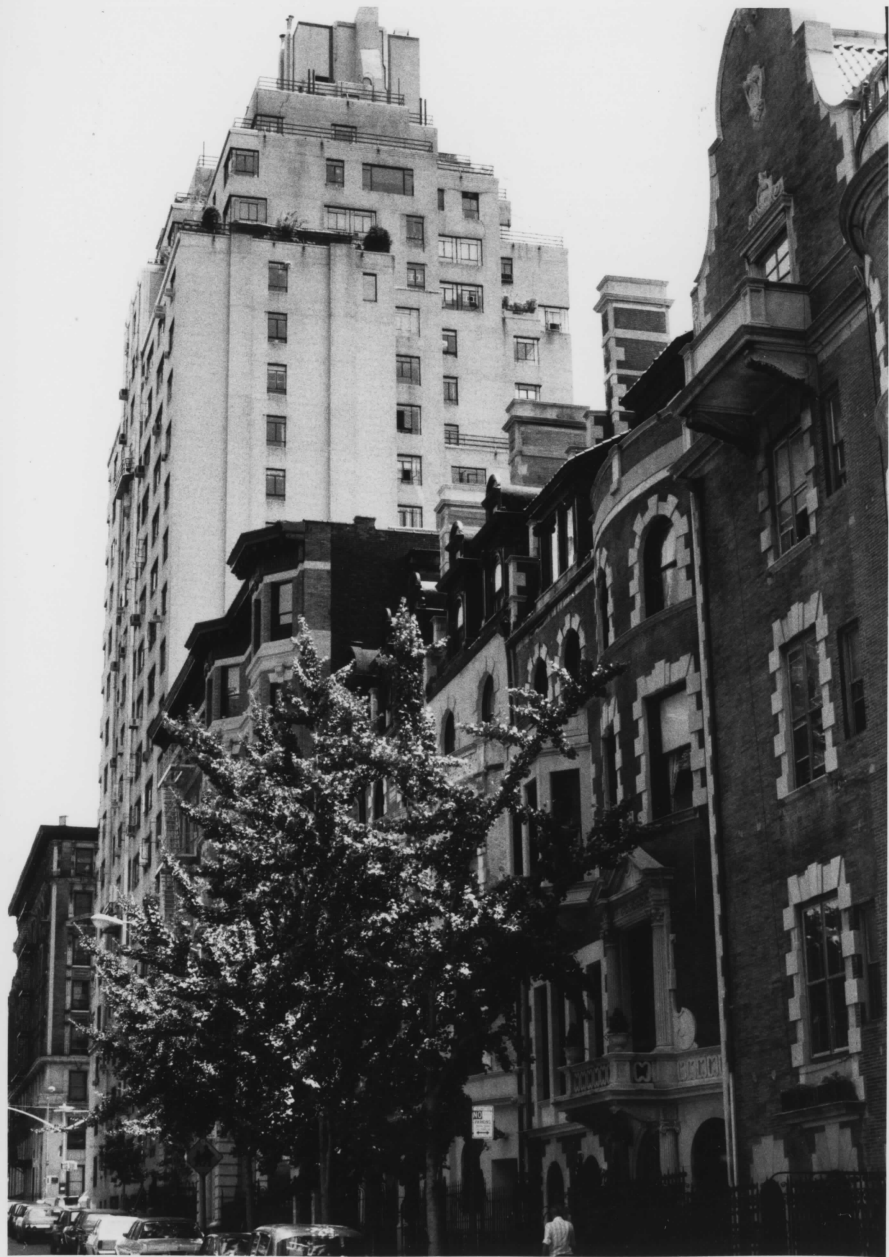
Photo No. 2

Riverside Drive/West 80th-81st Streets
Historic District New York County, NY
West 80th Street, south side (from right to
left--77 Riverside Drive side facade and
326-306 West 80th Street and view out of
district) view from northwest

The majority of the row houses in the historic district were designed and built by Clarence True in a style that is identified with his work along Riverside Drive. The twenty-one houses that True designed in 1897 and 1898 are Beaux Arts style structures, many of which have Elizabethan details such as strapwork ornament and rounded gables. Others have Flemish stepped gables, French Renaissance pilasters with diamond patterns, and Beaux-Arts style cartouches. Most of these five-story and five-story and basement houses were constructed of Roman brick with limestone trim. Several of the houses have fronts clad entirely with limestone or sandstone. All have rooflines with picturesque profiles accented by gables, dormers, and tall chimneys. Examples of True's houses are located at 74-77 and 81-86 Riverside Drive (see photos 7-8), 320-326 and 319-323 West 80th Street (see photos 2-3), and 316-320 West 81st Street (see photo 5).

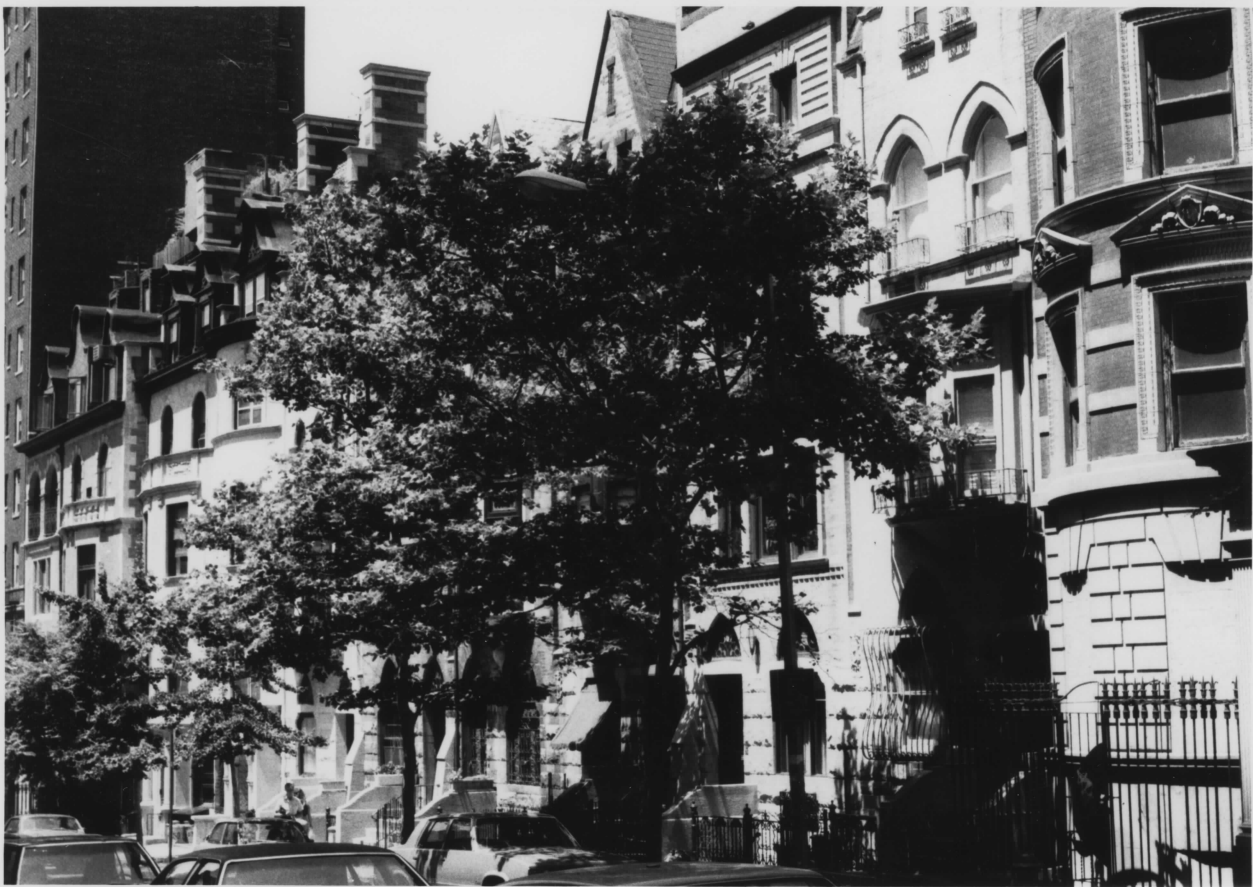
Photo No. 3

West 80th Street, north side (from right to

left--303-305 West 80th Street detail-

323 West 80th Street) view from southeast

The same architect and developer who designed and built the 81st Street row were also responsible for the row behind it at 307-317 West 80th Street (1894, see photos 3-4). These four-story and basement yellow brick houses with limestone bases and limestone and terra-cotta trim are articulated by pointed-arched Venetian Gothic style parlor floor windows with stained-glass transoms and by projecting rectangular and angled oriels, some with Spanish-tile roofs.

West 80th Street, north side (see photos 3-4)

- No. 303-305. Townsend & Harde, 1898. Six-story, Beaux-Arts style apartment building constructed of brick with limestone base and terra-cotta trim. Building vacant, but intact on the exterior as of October 1983.
- No. 307. Charles H. Israels, 1894. Four-story, peak-roofed, Neo-Venetian Gothic style row house constructed of yellow brick with limestone base and trim and fine stained-glass transom lights.
- No. 309. Charles H. Israels, 1894. Four-story, flat-roofed, Neo-Venetian Gothic style row house constructed of yellow brick with limestone base and limestone and terra-cotta trim. Fine stained-glass transom lights.
- No. 311. See No. 307.
- No. 313. See No. 307
- No. 315. See No. 309.
- No. 317. See No. 307. Alteration: stained glass removed, house painted.

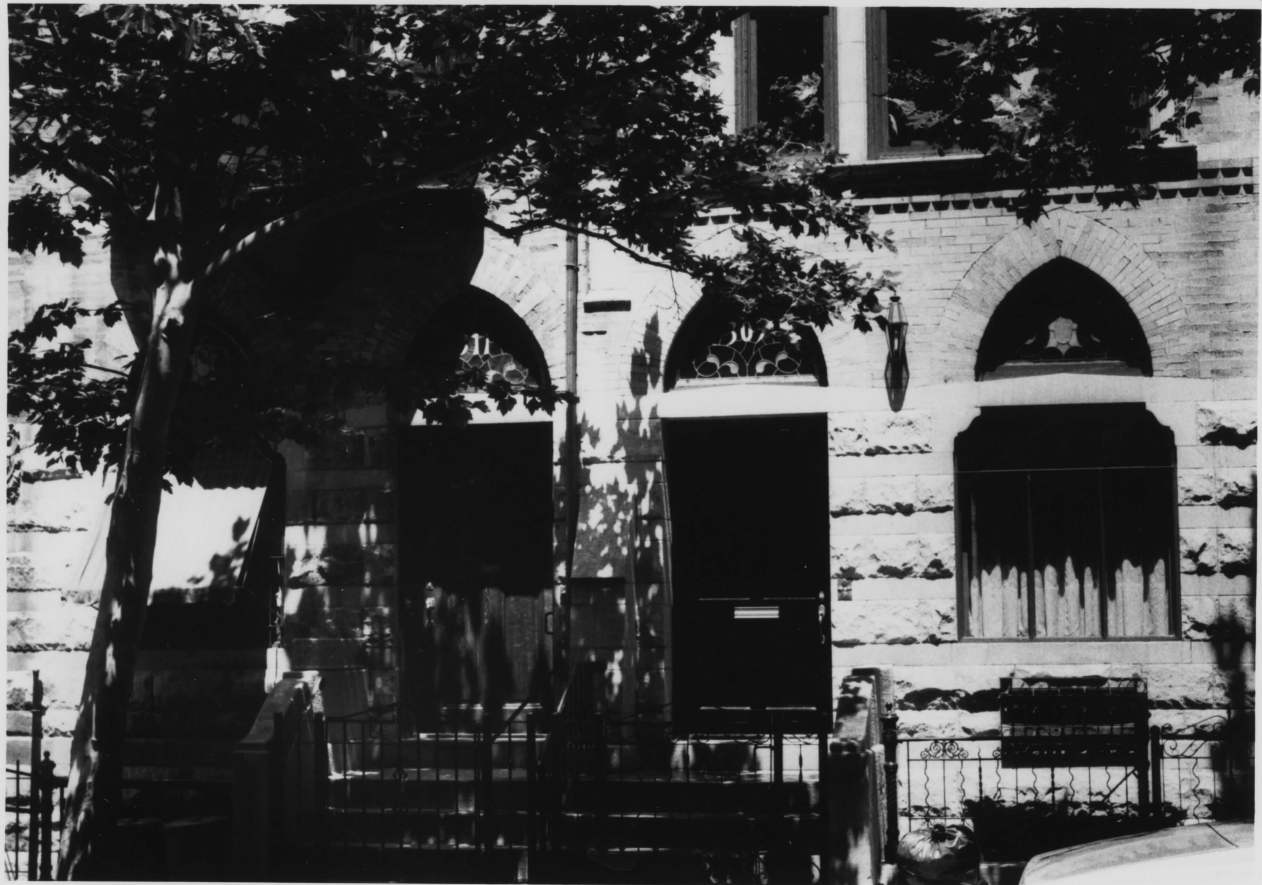
Photo No. 4

Riverside Drive/West 80th-81st Streets
Historic District New York County, NY
309-311 West 80th Street detail. View from
southeast

houses at 307-317 West 80th Street (see photos 3-4). The fact that Jews were involved with the construction of these houses reflects an important aspect of the Upper West Side's history. The development of the Upper West Side coincided with the rise of New York City's Jewish population as a major economic force. Because of discrimination, Jews often found it difficult to buy houses in more settled areas of the city; the newly developing Upper West Side proved to be a haven for Jewish families. New York's Jewish population was important to the development of the area and to its character after the new homes were occupied.

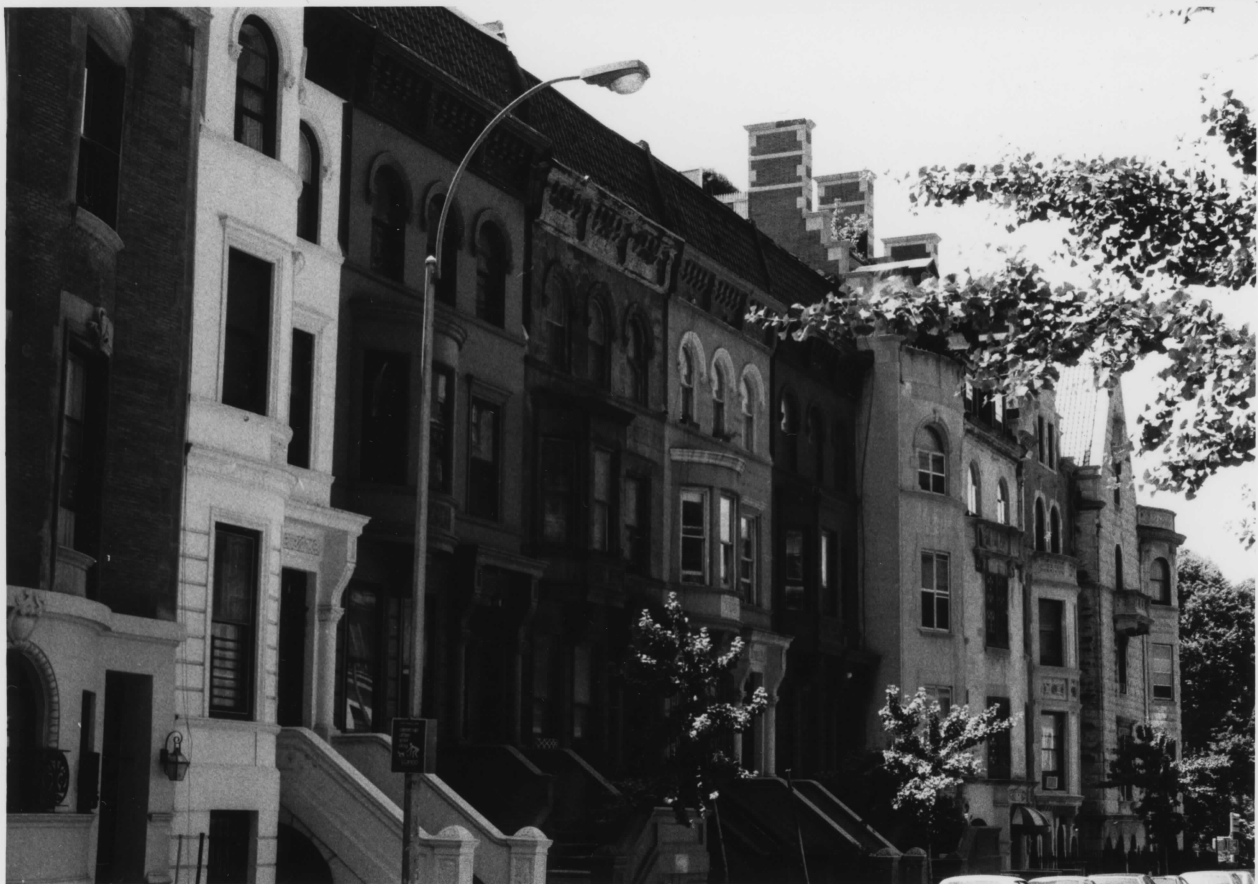
Photo No. 5

West 81st Street south side (Nos. 304 detail-
320 and 86 Riverside Drive side facade) view
from northeast

The five earliest houses erected in the area are 306-314 West 81st Street, a row of five three-story and raised basement late Romanesque Revival style buildings dating from 1892 (see photos 5-6). These houses were constructed with brownstone fronts and ornamented with Byzantine carving, dog-leg stoops, iron cornices, rounded and angled bays, and a continuous dwarf mansard roof clad with Spanish tile.

West 81st Street, south side (see photos 5-6)

- No. 304. Clarence True, 1897. Five-story, Beaux-Arts style row house constructed of Roman brick with limestone trim. Possible alteration: Original entrance may have been converted to a window and a new entrance provided.

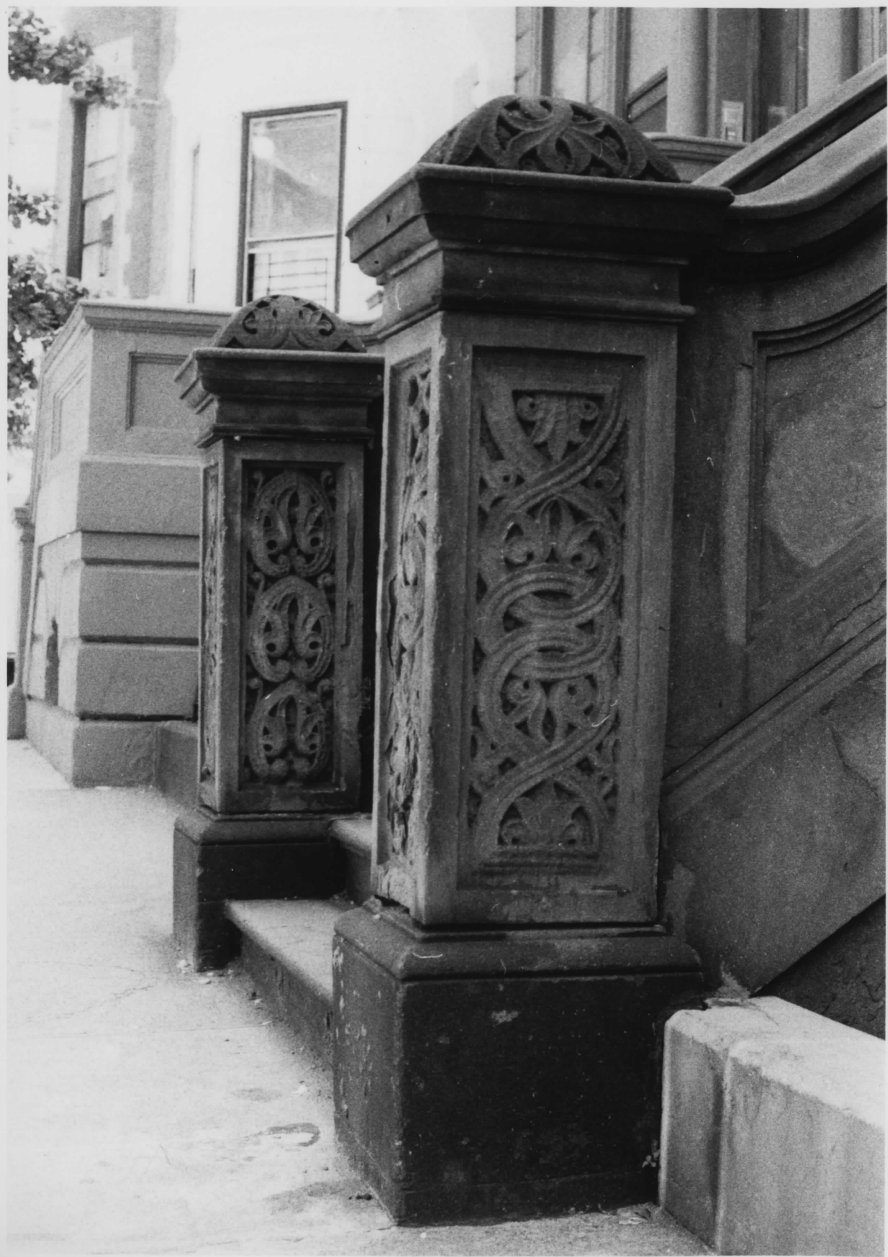
Photo No. 6

Riverside Drive/West 80th-81st Streets
Historic District New York County, NY
306 West 81st Street stoop detail, view
from northwest

- No. 306. Charles H. Israels, 1892. Three-story and raised basement Romanesque Revival style row house constructed of brownstone with Spanish tile dwarf mansard roof. Facade painted.

The earliest buildings within the district are a row of five houses designed in 1892 by Charles H. Israels for Bernard Levy at 306–314 West 81st Street (see photos 5–6). In 1894 Israels and Levy again teamed up for the design and construction of a row of six

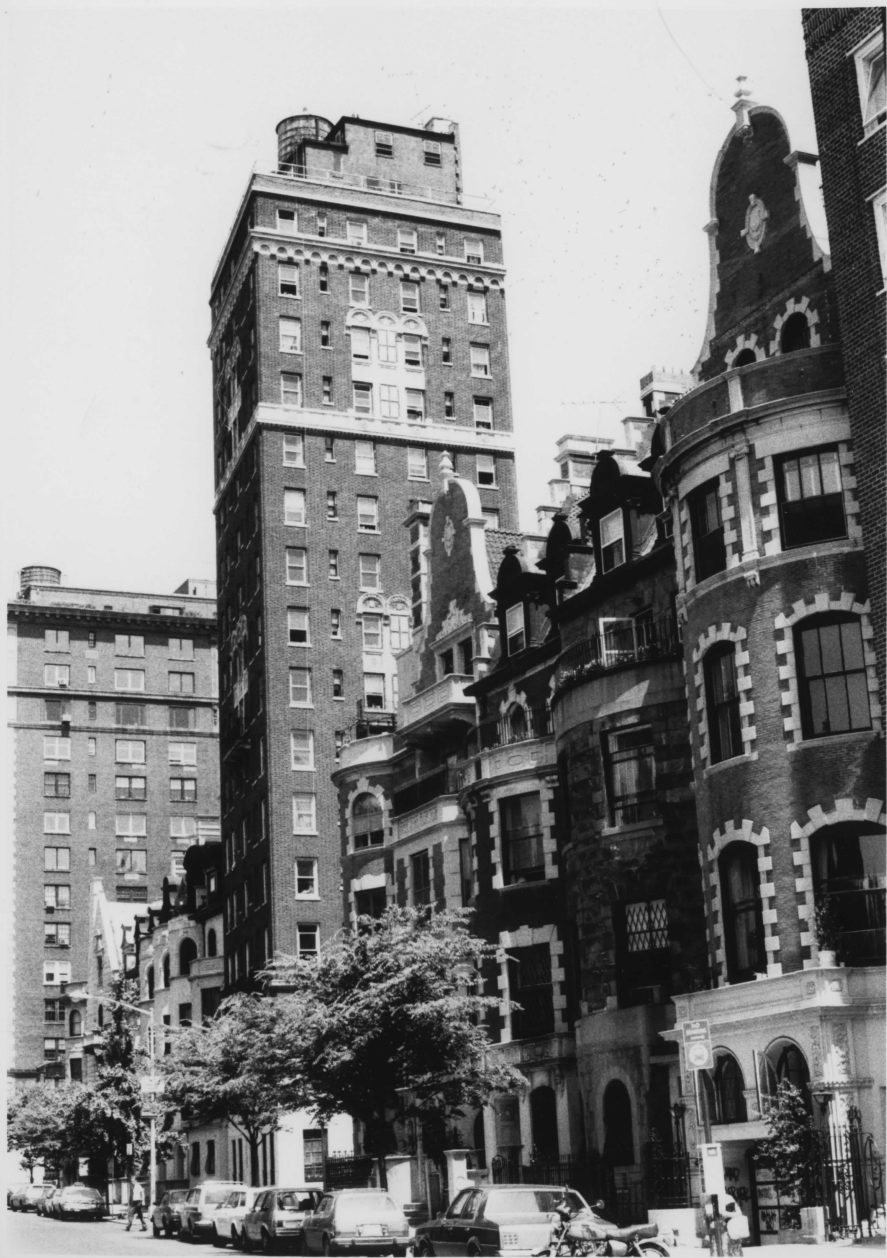
Photo No. 7

74-86 Riverside Drive (including intrusion
at 80 Riverside Drive) view from southwest

There is one intrusion in the district, No. 80 Riverside Drive, a fifteen-story red brick apartment building designed in 1919 by Maurice Deutsch (see photo 7). This building replaced one of Clarence True's row houses.

Riverside Drive between West 79th and West 80th Streets (see photo 7)

Riverside Drive between West 80th and West 81st Streets (see photos 7-8)

No. 80. Maurice Deutsch, 1919. Sixteen-story, Neo-Georgian style apartment building constructed of brick laid in Flemish bond with two-story stone base and terra-cotta trim. Intrusion in district.

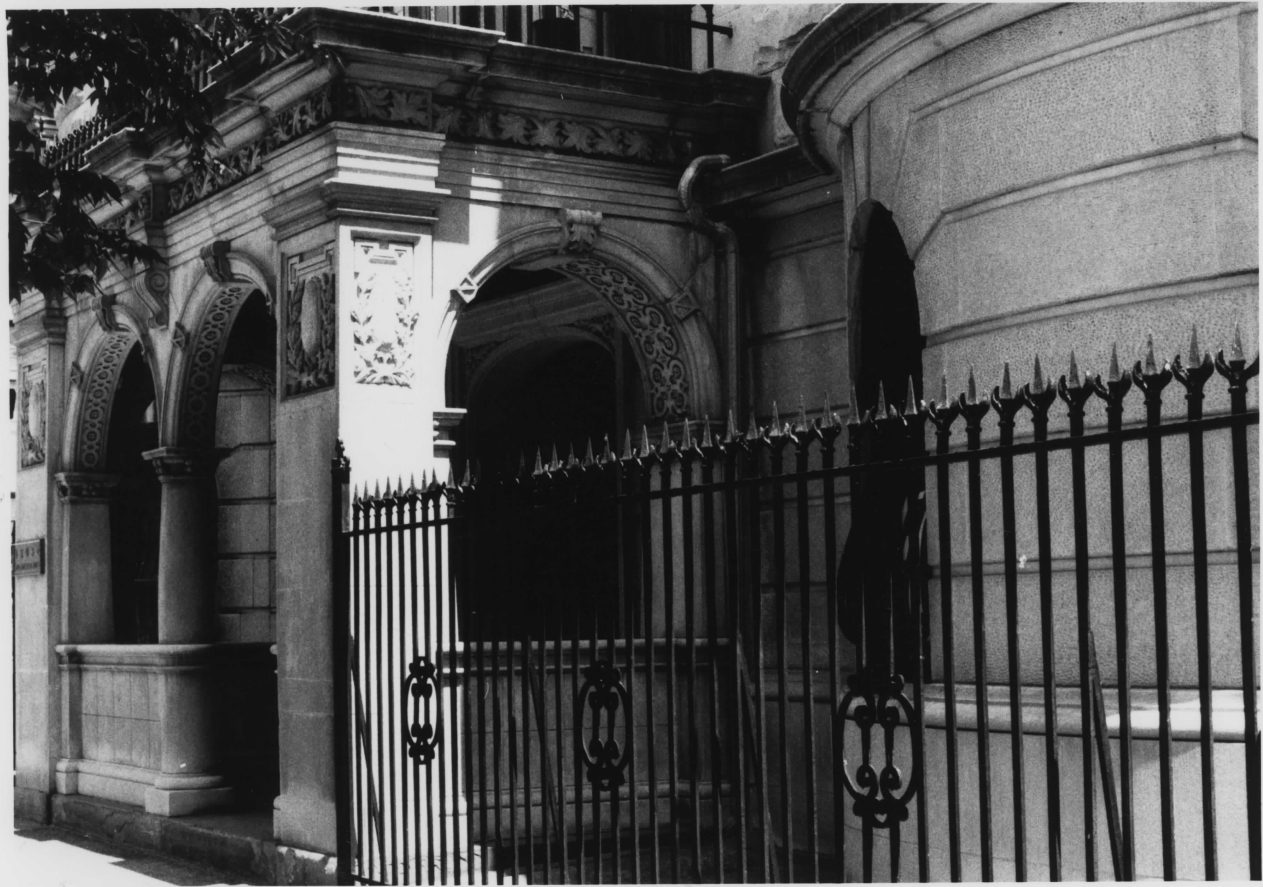
Photo No. 8

Riverside Drive/West 80th-81st Streets
Historic District New York County, NY
86 Riverside Drive detail. View from
southwest

No. 86. Clarence True, 1897. Five-story, Beaux-Arts style row house with Gothic and Elizabethan trim, constructed of rock-faced limestone with smooth limestone base and trim.
