BUILDING-STRUCTURE INVENTORY FORM

1. BUILDING NAME(S): Eastman Cottage

3. STREET LOCATION: 130 Mott Avenue

Roslyn Village Multiple Resource Area
Roslyn, Nassau Co., NY
Component 4: Eastman Cottage
130 Mott Avenue

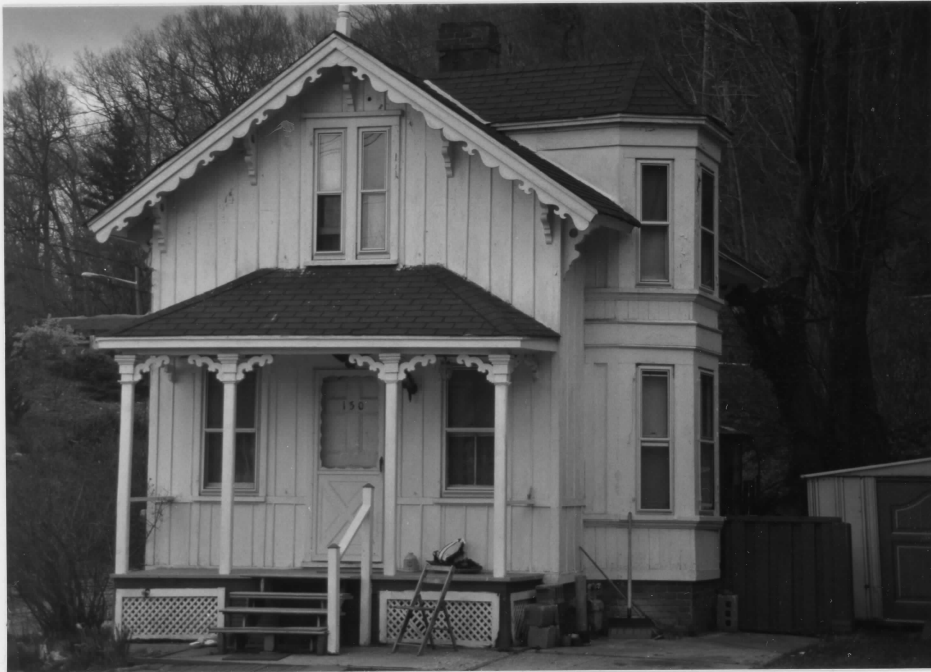
18. The Eastman Cottage is a one-and-one-half story frame residence with a board and batten exterior designed in the picturesque cottage tradition of Downing and Vaux. The house is rectangular in plan with its principal facade at the north gable end. A small gabled kitchen extension and an attached privy or woodshed extend southward from the southeast corner of the house.

The facade of the house features a central first floor entrance flanked by two windows with two-over-two double-hung sash and bracketed pent roots. A hipped-roofed front porch supported by four columns with scroll-sawn brackets projects forward from the facade. A window with paired one-over-one double-hung sash is centered above the entrance at the attic story. The projecting gable roof is supported by five scroll-sawn brackets at the facade and detailed with scroll-sawn bargeboards. The gable ridge is surmounted by a simple wooden finial.

South facade of house viewed north from Mott Avenue.
