BUILDING-STRUCTURE INVENTORY FORM

- BUILDING NAME(S): Roslyn Grist Mill
- COUNTY: Nassau TOWN/CITY: NA VILLAGE: Roslyn
- STREET LOCATION: 1347 Old Northern Blvd.
- OWNERSHIP: a. public b. private
- PRESENT OWNER: Nassau County ADDRESS: 1 West St., Mineola, N.Y.
- USE: Original: grist mill Present: vacant
- ACCESSIBILITY TO PUBLIC: Exterior visible from public road: Yes No
Interior accessible: Explain restricted

Roslyn Village Historic District, Roslyn, Nassau Co., Roslyn Grist Mill
Components 2

Component 2: Roslyn Grist Mill
1347 Old Northern Boulevard

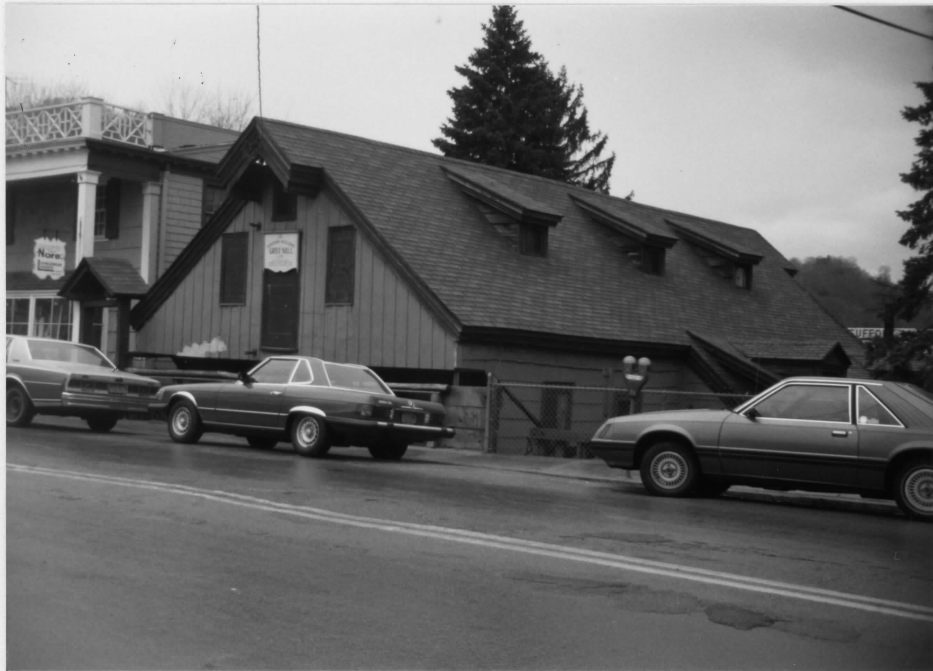
South front of mill viewed northwest from Old Northern Boulevard.

The south or principal facade of the mill features a cantilevered attic story projecting four feet forward of the second story wall plane. Plank doors are located at the center of the second and attic stories and a projecting hoistway is positioned above them at the top of the gable. The doorways are flanked by six-over-six double-hung sash windows installed in 1916. The north elevation features a similar arrangement of doors and an overhead pulley apparatus. Window openings are irregular and, where they have not been boarded-up, feature six-over-six sash from the 1916 rehabilitation. The east elevation includes a lean-to extension, enlarged and rebuilt in 1916, and four shed roof window dormers, including one continuous dormer with ten six-light windows.

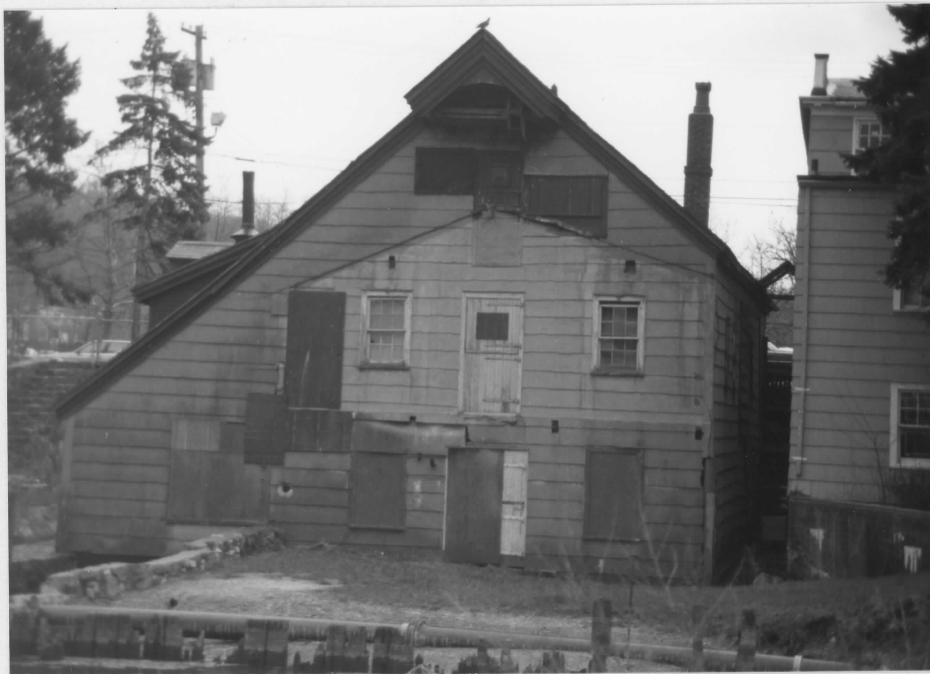
North end of mill viewed from bulkhead north of mill.
